Pest Inspection Report

1 Graduate Place , Perth Suburb, 6163

Inspection prepared for: Sample Client
Agent: Sample Agent - Real Estate Place

Inspection Date: 16-10-2012 Time: 9:00AM
Weather: Cloudy, 10C

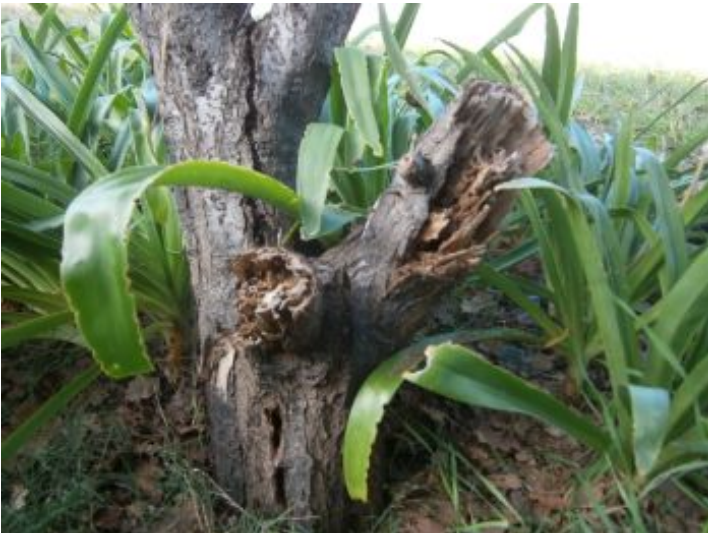
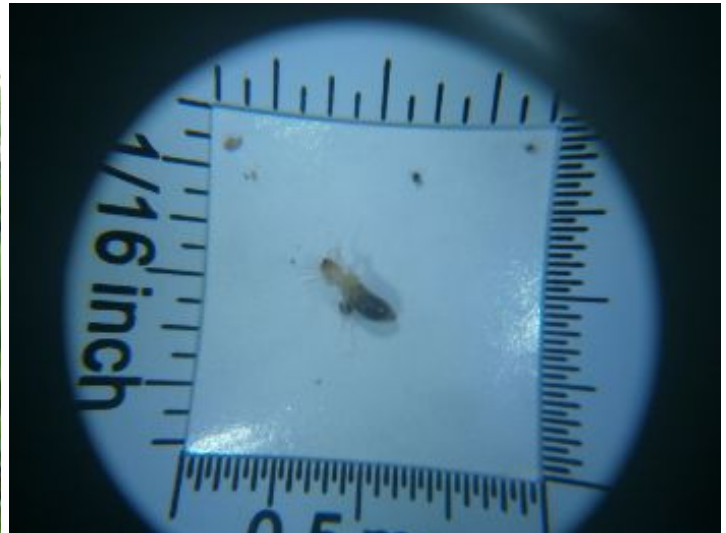
- Evidence of subterranean termite activity was detected in a tree located on the verge on the southern side of the property.

A termite management plan should be put in place. AS 3660.2 recommends that a routine inspection for termite management purposes be carried out at least annually.

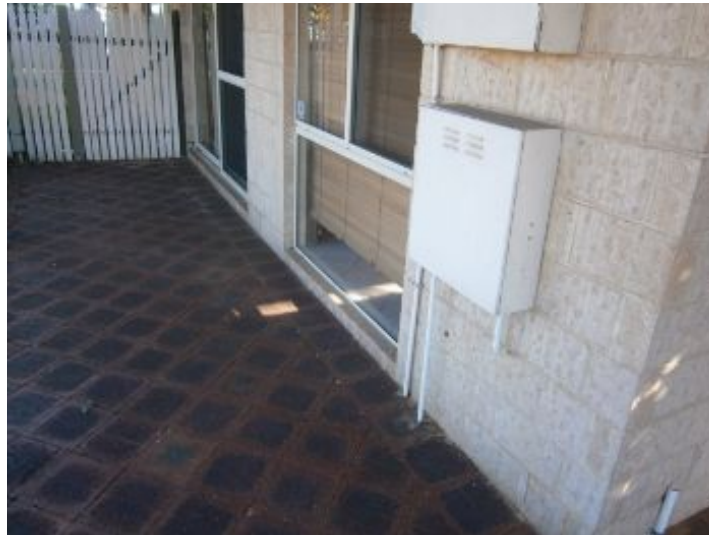
- External concrete slab edges should be exposed. If they are concealed by pathways, patios, pavers or garden beds, there is a high risk of concealed termite entry.
- A building constructed on a concrete slab is susceptible to concealed termite entry.
- In order to minimise timber pest attack, slab edges should have a clearance of 75mm and not covered.

- Slab edges are covered by pavers.

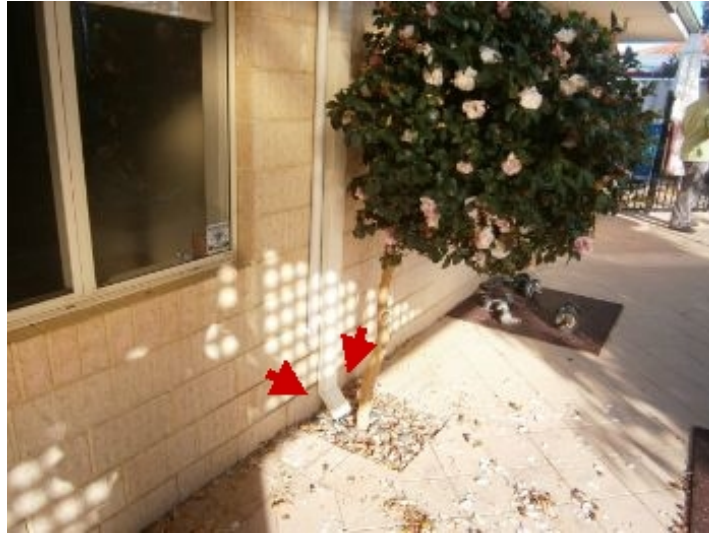
- Some of the down pipes are not plumbed into the storm water. This allows water discharged to pool beside the external walls and soak in adjacent to the structure. This can cause foundation settlement, dampness in external walls and can create an ideal environment for termites. It is recommended that all downpipes should be plumbed into the storm water
- The air conditioner discharge pipe discharges on the foundations. This should ideally be directed into the stormwater, or at least 3 metres away from the building.

- Air conditioner overflow discharge adjacent to foundations. Recommending directing to storm water drain/soak well or away from the foundations.
- Appears to be downpipes which are not connected to the storm water or soak wells.

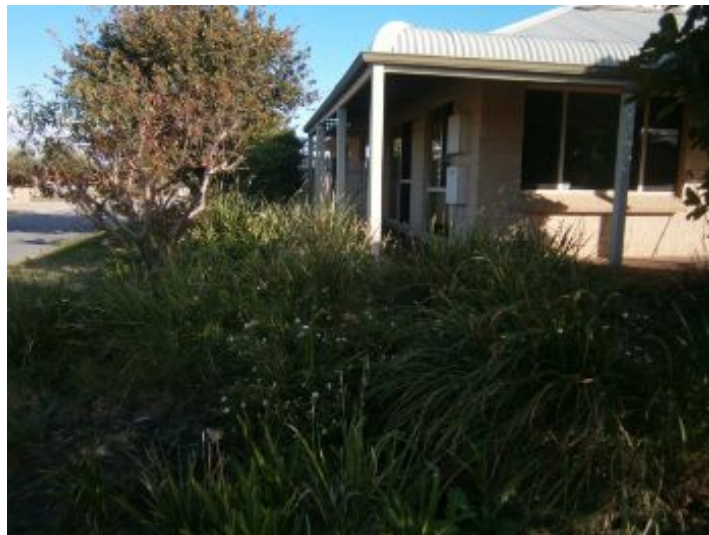
- Termites usually construct their nests in or below trees. For that reason, trees that are a susceptible species for infestation need to be monitored as part of any effective termite management programme.
- Remove any garden beds abutting the home to eliminate excessive moisture.
- Prune or remove any plants that are in contact or proximity to home to eliminate pathways of wood destroying insects.
- Tree limbs within 3m of roof should be trimmed away to provide air and sunlight to roof, while minimizing debris, dampness and abrasion damage.

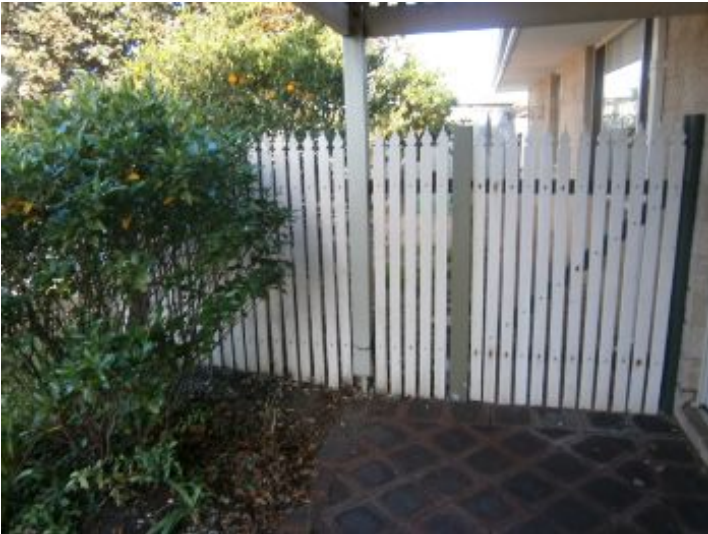
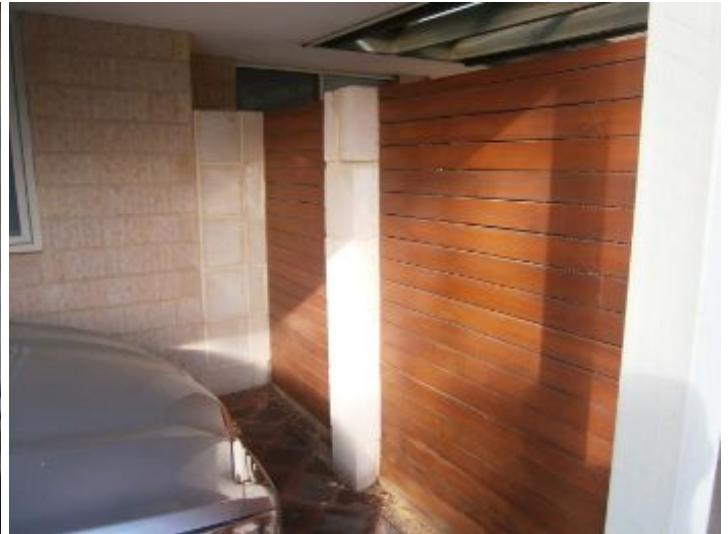
- Timber fences and gates are often subject from termite attack and other timber destroying pests as they are in direct contact with the soil. Regular inspections and removal of affected timbers are recommended.
- Timber gate is in good condition.
- Timber fences are in good condition.

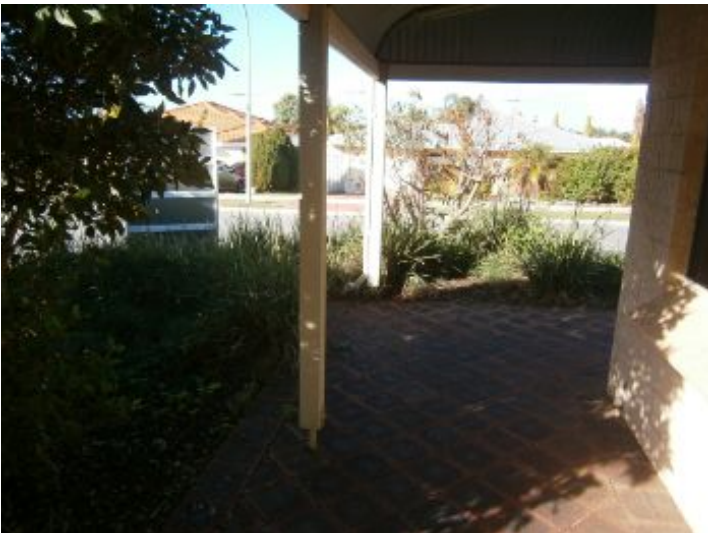
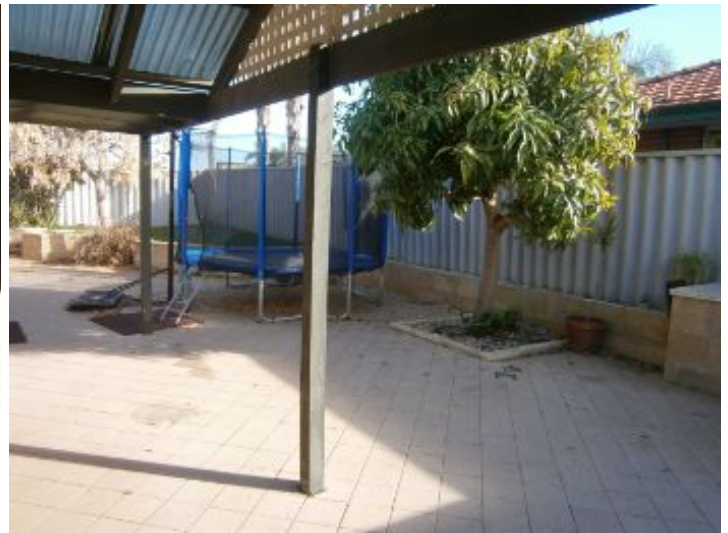
- There are timber posts in contact with the ground which may allow termite access to the structure.

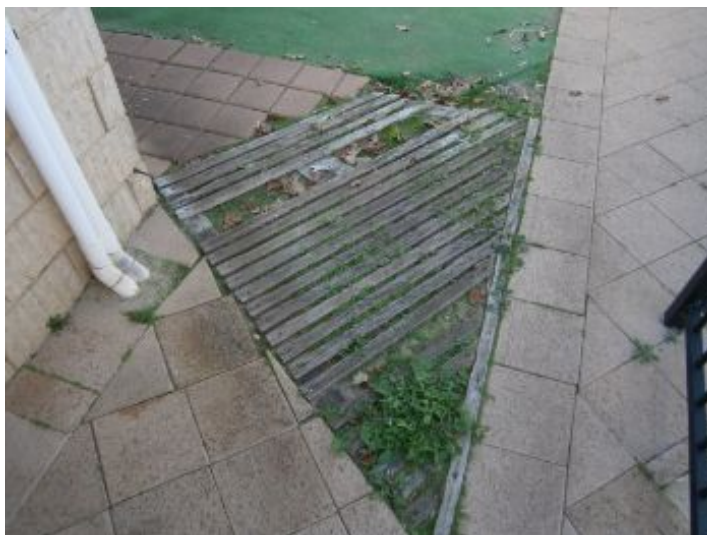
- There is Earth/Wood contact between the timber posts and the ground.
- There is landscaping/stored timber, or old tree stumps in contact with the ground that provides possible breeding grounds for subterranean termites. This should be removed.

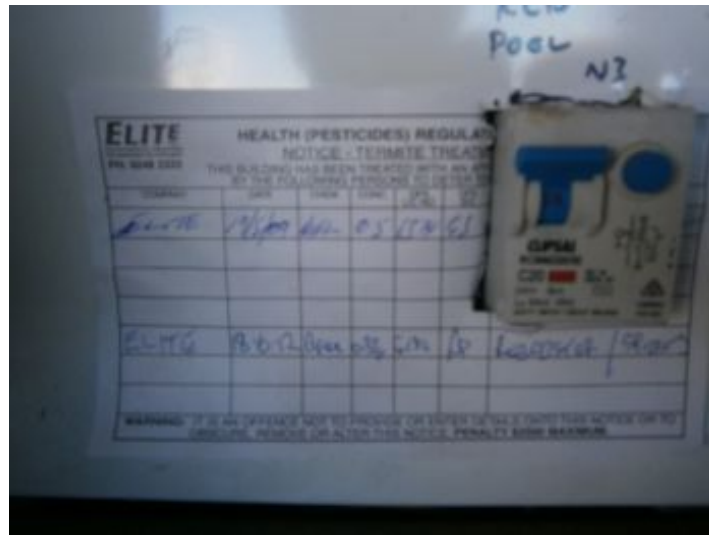
- Subterranean Termites are defined as the group of termite species that make tunnels through the ground to reach a source of food, which in some cases may be a considerable distance from the nest. The most usual location for this group to nest is underground or in concealed areas such as the trunk of a tree, root crown of a tree, or at the base of timber in ground contact such as retaining walls.
- It appears that the last termite treatment to the property was undertaken in June, 2011.
- A termite management plan should be put in place. AS 3660.2 recommends that a routine inspection for termite management purposes be carried out at least annually.
- If termite activity or damage is noted it is possible that further termite damage may be present in concealed areas.

- **Immediate pest termite treatment is recommended.**
