**Resicert**

# Structural Certification Report

1 Sample Drive, Sampleville, 9999

Date of Inspection: 8/2/2016 Time: 09:00AM  
Weather: 29C Sunny

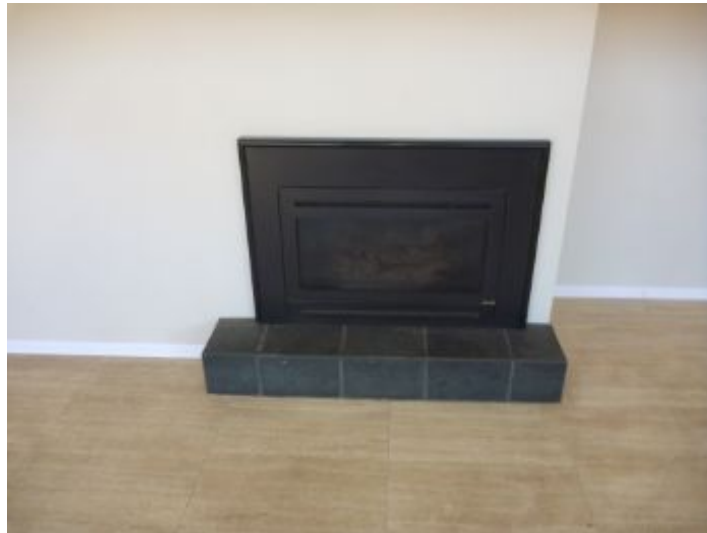
- A gas fired heater was noted. This was not tested as part of the inspection process and should be checked at the final pre-settlement inspection.

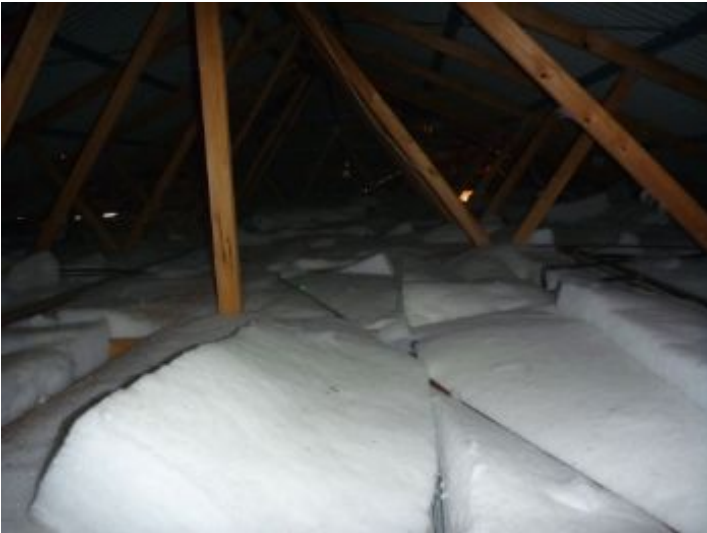
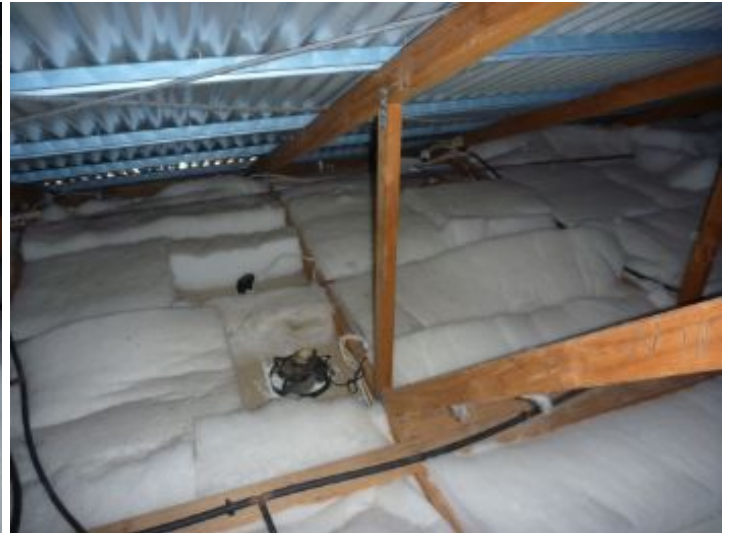
- Polyester batt insulation noted in the accessible ceiling space.

- Insulation averages about 150mm in depth

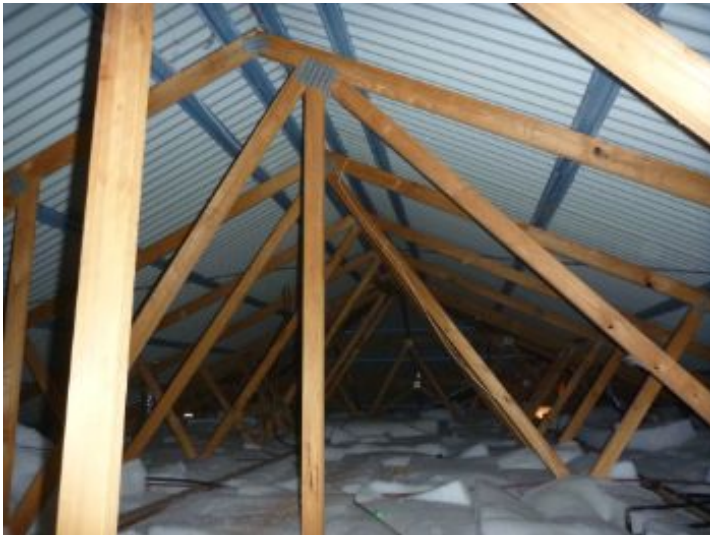
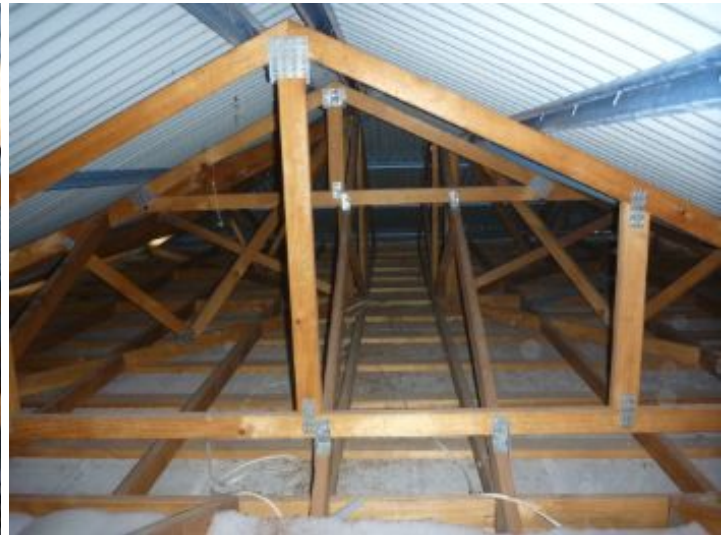
- The timber roof structure appears sound.

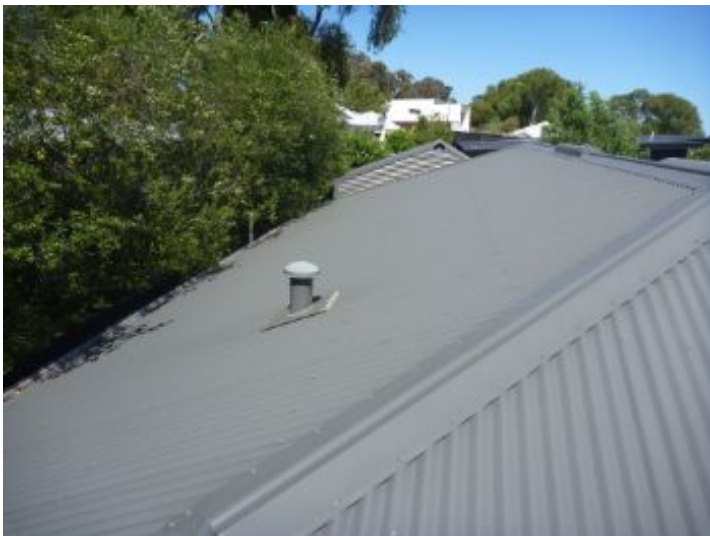
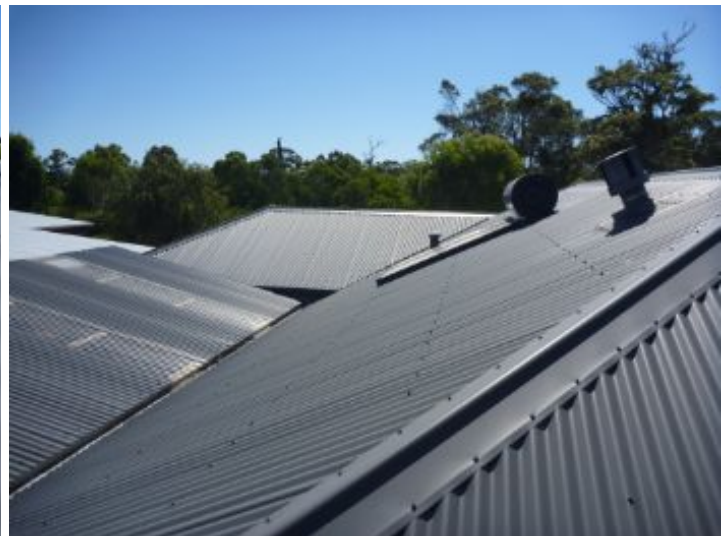
- The metal roof covering appears to be in satisfactory condition other than noted.

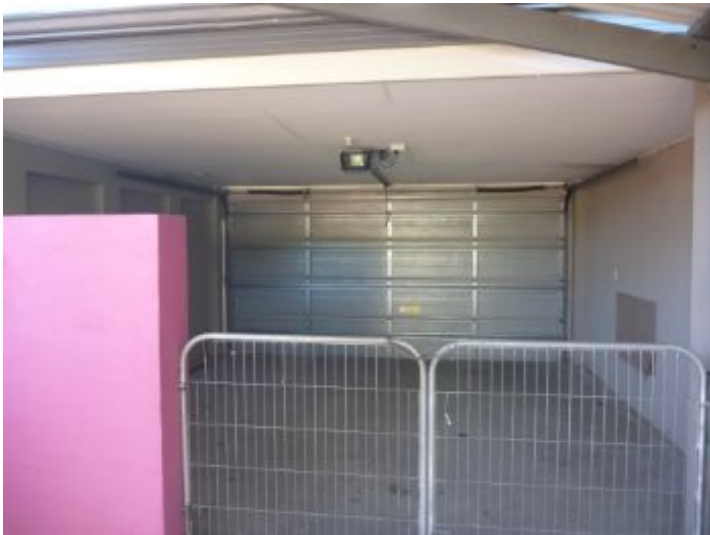
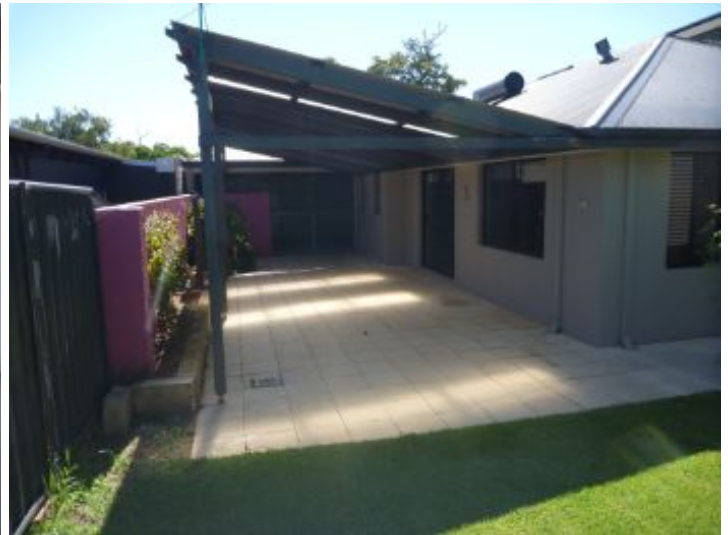
- The attached patio structure appears to be structurally sound.
- The attached garage appears structurally sound.

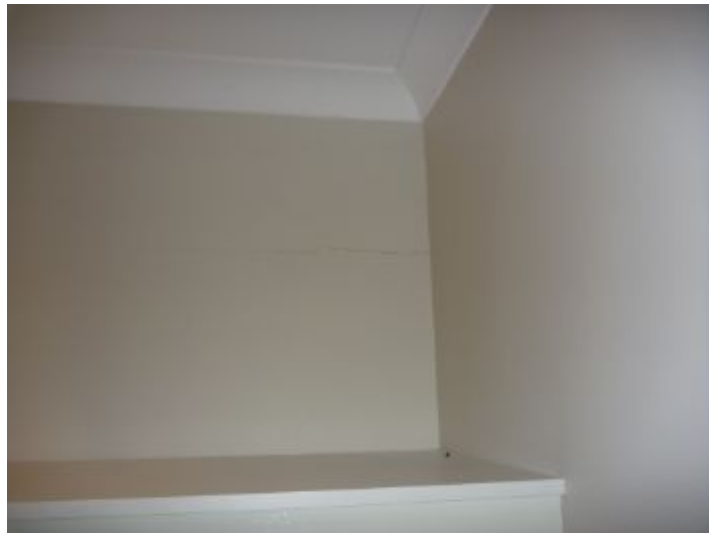
- Due to normal minor differential movement within the property or foundations, small cracks have appeared at various locations around the property and can be repaired normally. They do not appear to have affected the structural integrity of the home.

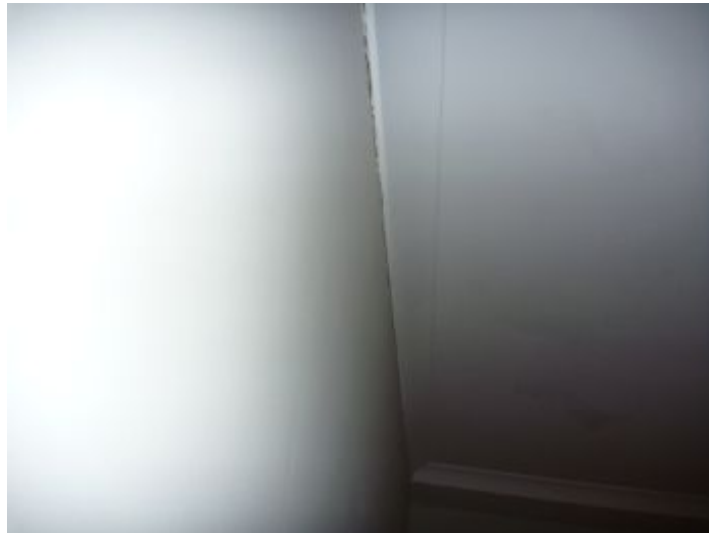
- There is minor cracking which has occurred at the interface between the ceiling cornice and the wall at various locations. This can be a result of foundation settlement and/or movement in the roof structure. This does not appear to have affected the structural integrity of the home and can be repaired normally.

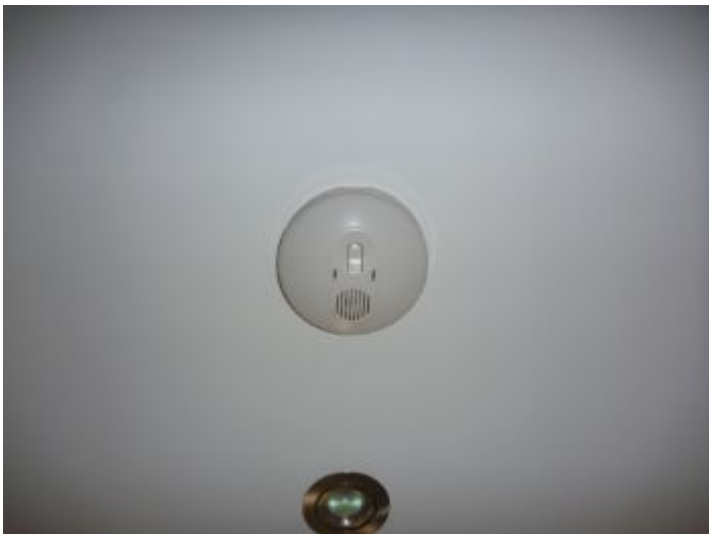
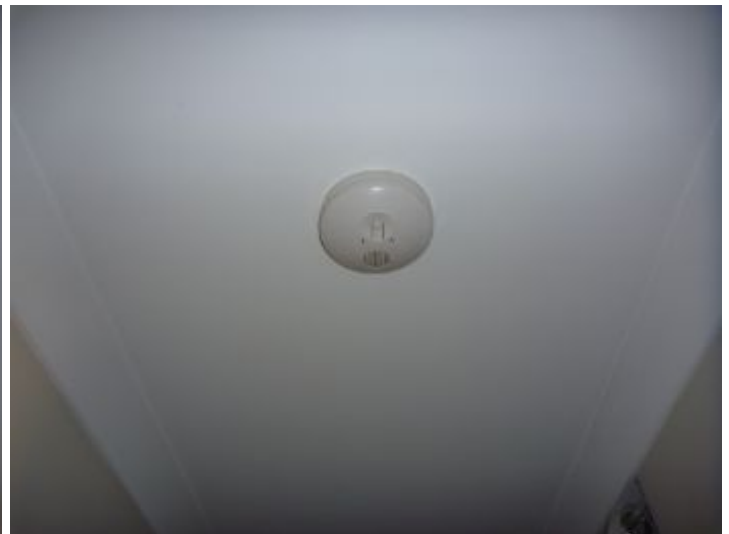
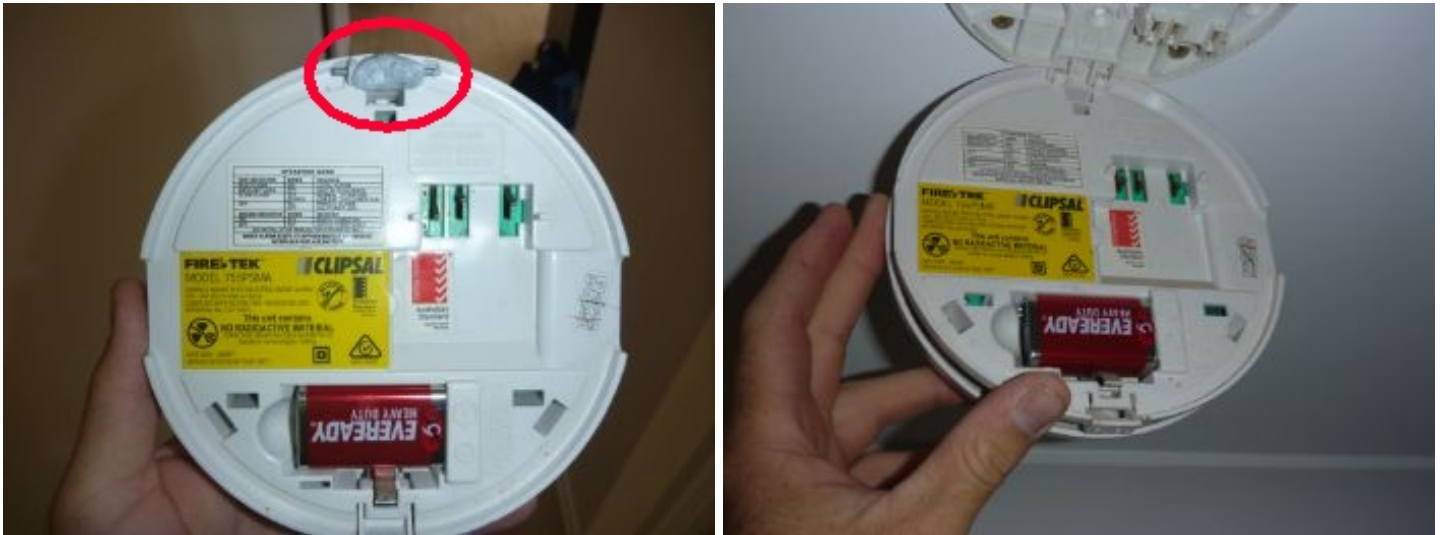
Interior Areas		
Page 10 Item: 3	Smoke Alarms	<ul style="list-style-type: none"><li>• The smoke detector in the entry is damaged resulting in the detector not engaging with the base plate and the hard wired power supply. This detector requires replacement.</li></ul>

- Testing of smoke detectors is not included in this inspection. Pushing the "Test" button only verifies that there is power at the detector--either a battery or hard wired to the house power--and not the operational workings of the detector. The operational check is done by filling the sensor with smoke and is beyond the scope of this inspection. Battery operated smoke alarms should be checked routinely and the batteries changed frequently.
- Hard wired smoke alarms installed in the bedroom hallway and the entry.
- Recommend smoke alarm replacement by: 2017
- **The smoke detector in the entry is damaged resulting in the detector not engaging with the base plate and the hard wired power supply. This detector requires replacement.**

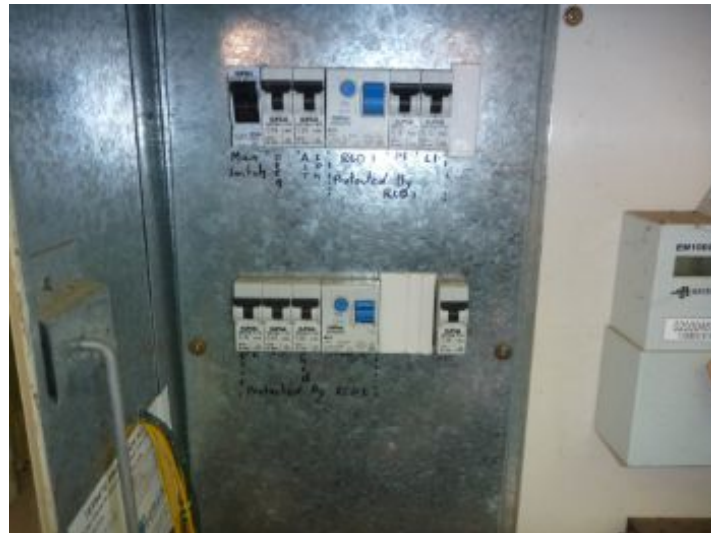
- Main Location:
- South side of the house.

- There are at least 2 RCD's installed which protect both the powerpoint and light circuits. This complies with current regulatory requirements.
