Property Inspection Report

4 Test Avenue, Testville, 9999

Inspection prepared for: Client Name
Date of Inspection: 18/2/2016 Time: 10:00AM
Weather: 26C, Sunny

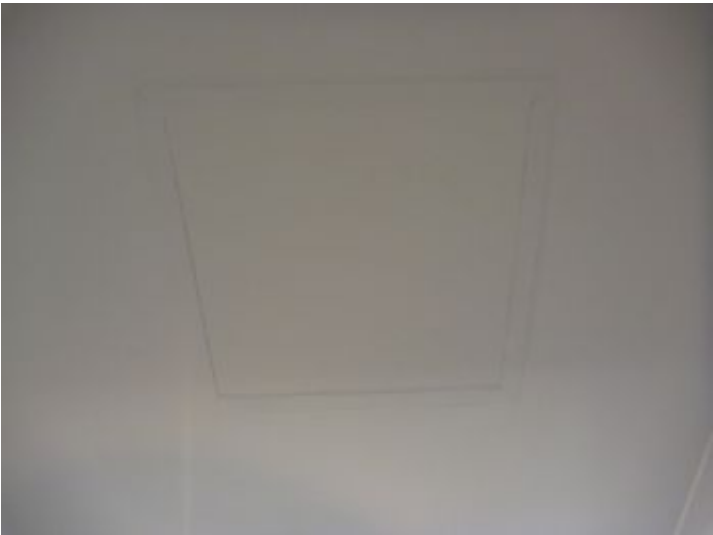
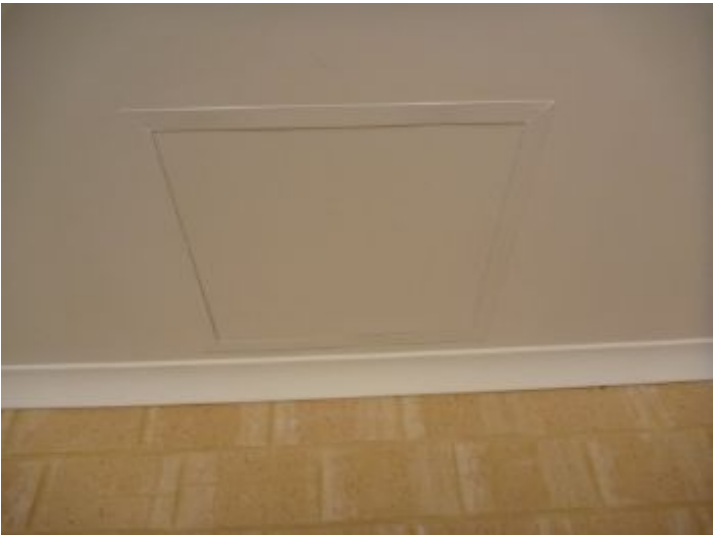
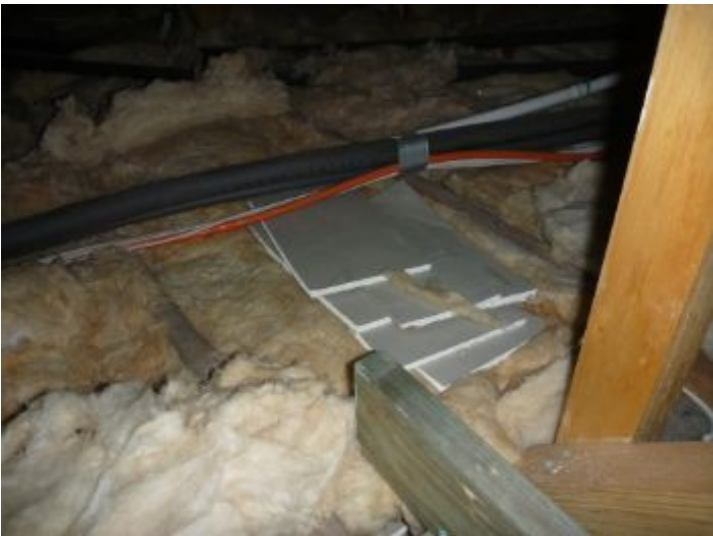
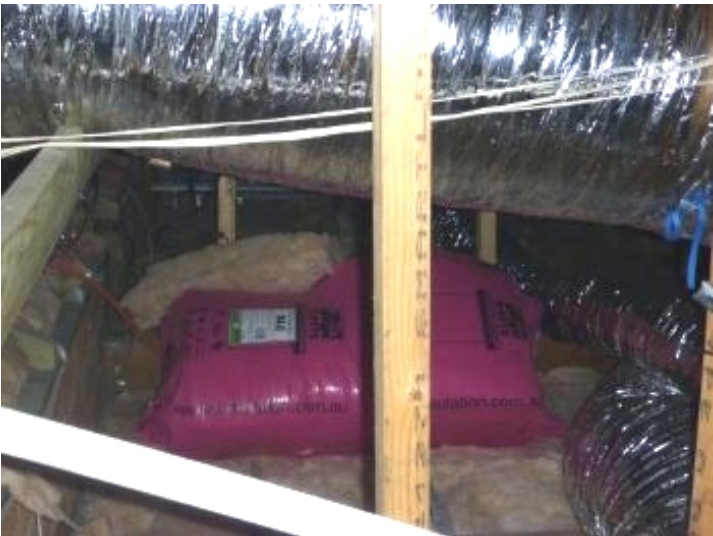
- Building material noted in the roof space. This needs to be removed.

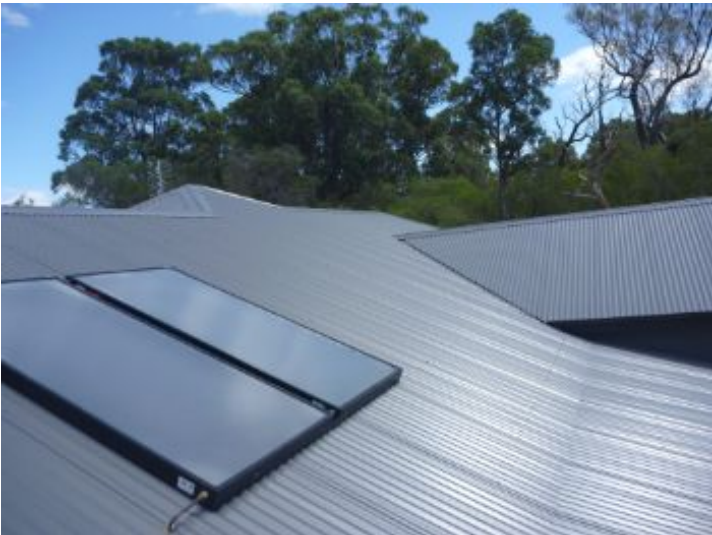
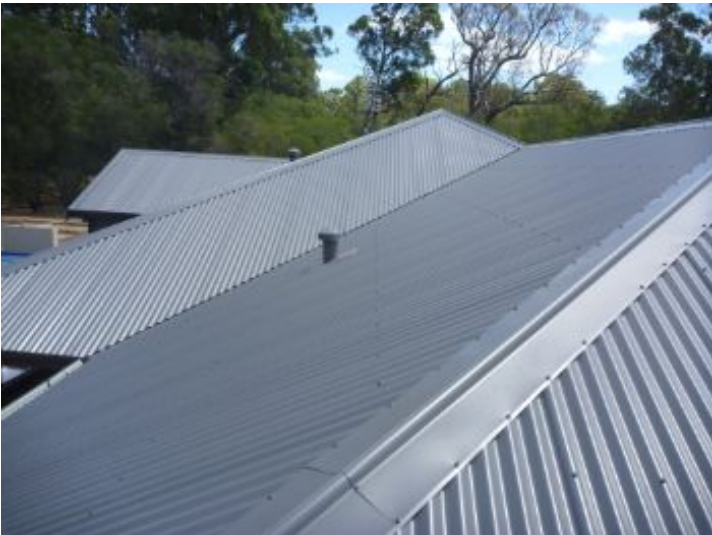
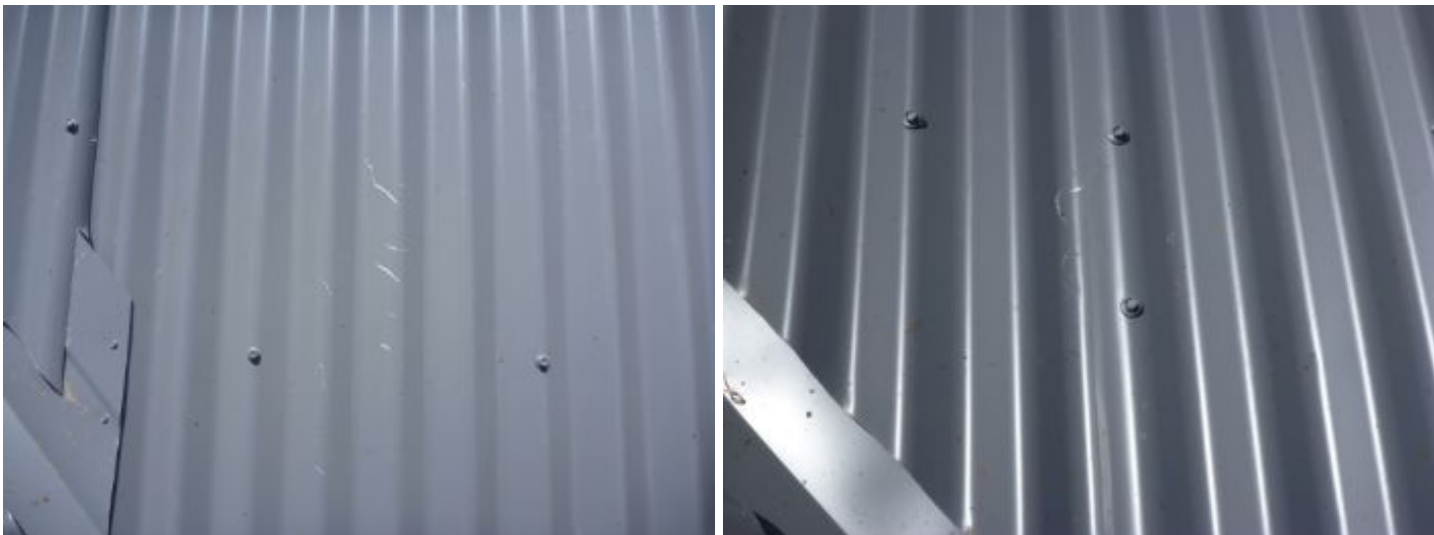
- Materials:
- Roof was walked upon for the inspection
- Observations:
- TV Antennae noted on the roof.
 - Generally the colourbond iron roof sheeting appears to be in satisfactory condition.
 - Some of the colourbond sheeting has been scratched removing the colourbond coating.

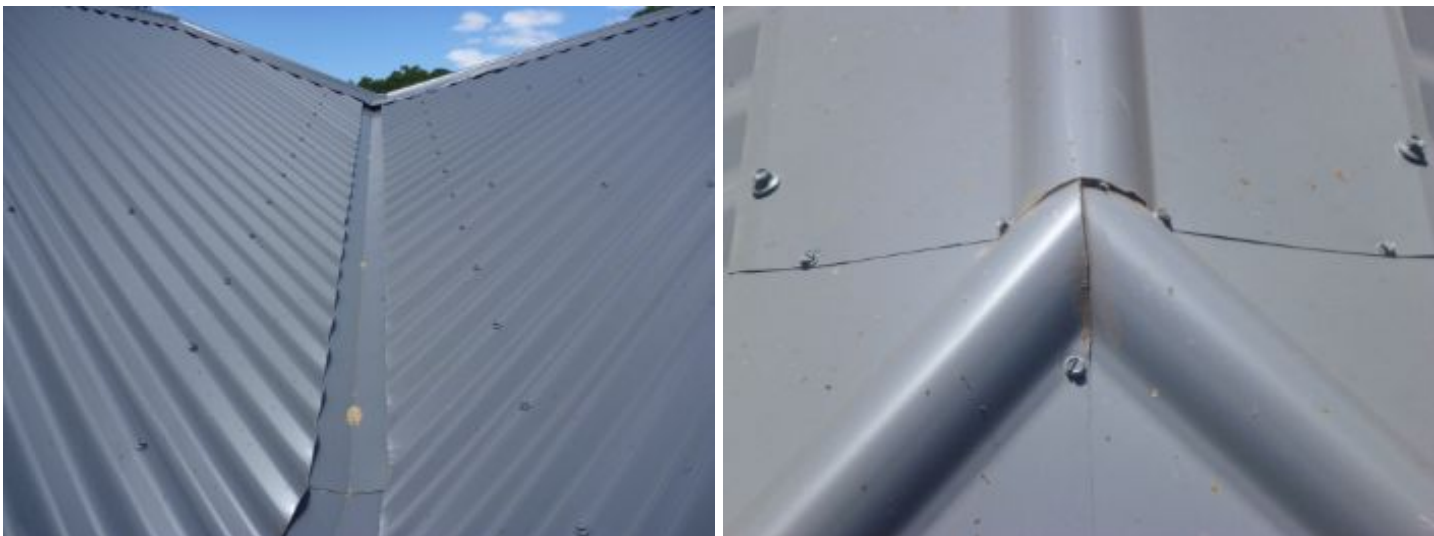
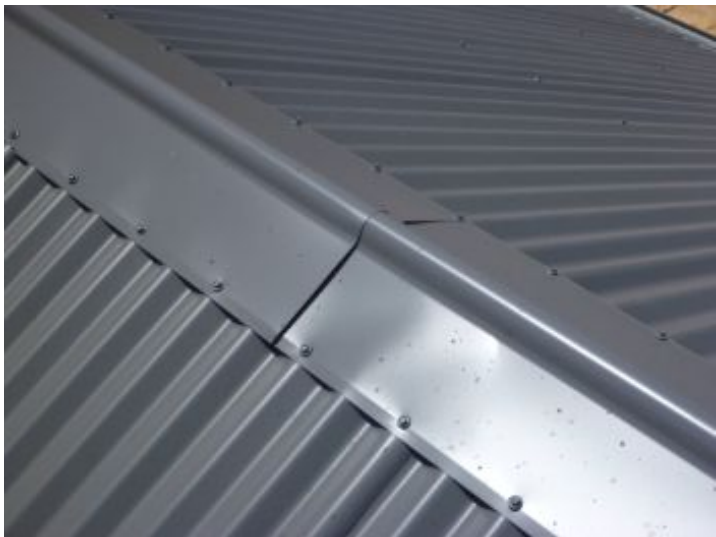
- Observations:
- Flashing is an impervious material (usually galvanized sheet metal) that comes in a variety of shapes and sizes and is used to cover, waterproof, and direct water away from roof penetrations and from valleys and intersections between the roof covering and other materials.
 - Generally the roof flashing, where visible, appears to be in satisfactory condition.
 - Some of the ridge flashing intersections have not been siliconed.
 - The ridge capping joint above the Entrance/Living area requires additional fixings.

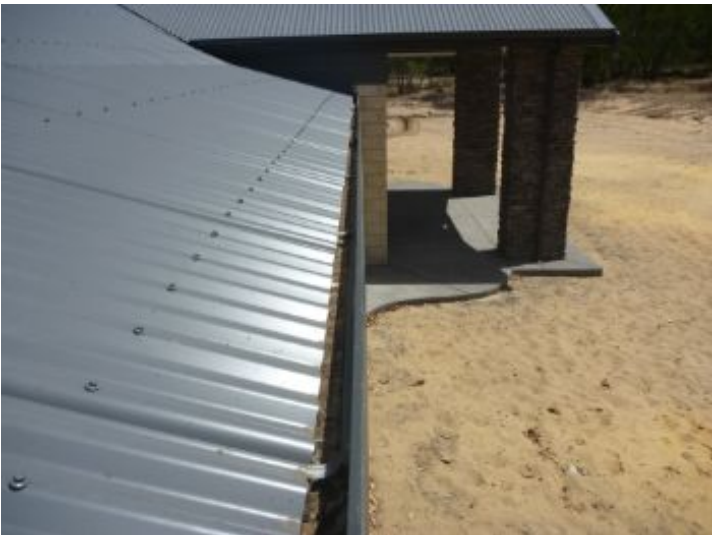
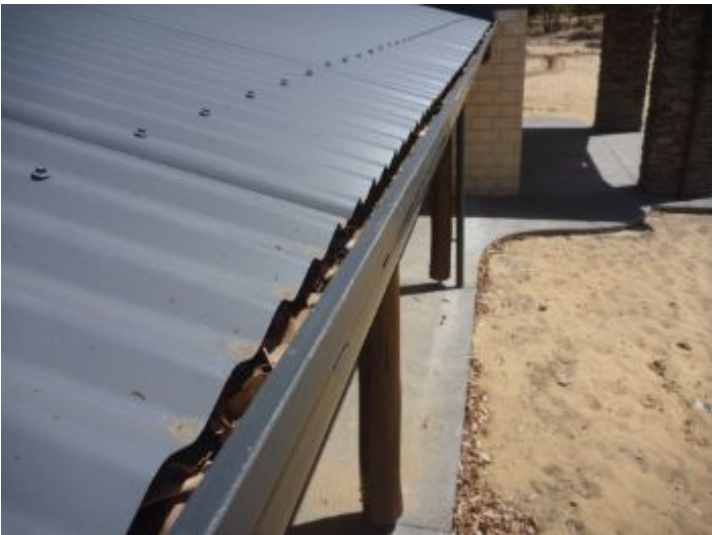
- Observations:
- No major function concerns noted at time of inspection.
 - The gutter adjacent to the garage has significant scratching along the top edge.

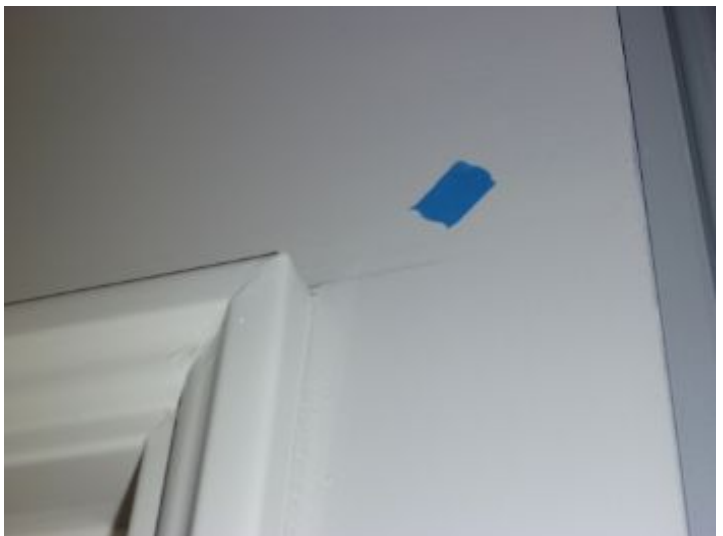
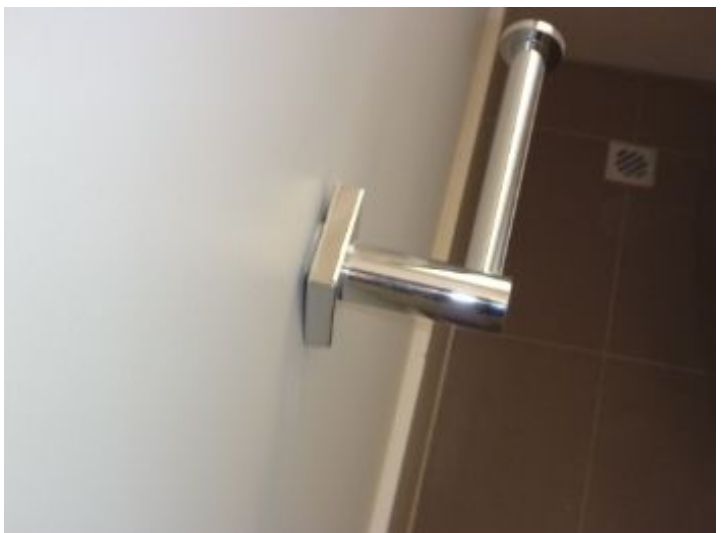
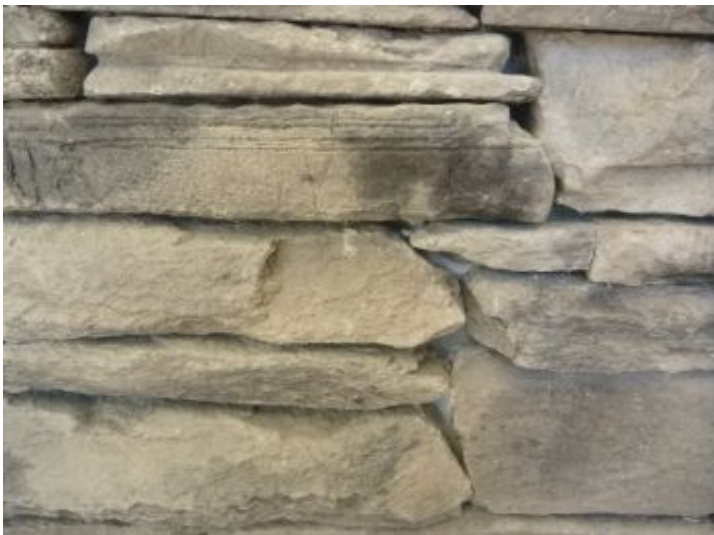
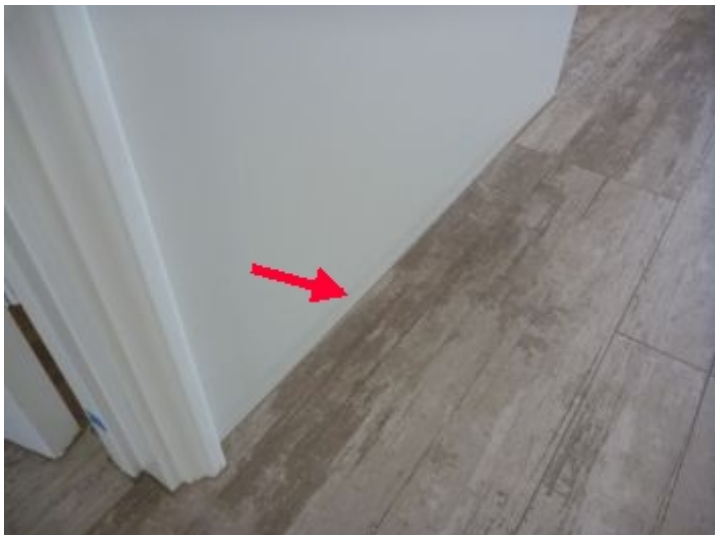
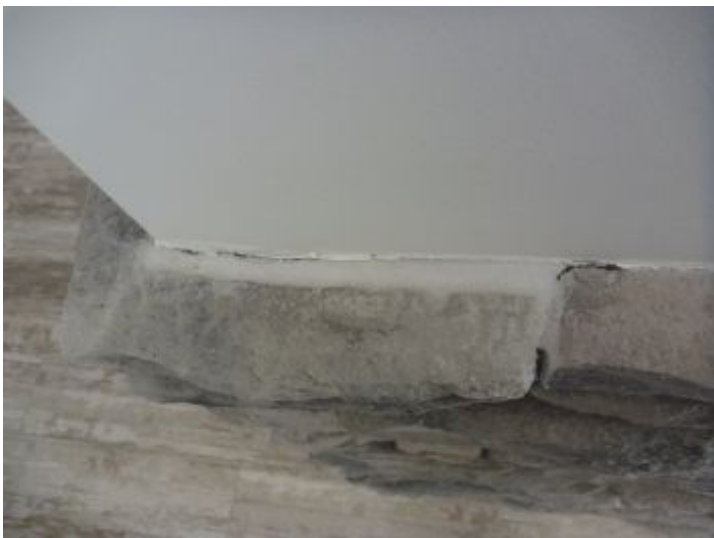
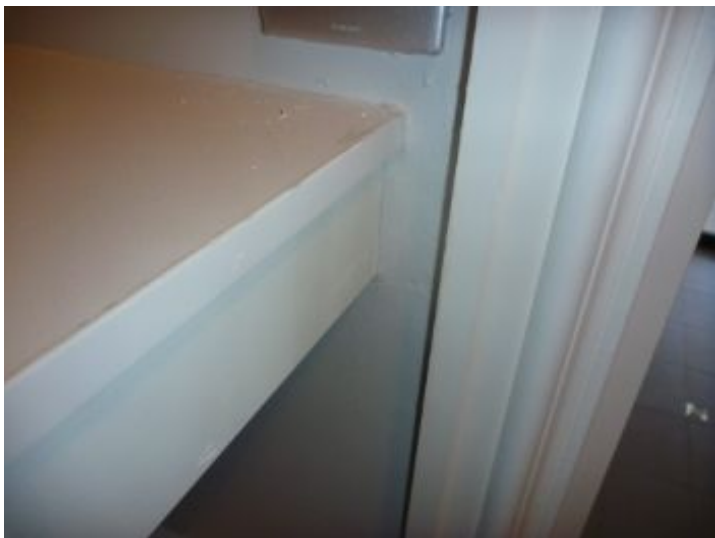
- There are marks and scratches to the interior walls at various locations. These have been marked with blue painter's tape.
- Very minor shrinkage crack noted in the wall plaster in the Living / Dining Room wall adjacent to the Entertainment Room. This does not appear to be a structural issue and can be repaired normally.

- The internal walls either side of the Laundry WIL door have not been sanded / finished to a satisfactory standard.
- The Ledgerstone walls have mortar noted on the stone throughout. Installer is to provide written confirmation that the stone cladding has been installed as per the manufacturers installation instructions.

- Large mortar bed noted on one of the top Ledgerstone corners.
- The gyprock sheet adjacent to the kitchen area has the recessed edge exposed at the finished floor level.

- The towel rail fixing in the Bath room is not straight.
- The toilet roll holder in the Laundry WC is loose and hanging off the wall.

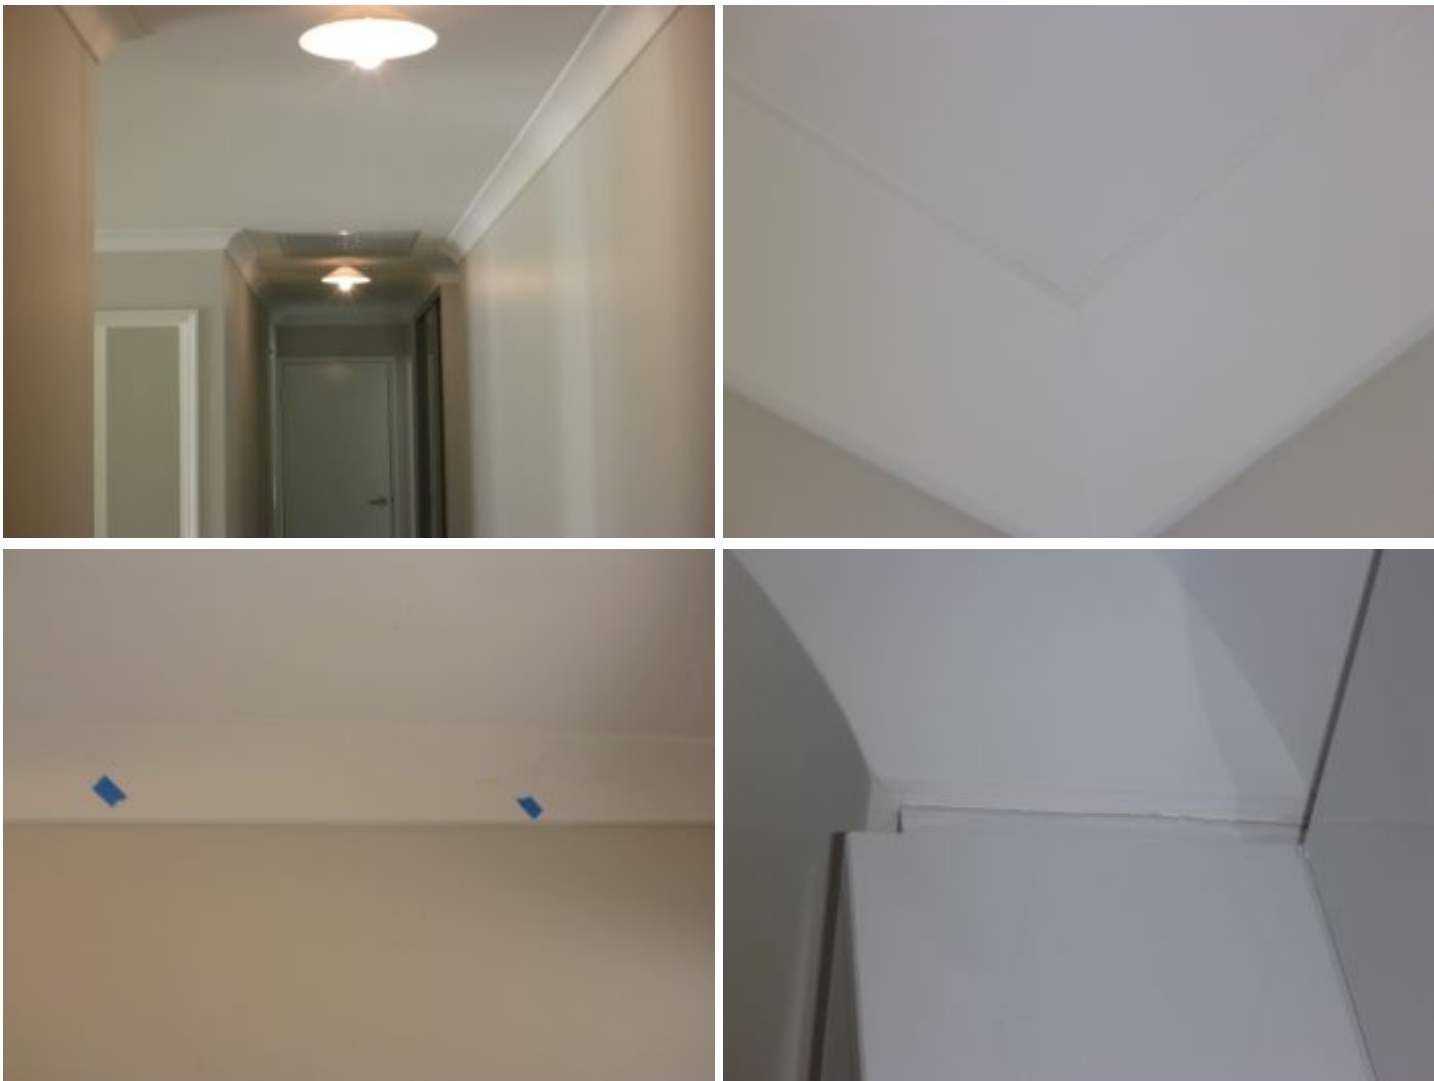
- There are marks, scratches and popped screws to the interior ceilings and cornices at various locations. These have been marked with blue painter's tape.
- There is minor cracking which has occurred at the interface between the ceiling cornice and the wall and some cornice joints at various locations. This can be a result of foundation settlement and/or movement in the roof structure. This does not appear to have affected the structural integrity of the home and can be repaired normally.
- Several ceiling gyprock joints in the Master bedroom, Study, Kitchen, Activity and Guest rooms are visible from a normal viewing position.
- The ceiling around the Garage manhole has been patched and the painting patch is visible.
- Significant gap noted between the kitchen cabinet and the cornice.

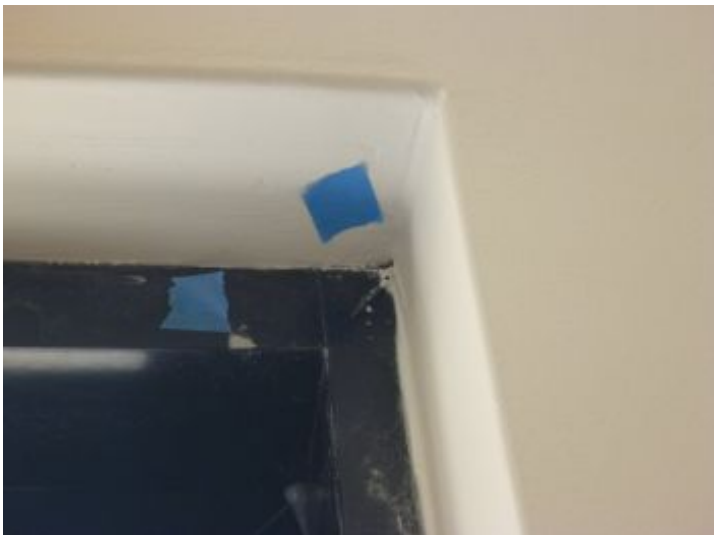
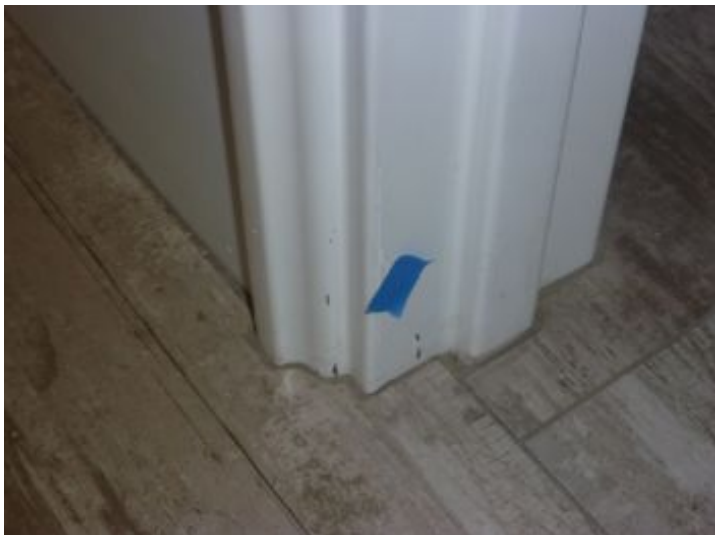
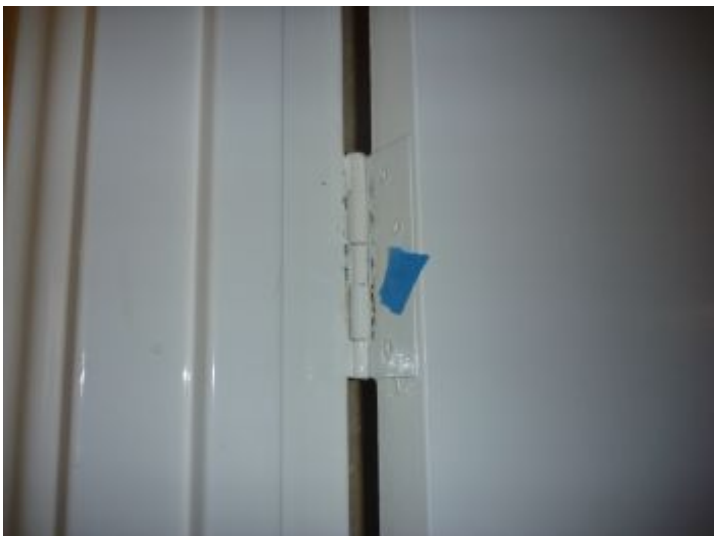
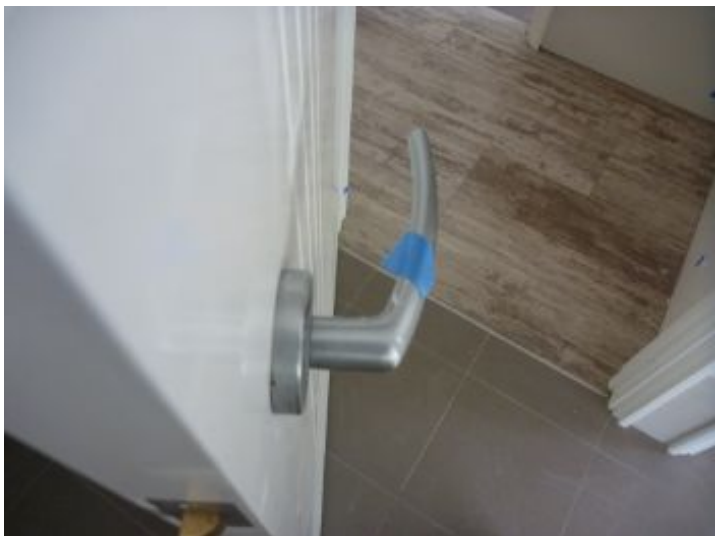
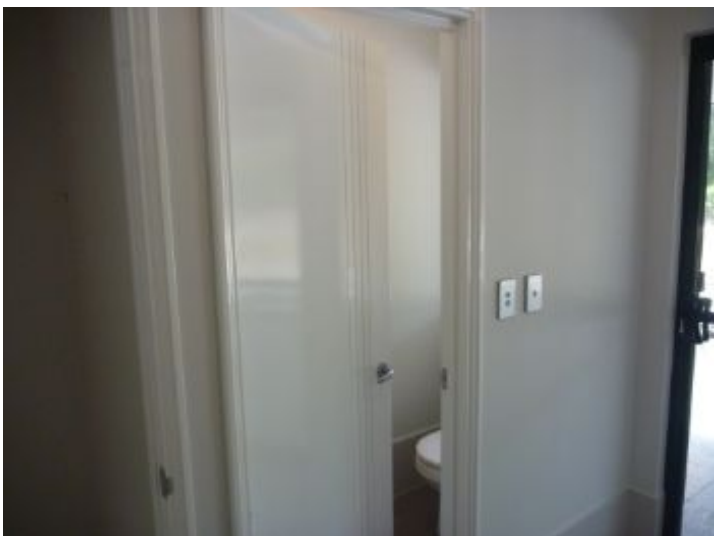
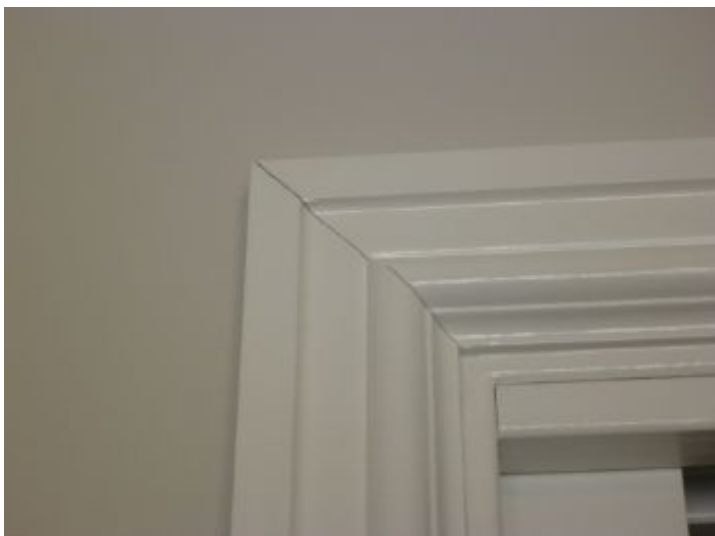
- Observations:
- The exterior doors function satisfactorily.
 - The interior doors function satisfactorily.
 - The sliding door in the Master bedroom and Ensuite WC door were locked at the time of the inspection and could not be tested/inspected.
 - The Laundry WC and Master Bedroom doors are not closing properly, an adjustment to the strike plate is required.
 - Chipped and scratched painting to door frames noted throughout. These have been marked with blue painters tape.
 - Paint and scratches noted on some door hardware. These have been marked with blue painters tape.
 - Significant gaps noted on the Laundry WIL architrave mitre joints.
 - Small paint missing from Kitchen WIP door.
 - Chips and scratches noted on the aluminium door frames throughout.
 - Marks and scratches noted to the Entertainment Room doors.

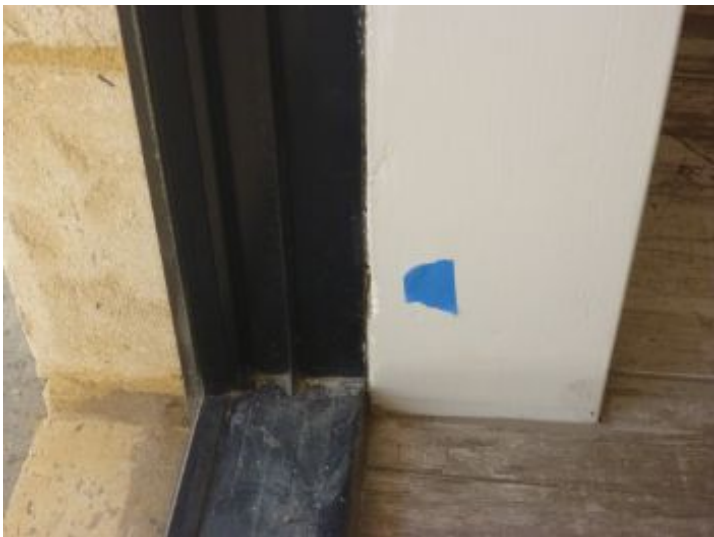
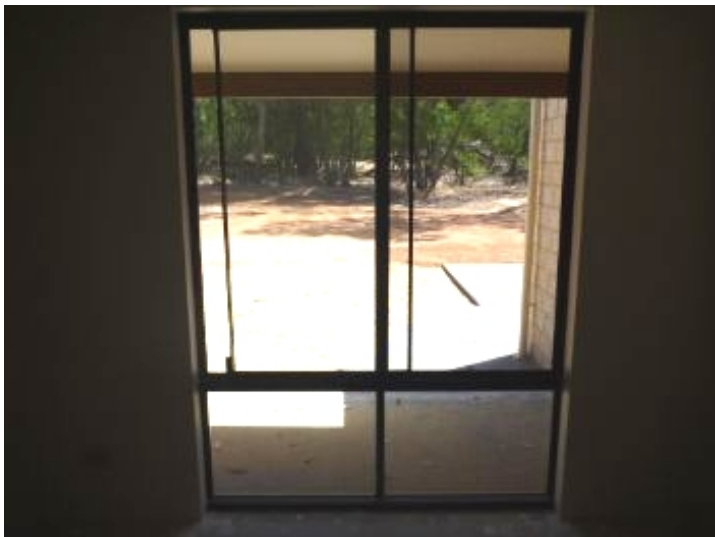
- Materials:
- Aluminum framed windows noted.
- Observations:
- Windows operated during the inspection appeared functional.
 - Chips and scratches noted on the aluminium window frames throughout.
 - The plaster around the window frames has not been completed satisfactorily with some cracking, gaps and blemishes noted. These have been marked with blue painters tape.
 - Grout noted in the Bath room window frame.

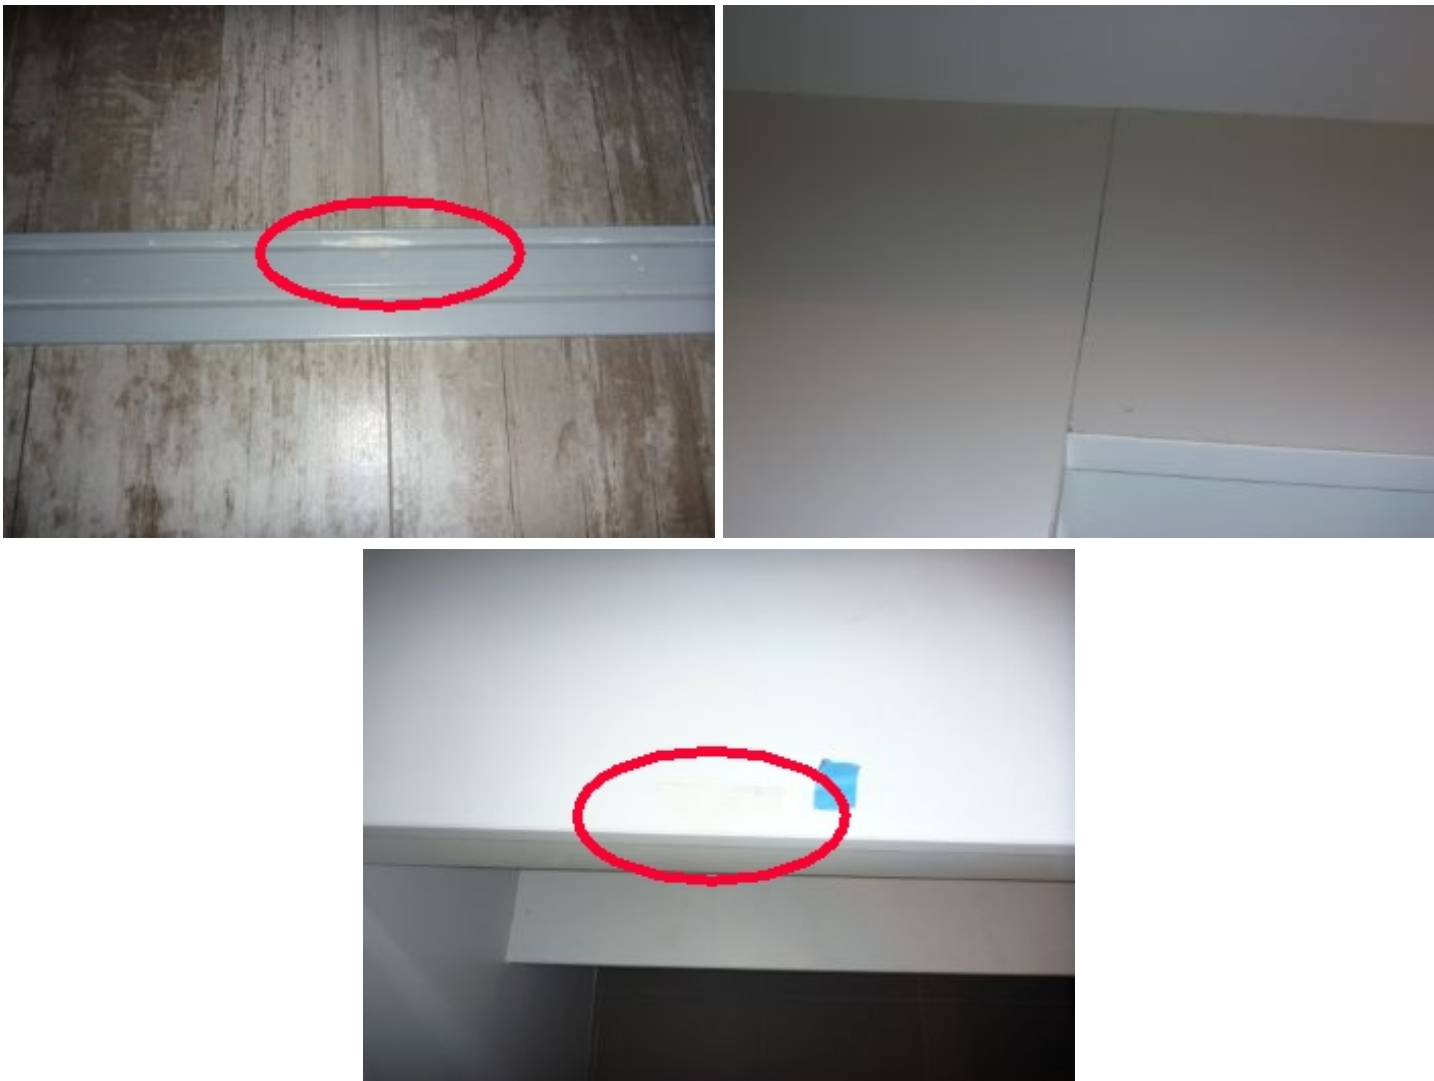
- Observations:
- Marks and scratches noted to the closet walls and ceilings. These have been marked with blue painters tape.
 - The Linen doors are out of square and require adjustment.
 - The Linen door has plaster noted in the runner.
 - Significant gaps and visible fixings noted within the closet / pantry shelving through out.

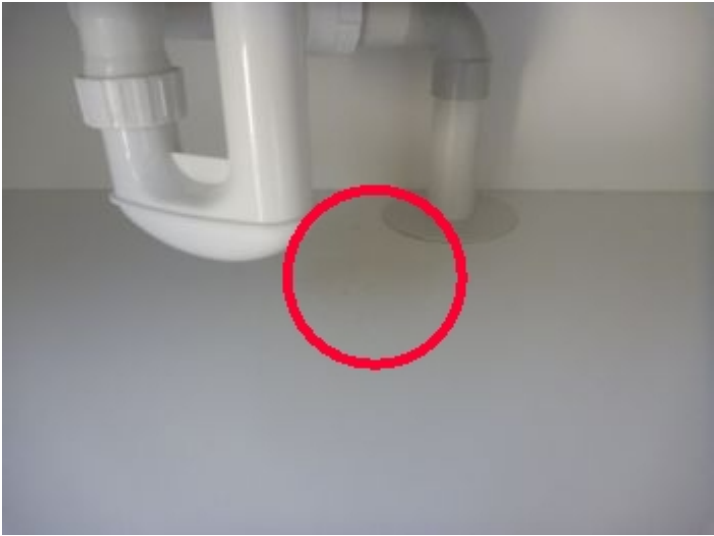
Observations:
• The sinks and related components functioned normally when tested.
• The left hand Ensuite vanity basin appears to have a crack in the bottom of the basin and is leaking.

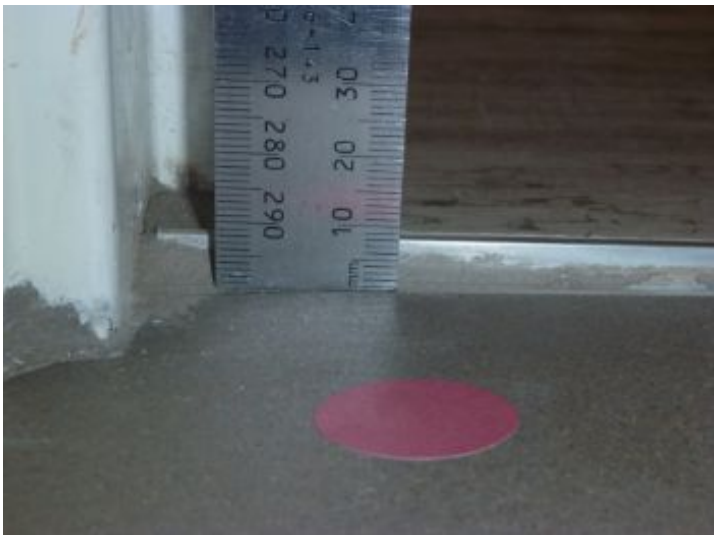
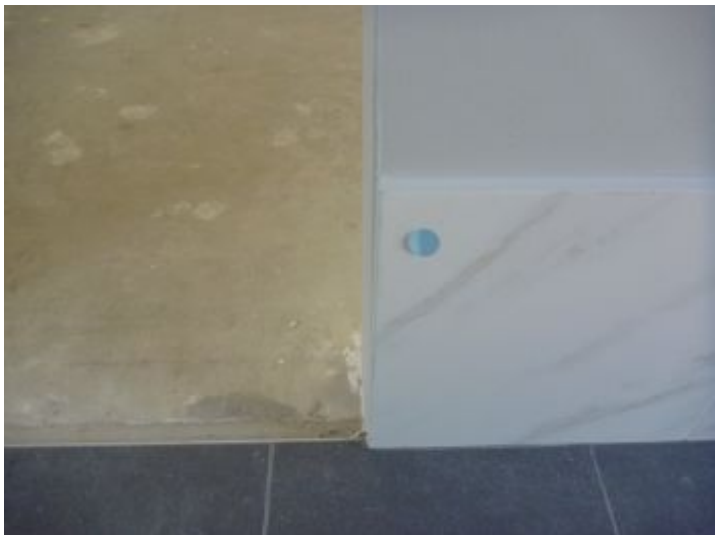
- There is a large tiling 'lip' (8mm) in the door way of the Bath room.
- 'Lipping' noted throughout the Bath room tiled floor. Tile 'lipping' is where the edge of a tile is higher than the adjacent tile.
- The skirting tile in the Ensuite does not align with the end of the wall.

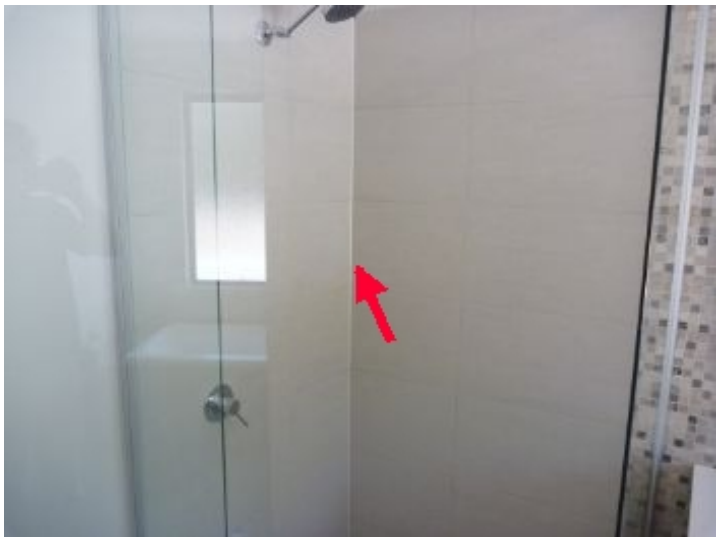
Observations:
• 'Lipping' noted within the Bath room shower walls.
• The internal corner of the Bath room shower walls has been sealed with white silicone however it should be sealed with a silicone colour similar to that of the grout.

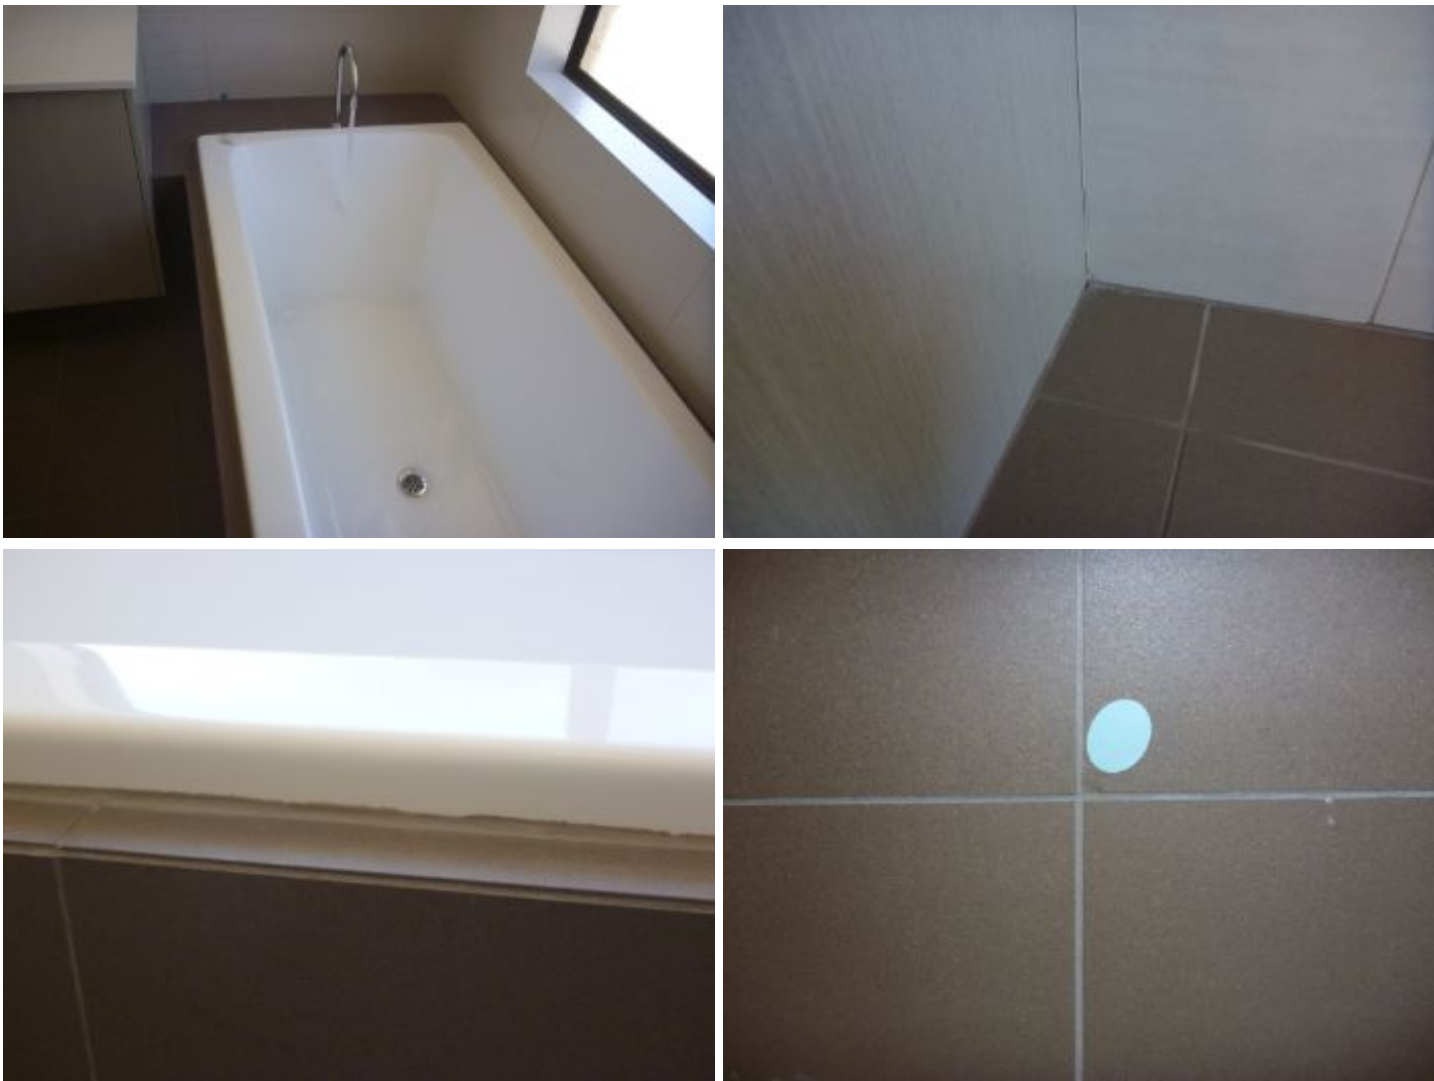
- The bath tub and related components operated normally when tested.
- Chipped tile noted on the bath frame wall.
- The silicone between the bath and the tiling vary significantly in thickness and is of a poor finish.
- The tiling joint around the bath and the wall has been grouted and is starting to crack. This should be sealed with a suitable silicone.

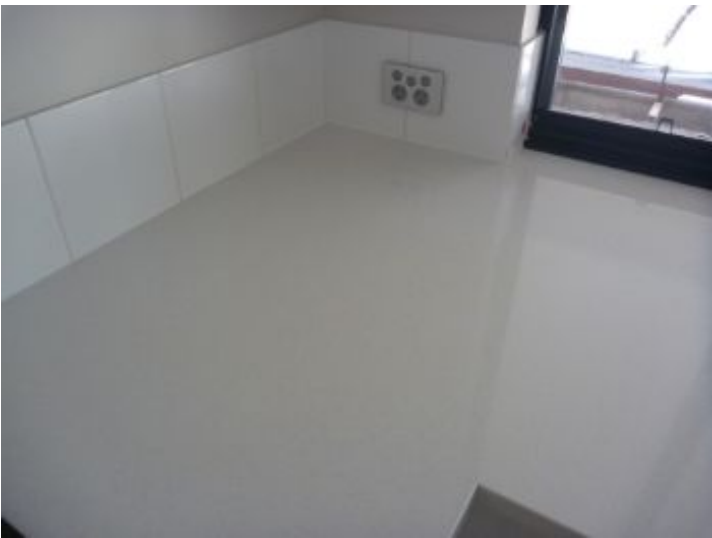
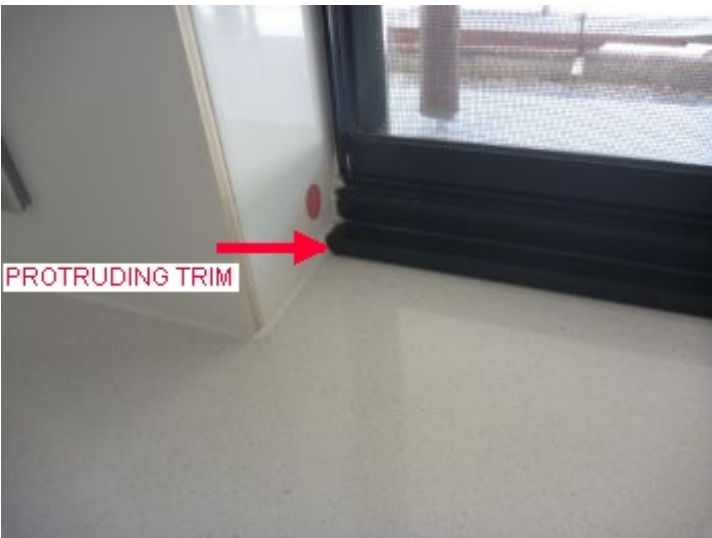
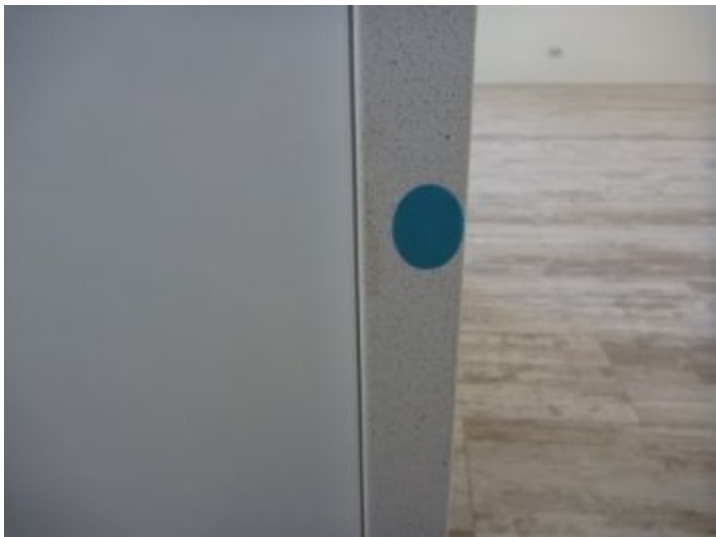
- Observations:
- Generally appeared functional at time of inspection.
 - Marks/stains noted on Kitchen bench waterfall end.
 - The window in the kitchen has a metal trim installed to cover the gap between the bottom of the window and the benchtop however as this trim protrudes out above the bench top it will create problems for the glass splashback installation.

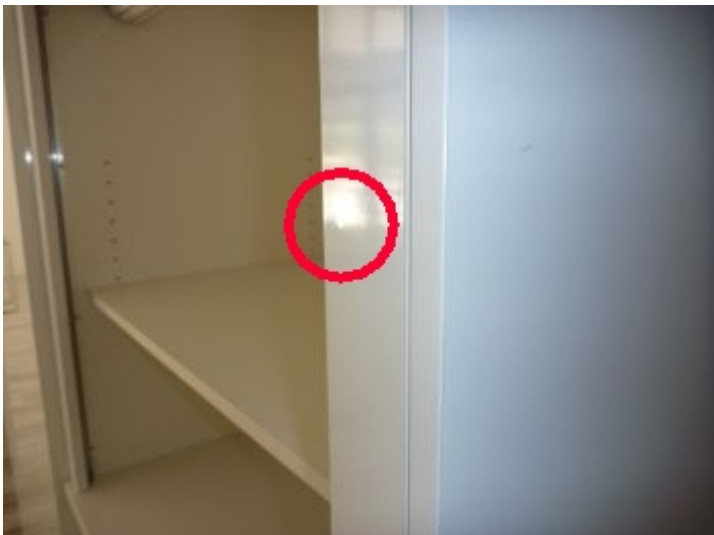
- Observations:
- Generally appeared functional and in satisfactory condition.
 - Some cabinet doors do not align properly. Some adjustment is required.
 - Mark/scratch noted to one of the overhead cupboard doors
 - The Appliance cupboard has visible bulging in the cabinet from the screws used.
 - Marks noted on the Kitchen WIP shelving.
 - The shelving on the left hand side of the rangehood has not been installed level and requires adjustment.

Screw bulging

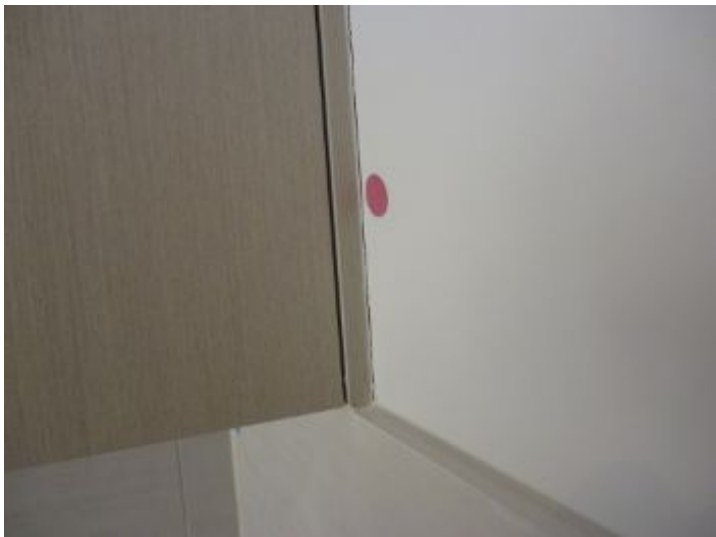
- Observations:
- Appeared functional and in satisfactory condition, at time of inspection.
 - The joints between the cabinets and the wall/tiles are cracking and should be sealed with a suitable silicone.

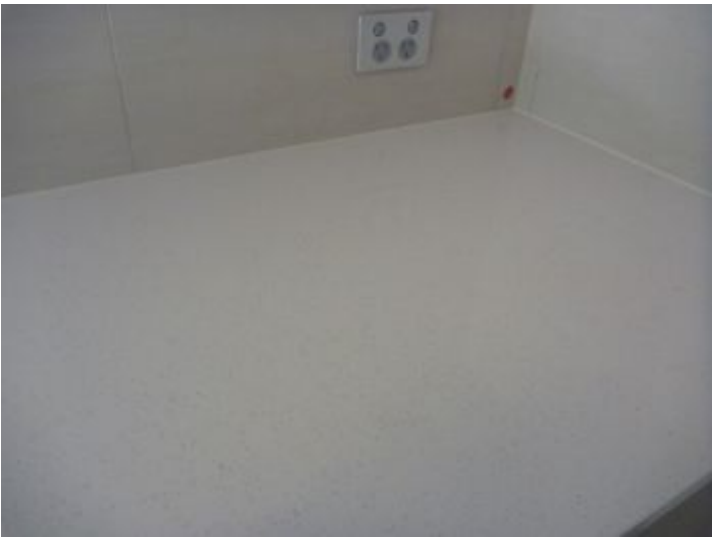
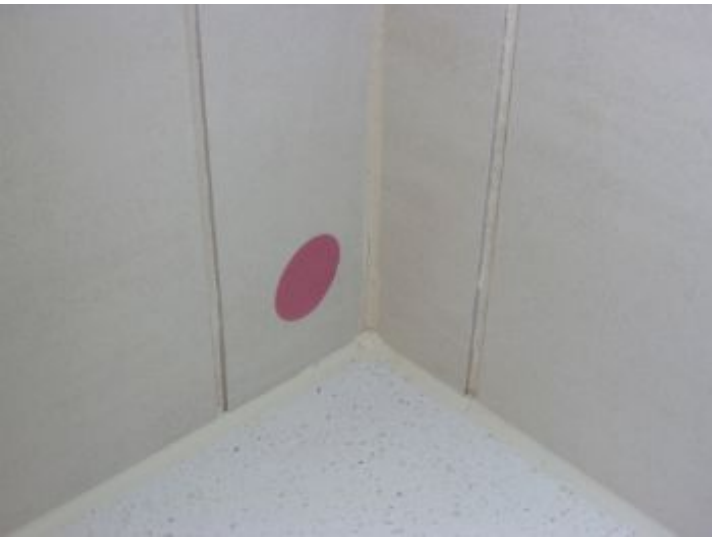
- Observations:
- Appeared functional and in satisfactory condition, at time of inspection.
 - The internal splashback tiled joint has been grouted and is starting to crack. This should be sealed with a suitable silicone.

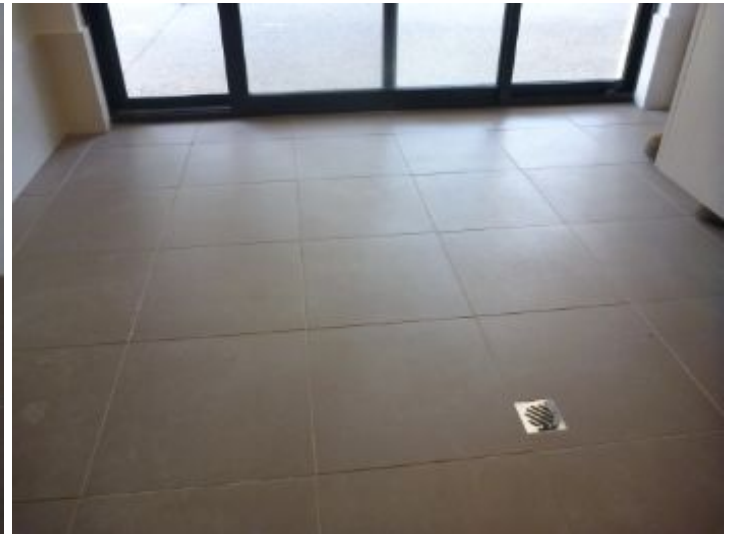
- 'Lipping' noted throughout the tiled Laundry floor.
- The joint between the floor and skirting tile has been grouted and is cracking. This should be sealed with a suitable silicone.

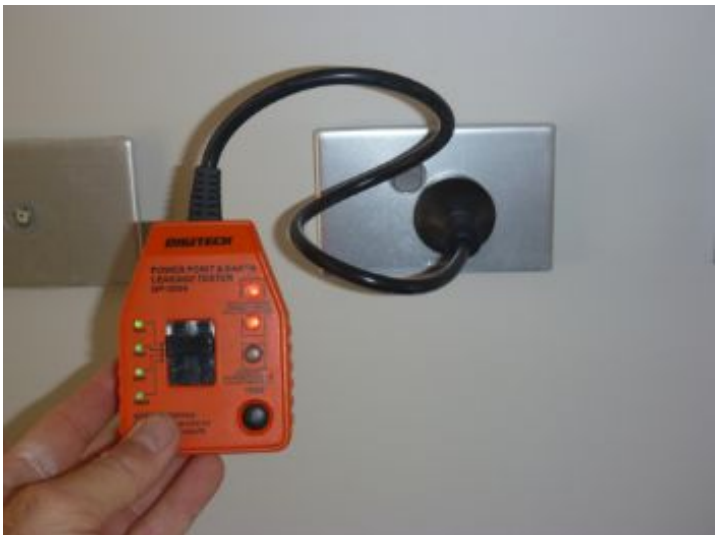
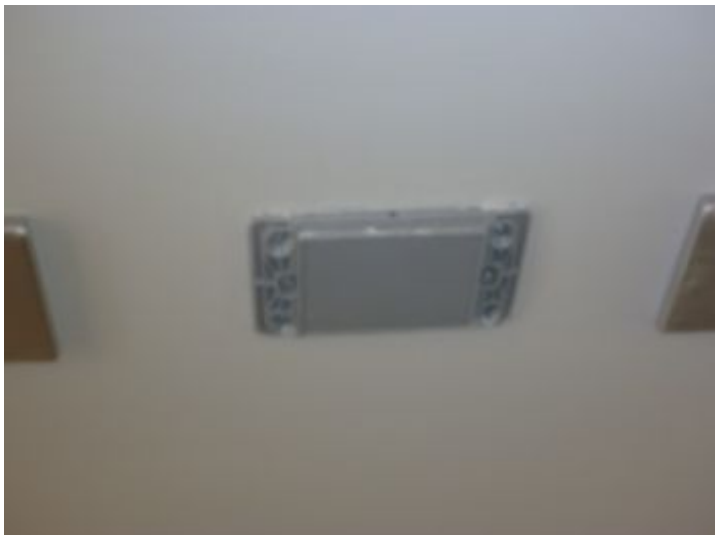
- There are some outlet cover plates missing in the Living, Dining and Entertainment rooms.
