Property Inspection Report

4 Test Avenue, Testville, 9999

Inspection prepared for: Client Name
Date of Inspection: 18/2/2016 Time: 10:00AM
Weather: 26C, Sunny

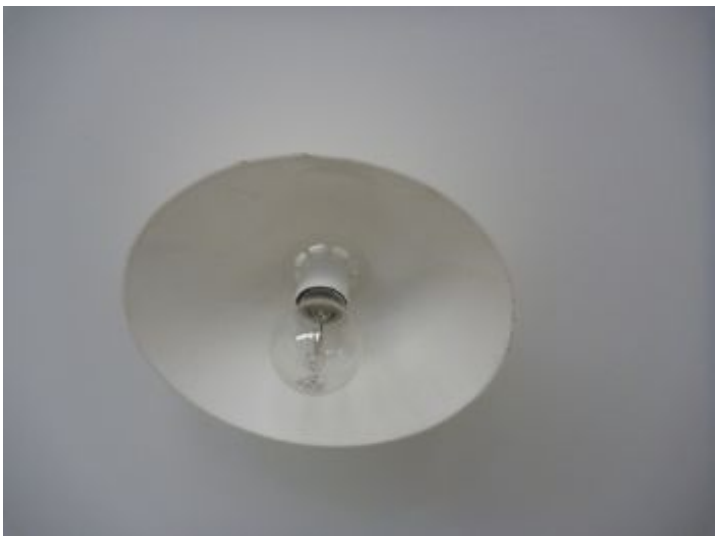
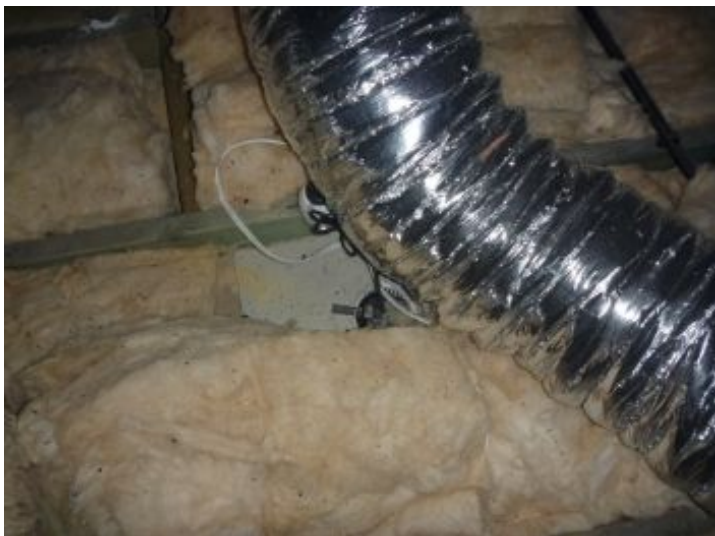
- Comments:
- All tested interior and exterior light fixtures and switches were functional unless noted.
 - Some low voltage halogen lights were noted in the property.
- Observations:
- The Laundry light fitting has marks and scratches noted.
 - The required separation between some downlights and the insulation/ducting within the roof space is insufficient and needs to be rectified.

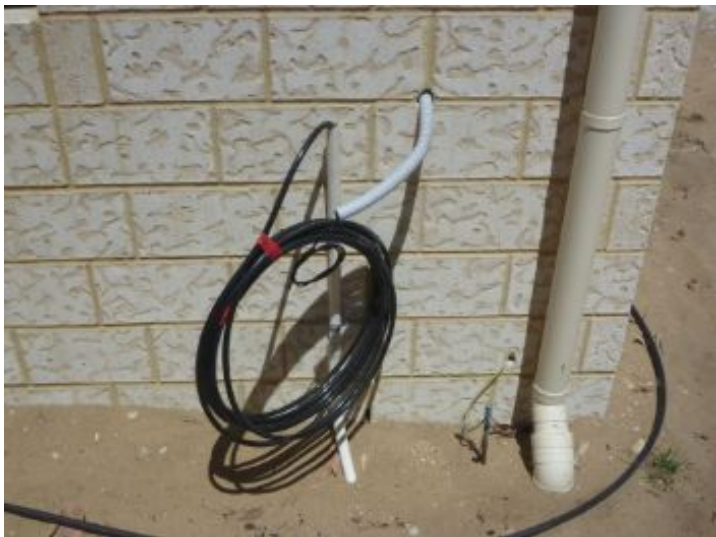
- Observations:
- Some incomplete external wiring noted.

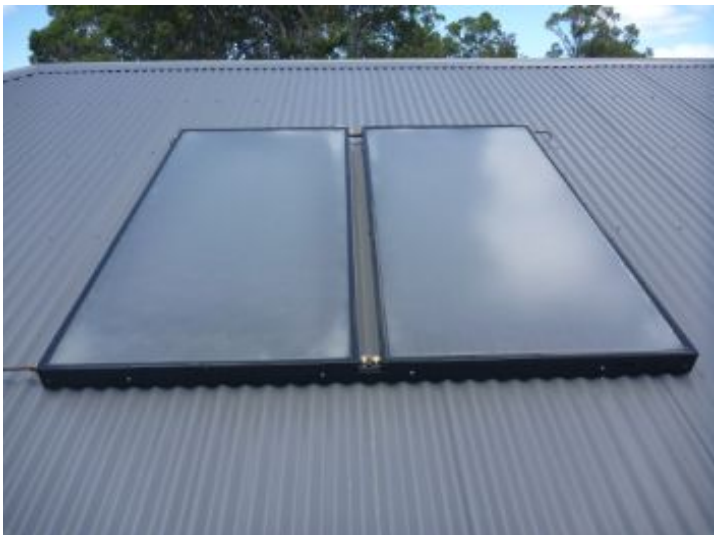
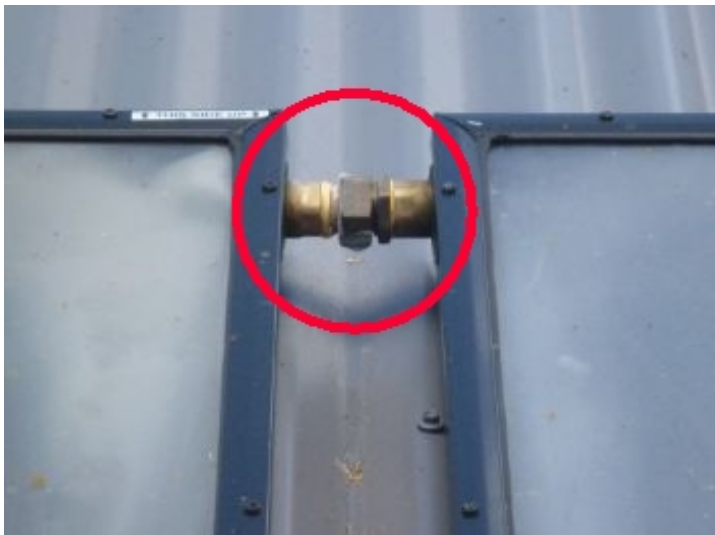
Observations:
• The hot water heater was not turned on. It is recommended that this is turned on and operational prior to the final handover to confirm that the hot water system is operational.
• The top pipe joint between the 2 solar panels is leaking and requires repair.

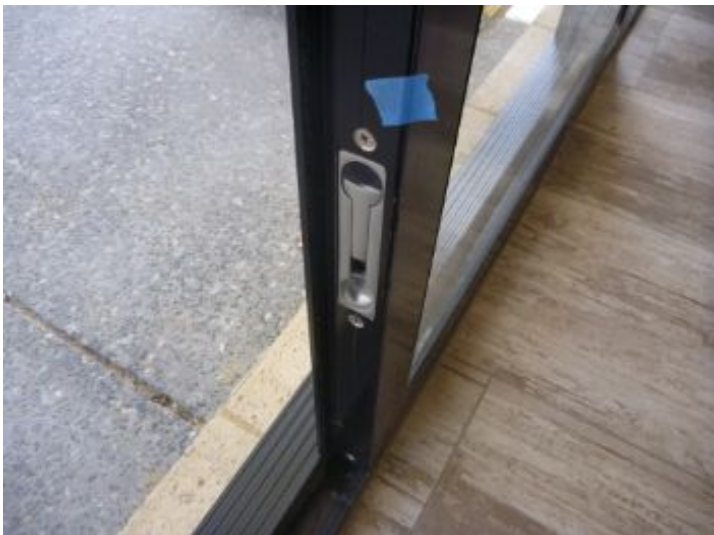
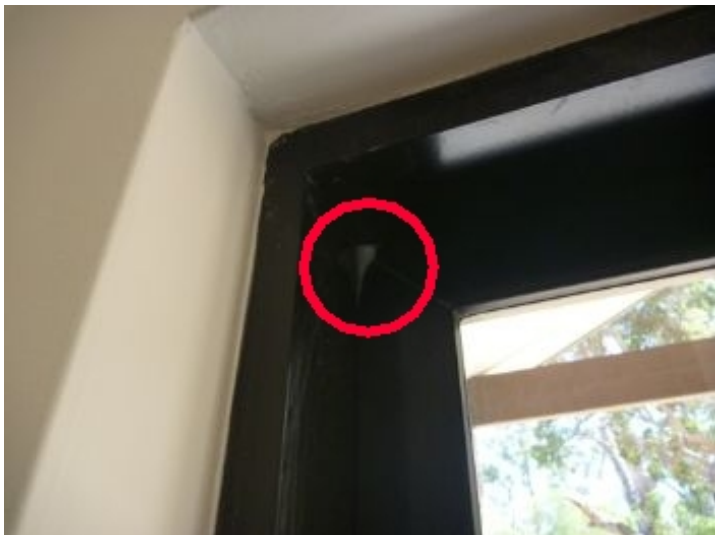
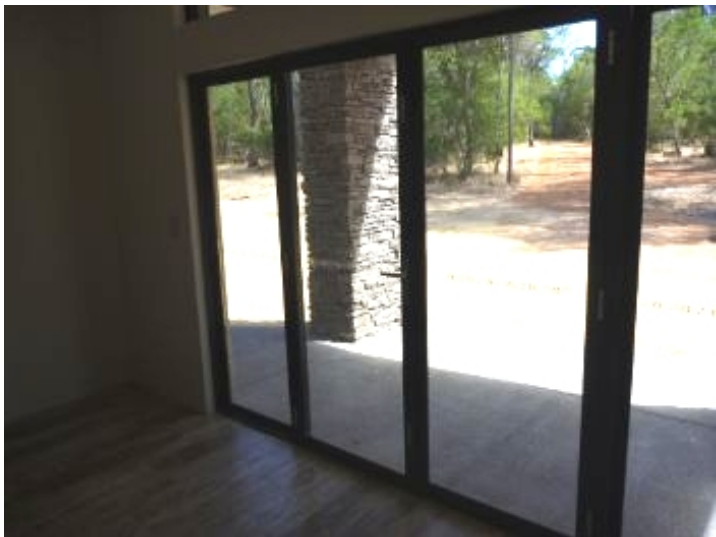
- Observations:
- Operated exterior doors were functional at the time of the inspection unless otherwise noted.
 - The entrance door does not latch properly and requires adjustment.
 - The entrance door lower flush bolts on both doors do not operate correctly and require adjustment.
 - Marks and scratches noted on the external door frames throughout.
 - Excess silicone noted in the corners of the glass panels of the entrance door.

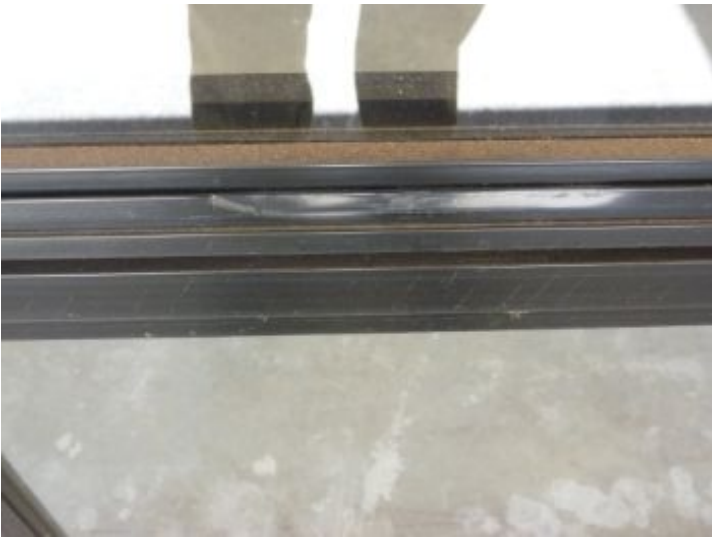
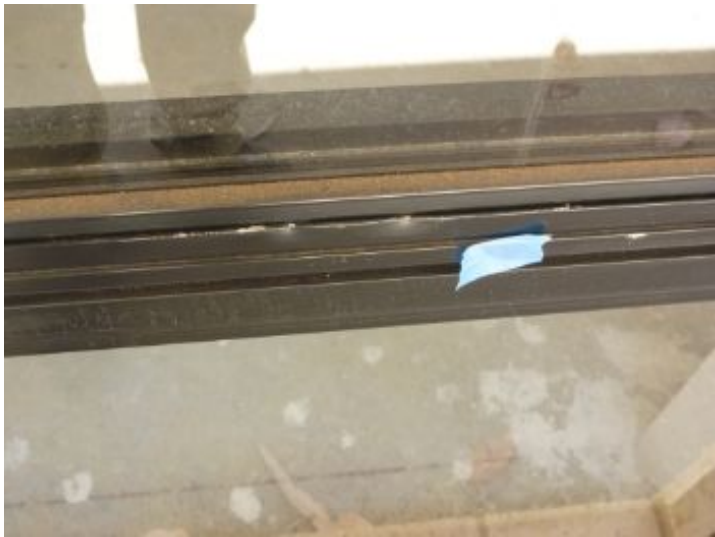
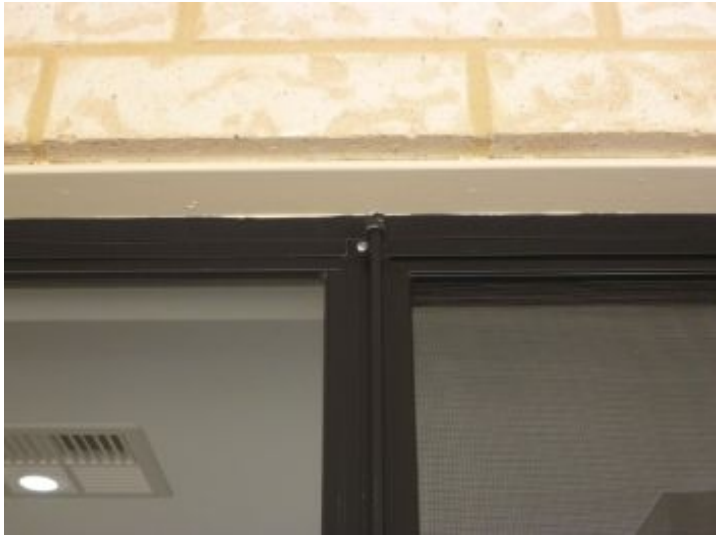
- Observations:
- Components appeared in satisfactory condition at time of inspection.
 - Marks, scratches, dents and paint noted on the external window frames throughout.

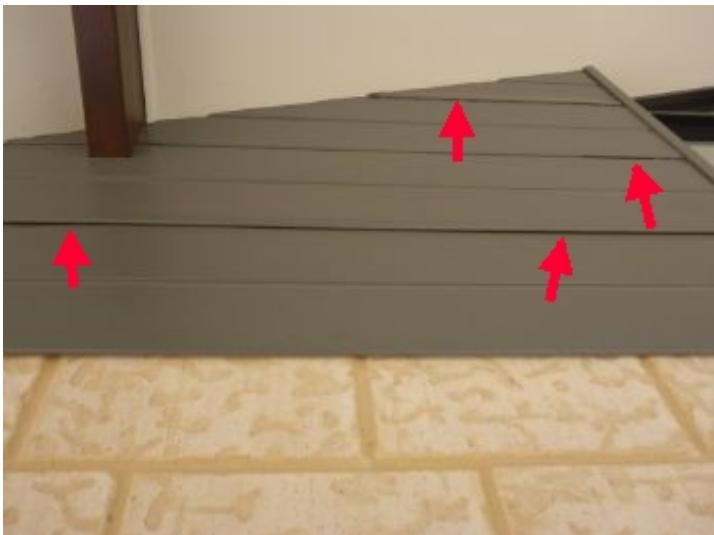
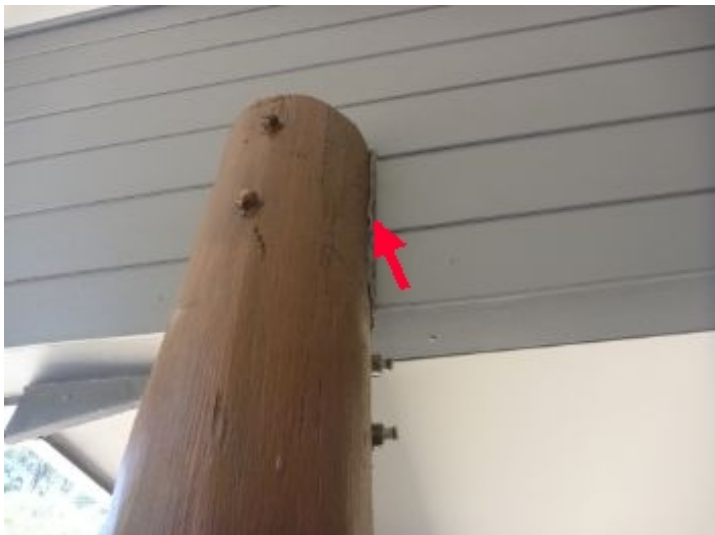
- Generally the external cladding appears to be in satisfactory condition unless otherwise noted below.
- Gaps noted in the bottom joint of some cladding sheets.
- Large gaps noted between the timber posts and cladding. An attempt has been made to fill these gaps with a poor result.
- Gaps noted between the end of the cladding and the adjacent sheet at the internal corner in the Alfresco area.

Gaps in Cladding Joints

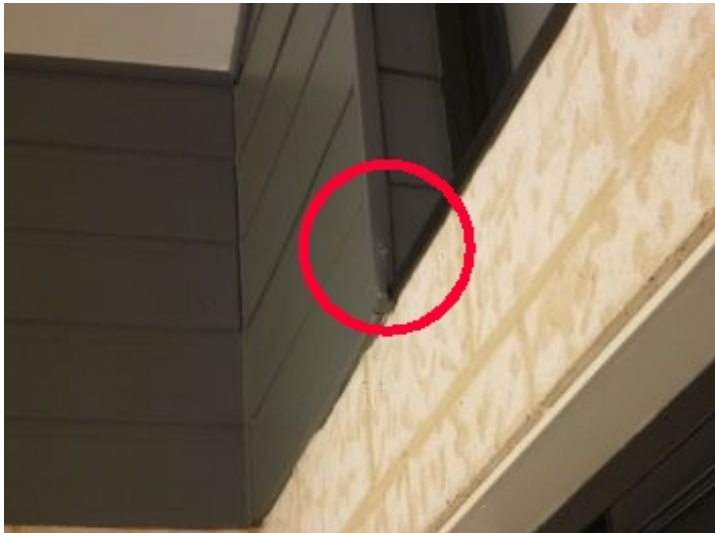
- Some starved paint areas noted on the external cladding in the Alfresco area and the lintel over the Garage door opening.

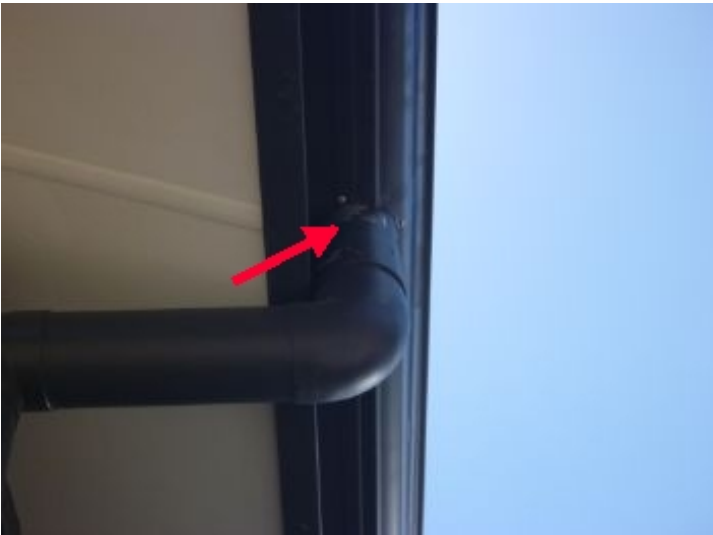
- Observations:
- Surface drainage conditions within 3 metres of the inspected structure appeared satisfactory.
 - Some paint missing to the rear Alfresco downpipe.

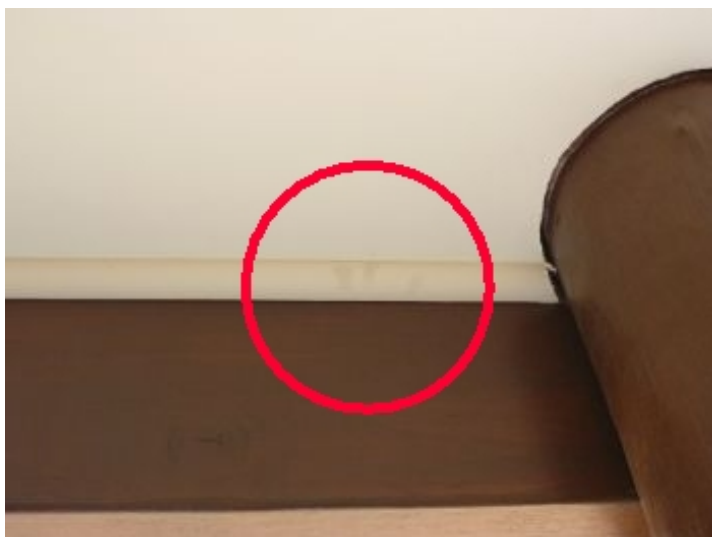
- The Alfresco and Patio appear to be structurally sound.
- Patched painting and painting of some trims which are visible and also appear to be a different colour noted throughout the Patio, Alfresco and Verandah linings.
- Large gaps noted around all the the timber posts and the Patio, Alfresco and Verandah linings.
- The external corner mouldings around the rear Verandah linings have gaps and are not finished flush.
- The rear Alfresco clad timber framed areas have nails visible and the joint between the cladding is quite large and of a poor finish.
- Cracking cornice noted on the rear Alfresco.
- The front Verandah lining have some cracks in the sheet joints and some trims noted with marks and gaps in the trim joints.
