# Timber Pest Inspection Report

15 Timber Close, Sampleton, WA 1234  
Inspection prepared for: Jane Smith  
Real Estate Agent: Bob Brown - The Real Estate Company

Date of Inspection: 7/12/2015 Time: 9:00AM  
Weather: Fine, 28c

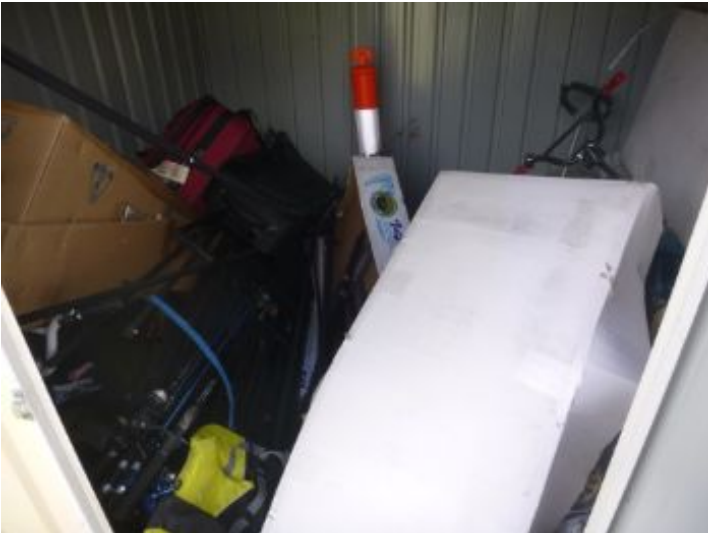
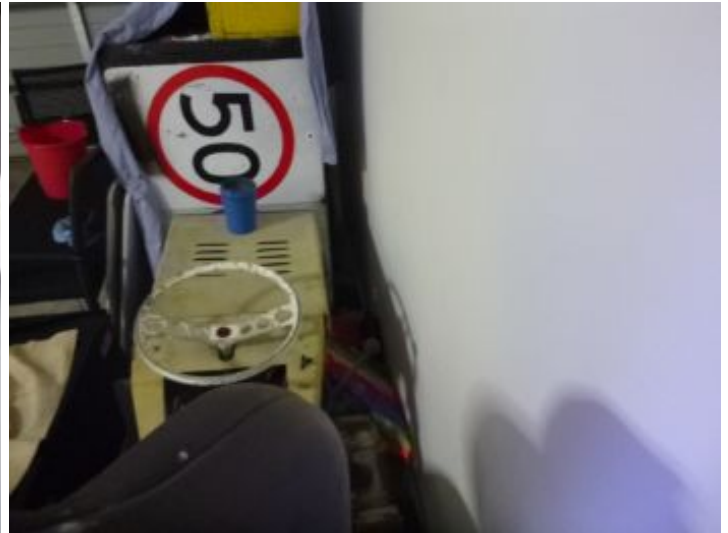
- Interior
- Internal roof space at eaves.
- Garage - Shed

The shed visual inspection was obstructed or restricted because obstruction due to items stored.

The interior visual inspection was obstructed or restricted because obstruction due to items stored.

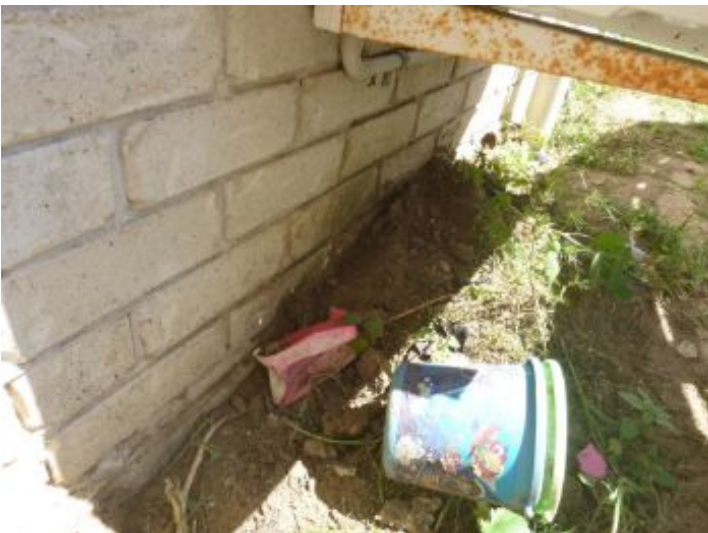
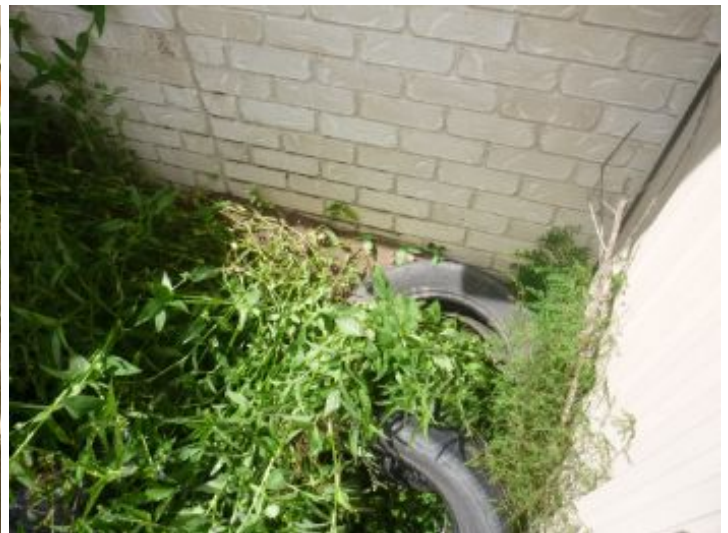
- Slab edges are covered by soil. This may allow termite entry into the wall frame. Slab edges should be cleared of soil.
- The ground was found to be above the damp proof course, potentially causing breaches of any termite barrier.

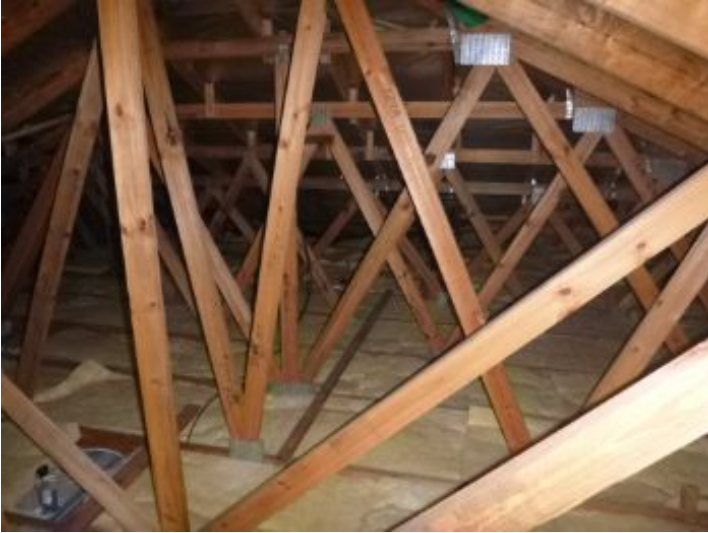
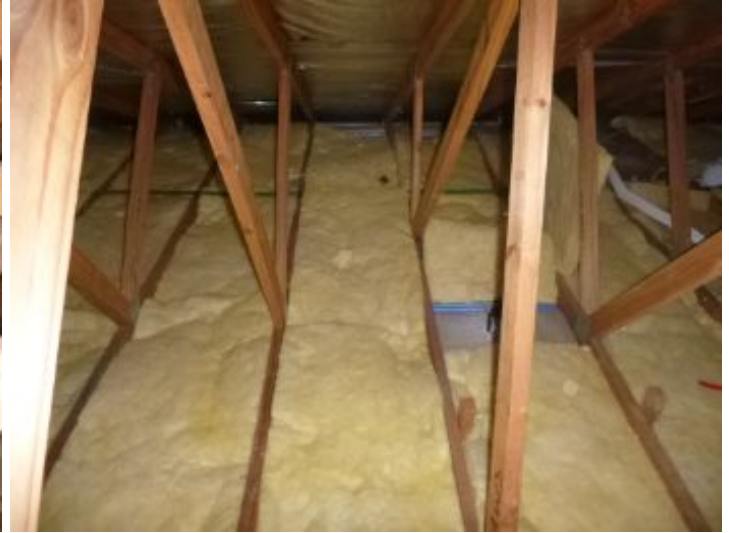
- Access was available through a manhole in the bathroom and garage.
- Limited visibility and access due to insulation and pitch.

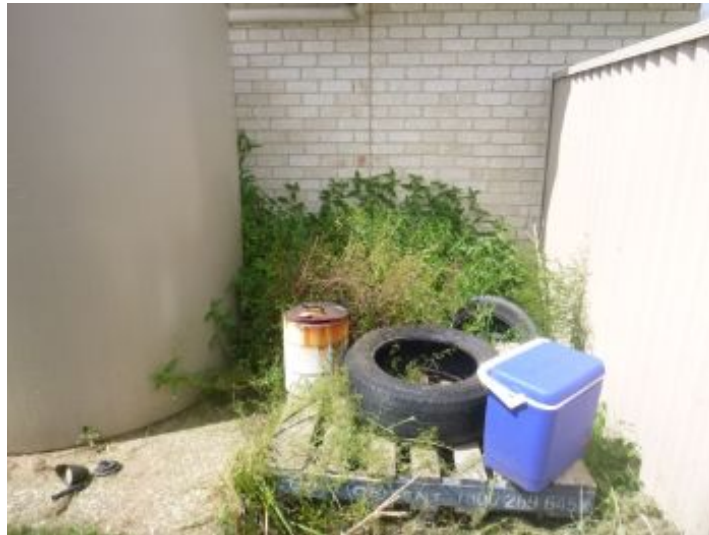
- There is landscaping/stored timber, or old tree stumps in contact with the ground that provides possible breeding grounds for subterranean termites. These should be removed.

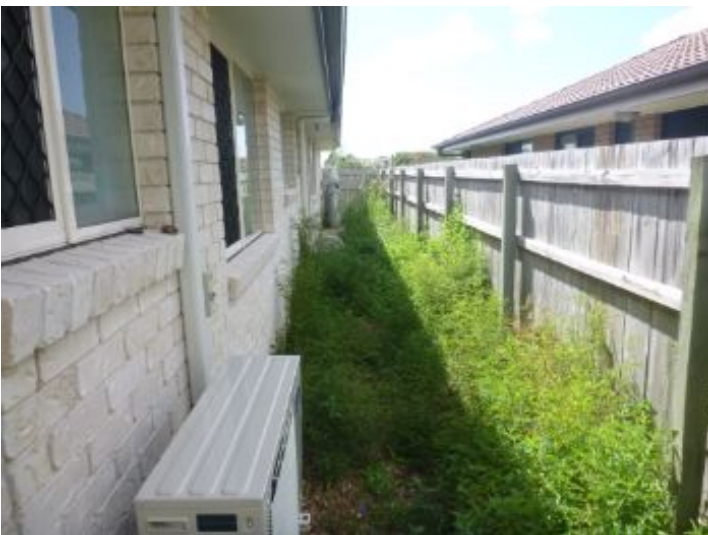
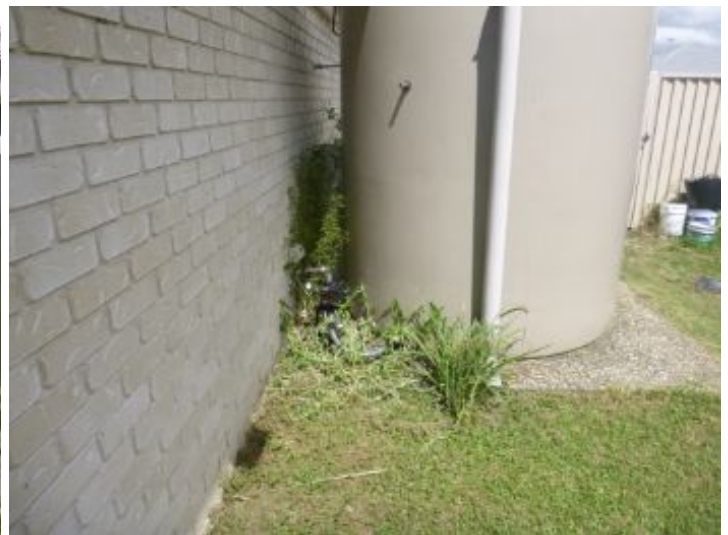
- There is grass and weeds touching the house structure, which can provide possible entry points/bridging for termites into the home. These should be pruned or removed.

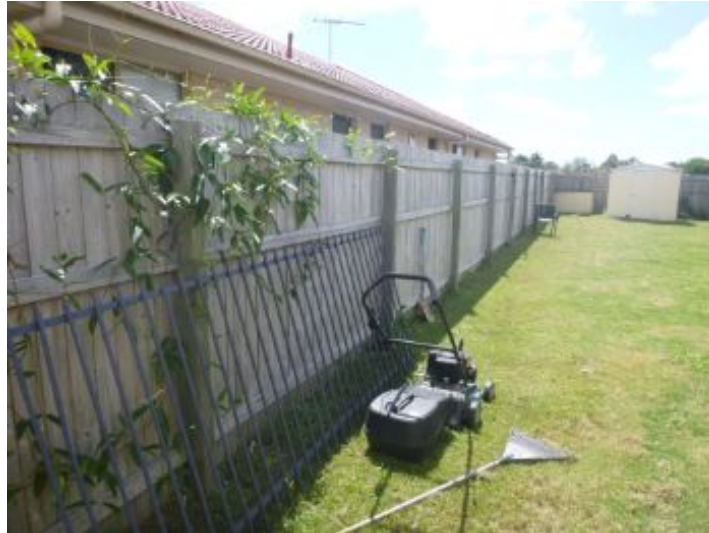
- Timber fences are generally in good condition.

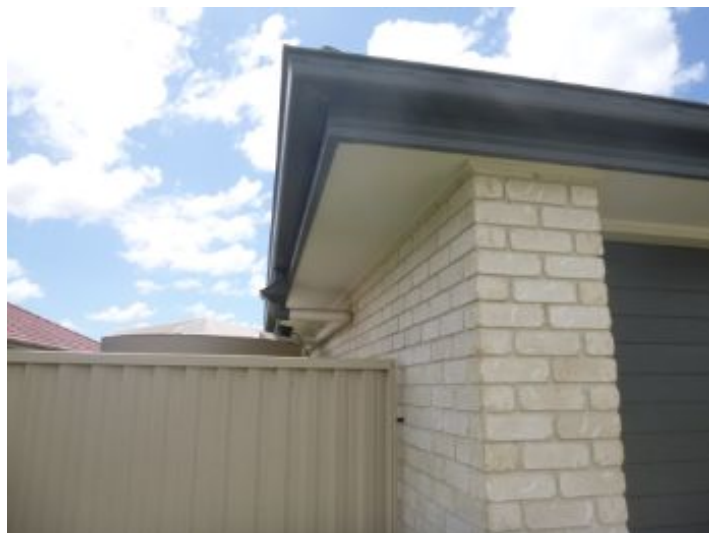
- The eaves are in satisfactory condition.
