# Property Inspection Report

2 Sample Drive, Sampleville, 9999

Inspection prepared for: Client Name  
Date of Inspection: 23/2/2016 Time: 3:00PM  
Weather: 20C Cloudy

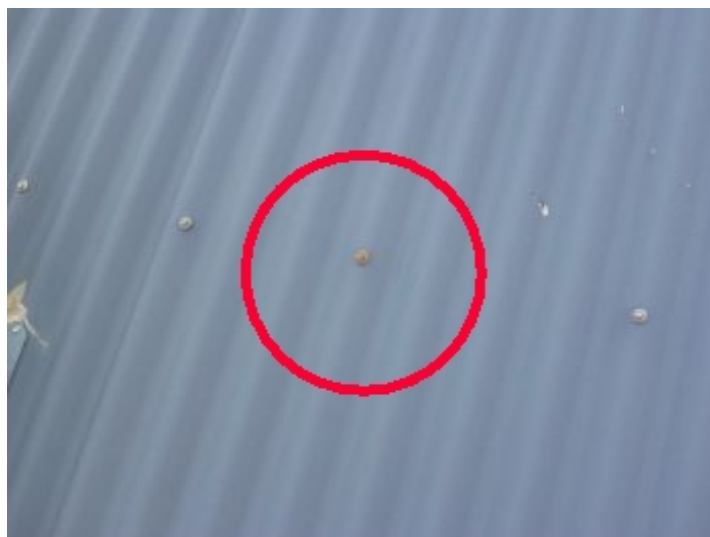
### 3. Roof Issues

- Some of the screw fixings located on the roof sheeting are rusty and should be replaced in due course.

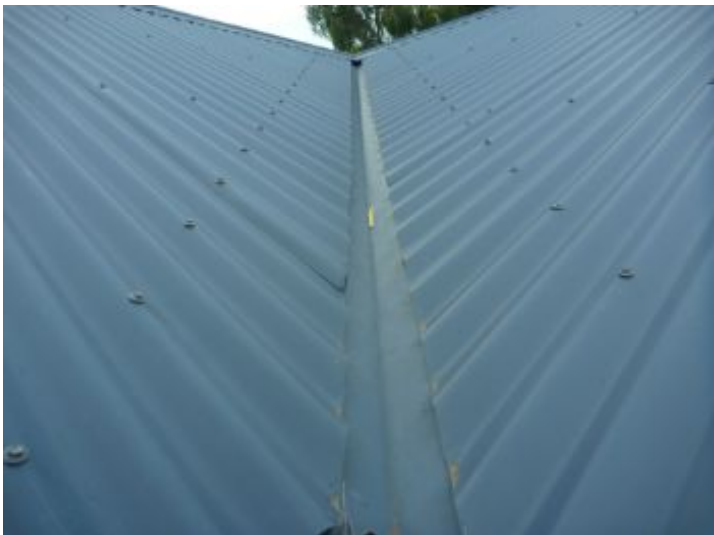
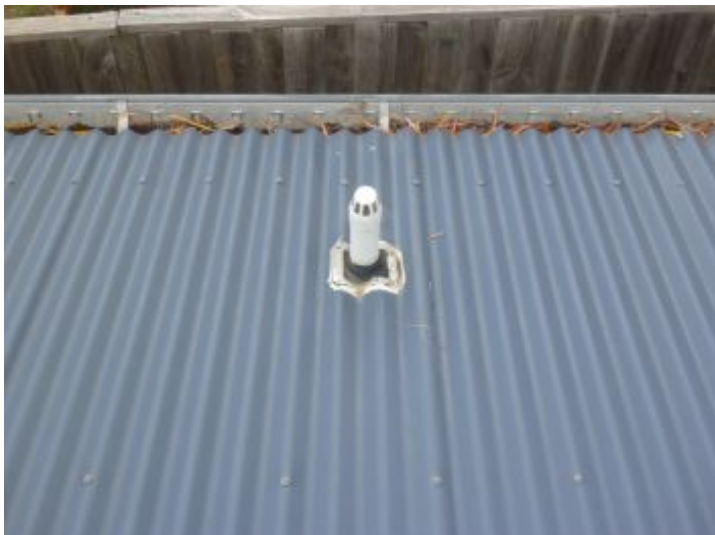
### 4. Flashing

- Flashing is an impervious material (usually galvanized sheet metal) that comes in a variety of shapes and sizes and is used to cover, waterproof, and direct water away from roof penetrations and from valleys and intersections between the roof covering and other materials.
- The roof flashing, where visible, appears to be in satisfactory condition.
- The roof penetration flashings have been sealed with silicone. These flashings should be monitored as silicone can deteriorate over time.

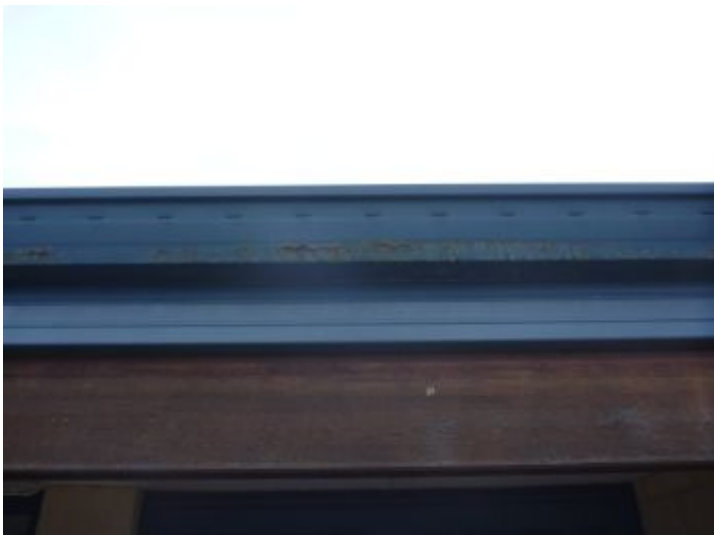
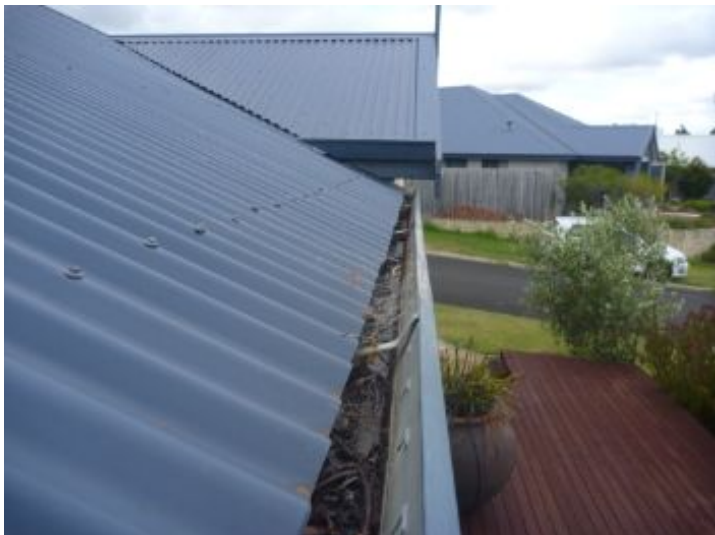
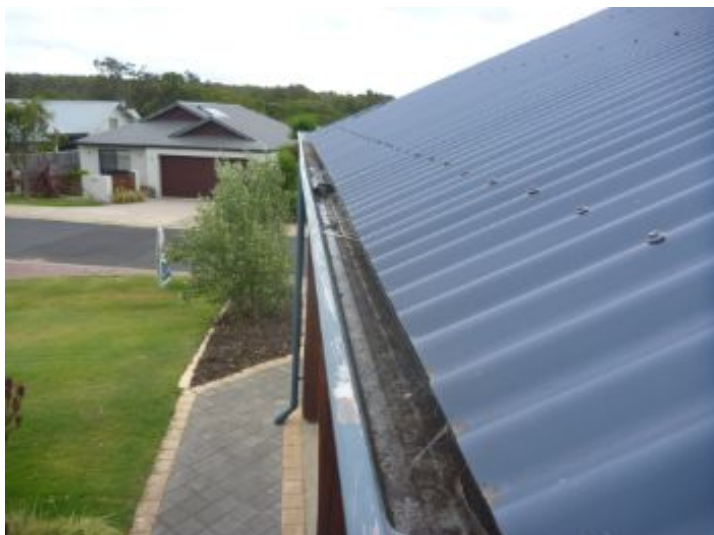
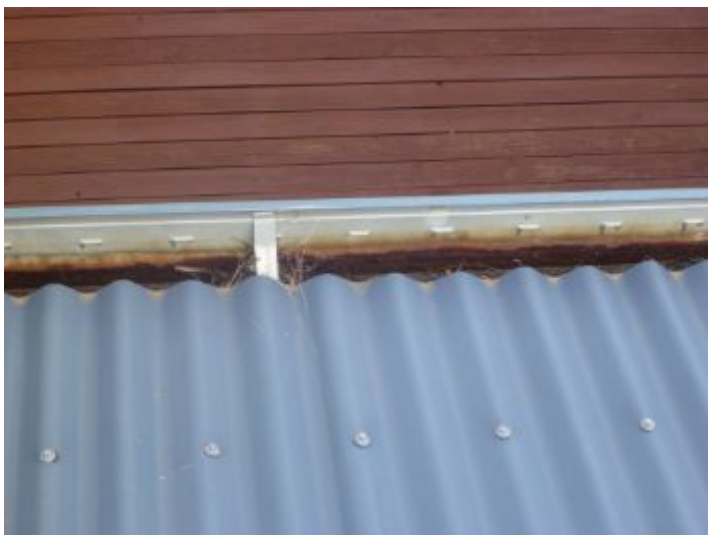
5. Roof Drainage

- Observations:
- No major function concerns noted at time of inspection.
  - The gutter above the entrance are are significantly rusted or corroded in areas and may leak. You may wish to fill them and test for leakage and then service or replace them as needed.
  - The gutters should be regularly cleared of debris to ensure the proper flow of water from the roof.

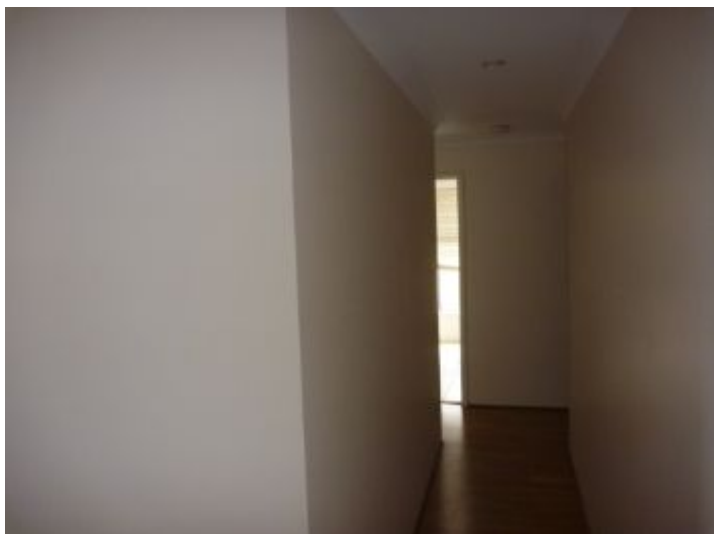
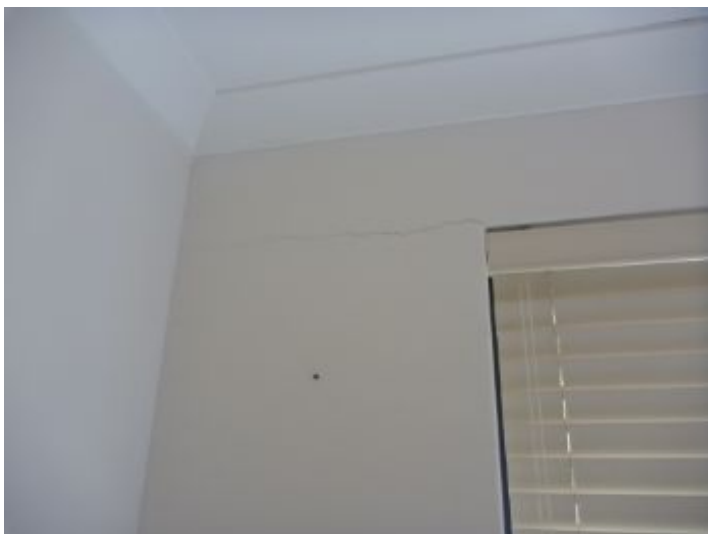
### 1. Wall Condition

- Due to normal minor differential movement within the property or foundations, small cracks have appeared at various locations within the home. These cracks do not appear to have affected the overall structural integrity of the property and can be patched normally

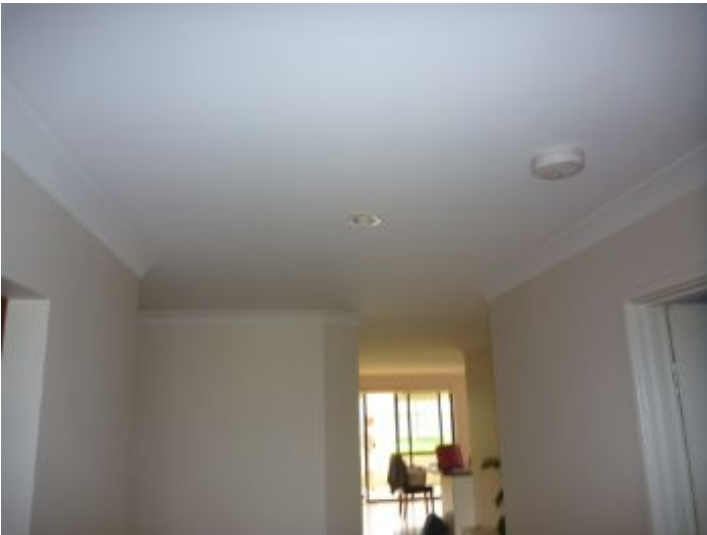
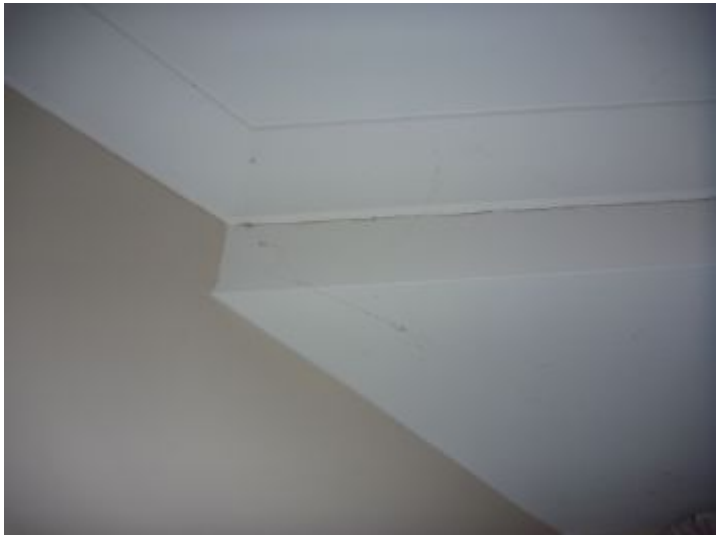
### 2. Ceiling Condition

- There is minor cracking which has occurred at the interface between the ceiling cornice and the wall at various locations. This can be a result of foundation settlement and/or movement in the roof structure. This does not appear to have affected the structural integrity of the home and can be repaired normally.

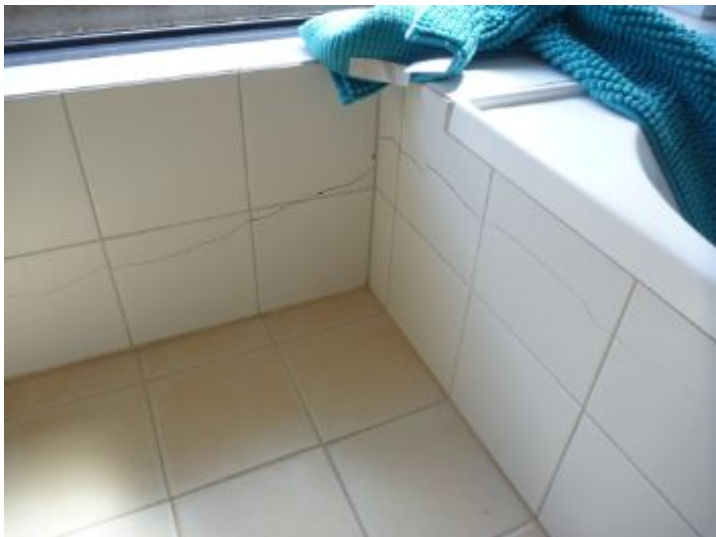
### 6. Floor Condition

- Numerous cracked tiles noted. These cracks do not appear to have affected the overall structural integrity of the property and the tiling can be patched normally.

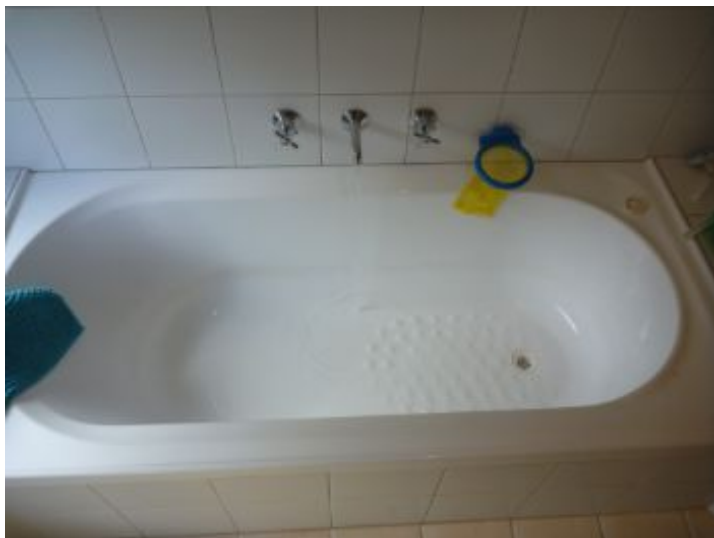
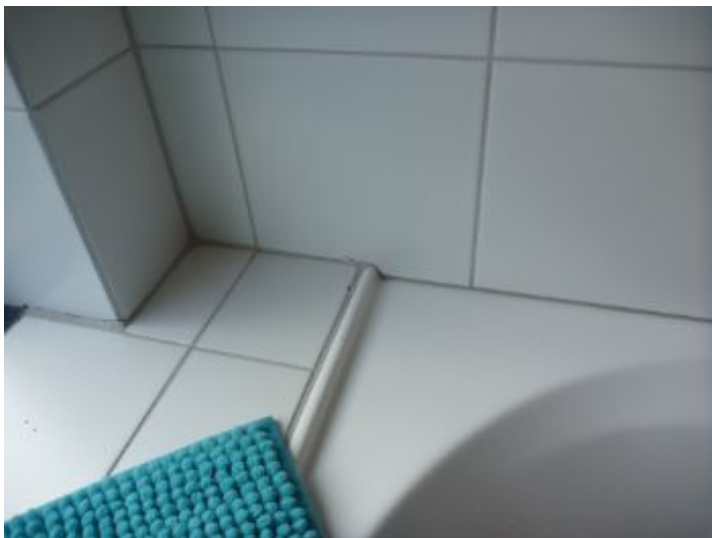
### 9. Bath Tubs

- The bath tub and related components operated normally when tested.
- The gap between the bath and the wall tiles requires sealing to prevent moisture intrusion into the wall.

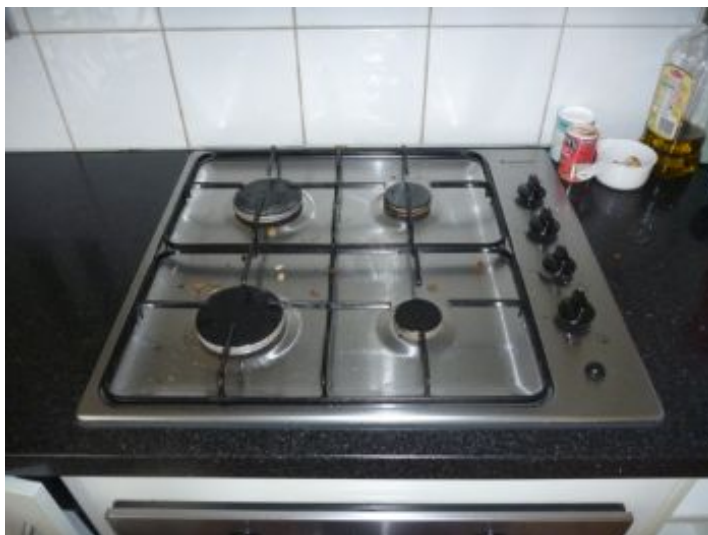
### 1. Cook top condition

- Gas cook top noted.
- Unable to test due the cook top as the self igniter is not functioning and requires servicing. This should be rectified and then the cook top tested for normal operation.

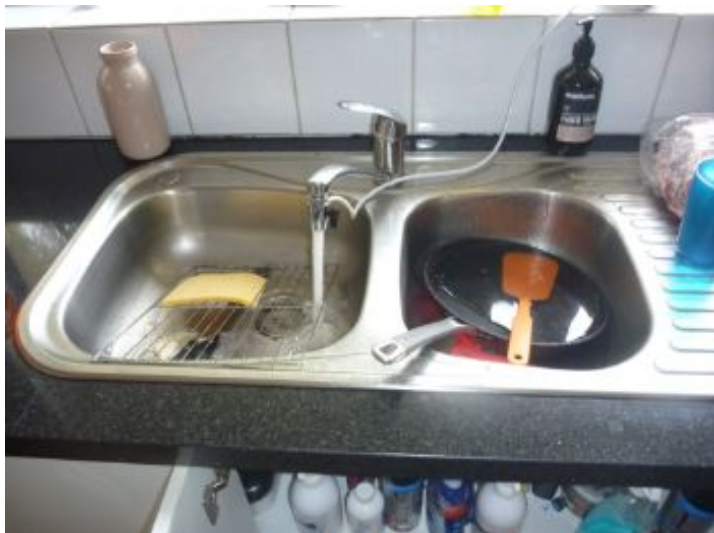
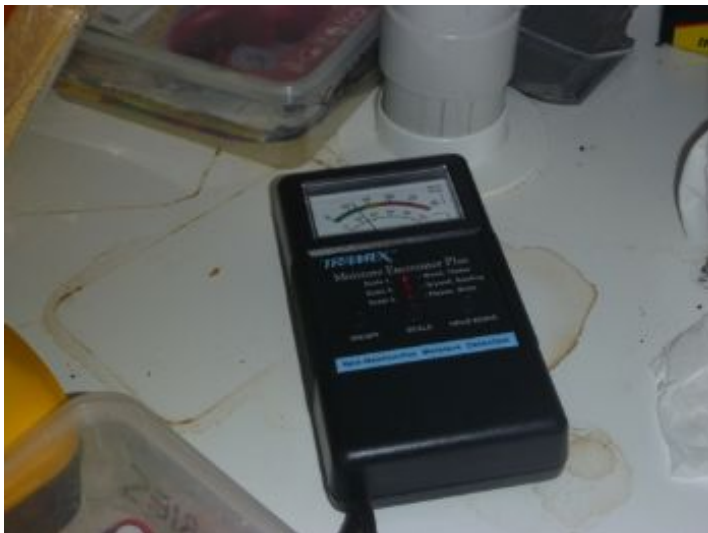
- The sink and related components are functional.
- Stains from presumed past leaks noted. This tested dry at the time of the inspection, recommend monitoring for any further intrusion.

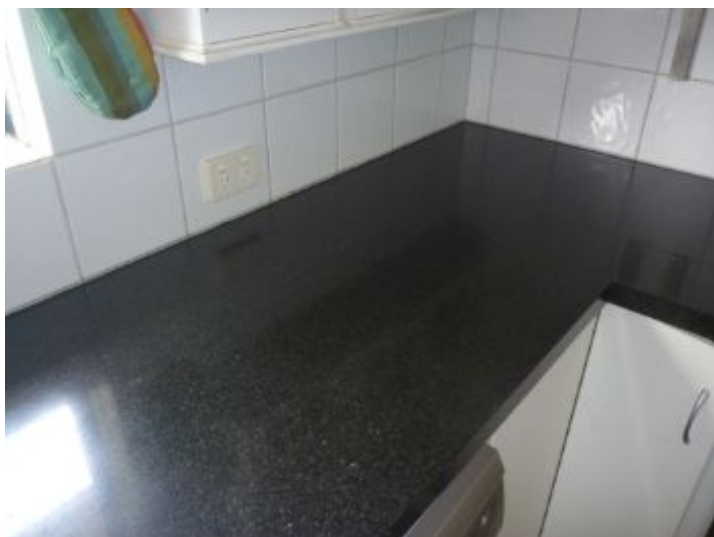
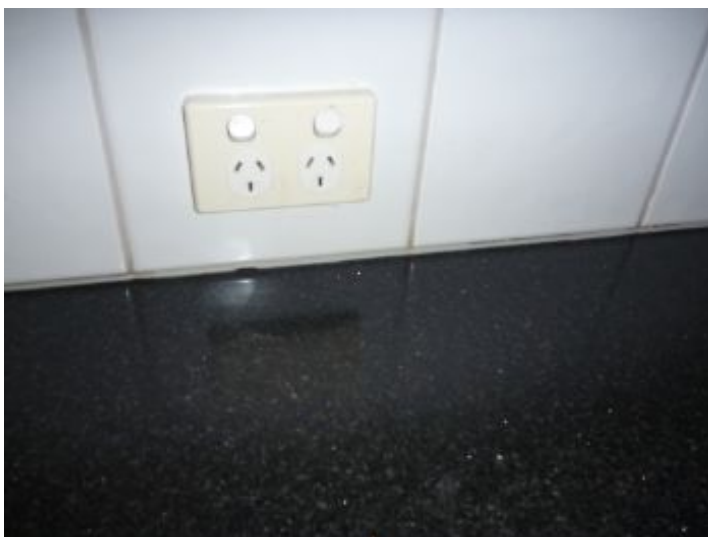
#### 4. Counters

- Appeared functional at time of inspection.
- Solid Surface tops noted.
- The gap between the counter and the splashback requires sealing to prevent moisture intrusion into the cupboards.

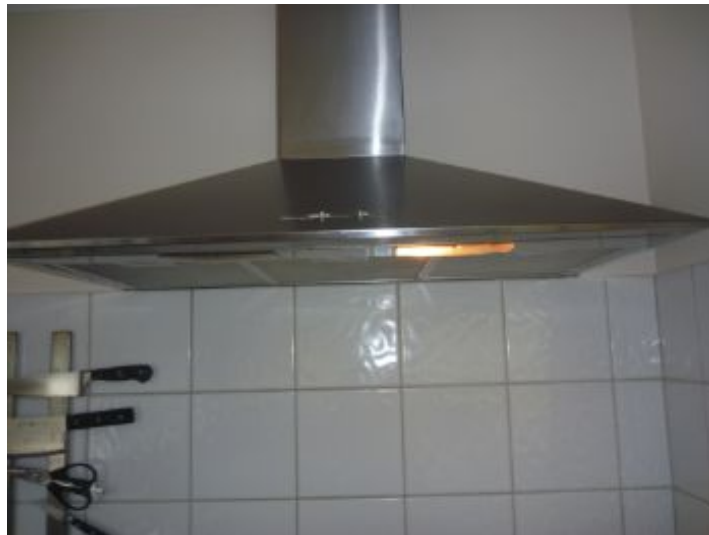
### 6. Vent Condition

- One vent fan light is inoperable. Recommend replacing bulb and re-testing. If still not working a qualified electrician should be consulted to rectify.

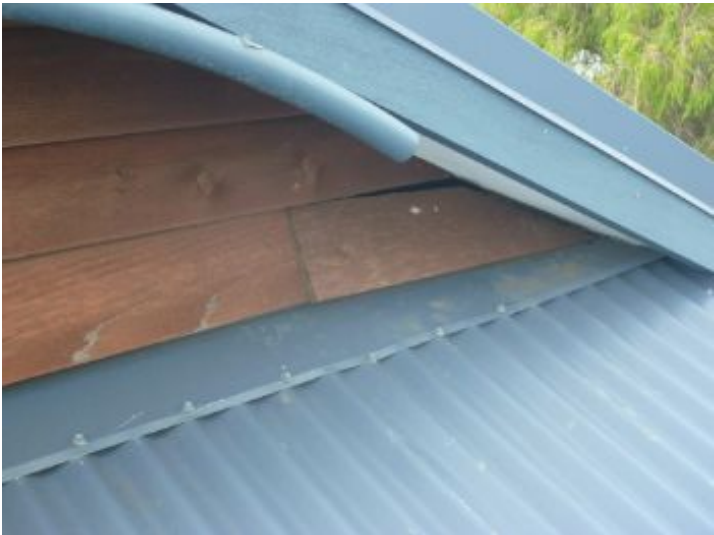
## 3. Cladding Condition

- External cladding appears to be in satisfactory condition relative to its age.
- A small piece of cladding is loose on the front roof gable and some minor maintenance is required.

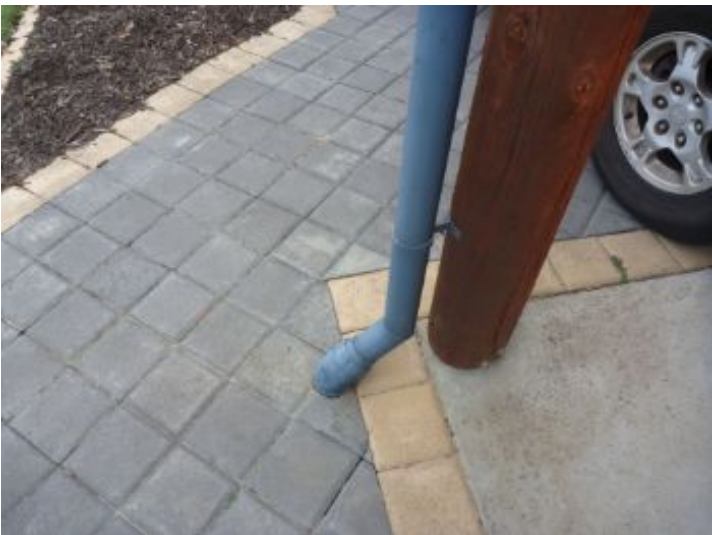
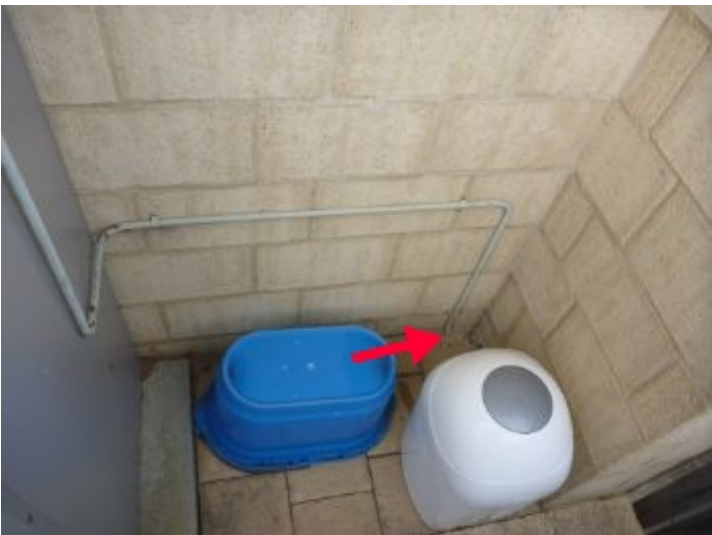
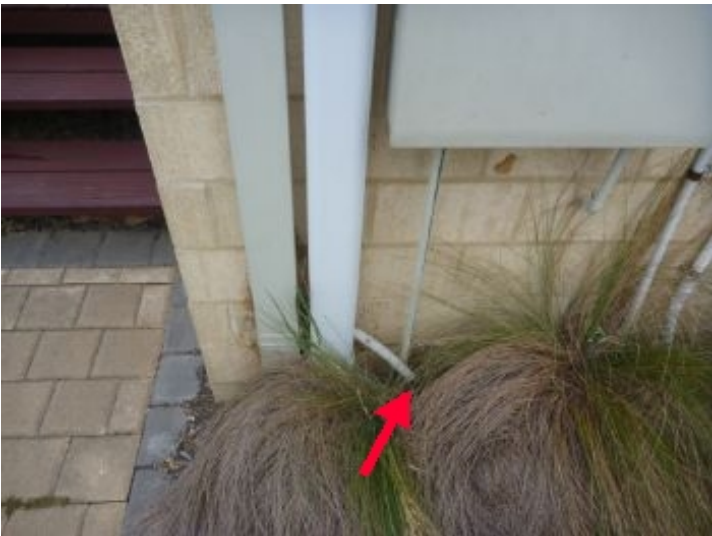
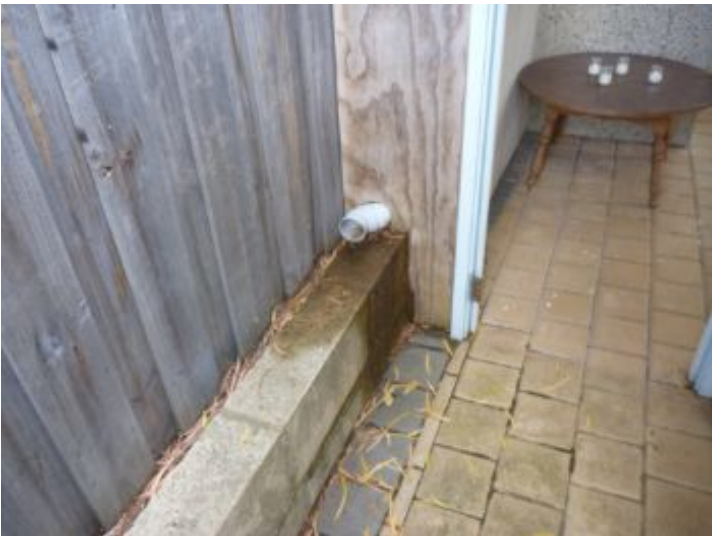
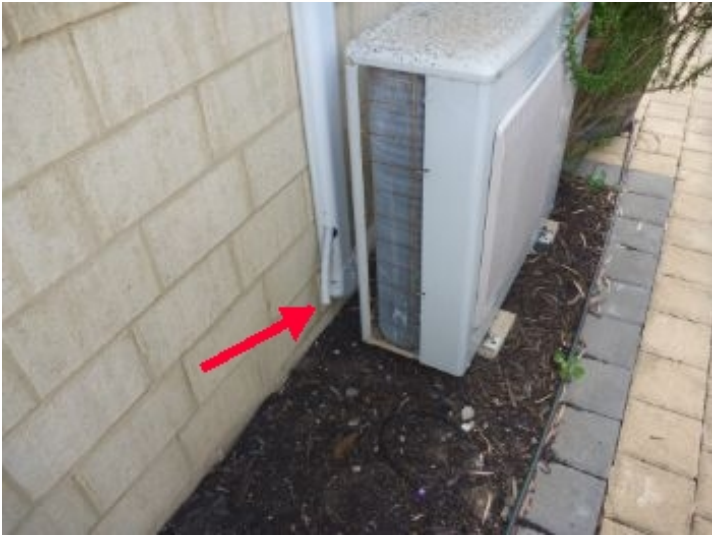
2. Grading and Drainage

- Observations:
- Surface drainage conditions within 3 metres of the inspected structure appeared satisfactory.
  - Some of the down pipes do not have soak wells installed. This allows water discharged to pool beside the external walls and soak in adjacent to the structure. This can cause foundation settlement, dampness in external walls and can create an ideal environment for termites. It is recommended that either soak wells be installed at least 3 meters away from the building for all down pipes or alternatively all water is directed at least 3 metres away from the external walls.

- The hot water system overflow pipe discharges on the foundations. This should ideally be directed into a soak well or at least 3 metres away from the building.

- The air conditioner discharge pipe discharges on the foundations. This should ideally be directed into the stormwater, or at least 3 metres away from the building.

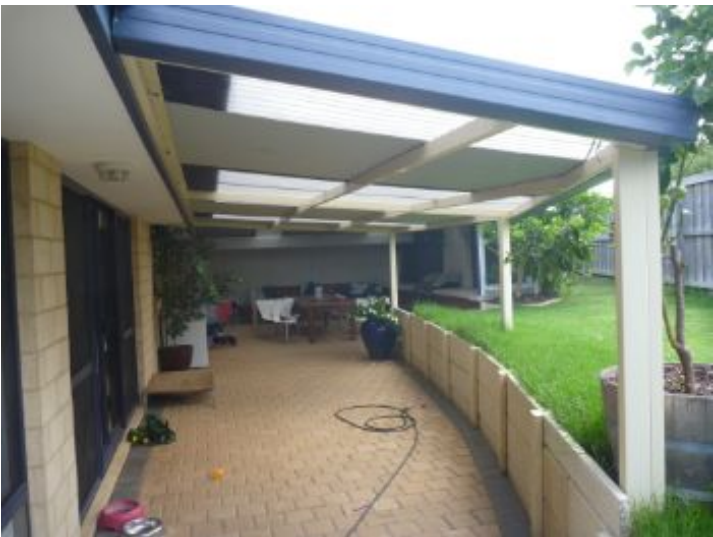
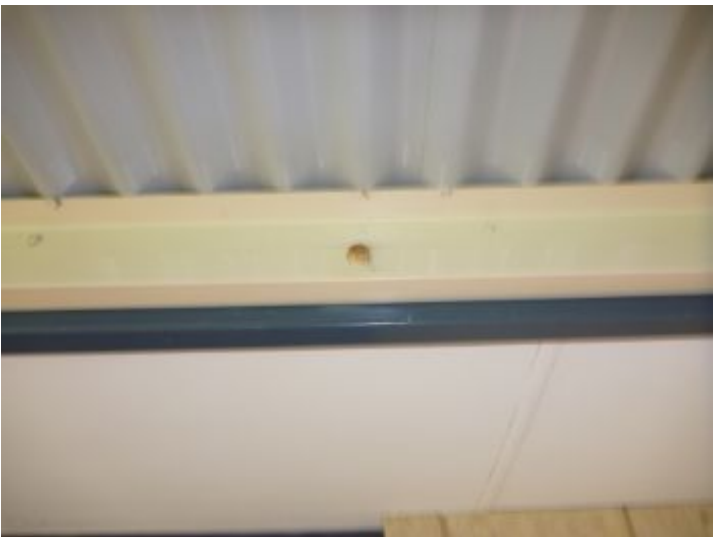
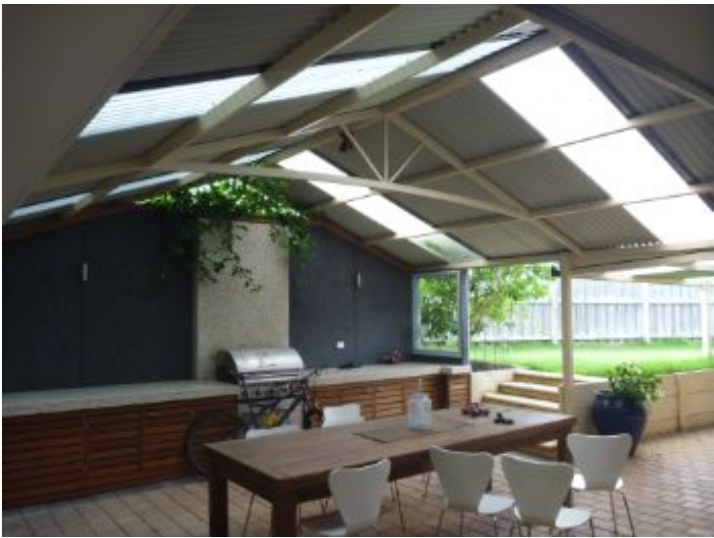
### 6. Stairs & Handrail

- No deficiencies noted. Appears to be structurally sound.
- The fixings for the patio area have surface rust and require maintenance.
