Property Inspection Report

Sample Report, WA

Inspection prepared for: Sample Report
Date of Inspection: 8/2/2024 Time: 8:30am
Weather: Fine 24C

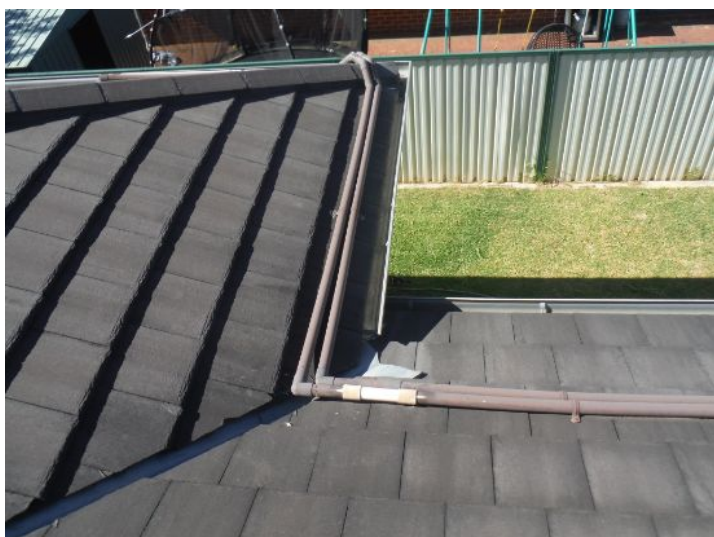
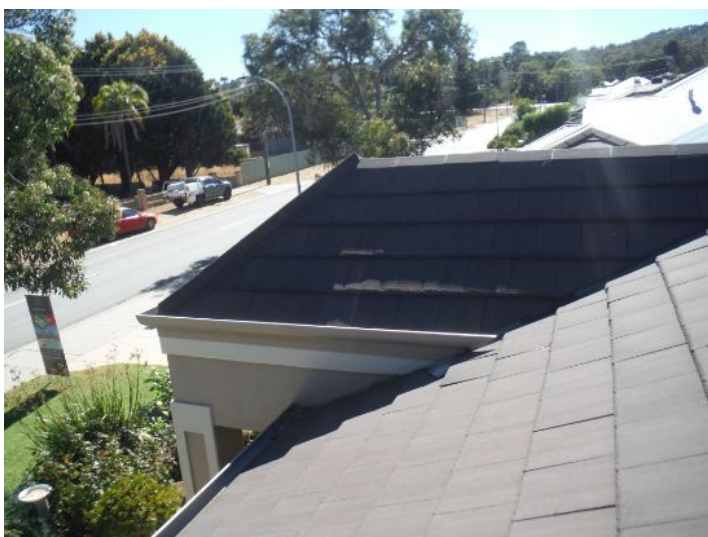
Noted pool heating pipes.

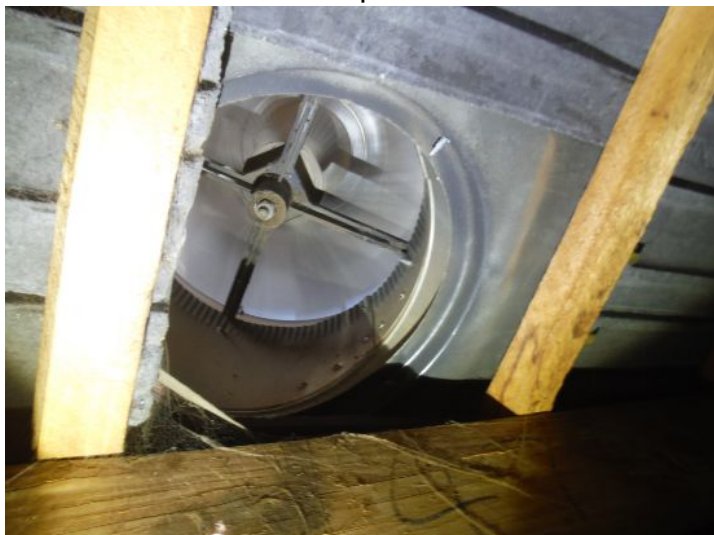
- The rear roof ventilation fan is noisy in operation. Requires maintenance or replacement.

Noted the rood ventilation fan is very noisy. Recommend maintenance or replacement.

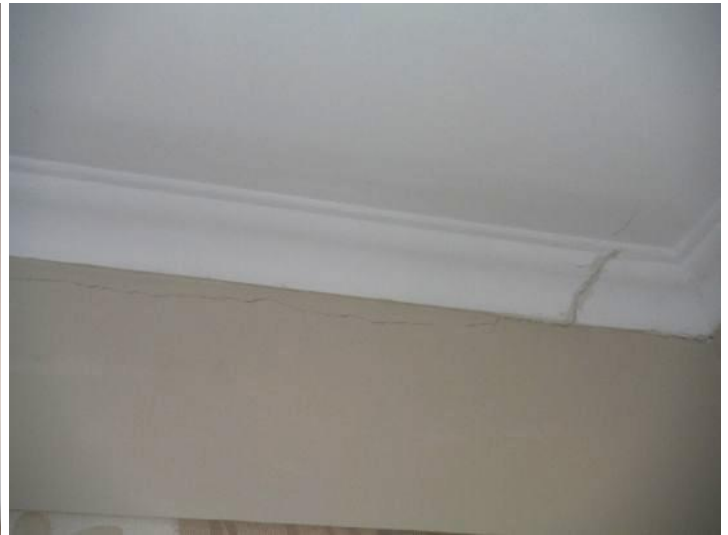
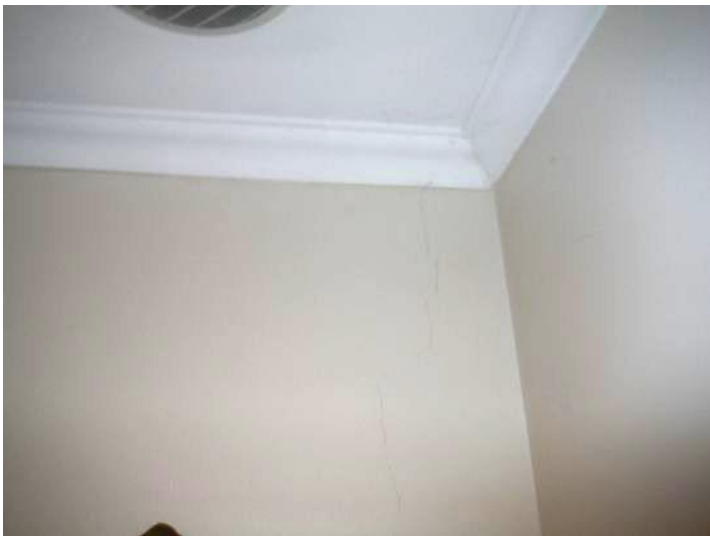
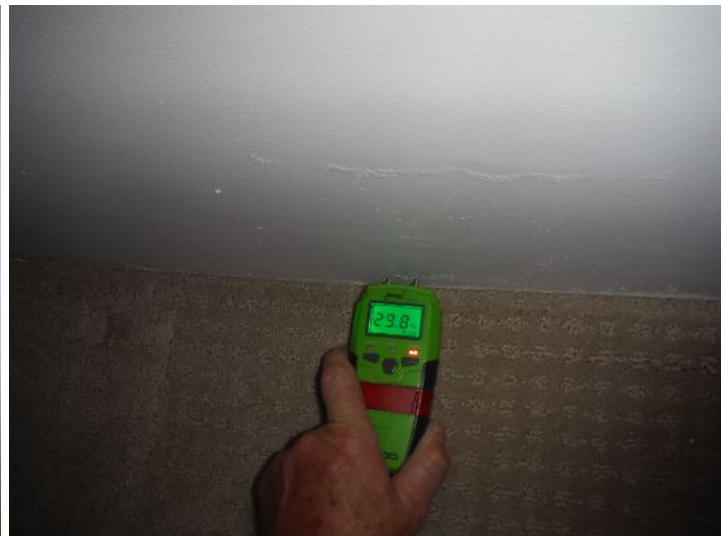
- Very minor shrinkage cracks in the wall plaster in some locations. This is not a structural issue and can be repaired normally.
- There is evidence of dampness in the wall which is adjacent to the ensuite shower. This is most likely as a result of the seals and tile joints not functioning correctly. The tiles and joints should be checked for leaks and resealed to prevent any further dampness. Then the wall should be allowed to dry out fully before being sanded/repainted as required. This does not appear to have affected the structural integrity of the wall.

Adjacent to the ensuite shower.

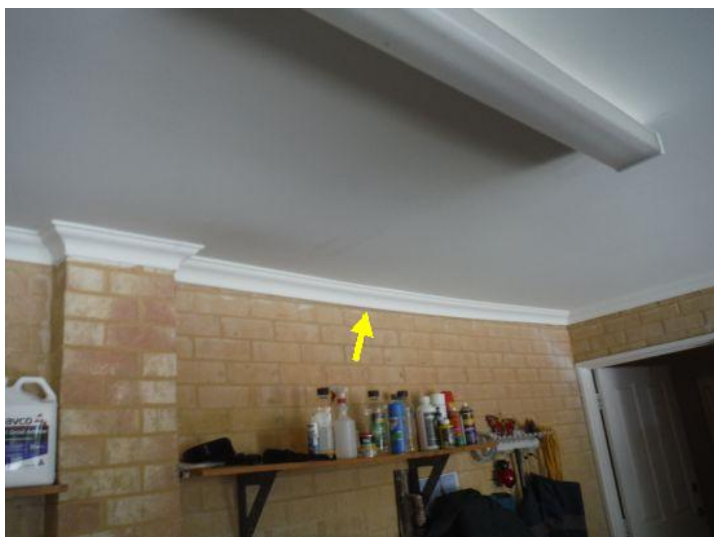
Slight sagging noted in the garage. Monitor for maintenance.

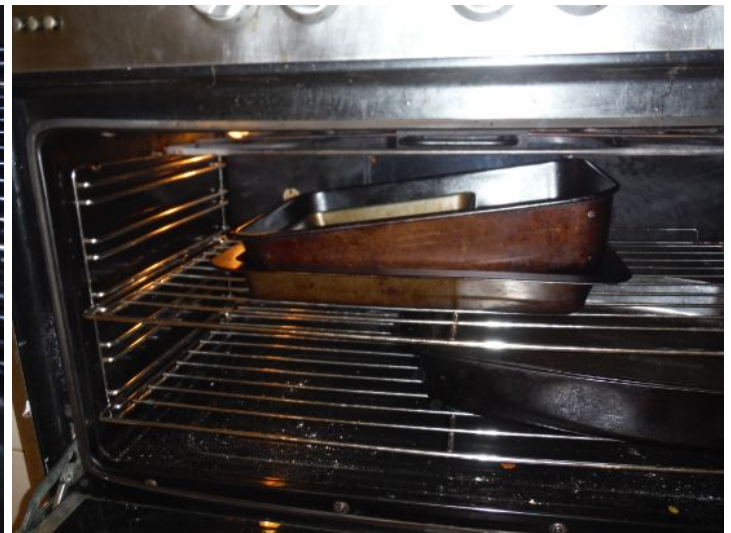
- The electric oven elements were tested at the time of inspection and appeared to function properly.
- The oven door does not seal properly and requires maintenance.
- The oven door opens fast. Recommend maintenance to the hinges to slow the door down.

The door hinges need adjustment to reduce the door weight.

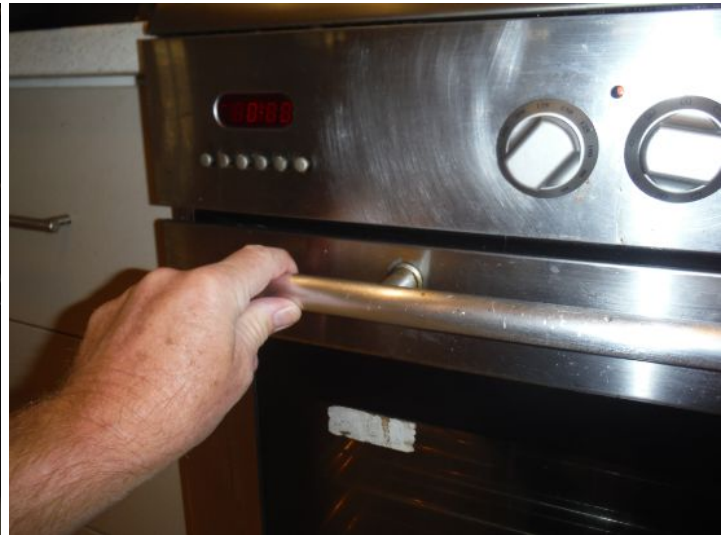
The door handle needs tighteneing.

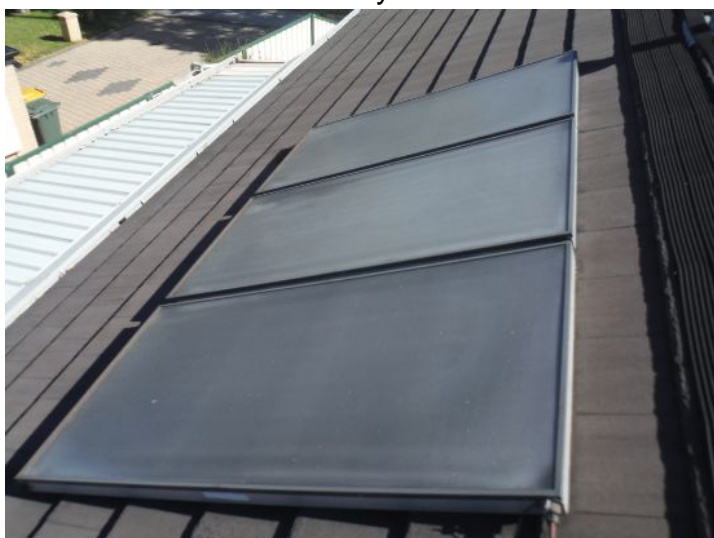
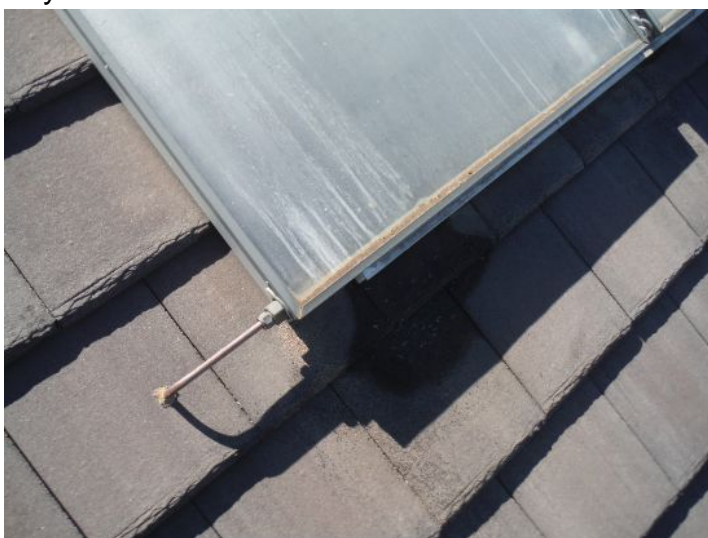
Noted small moisture stain, monitor this are. May be condensation.

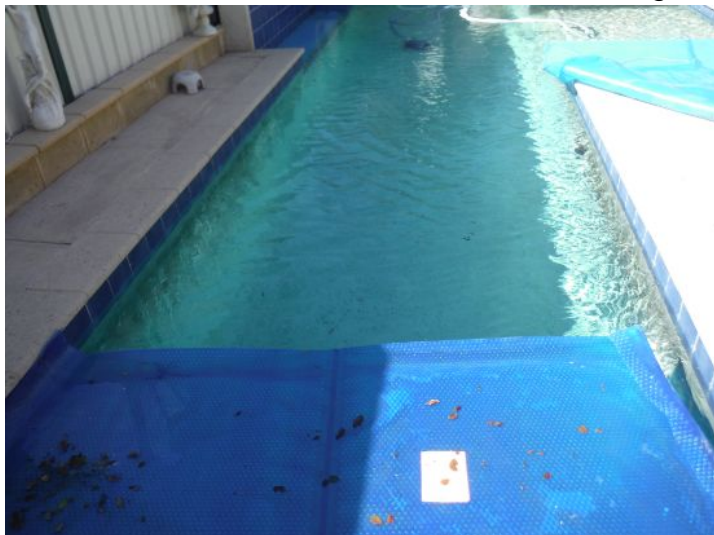
- Some surface staining was noted on the walls.

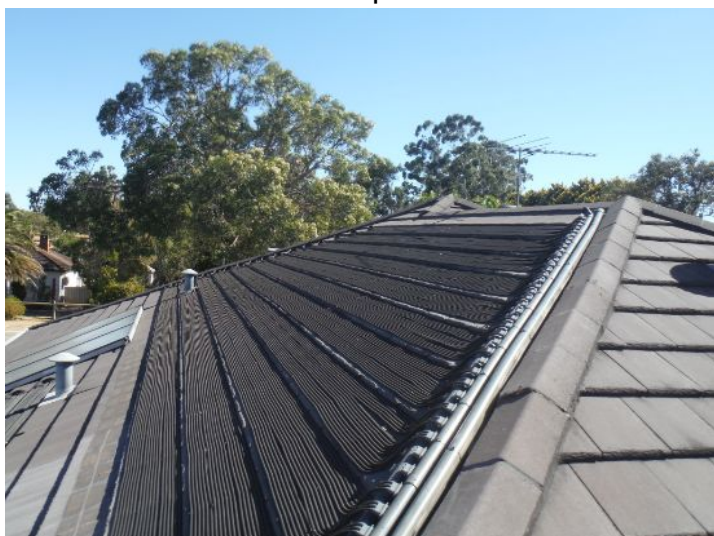
New heater tubing system has been installed in the last two years. Monitor for leaks as this carries salt water.

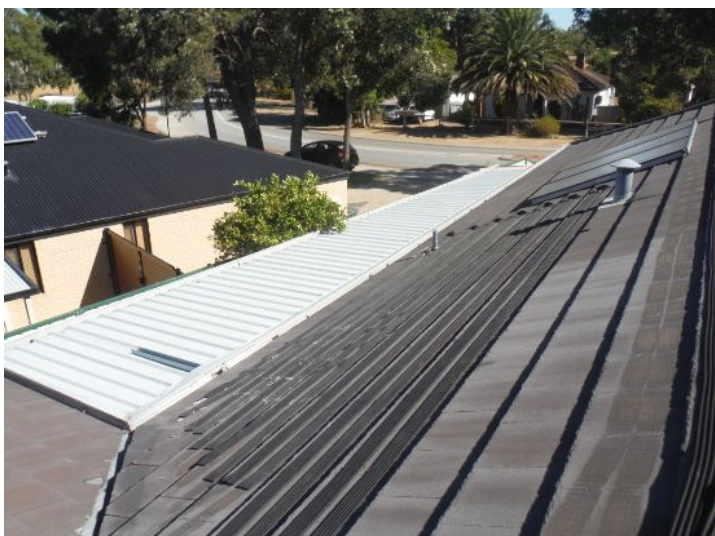
Old system still present.

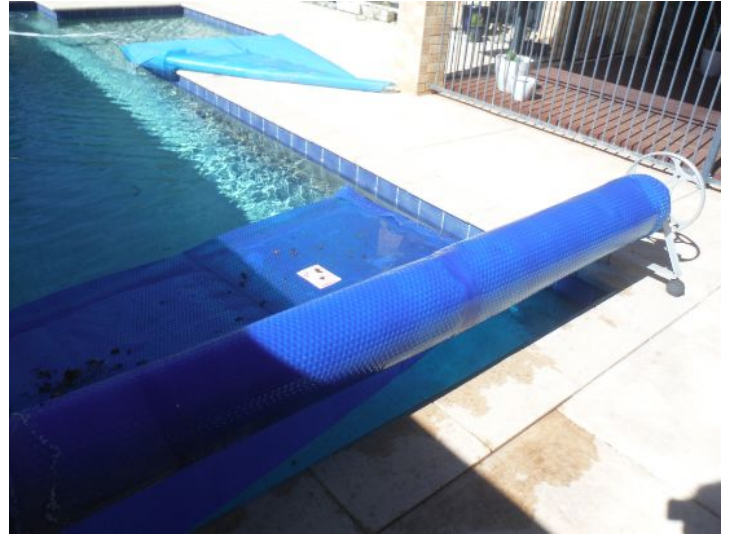
- The pool cover appears to be in satisfactory condition for its age. Noted three pieces.
- The pool cover should have an external white cover fitted when stored on the roller to prevent sun damage.
