Property Inspection Report

Sample Report, WA

Inspection prepared for: Sample Report
Date of Inspection: 20/10/2023 Time: 8:30am
Weather: Fine 20C

- Dilapidation Inspection

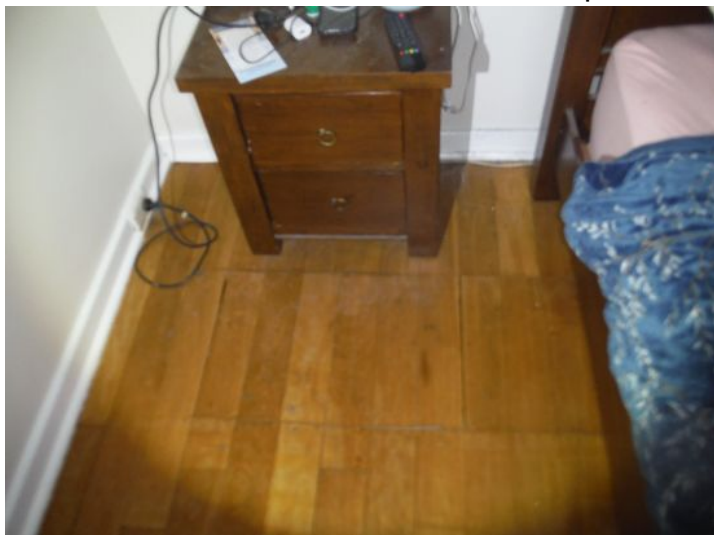
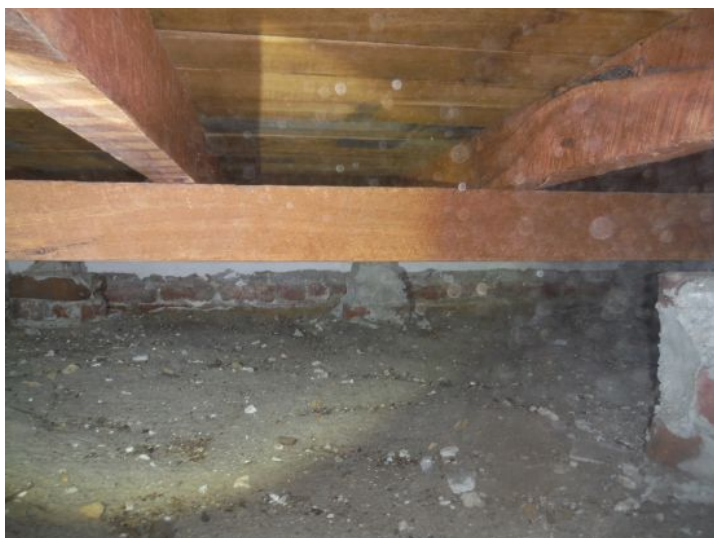
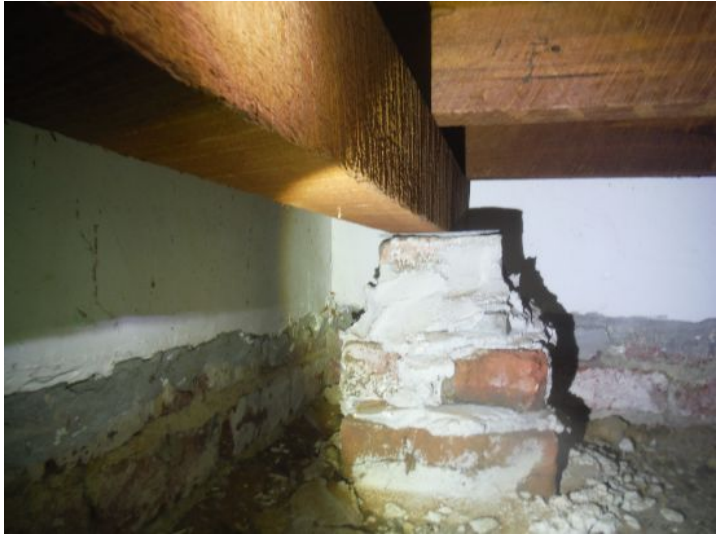
- The foundations appear to be performing satisfactorily.
- Noted one brick pier needs the cement sheet packing replaced.

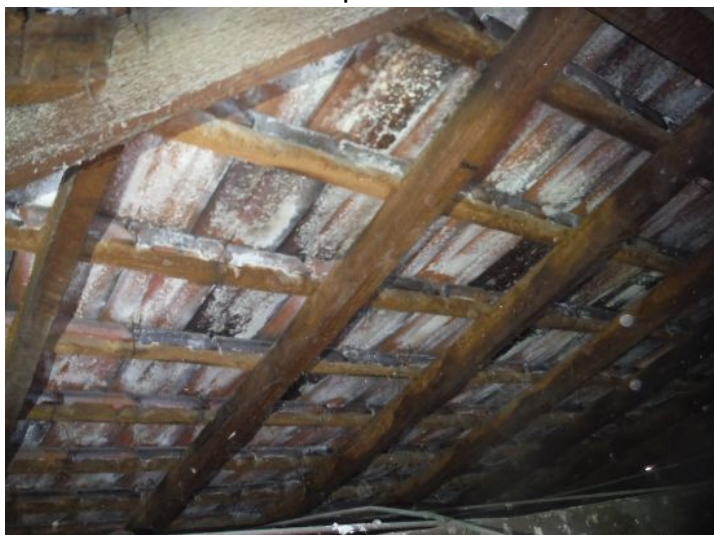
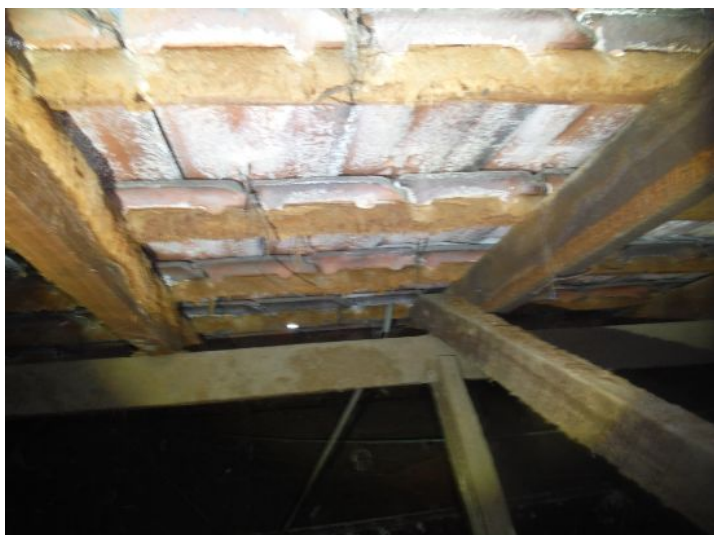
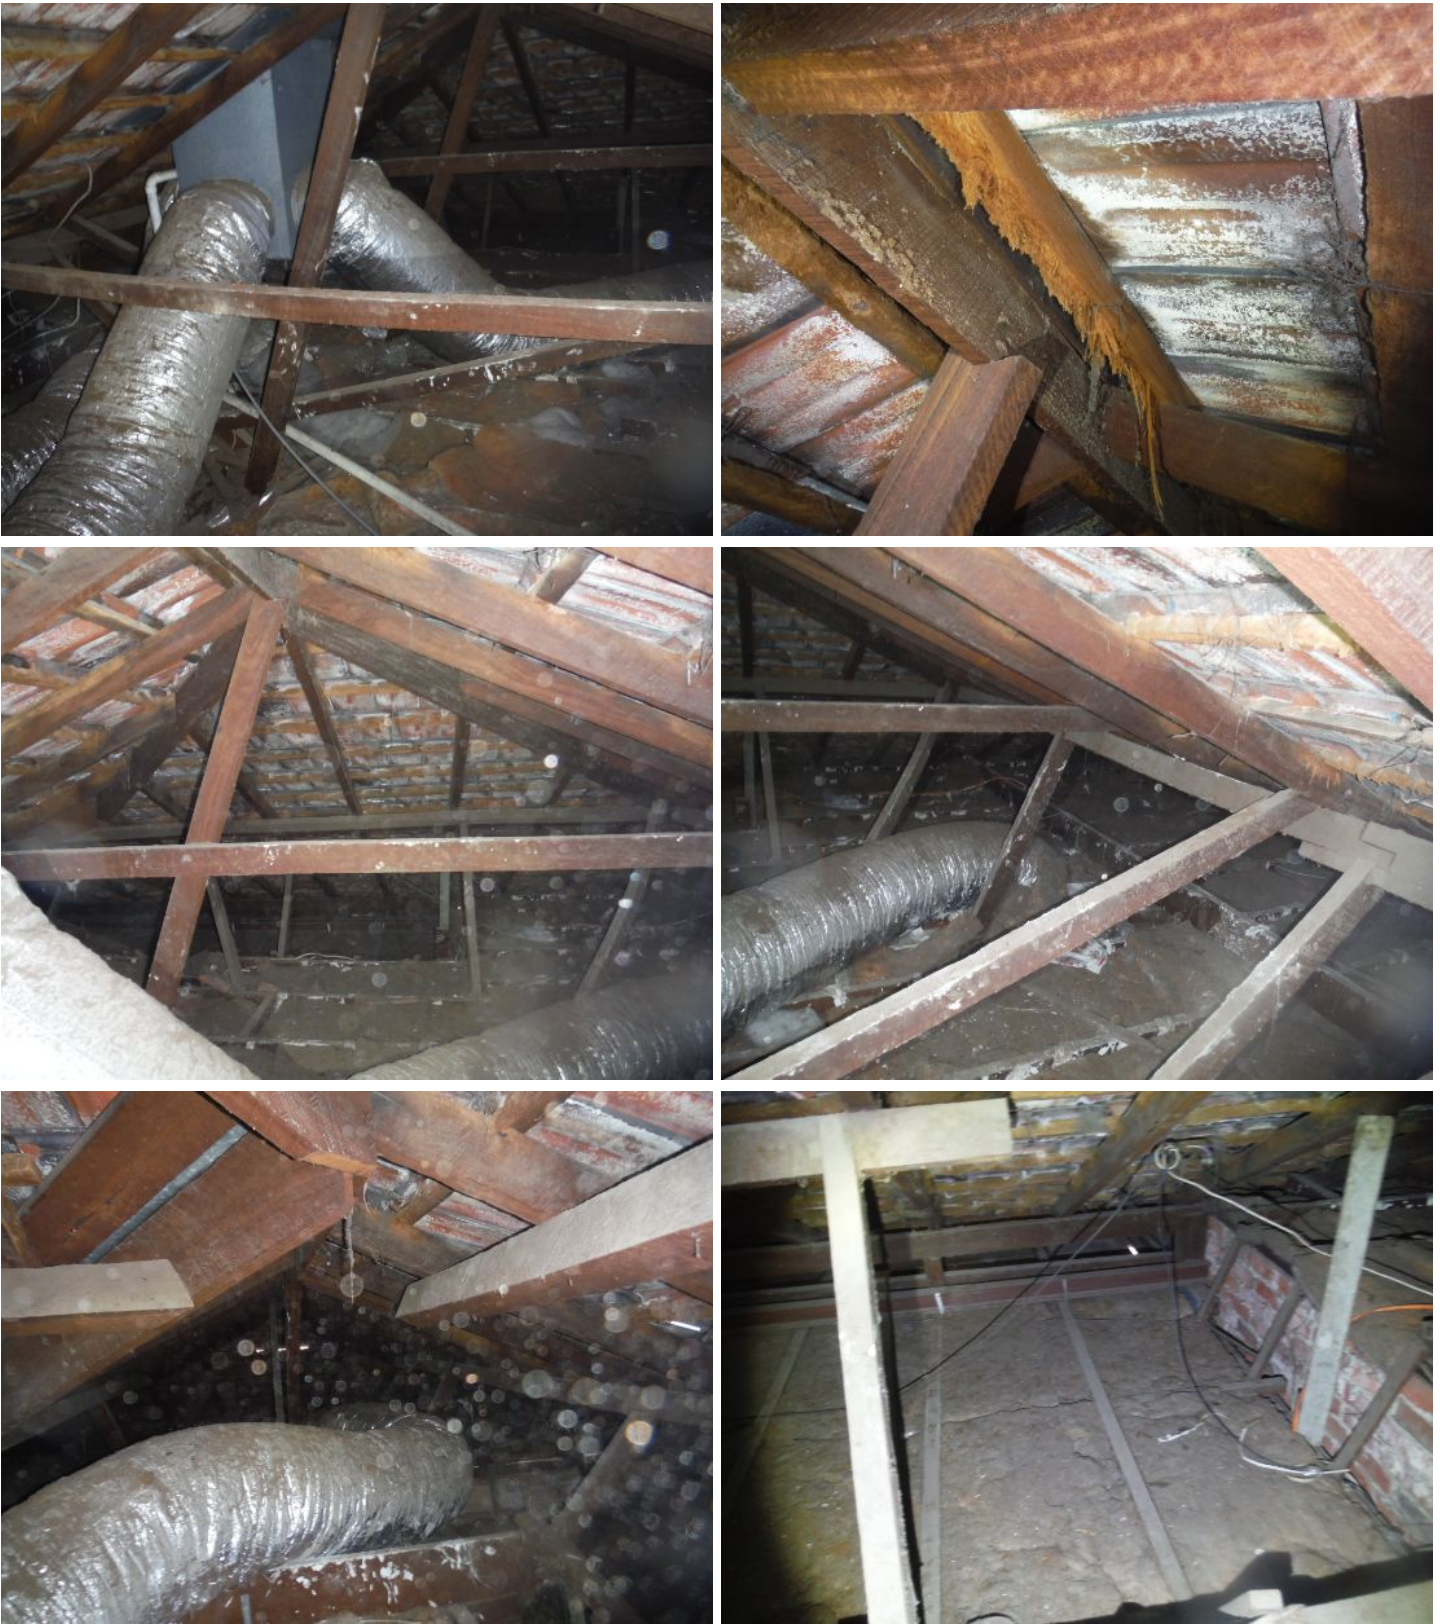
Above the front porch

- Evidence of "Chemical Delignification" - (Timber fretting) was noted on some of the timber batten components in the roof space. The roof battens appear to have lost 10% of their width at present. You may wish to obtain a quote for treatment of these battens from Power Drive Roofing.

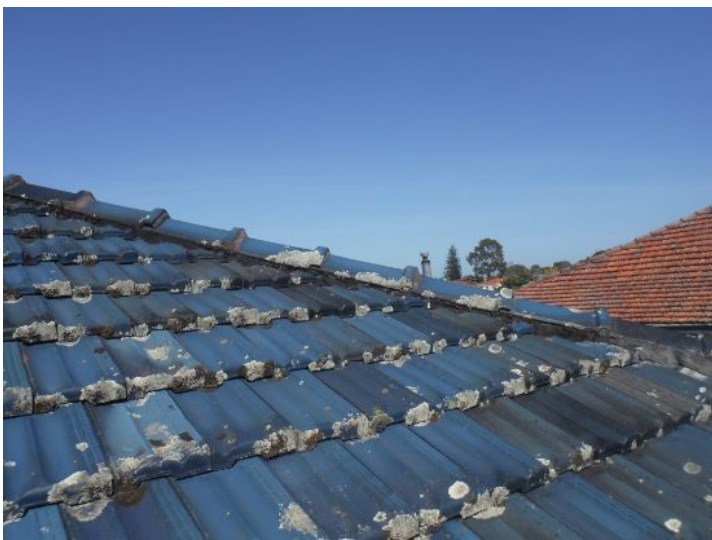
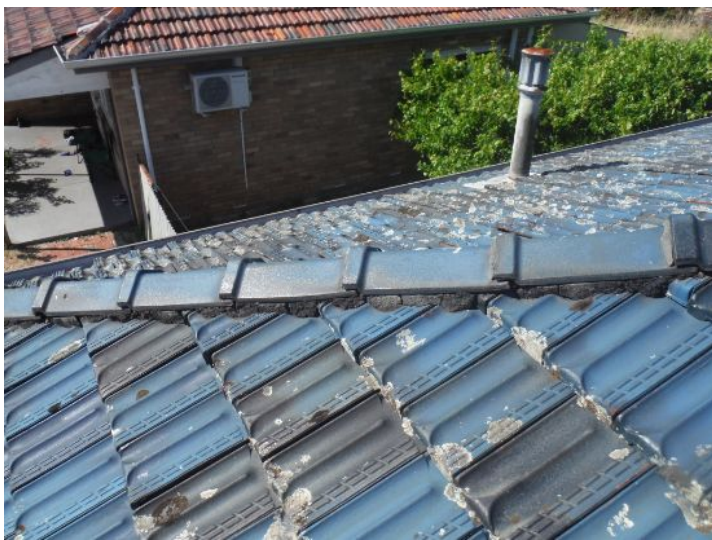
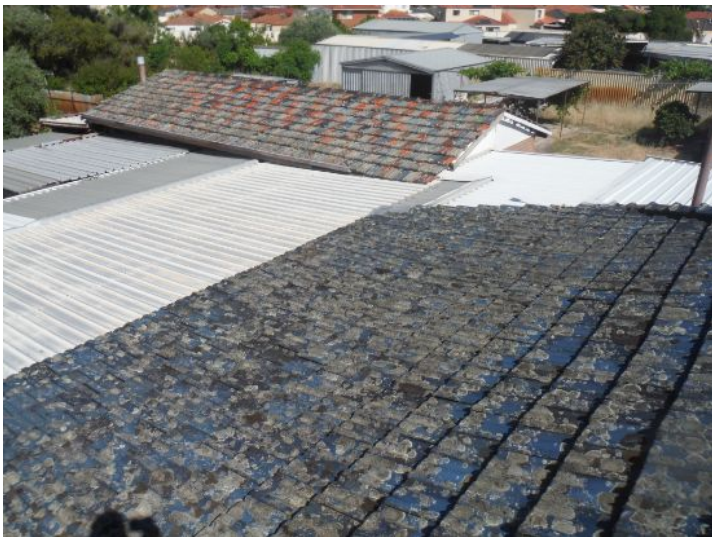
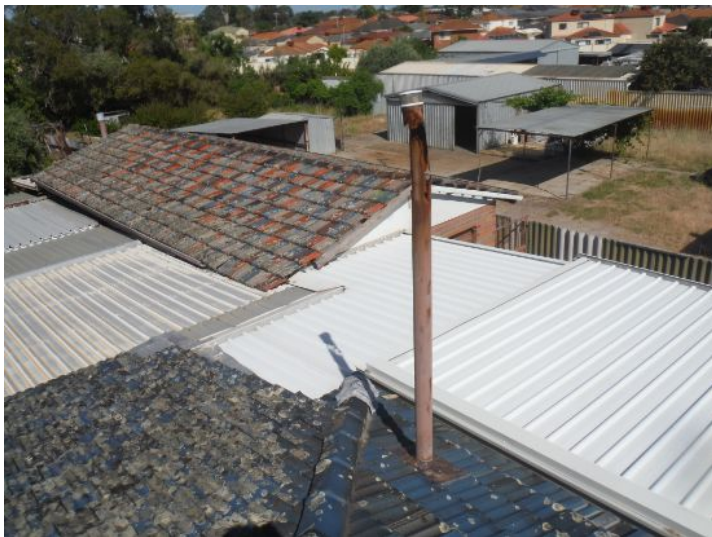
- There are cracks in the bedding cement. This is not unusual for a tiled roof, and is often caused by normal movements in the roof frame. It is recommended that maintenance work is carried out on the roof so that the loose tiles can be re-bedded using flexible bedding compound to help prevent re-cracking.
- Moss on roof. This can lead to the premature failure of the roof and subsequent leaks. You may want to remove the moss on the roof to prevent roof deterioration.

Noted the vent pipe has corroded. Recommend maintenace

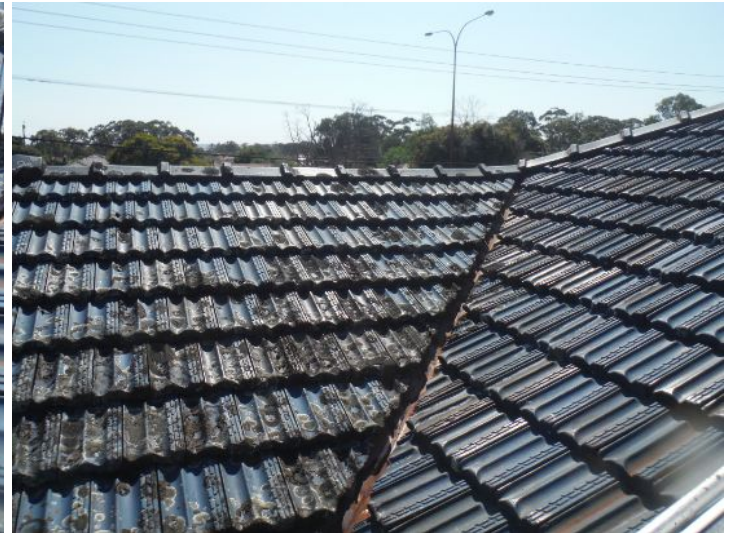
- Flashing is an impervious material (usually galvanized sheet metal) that comes in a variety of shapes and sizes and is used to cover, waterproof, and direct water away from roof penetrations and from valleys and intersections between the roof covering and other materials.
- In the inspector's opinion the flashings are near the end of their useful life due to wear.

Corroded flashing noted

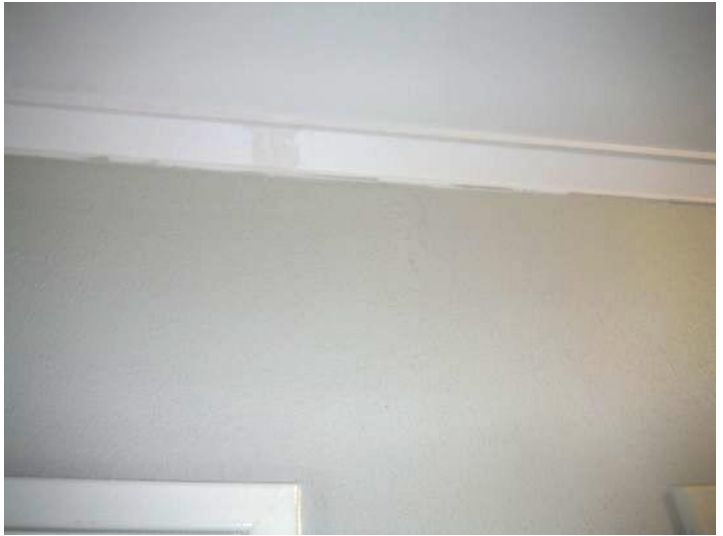
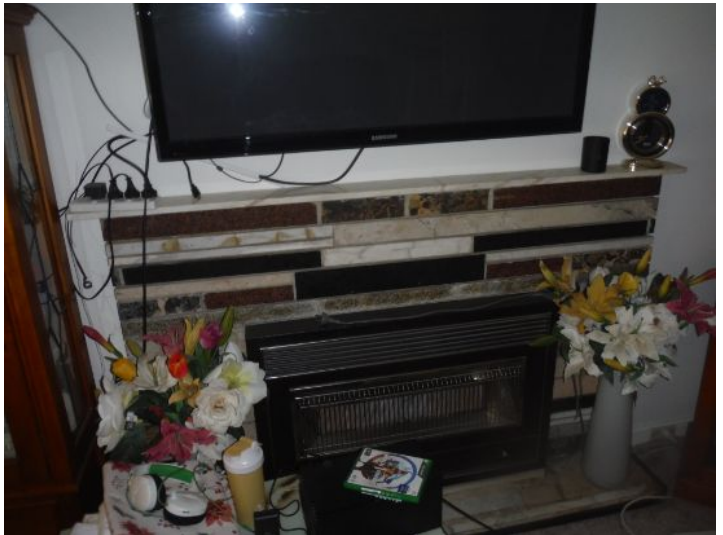
- Very minor shrinkage crack in the hallway wall plaster . This has been filled and painted in the past. Front lounge doorway.

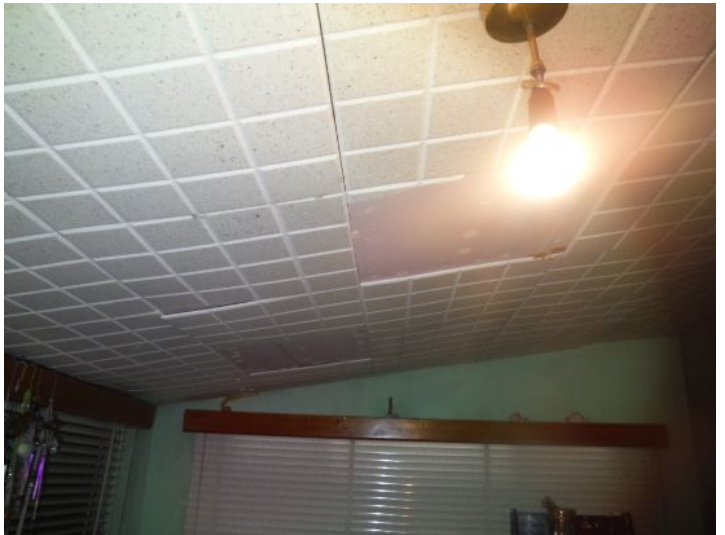
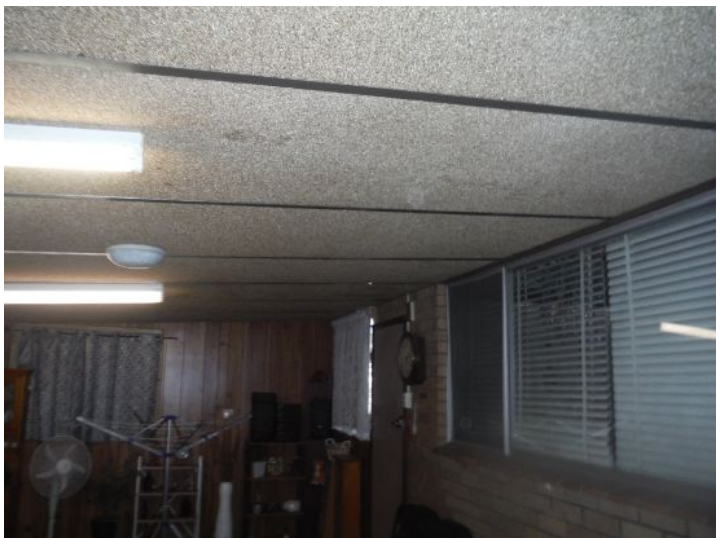
Laundry ceiling has been replaced.

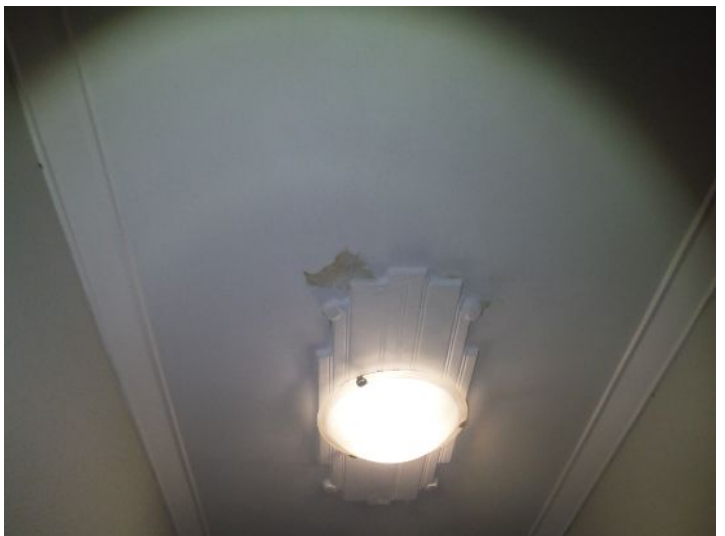
Stain noted at the hallway light

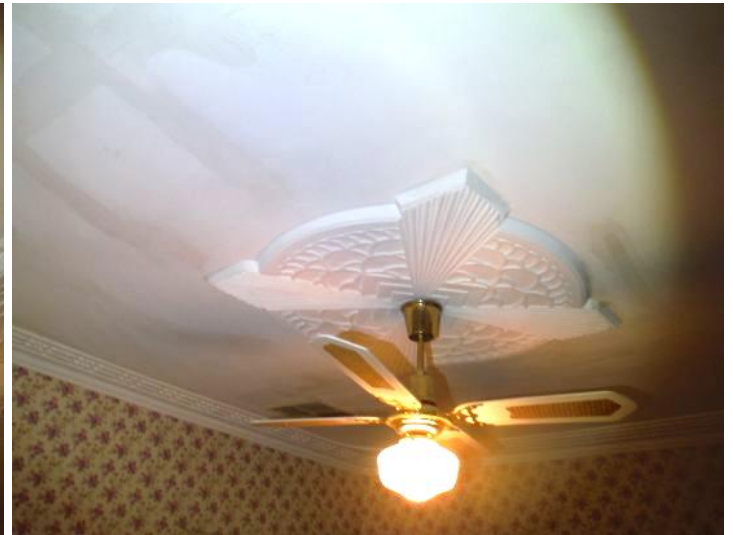
Front bedroom

Some surface cracks have been filled in the past at the front bedroom ceiling

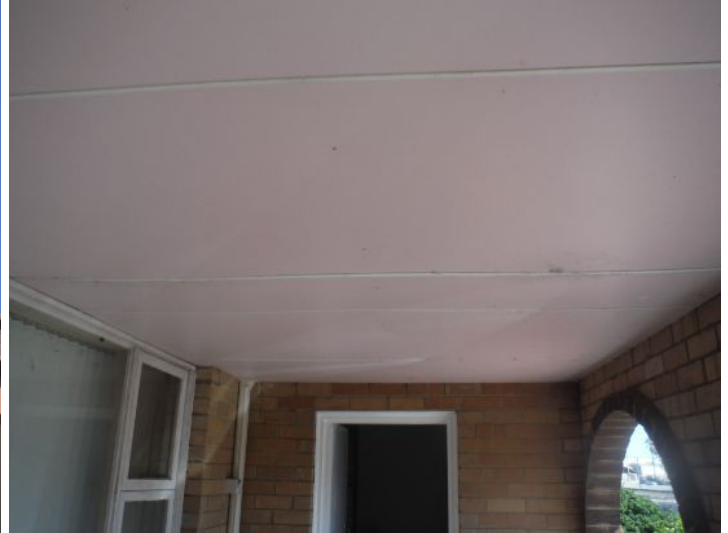
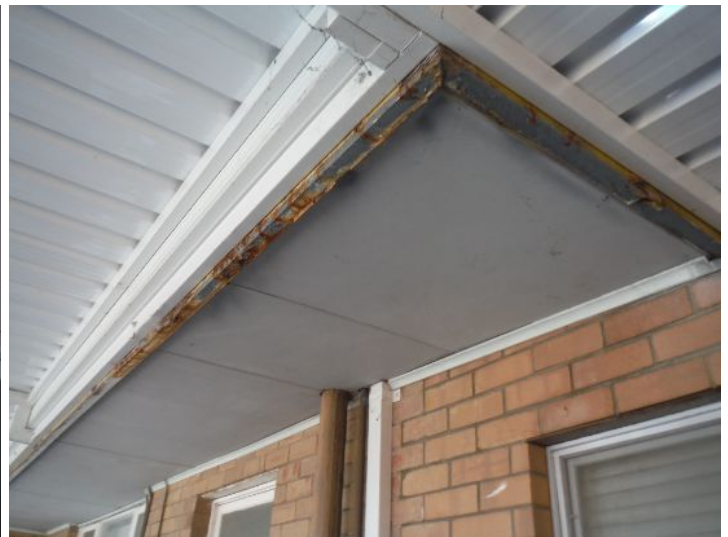
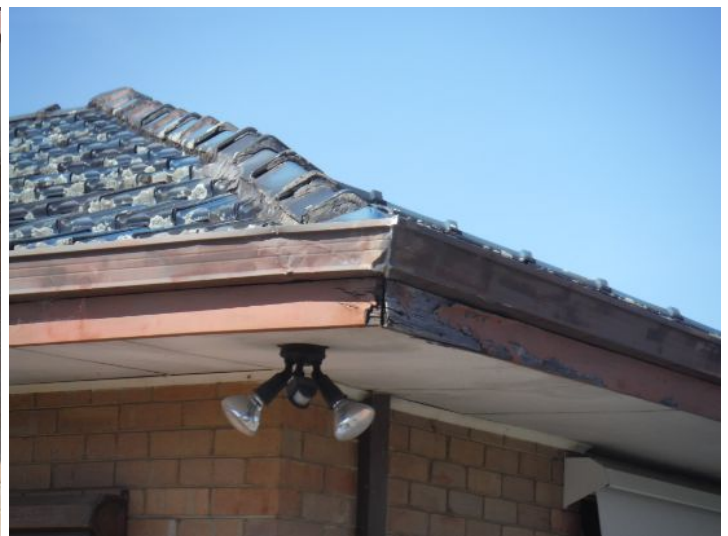
- Some weathered timber noted. Recommend review for maintenance as required.

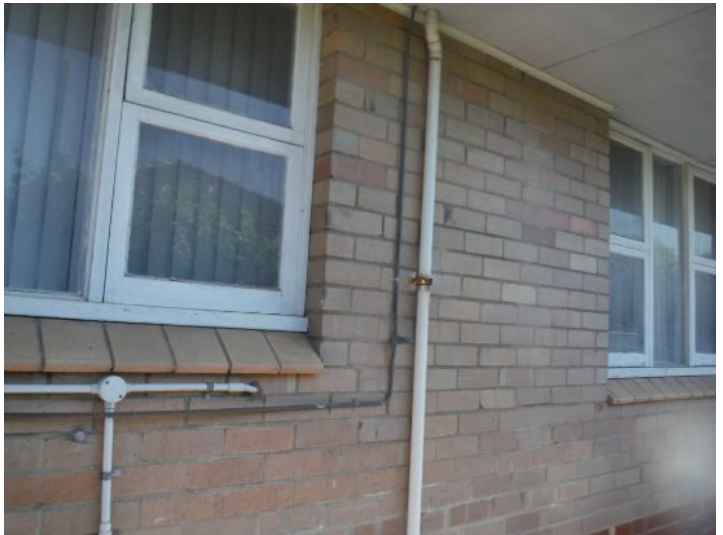
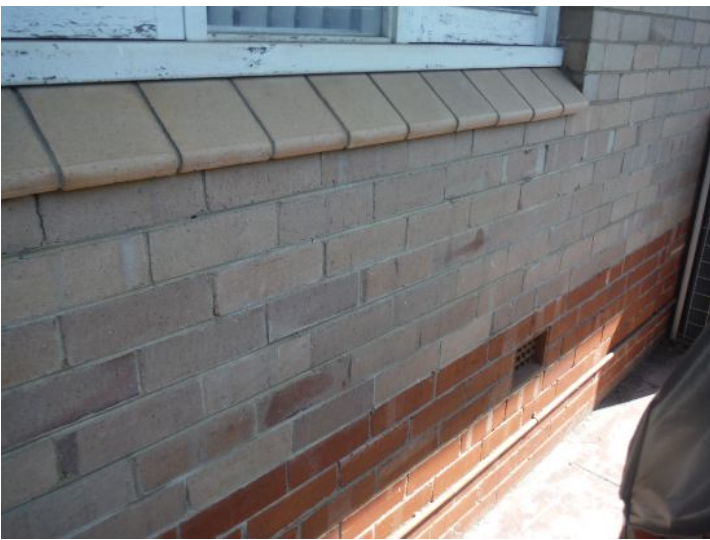
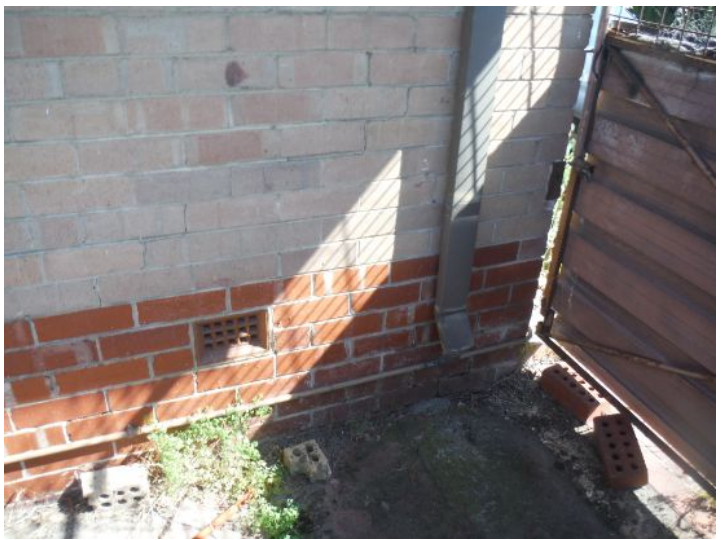
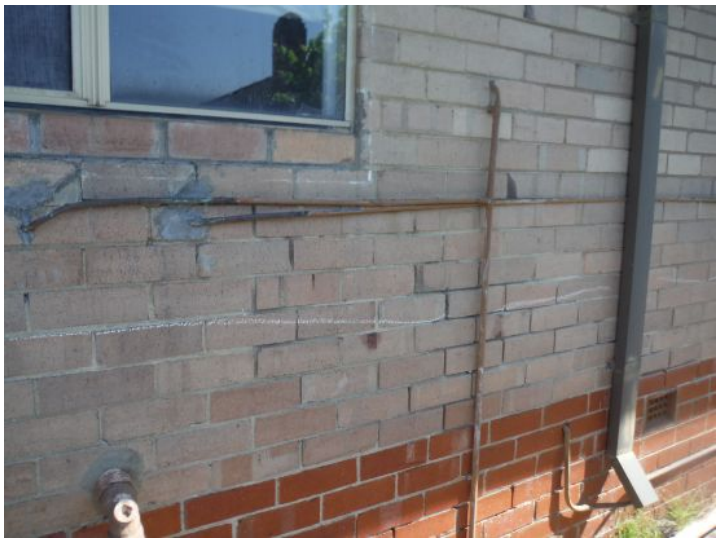
Corroded vent pipe noted.

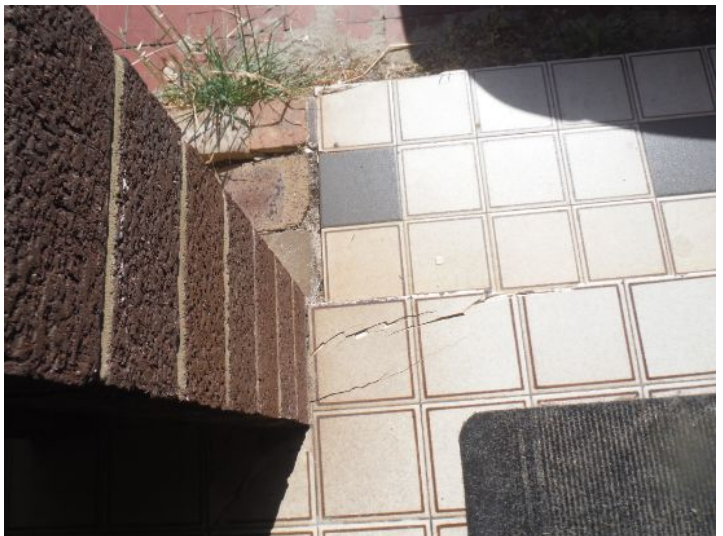
Crack at front porch steps noted.

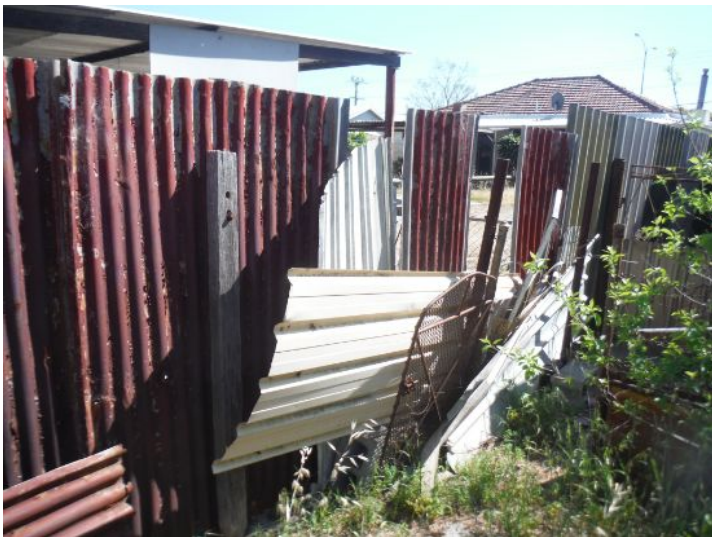
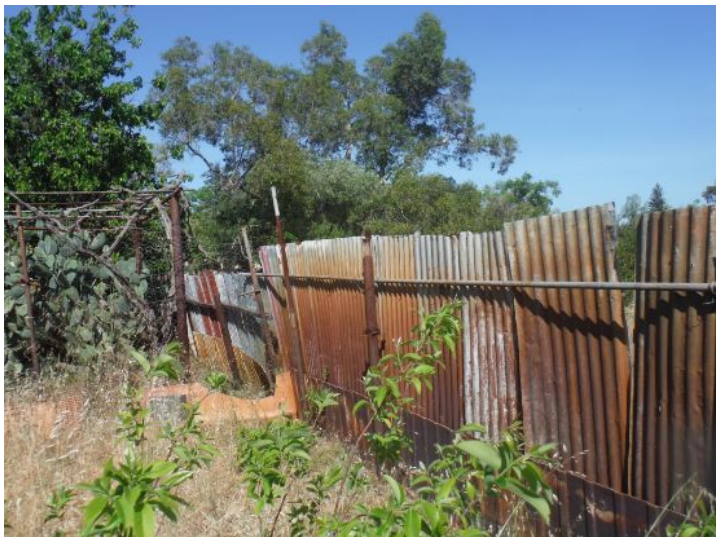
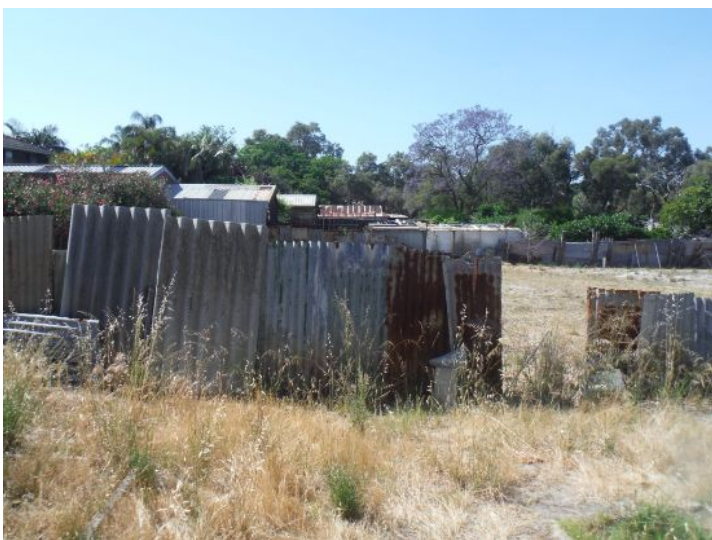
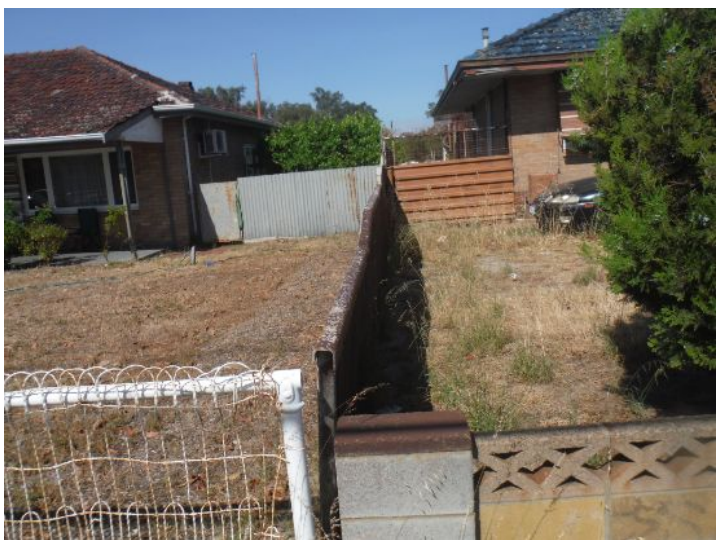
- Fence damaged in areas. Some maintenance will be required.
- There is a section of fencing missing on the south boundary.

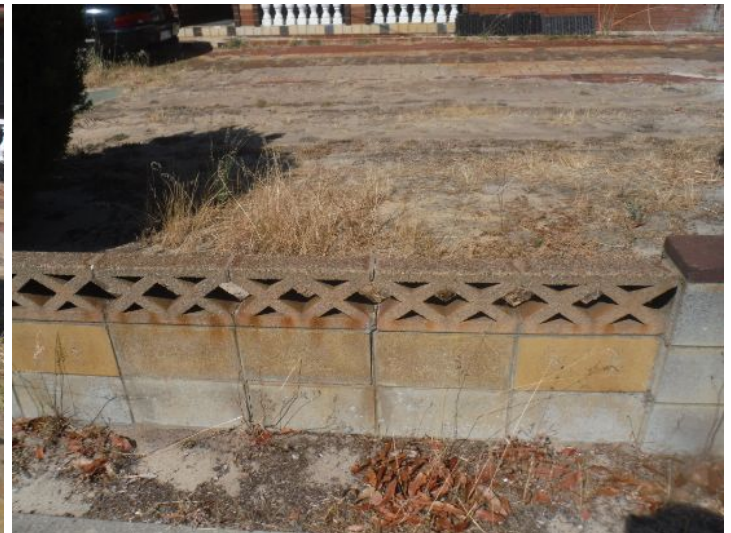
- Some cracks and areas damaged noted in external yard walls. This does not appear to have affected the overall structural integrity of the walls but will require some maintenance at some point.

Small vertical crack noted.

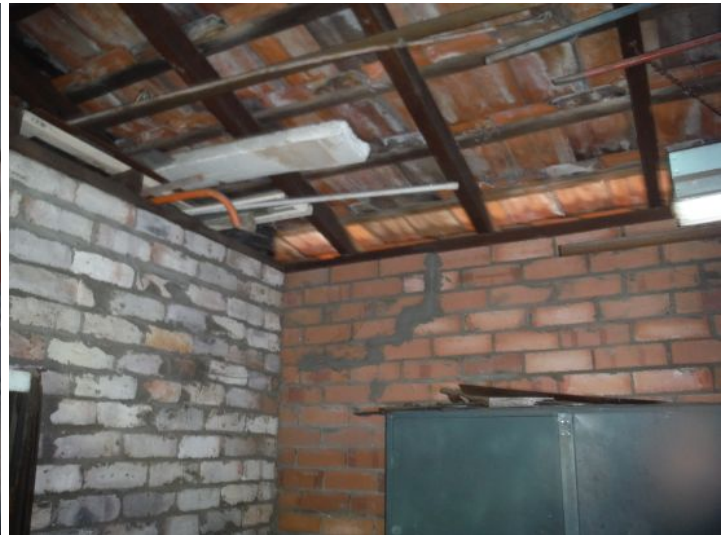
- The attached brick garage appears structurally sound. One repair in the brickwork noted on the North rear wall of the main garage. Appears sound repair.

Old repair noted
