Property Inspection Report

Sample Report, WA

Inspection prepared for: Sample Report
Date of Inspection: 13/9/2023 Time: 9:00 AM
Weather: 15C Rainy

Type:
• Standard Handover Defects Inspection
Reason:
• New Home Construction Handover

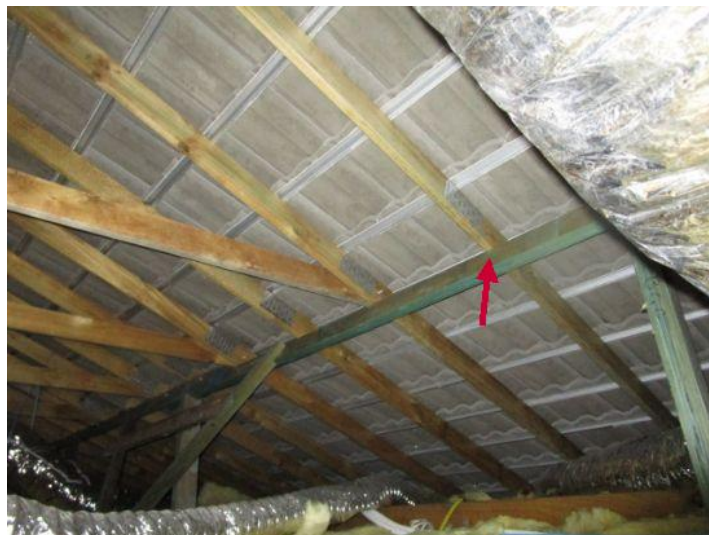
- The timber roof structure generally appears sound, although some roof members - rafters & underpurlins are not strapped together according to current standards. Recommend installing more straps/tie-downs.

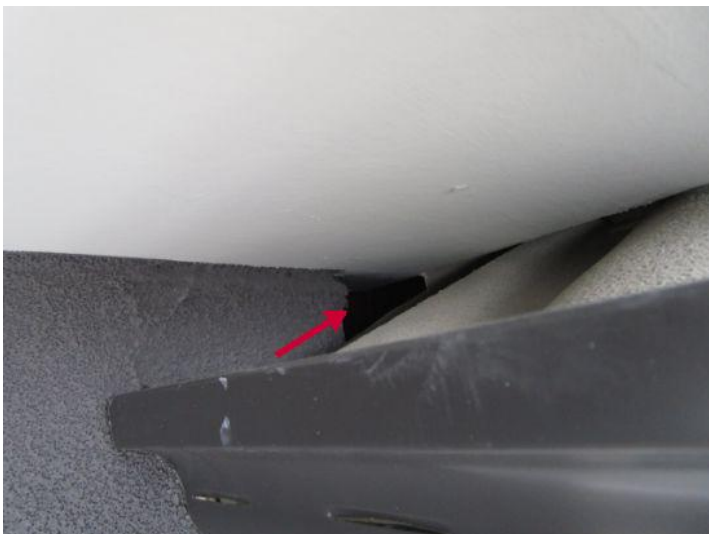
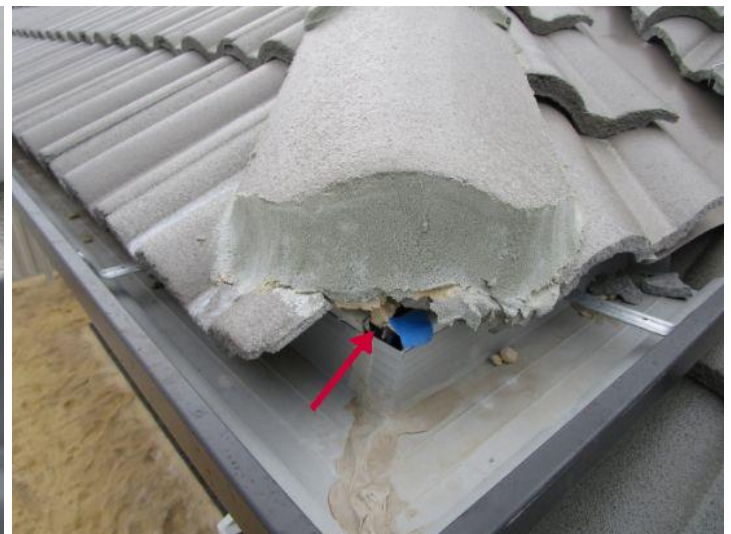
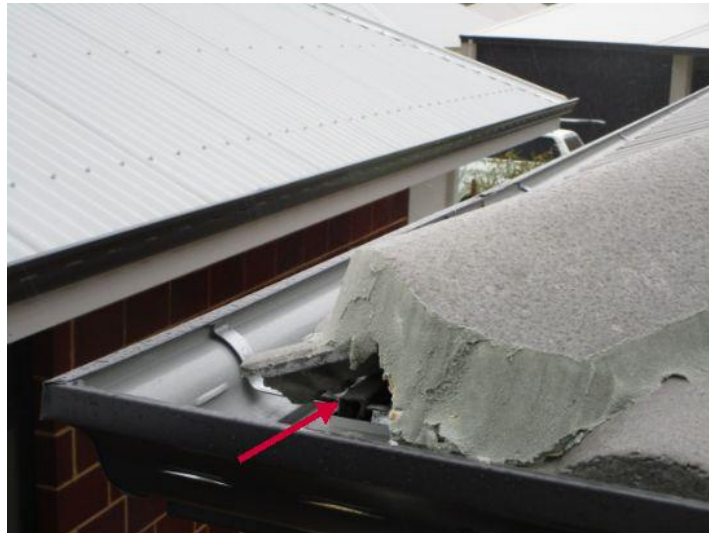
- There is a gap between the flashing and wall on the southeast, which can allow water ingress. Recommend covering this with flashing.
- There is a gap between tiles and (fascia & gutters) on the west side, which can allow water ingress. Recommend covering this with flashing.
- There is a gap between tiles and (fascia & gutters) on the north side, which can allow water ingress. Recommend covering this with flashing.

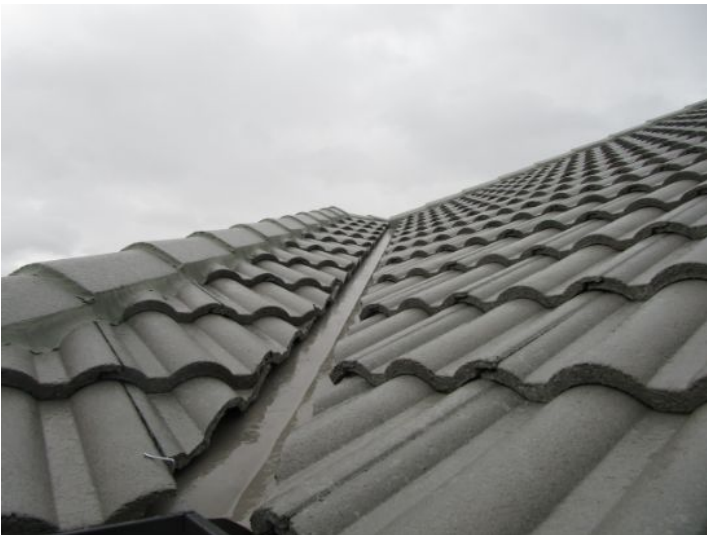
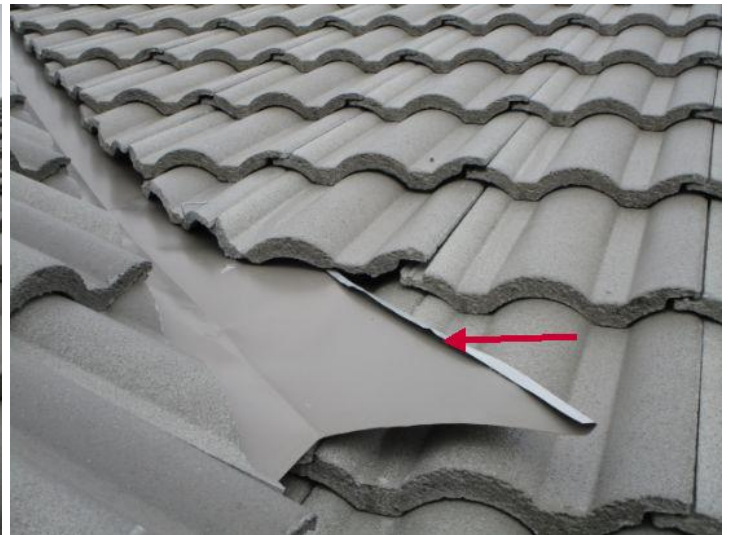
- Flashing is an impervious material (usually galvanized sheet metal) that comes in a variety of shapes and sizes and is used to cover, waterproof, and direct water away from roof penetrations and from valleys and intersections between the roof covering and other materials.
- The roof flashing, where visible, appears to be in satisfactory condition other than noted.
- The **valley flashing** on the southeast is not installed properly and requires attention.

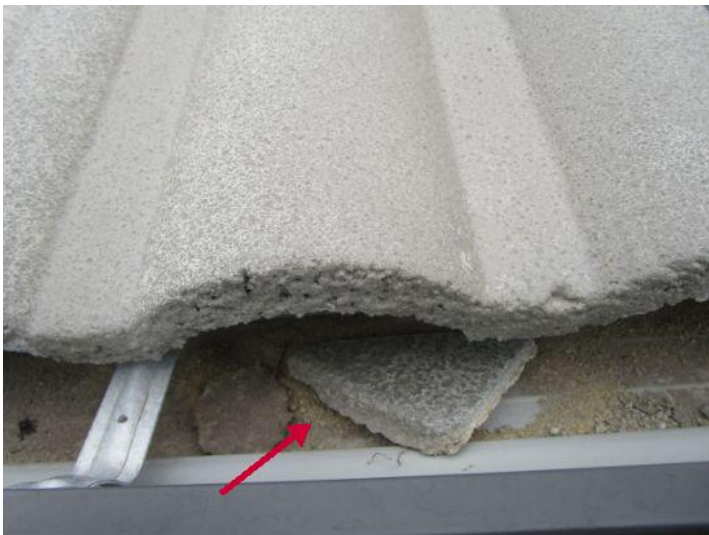
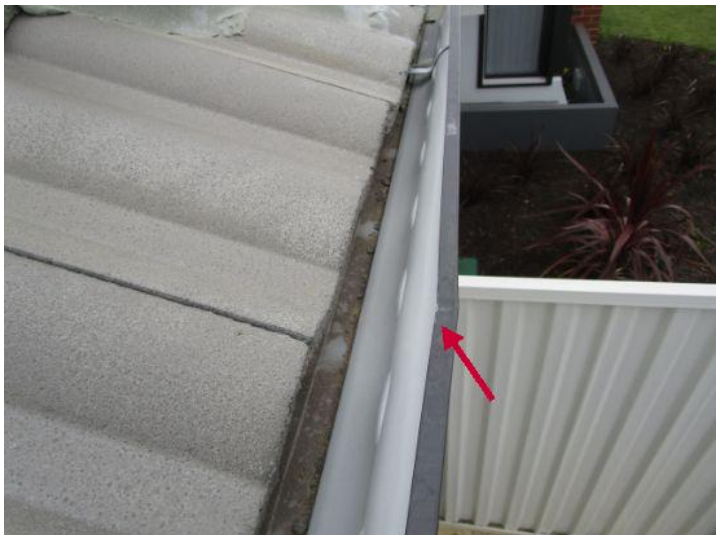
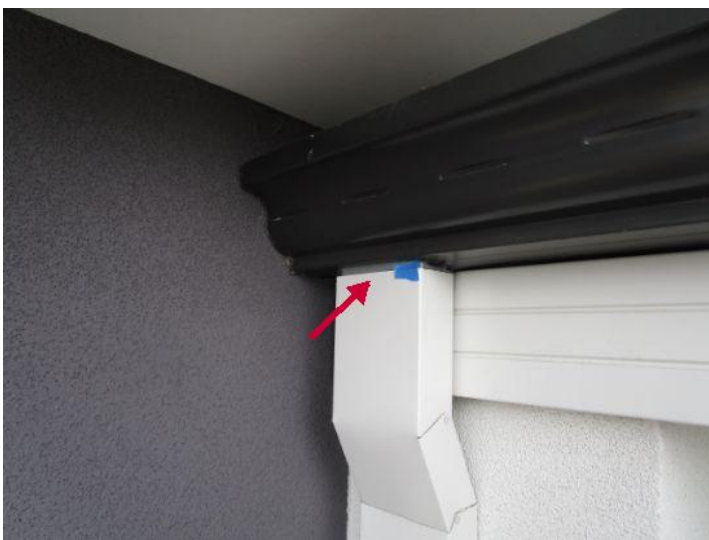
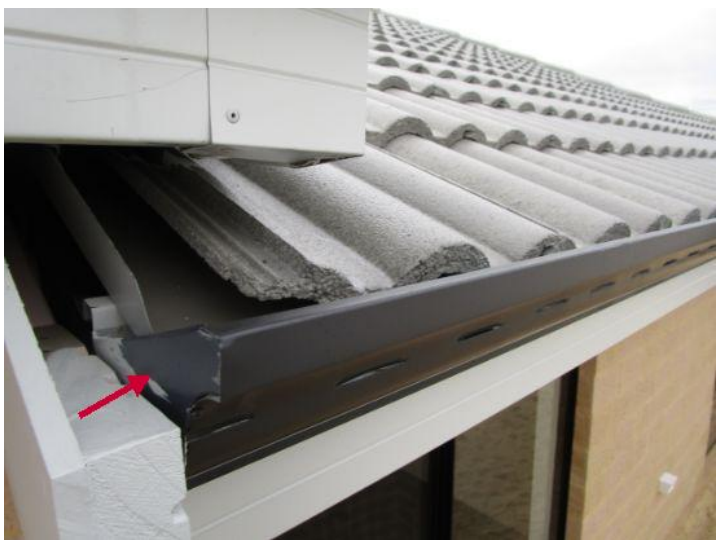
- No major function concerns noted at the time of inspection other than noted.
- The gutters should be regularly cleared of debris to ensure the proper flow of water from the roof.
- The gutter over the southeast side is bent and requires attention.
- The downpipe over the southeast side is not flushed properly to the gutters.
- The gutters over the west side are loose and need to be secured properly.

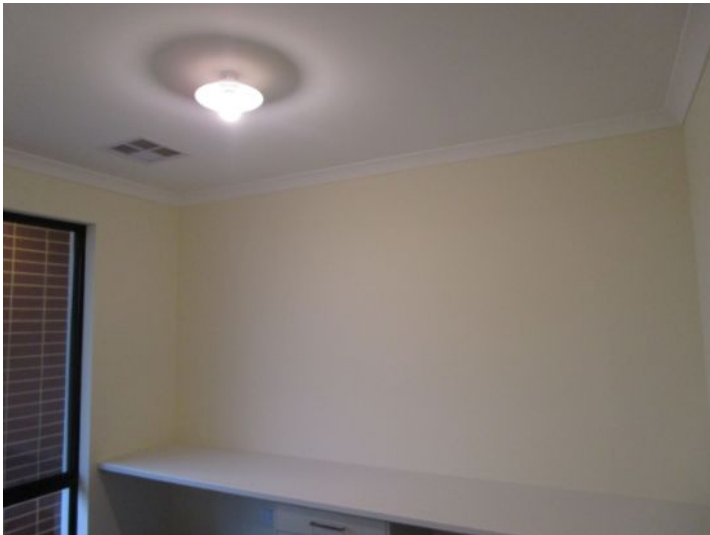
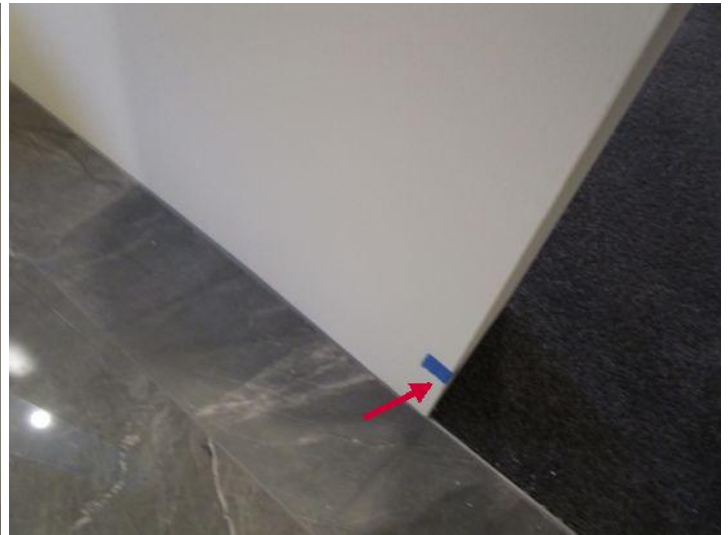
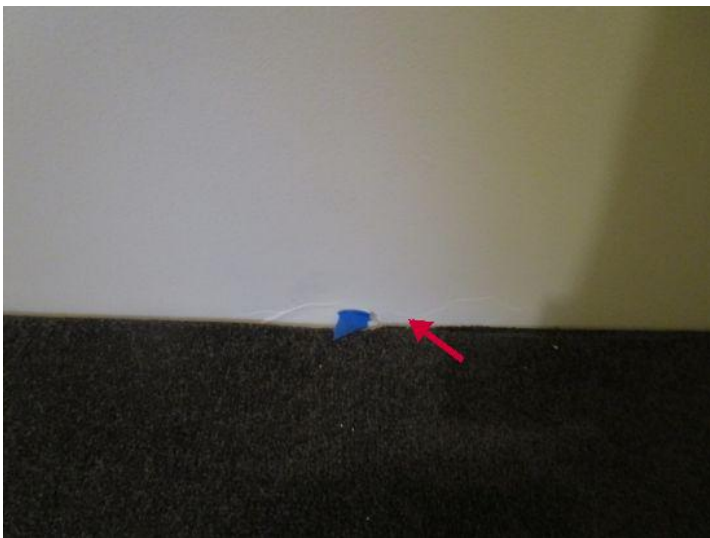
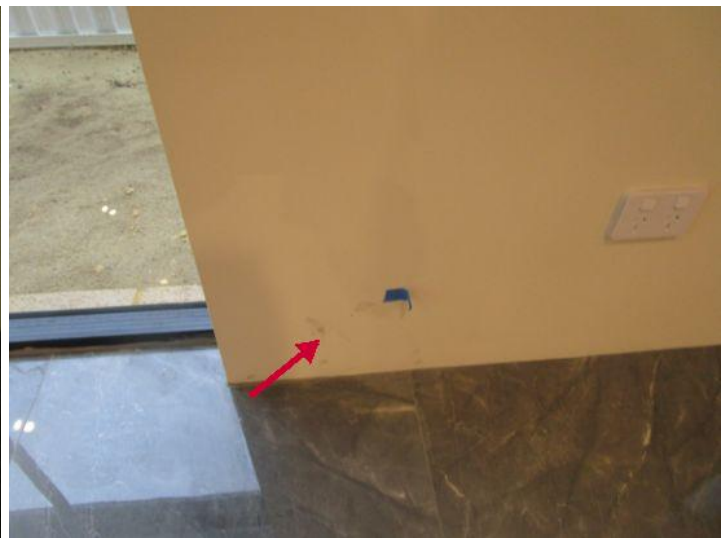
- There are marks and imperfections to the interior walls at various locations. These have been marked with blue tape.

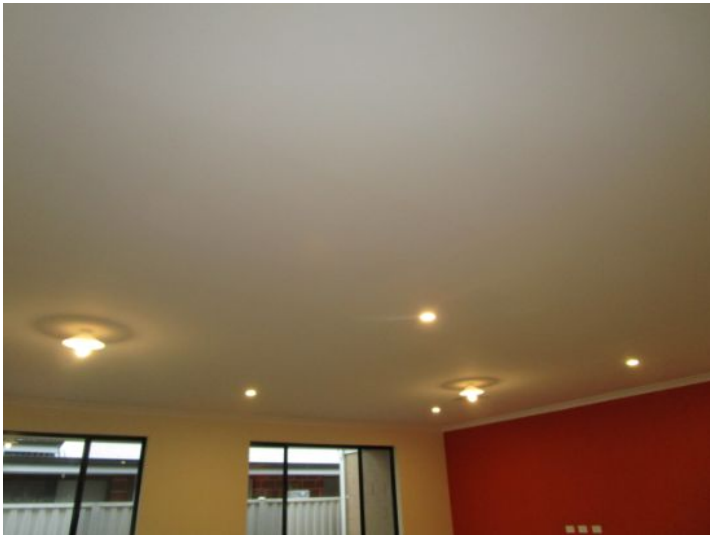
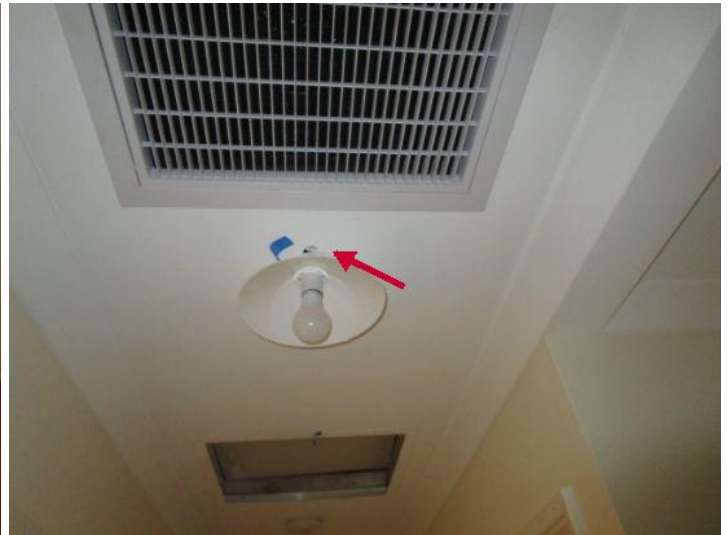
- There is a small hole near hallway light fitting and needs to be patched.

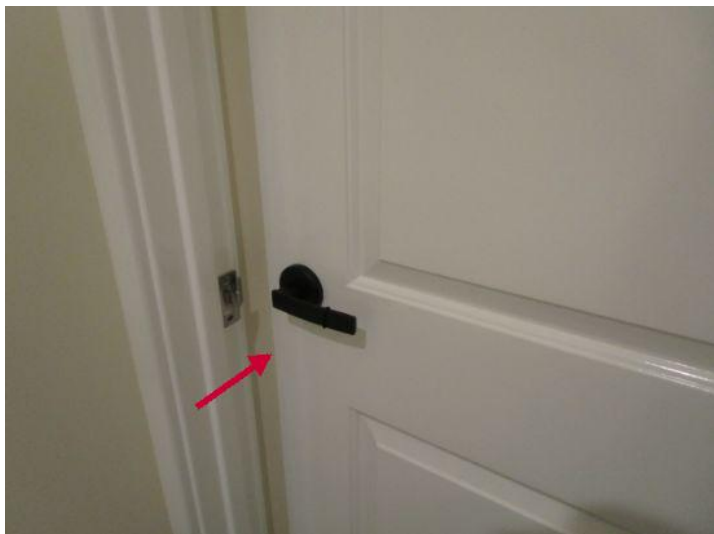
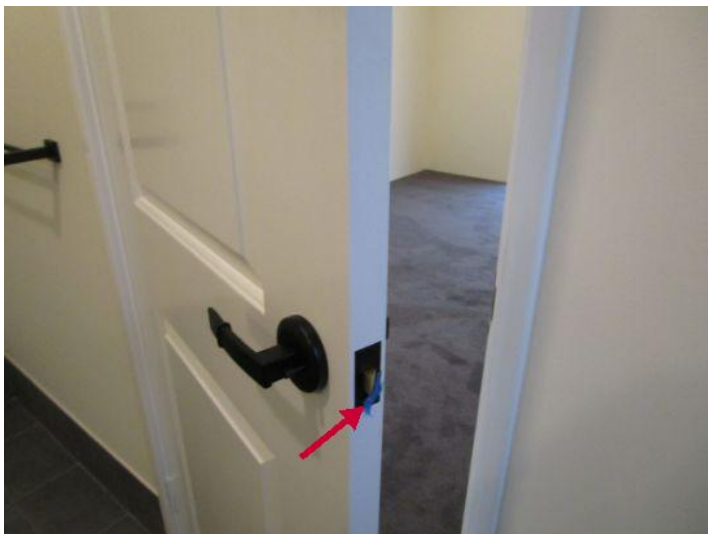
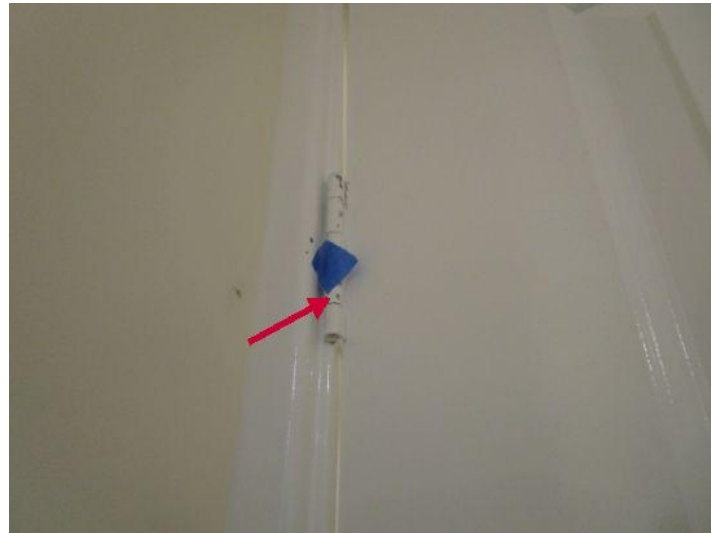
- The interior & exterior doors function satisfactorily other than noted.
- The door for the master bedroom is not closing properly because it is rubbing on the frame. Minor maintenance is required on the door.
- The door for the master bedroom shower is not closing properly because it is rubbing on the frame. Minor maintenance is required on the door.
- The hinges of the master bedroom door require repainting.

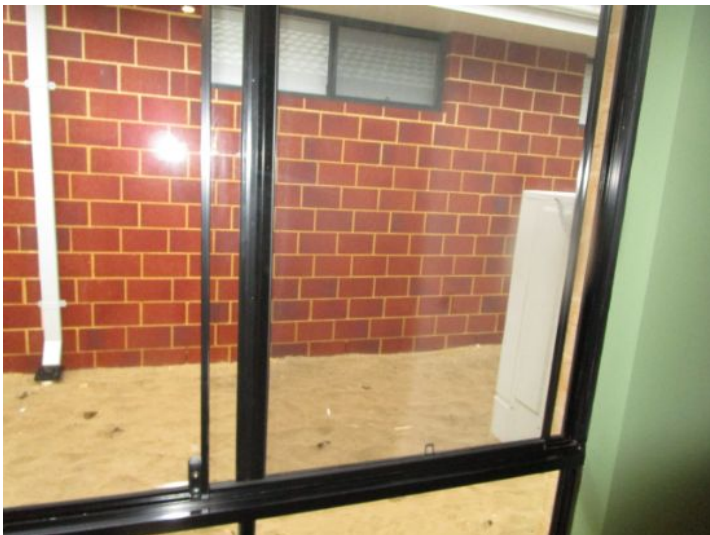
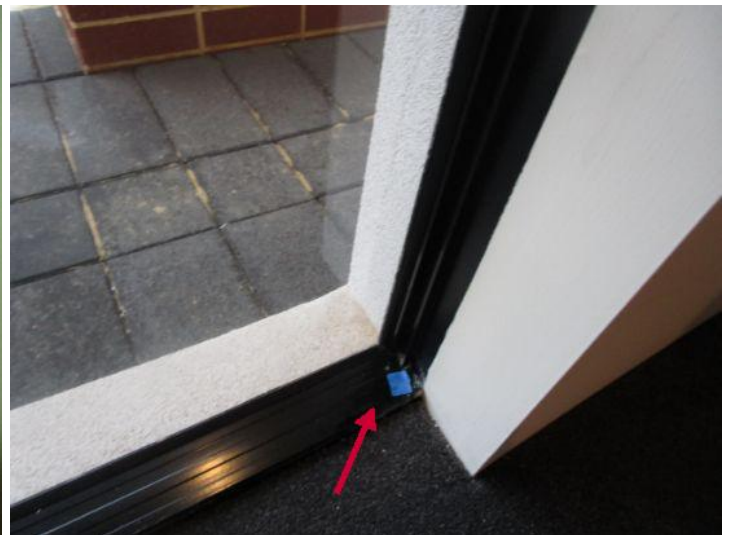
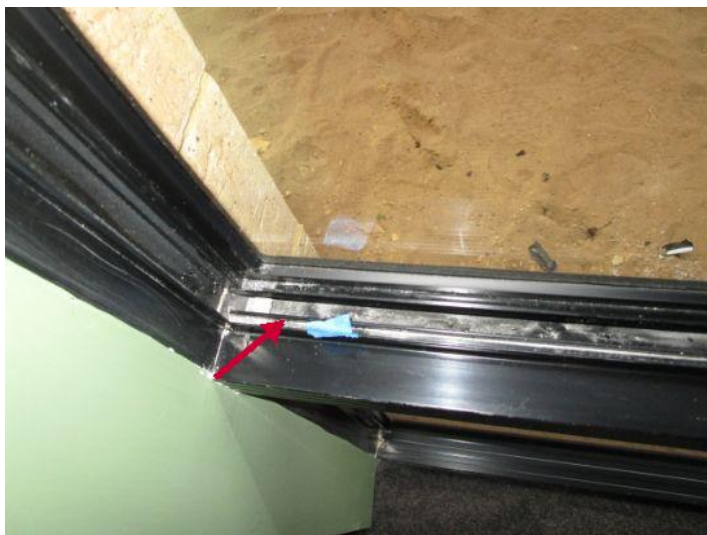
- Windows operated during the inspection appeared functional.
- One or more windows have plaster marks on frames and these are marked with blue tape, recommend cleaning.

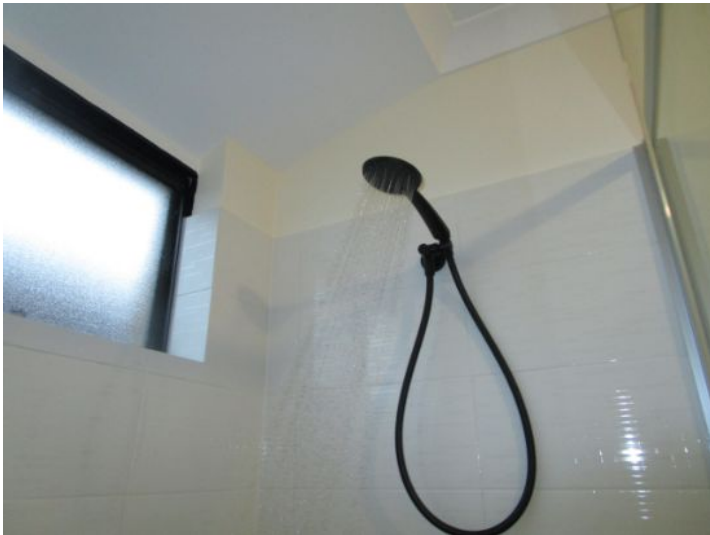
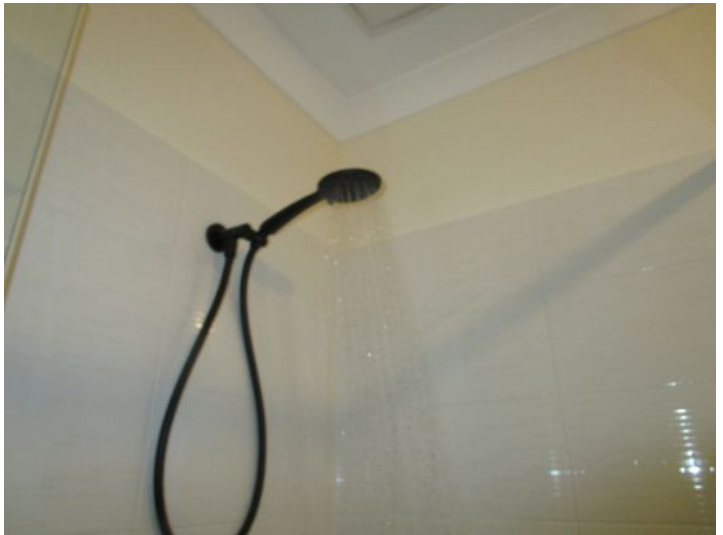
- The showers and related components operated normally when tested.
- There is only one shower installed in the ensuite, according to the contract, there should be two.

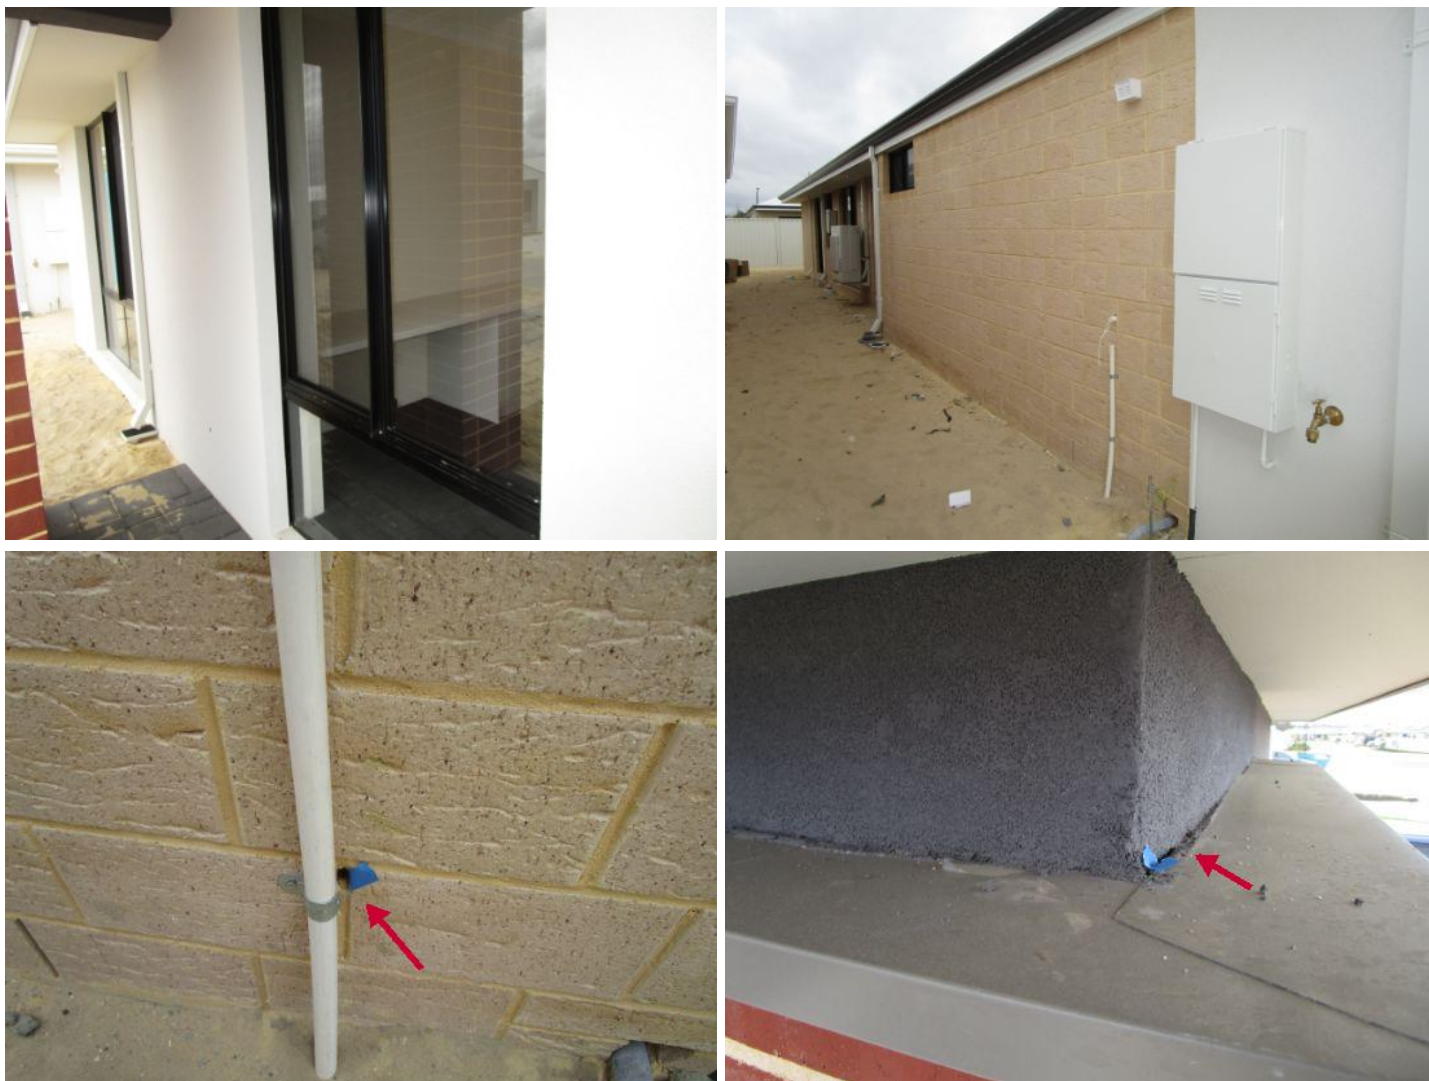
- There are sections of the external wall at south side of the property where the mortar is missing. Maintenance should be carried out on these sections of the wall to reinstate the mortar.
- There is a gap between the wall flashing and wall on southeast side, recommend filling it with silicone.

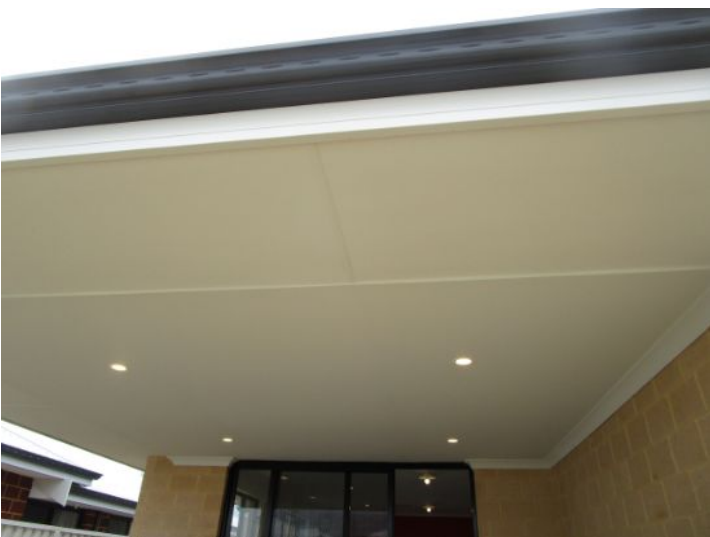
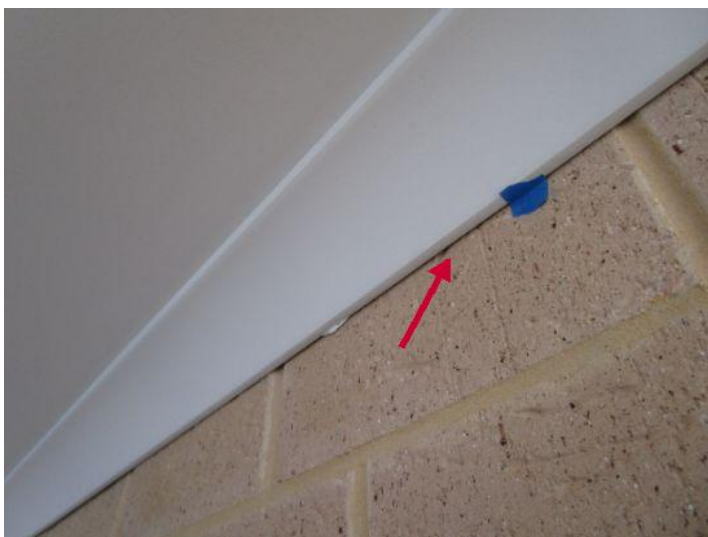
• Noted that the external alfresco ceiling is gyprock sheeting. It is important to keep this material well sealed and painted to prevent the ingress of moisture into the sheet material and taped joints. Recommend sealing the gap with silicone.

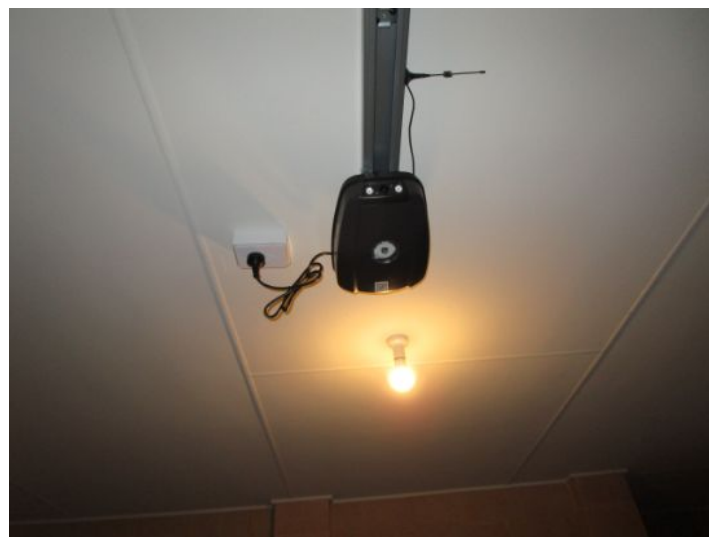
- Appeared functional at the time of inspection, the remote control needs to be paired with the opener.
