**Resicert**

# Timber Pest Inspection Report

Inspection prepared for: Sample Report  
Date of Inspection: 24/3/2022 Time: 1:00PM  
Weather: Fine, 28C

Type:  
• Timber Pest Inspection in accordance with AS4349.3-2010  
Reason:  
• Pre-purchase Inspection

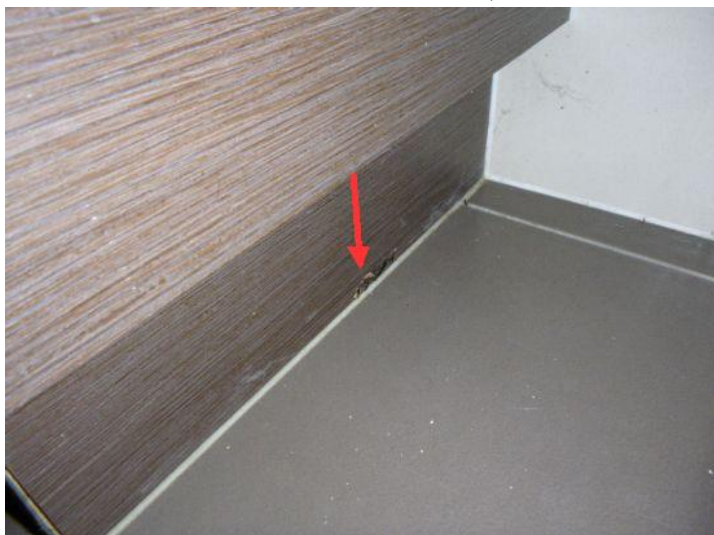
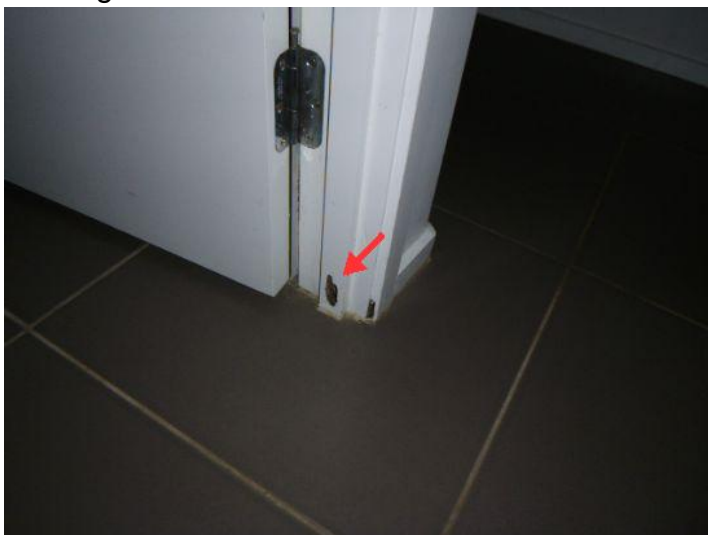
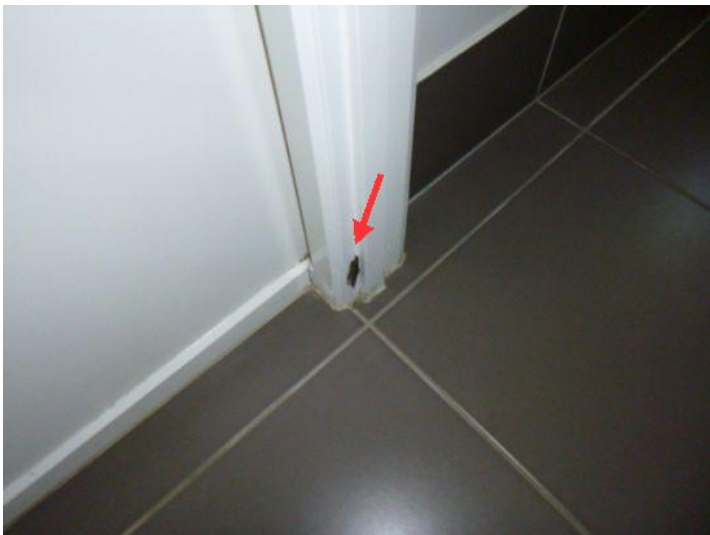
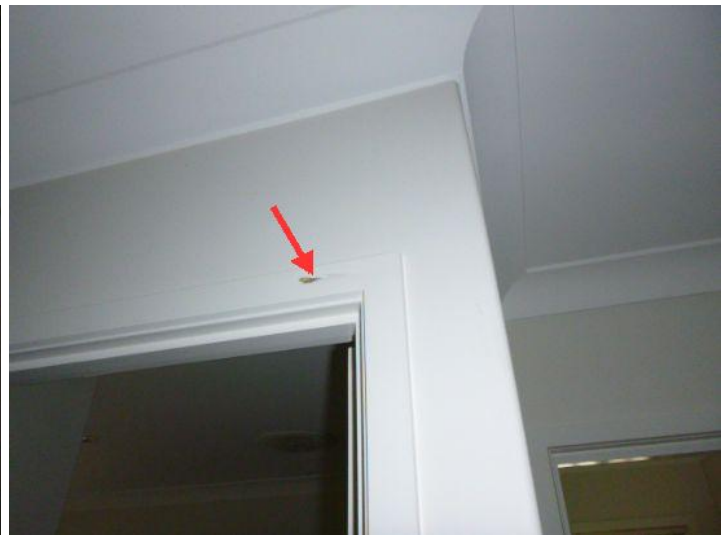
Due to visual obstruction the risk of undetected timber attack appears to be high

- There were no live termites found at the property inspected at the date and time of the inspection.
- Evidence of inactive termite damage and/or workings was detected in the the cabinet, architraves and skirtings around the bathroom.

A more invasive inspection is recommended to determine the full extent of the damage.

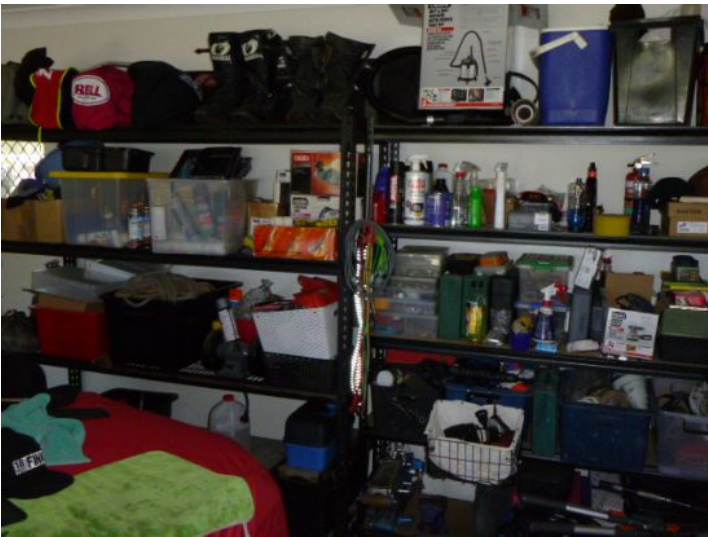
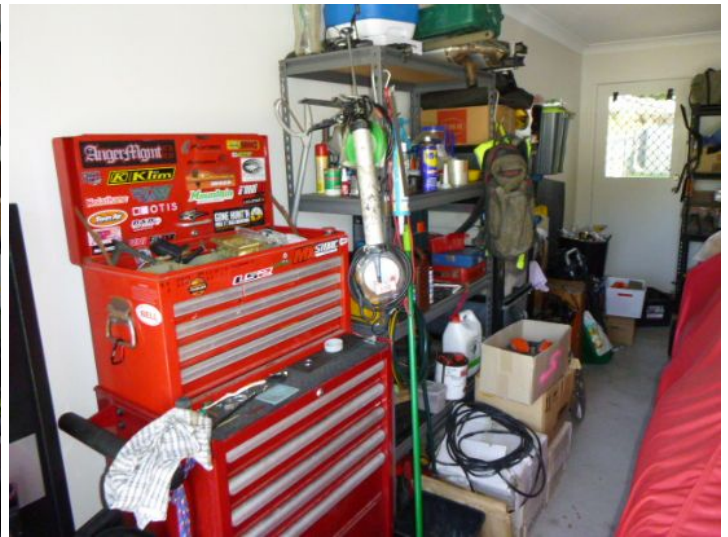
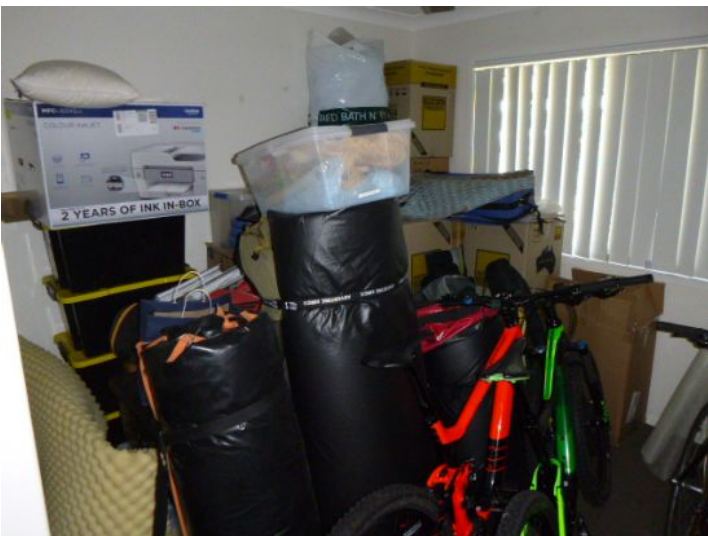
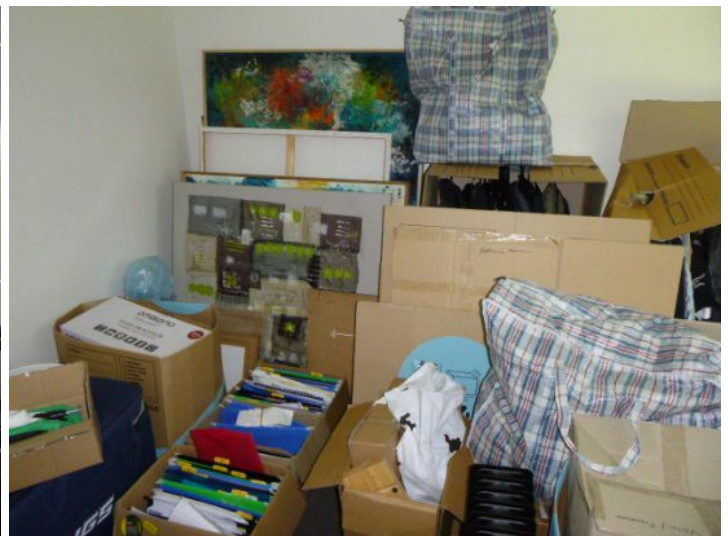
The interior visual inspection was obstructed or restricted because of obstruction due to items stored.

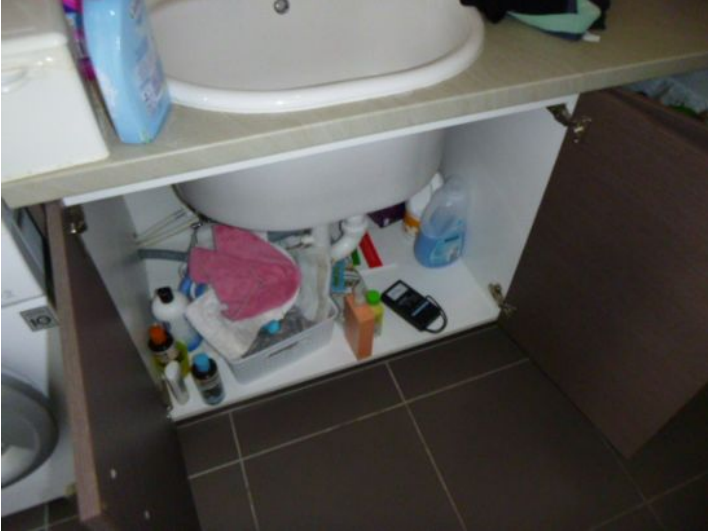
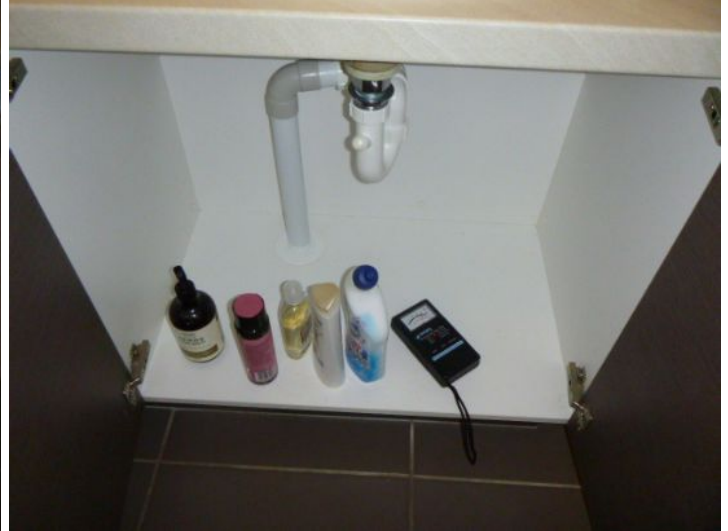
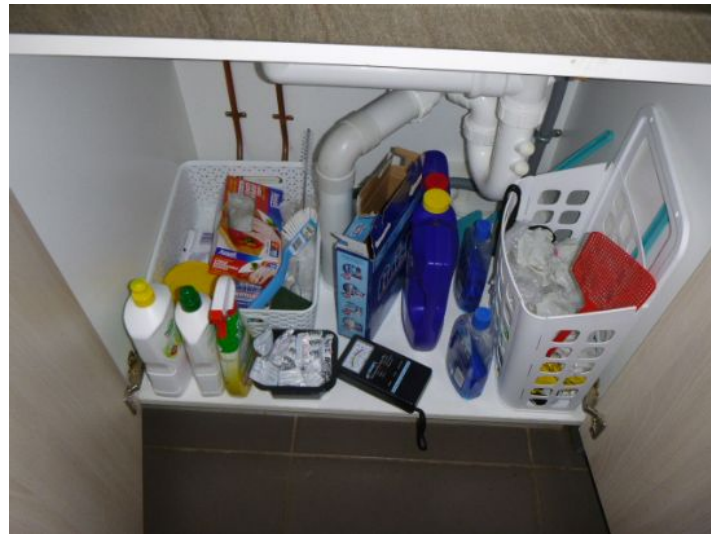
- A moisture meter confirmed the presence of excessive moisture in under the laundry, bathroom and kitchen sinks. No leaks were noted at the time of the inspection. Dampness provides a conducive environment for timber pest attack.

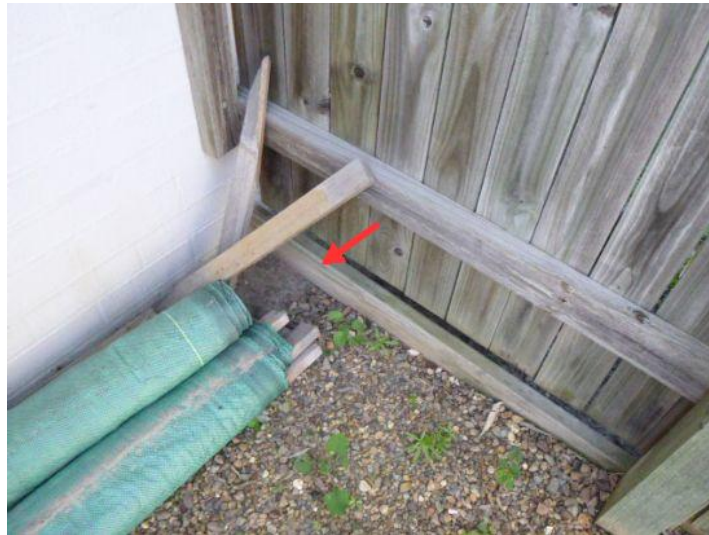
- There is timber landscaping materials used on the property or against the edge of the home, which could attract termites or provide possible entry points for termites into the home. These should be removed or checked regularly.

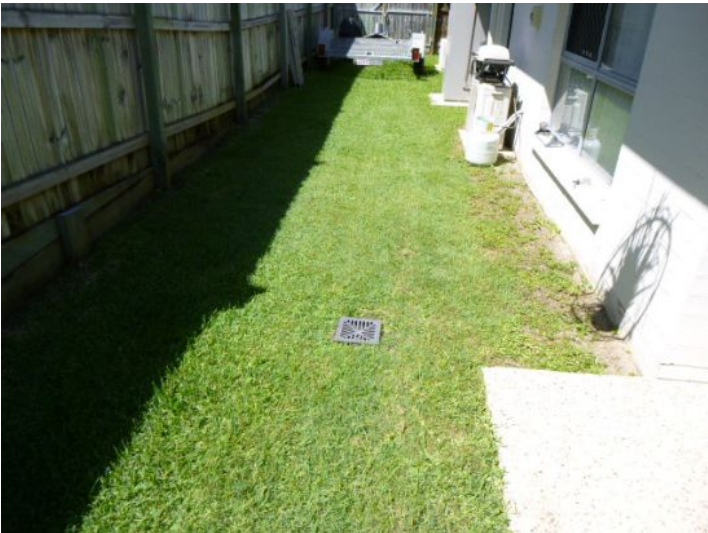
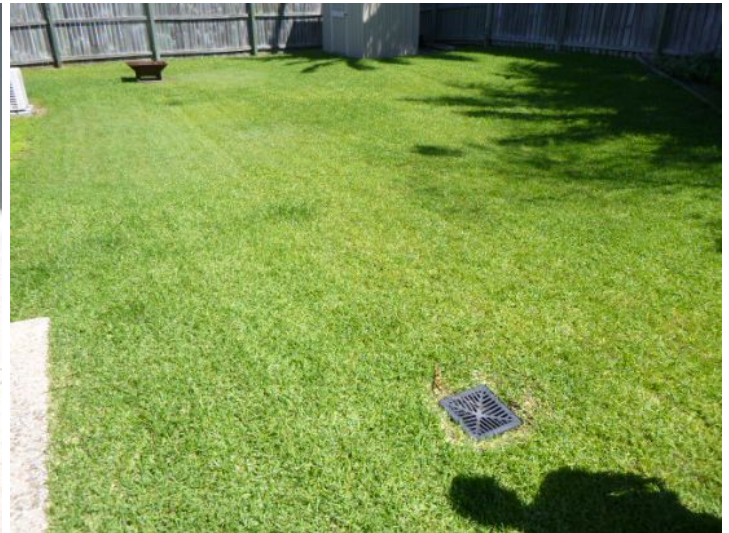
- It is important to redirect moisture away from the property to limit areas of excess moisture. Faulty gutters and downpipes in poor condition can cause water to seep into the foundations, causing conditions conducive to termites and fungal decay.
- Surface drainage conditions within 3 metres of the inspected structure appeared satisfactory given the prevailing weather conditions at the time of inspection. There was no evidence noted of water pooling at or around the building structure. These areas should be monitored during periods of heavy rainfall for a full representation of drainage conditions.

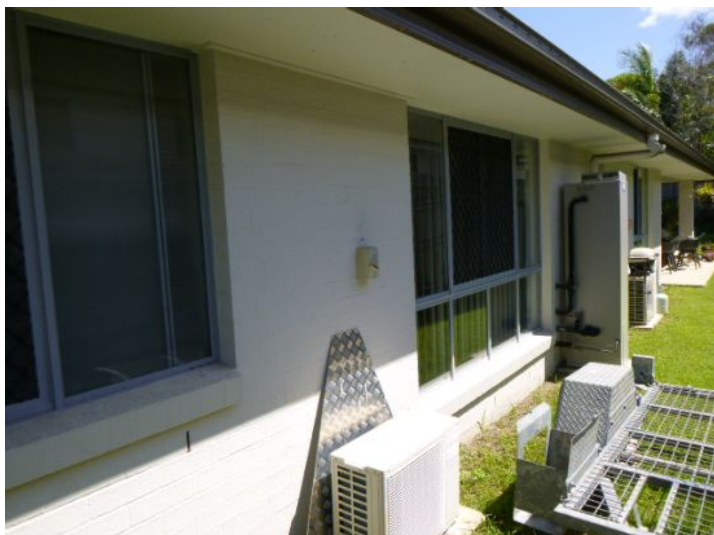
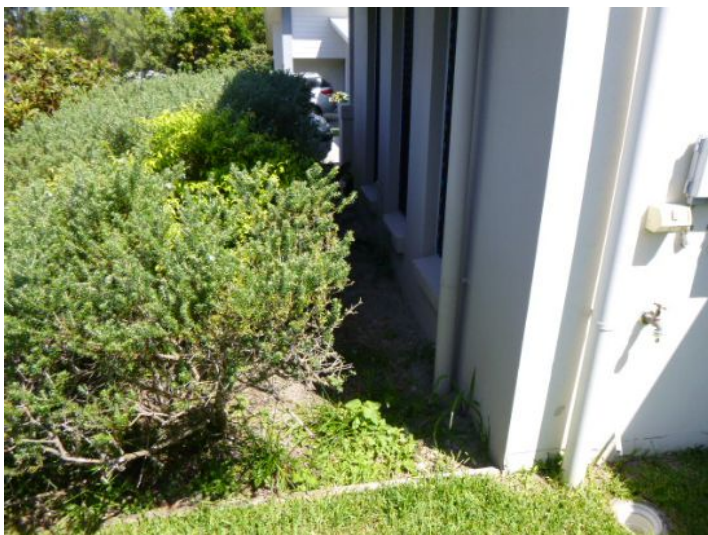
- There are garden beds which are abutting external walls. This can result in water moisture affecting the structure over time. It is recommended that either the beds be removed or a water barrier be place between the flower bed and the external walls. If these beds are retained it is important that any watering is directed away from the building and kept to an absolute minimum and is controlled. These are risk area for termite activity.
