**Resicert**

# Timber Pest Inspection Report

Inspection prepared for: Sample Report  
Date of Inspection: 3/3/2022 Time: 1:00PM  
Weather: Fine, 27C

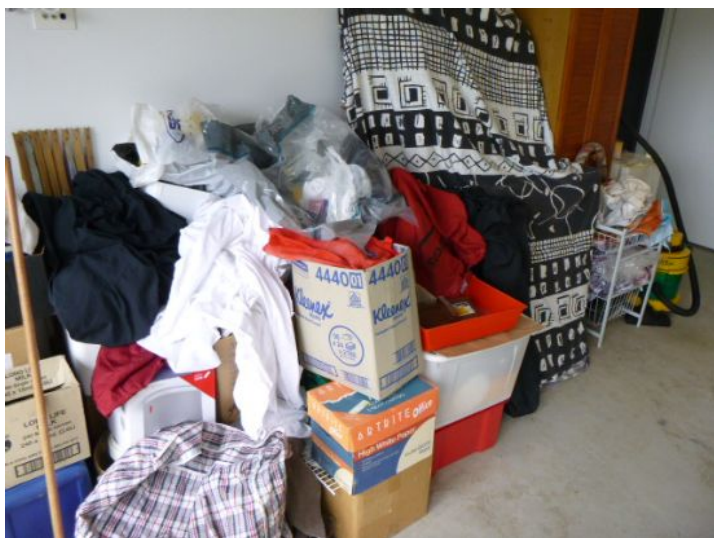
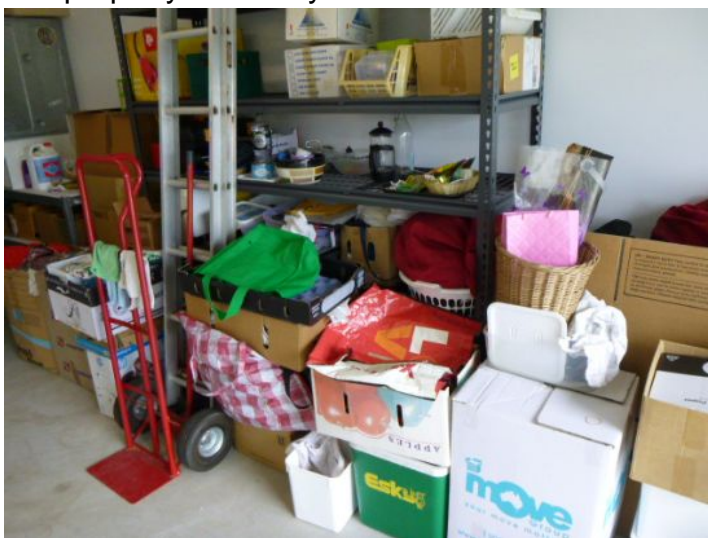
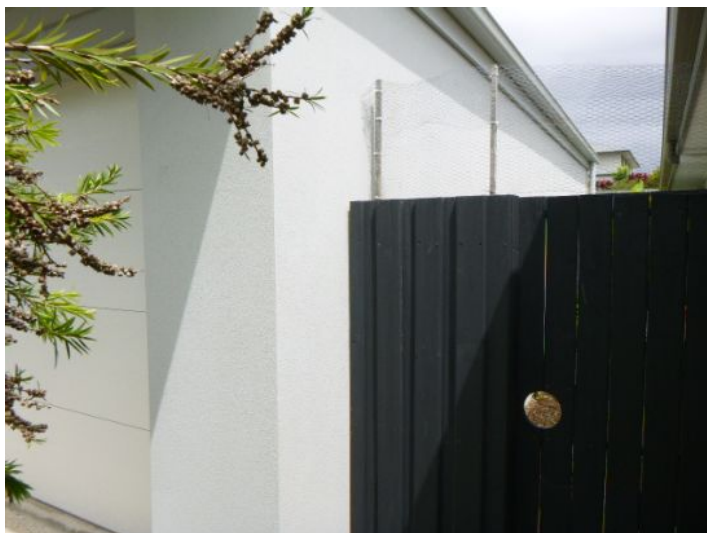
The interior visual inspection was obstructed or restricted because of obstruction due to items stored.

The exterior at the side of the garage did not have reasonable access available because it was on the property boundary.

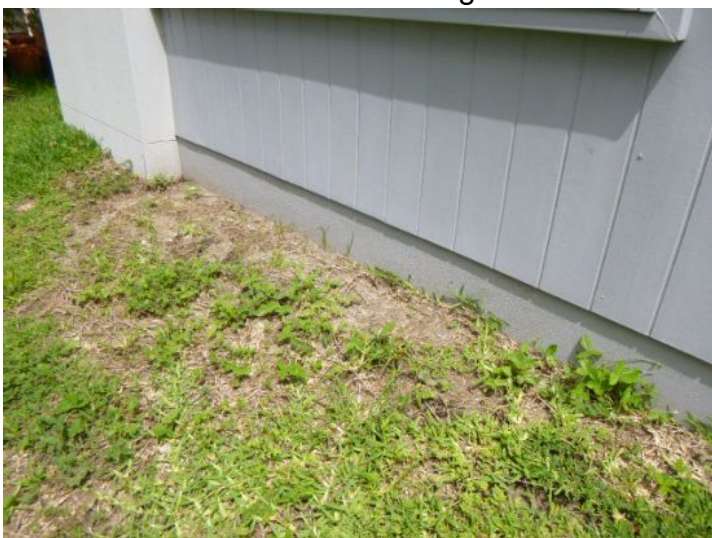
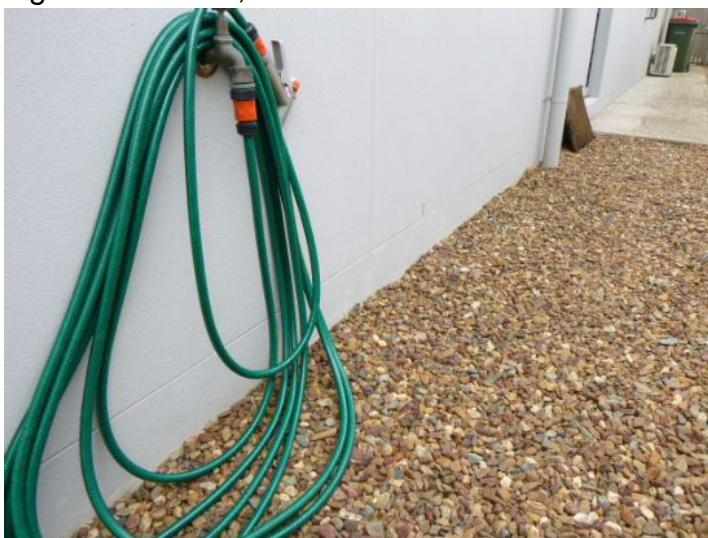
- Slab edges are clear and in good condition, unless noted.

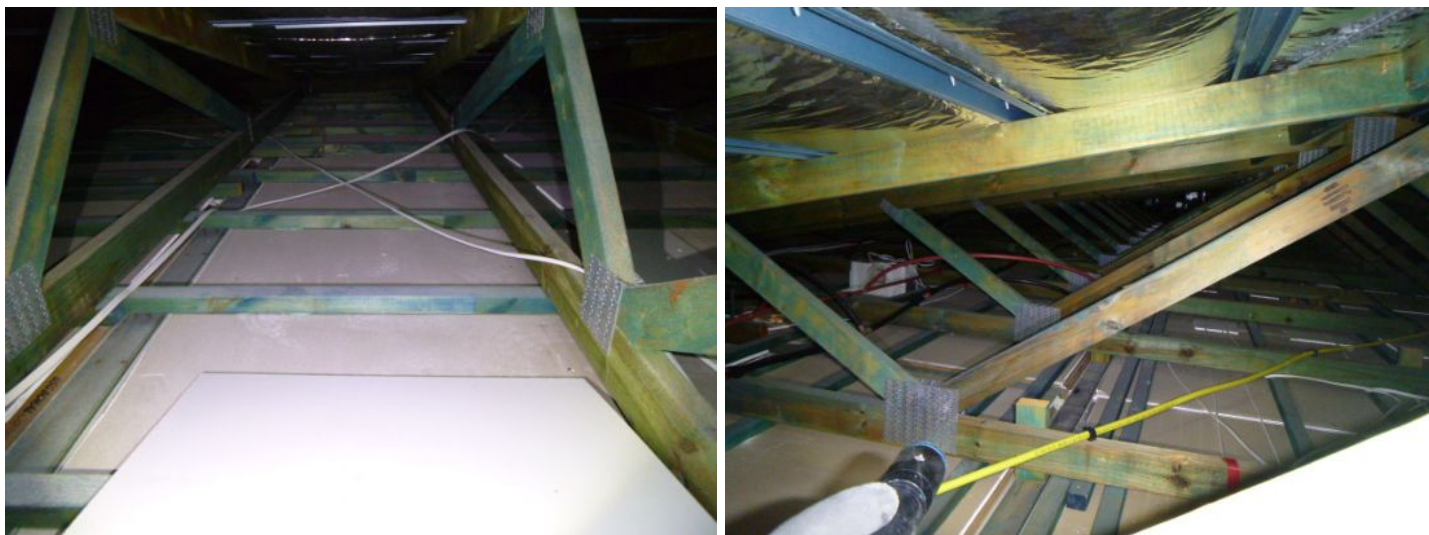
- Access was available through a manhole in the garage.
- Limited visibility and access due to pitch.

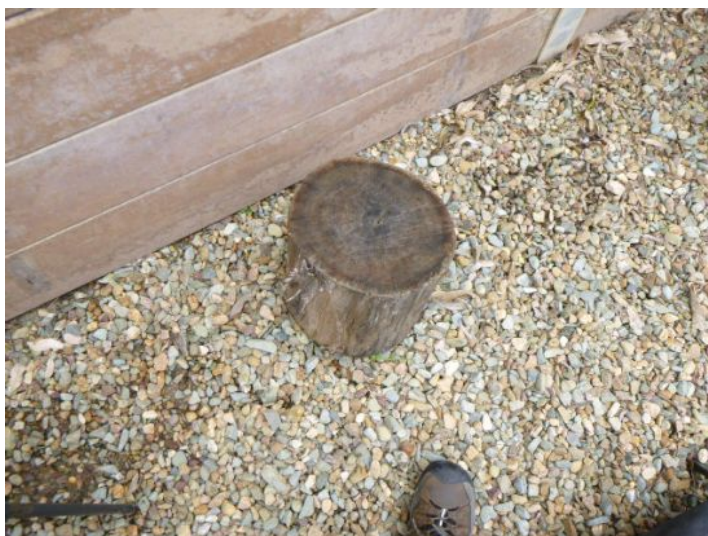
- There is timber landscaping materials used on the property or against the edge of the home, which could attract termites or provide possible entry points for termites into the home. These should be removed.

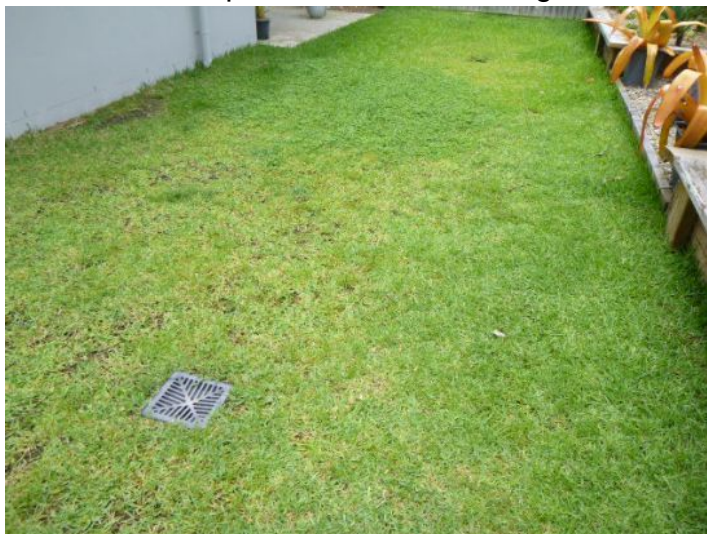
- It is important to redirect moisture away from the property to limit areas of excess moisture. Faulty gutters and downpipes in poor condition can cause water to seep into the foundations, causing conditions conducive to termites and fungal decay.
- Surface drainage conditions within 3 metres of the inspected structure appeared satisfactory given the prevailing weather conditions at the time of inspection. There was no evidence noted of water pooling at or around the building structure. These areas should be monitored during periods of heavy rainfall for a full representation of drainage conditions.

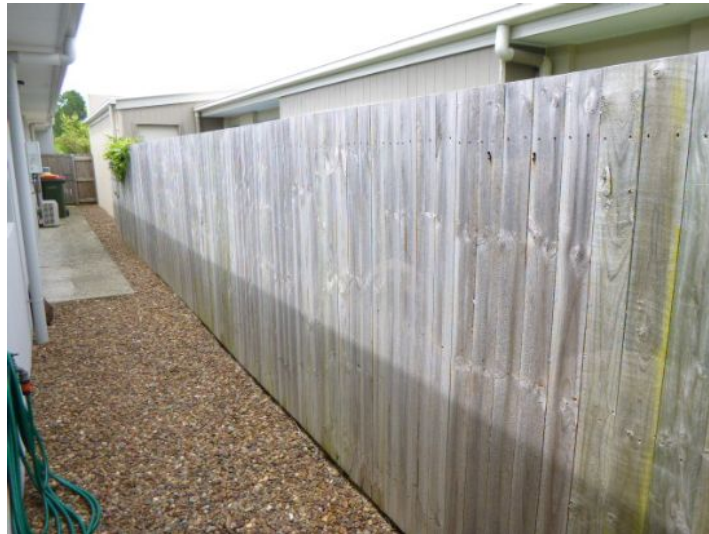
- Timber fences are in good condition.

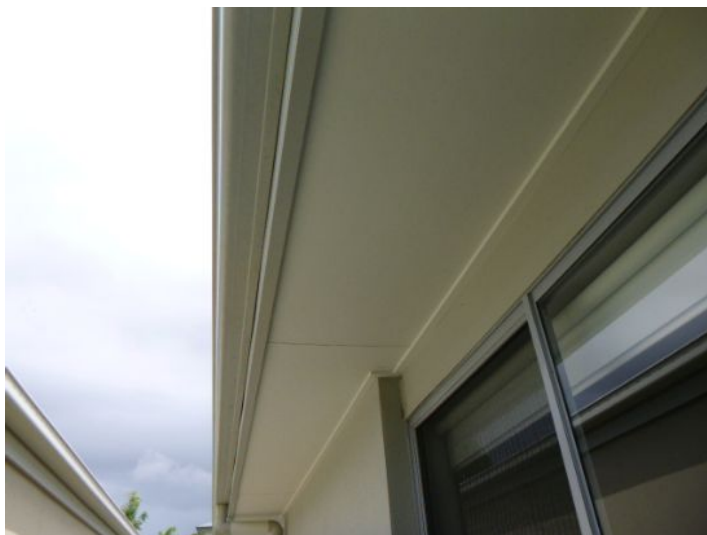
- The eaves are in satisfactory condition.
