**Resicert**

# Timber Pest Inspection Report

Inspection prepared for: Sample Report  
Date of Inspection: 28/3/2022 Time: 9:00AM  
Weather: Fine, 23C

- Timber Pest Inspection in accordance with AS4349.3-2010

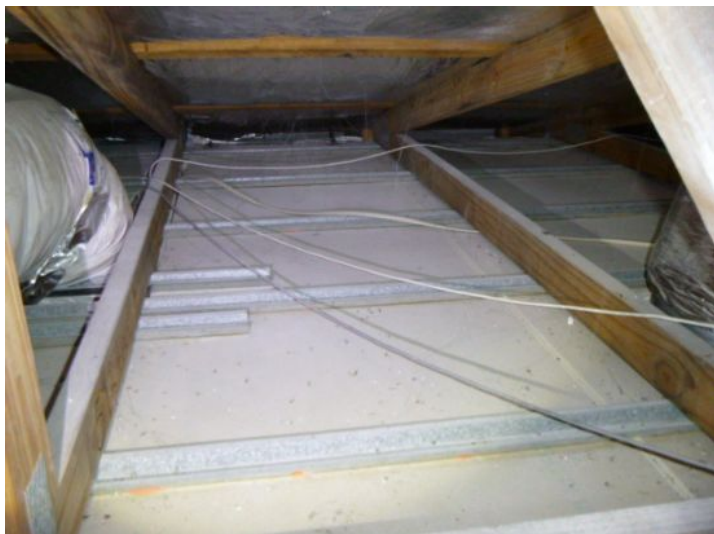
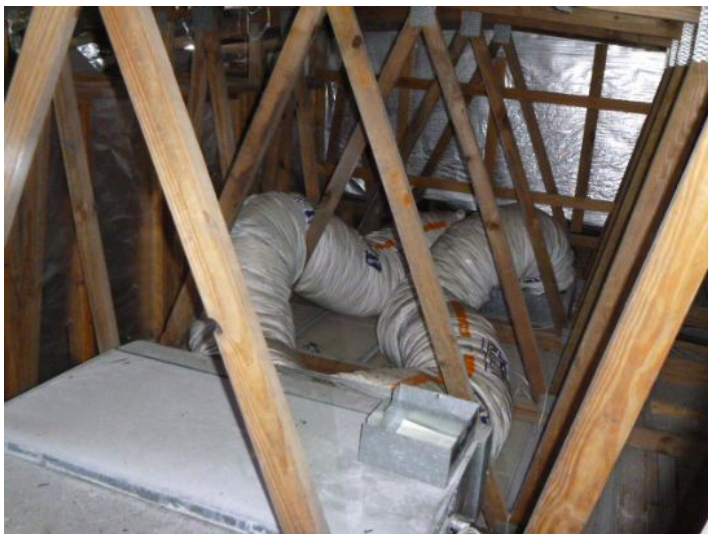
- Access was available through a manhole in the ensuite.
- Limited visibility and access due to pitch and ducting.

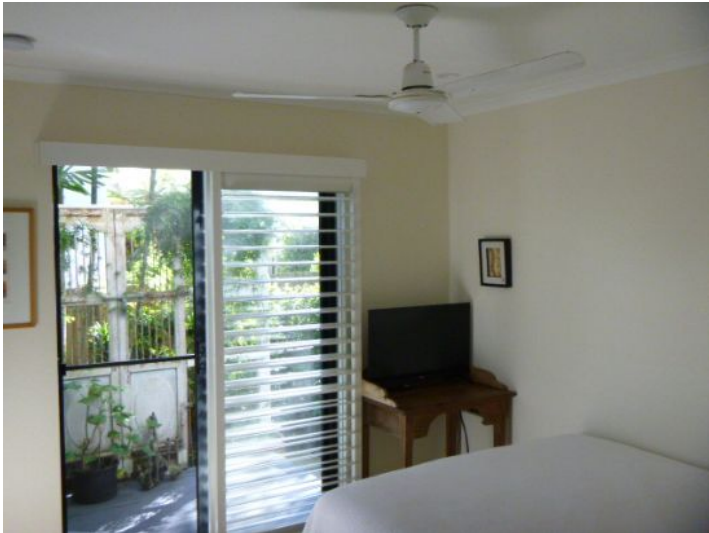
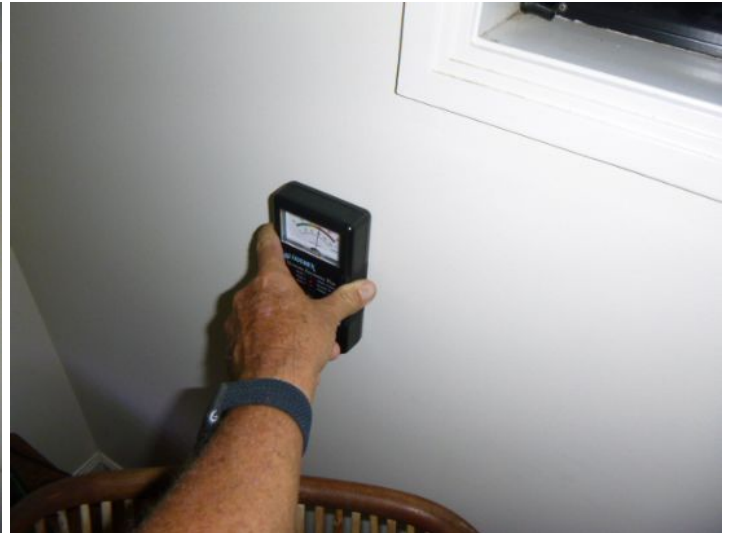
- Timber skirting and door frames appear functional.
- There is evidence of dampness in the wall which is located under the window in the office. Dampness provides a conducive environment for timber pest attack.

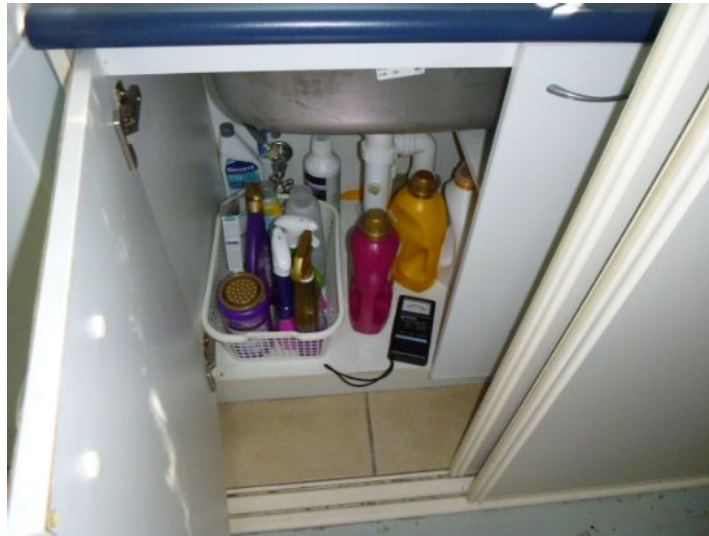
- A moisture meter confirmed the presence of excessive moisture in under the laundry sink. No leaks were noted at the time of the inspection. Dampness provides a conducive environment for timber pest attack.

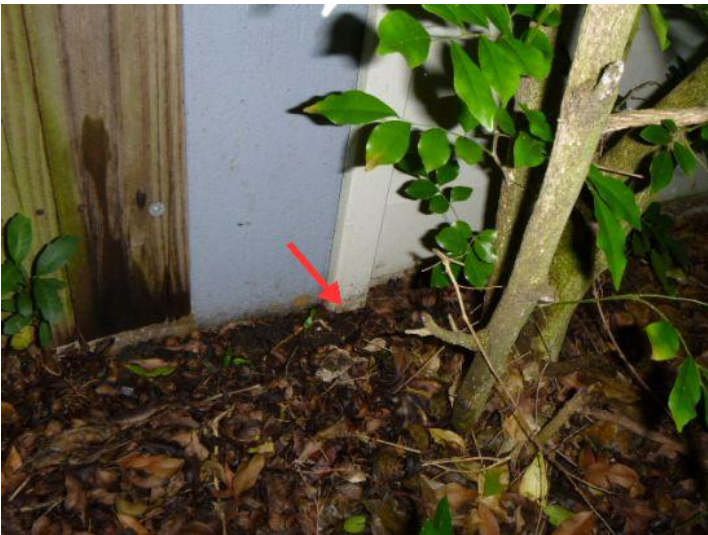
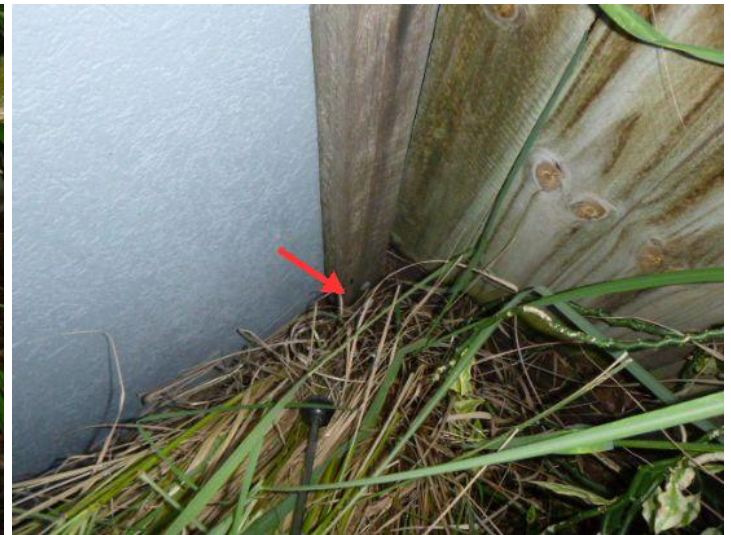
- There is timber materials used on the property or against the edge of the home, which could attract termites or provide possible entry points for termites into the home. These should be removed or checked regularly.

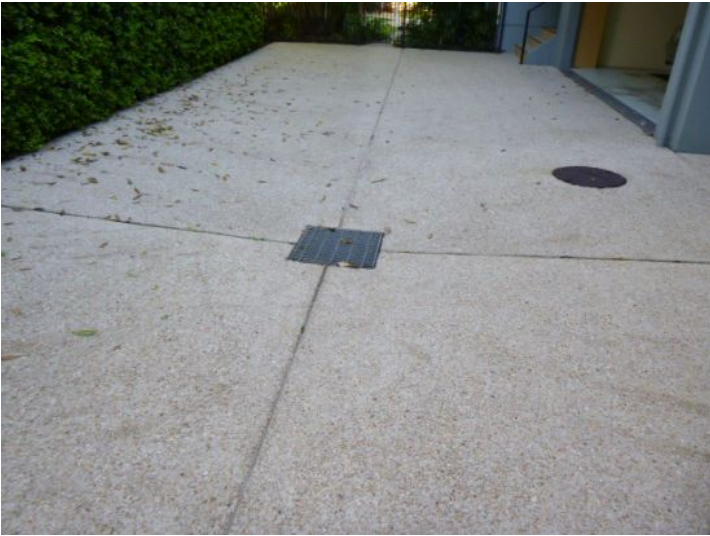
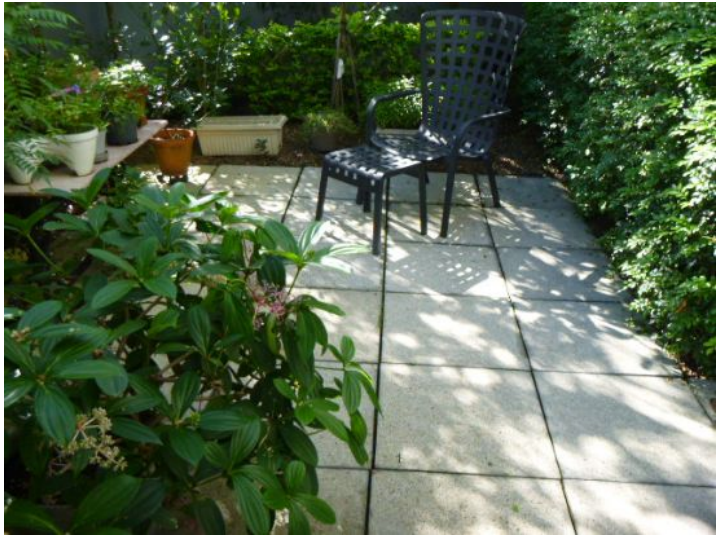
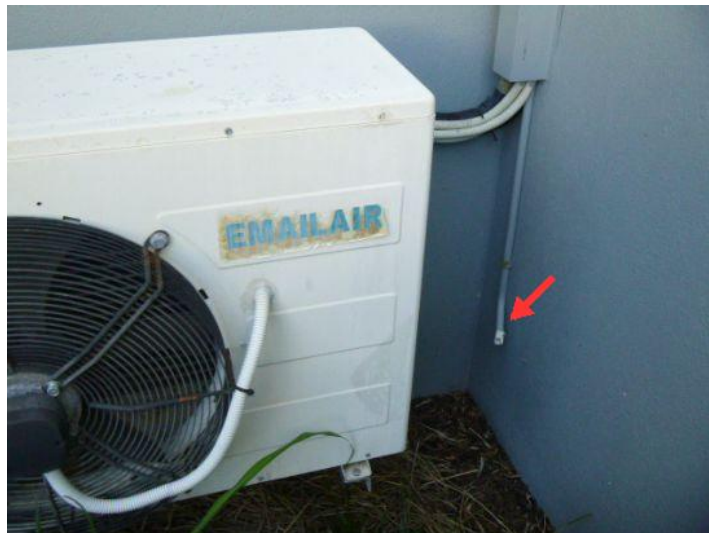
- It is important to redirect moisture away from the property to limit areas of excess moisture. Faulty gutters and downpipes in poor condition can cause water to seep into the foundations, causing conditions conducive to termites and fungal decay.
- Surface drainage conditions within 3 metres of the inspected structure appeared satisfactory given the prevailing weather conditions at the time of inspection. There was no evidence noted of water pooling at or around the building structure. These areas should be monitored during periods of heavy rainfall for a full representation of drainage conditions.
- Overflow pipes from air conditioners and water heaters are a source of moisture. It is important to redirect or extend the pipe away from the home into a drain or soak well to avoid moisture soaking into the foundations.

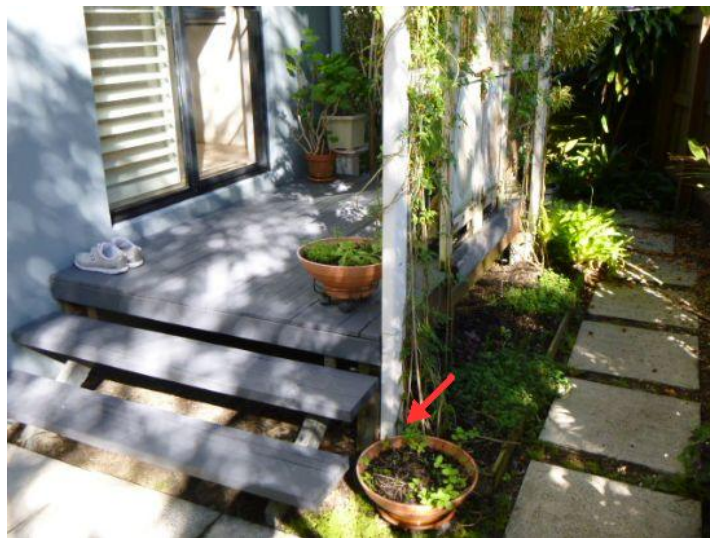
- There are timber posts in contact with the ground which may allow termite access to the structure.

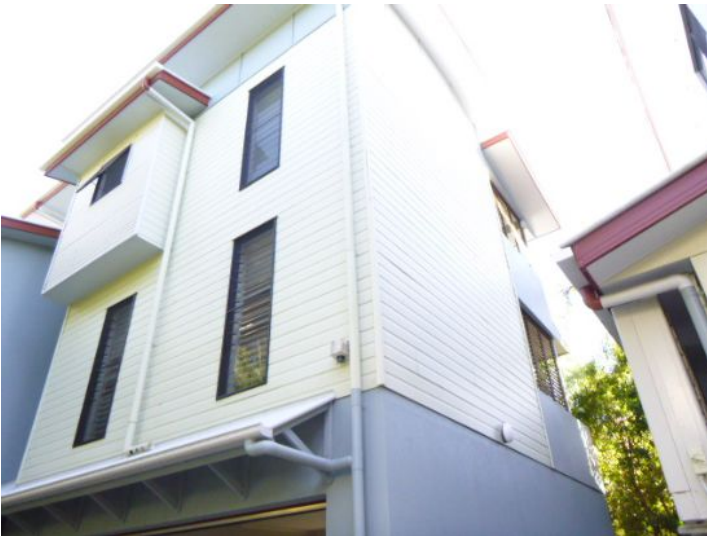
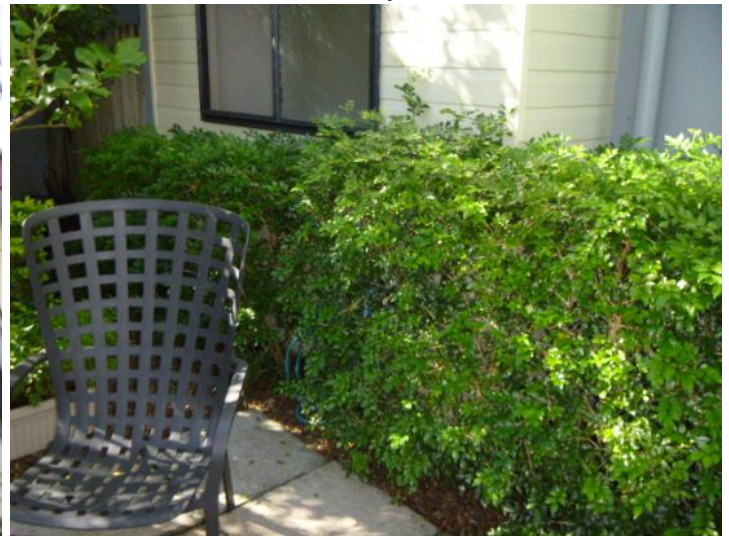
- There are garden beds which are abutting external walls. This can result in water moisture affecting the structure over time. It is recommended that either the beds be removed or a water barrier be place between the flower bed and the external walls. If these beds are retained it is important that any watering is directed away from the building and kept to an absolute minimum and is controlled. These are risk area for termite activity.
