# Property Inspection Report

Inspection prepared for: Sample Report  
Date of Inspection: 18/3/2022 Time: 12:00PM  
Weather: Cloudy 27C

Inspector: Resicert Property Inspections  
Sample Report

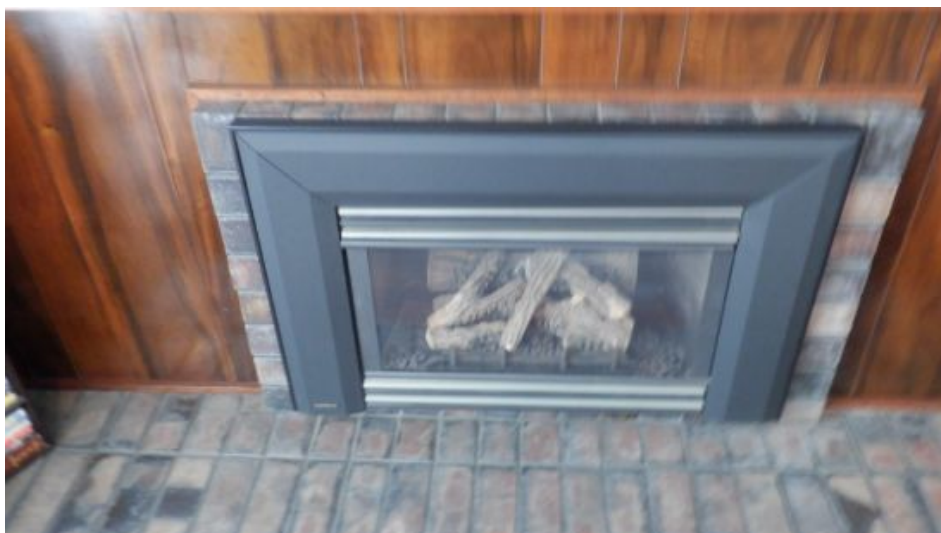
Noted gas fire, not tested in our inspection

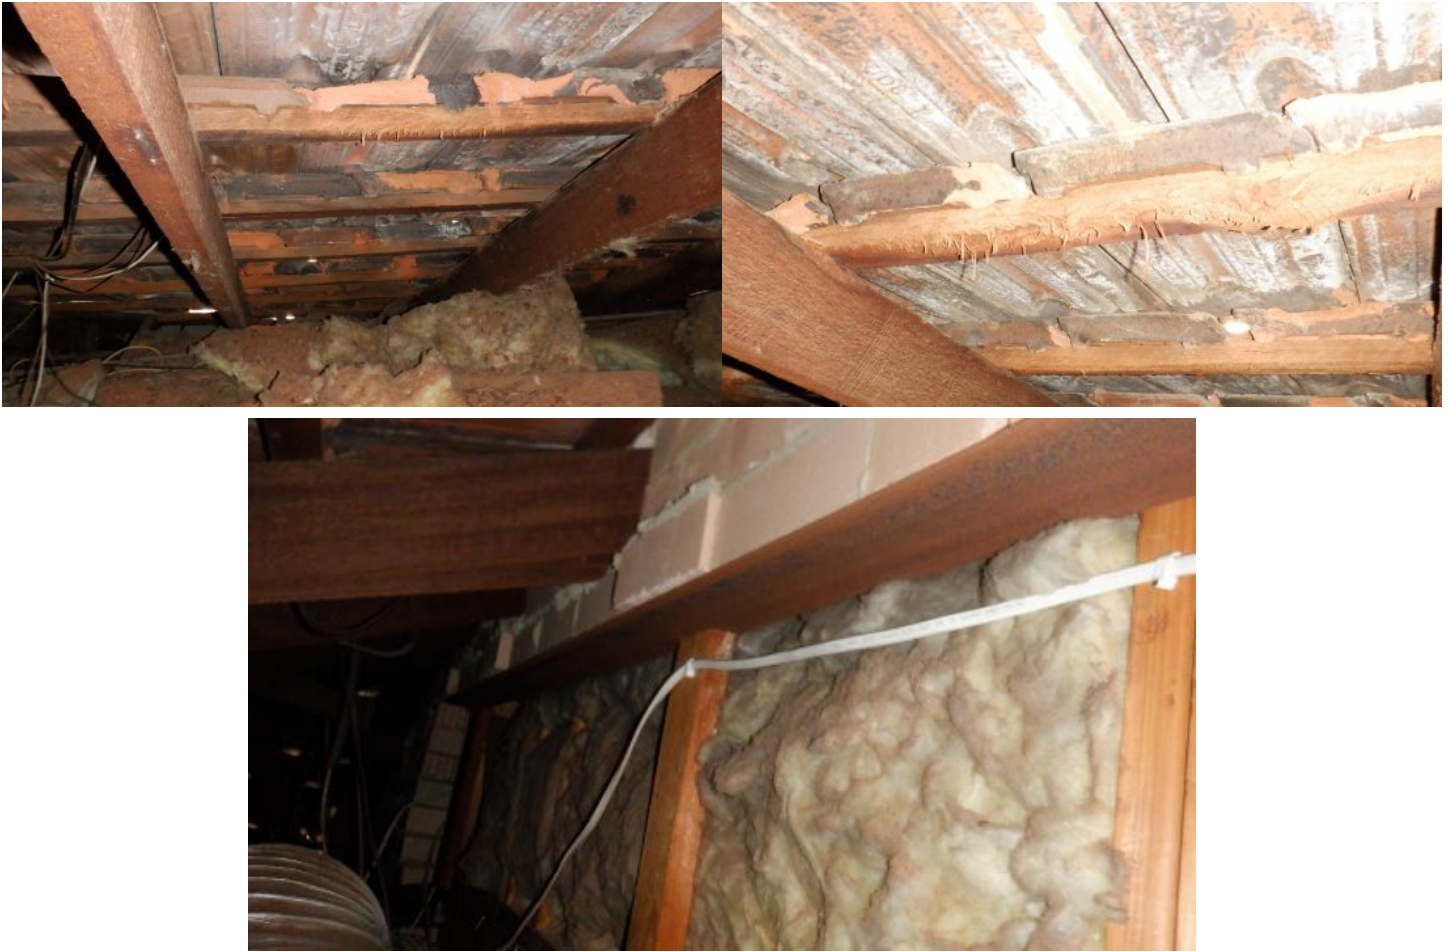
- Evidence of "Chemical Delignification" - (Timber fretting) was noted on some of the timber batten components in the roof space. It does not appear to have affected the integrity of the battens at present but should be monitored. This is likely to be present on the lower original roof batons.

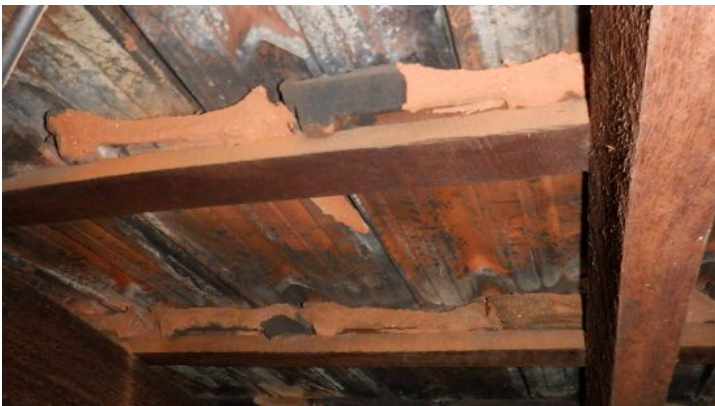
Noted some tile edges have flaked in areas, monitor for maintenance

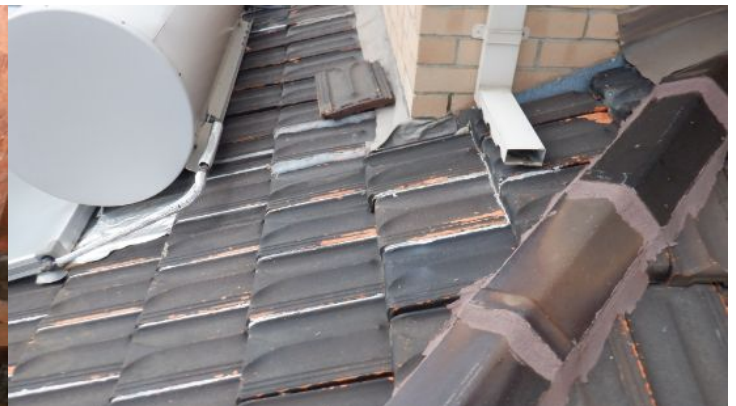
Monitor when raining

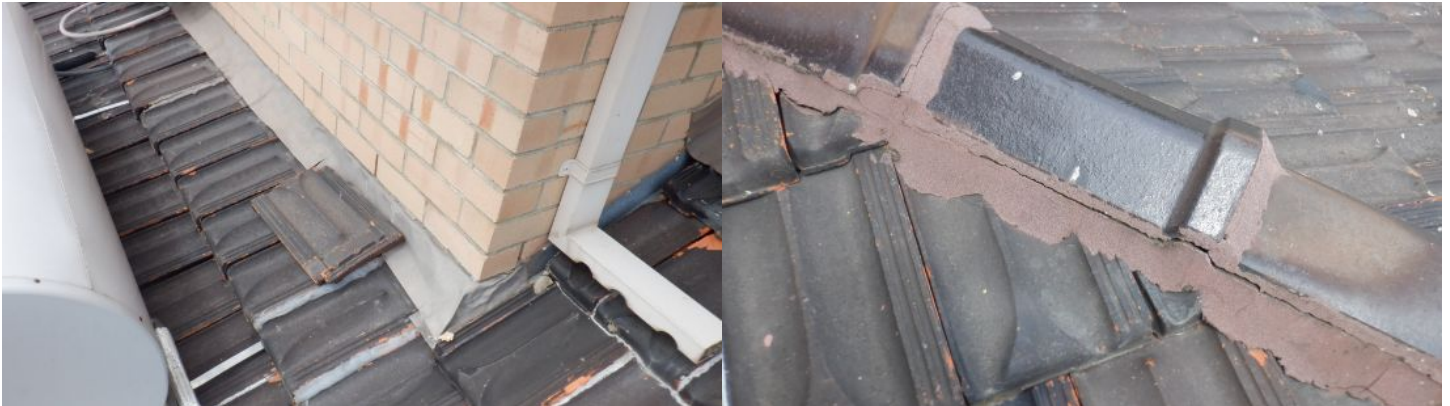
- There are previous silicone repairs noted. These tiles should be monitored, and ideally at some stage replaced as silicone can deteriorate over time.

Silicone has been applied to the tile joints below this downpipe area.

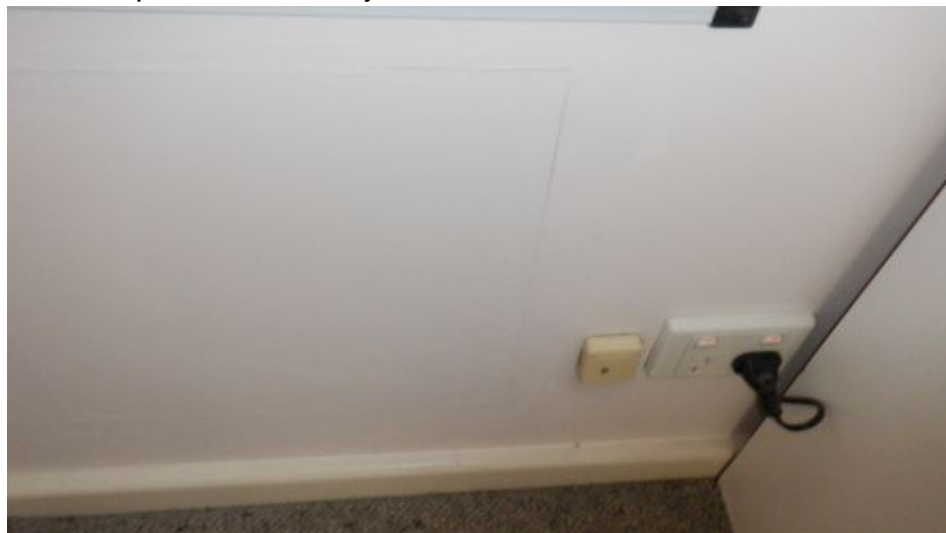
- Some minor cracking noted between the gyprock sheets at various locations within the property. These are not structurally significant and can be patched normally. Noted in the master bedroom.

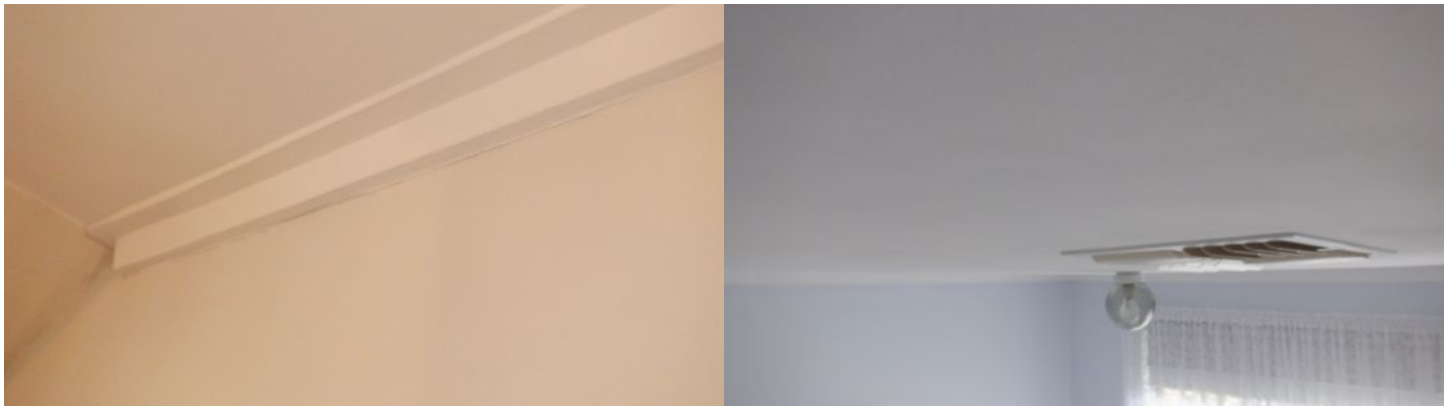
- Some minor sagging was noted in the bedroom ceiling. This did not appear to have affected the overall structural integrity of the ceiling but might require some maintenance in the future. We recommend that you monitor this area for any further sagging and engage an appropriately qualified tradesperson if the condition worsens.

Slight sagging noted in the front bedroom ceiling, monitor

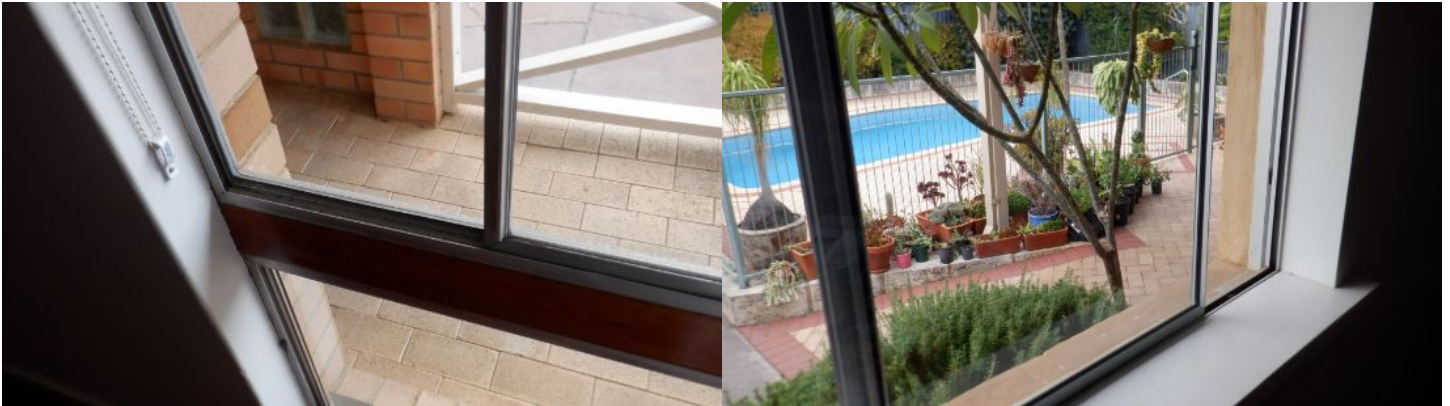
- Windows operated during the inspection appeared functional.
- Some fly screens were not installed at time of inspection.

Some fly screens were not installed

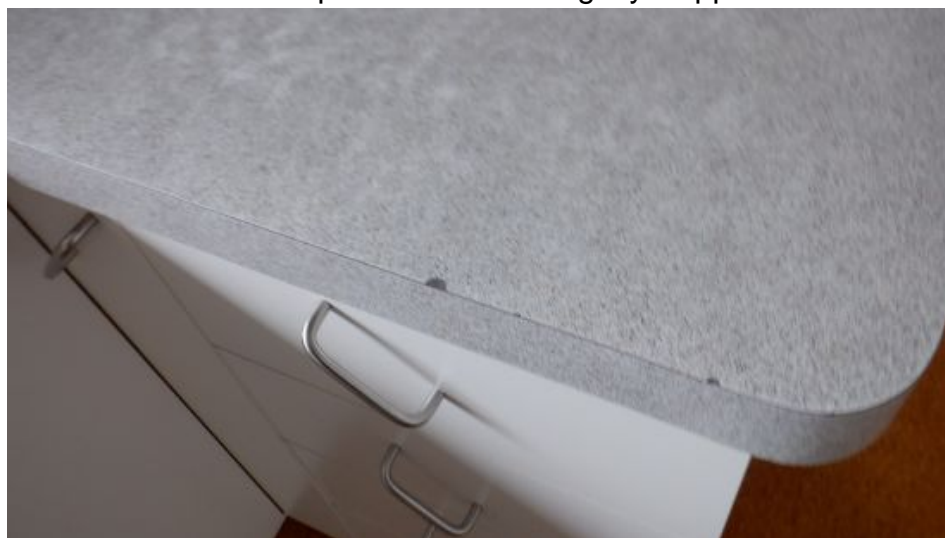
- Appeared functional at the time of inspection.
- Plastic laminate tops noted.
- The counter tops are noted as slightly chipped or worn in areas.

Small chips and wear noted, maintenance

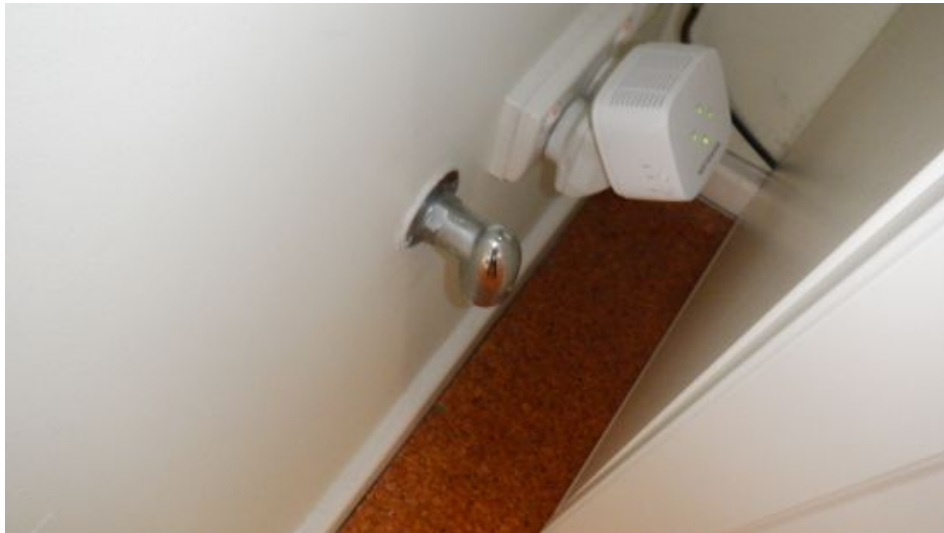
- Gas bayonet installed. No wall or ceiling vent observed. Location of this bayonet is in the dining room.

- There are no wall or ceiling vents. If you intend to use an unflued gas heater you may want to consider installing wall and ceiling vents to aid ventilation.

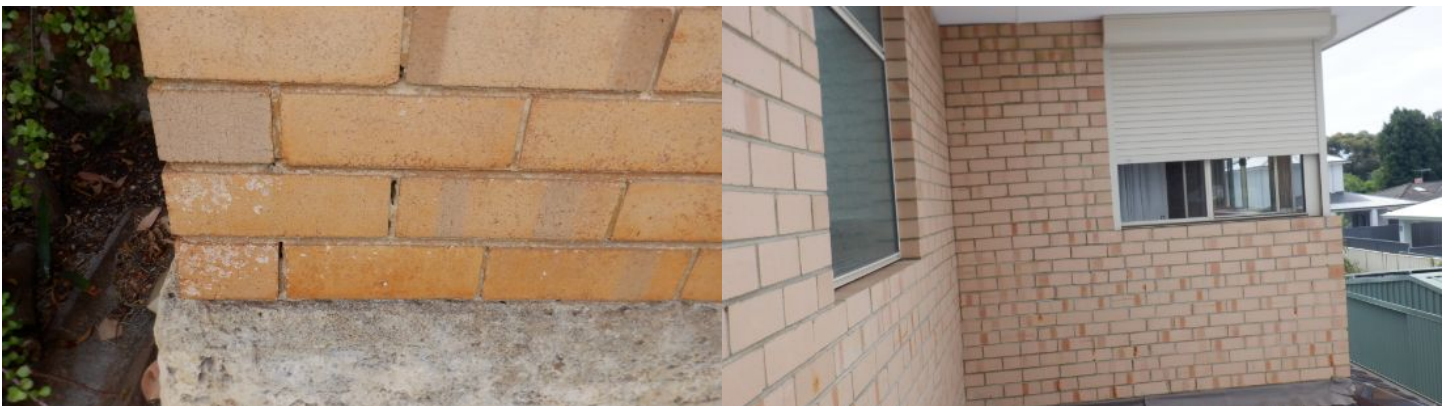
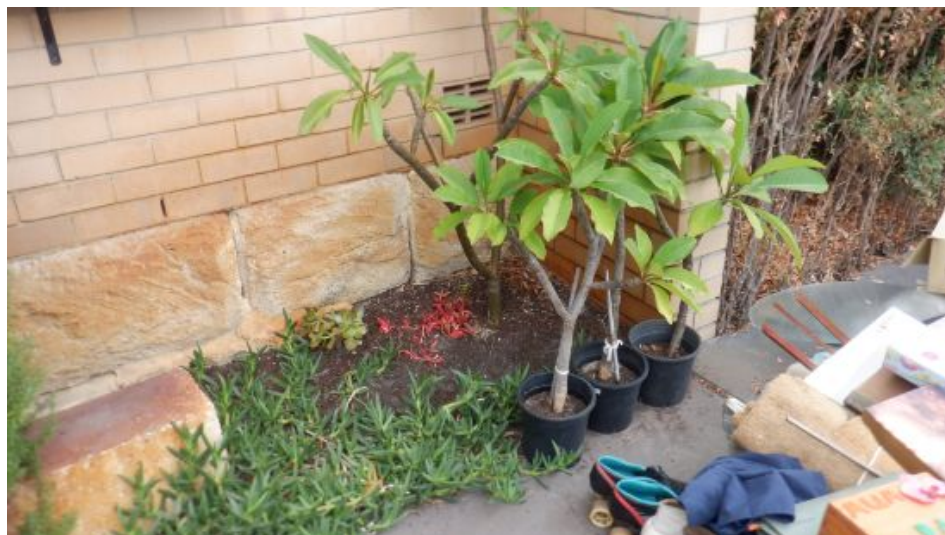
- There is a section of the external wall at west where the mortar appears to have fretted and deteriorated. Maintenance should be carried out on this section of the wall to reinstate the mortar and prevent it from deteriorating further.
- There are a number of garden beds which are adjacent to the external walls. This can result in water moisture affecting the structure over time. It is recommended that either the beds be removed or a water barrier be placed between the garden bed and the external walls. If these beds are retained it is important that any watering is directed away from the building and kept to an absolute minimum and is controlled.

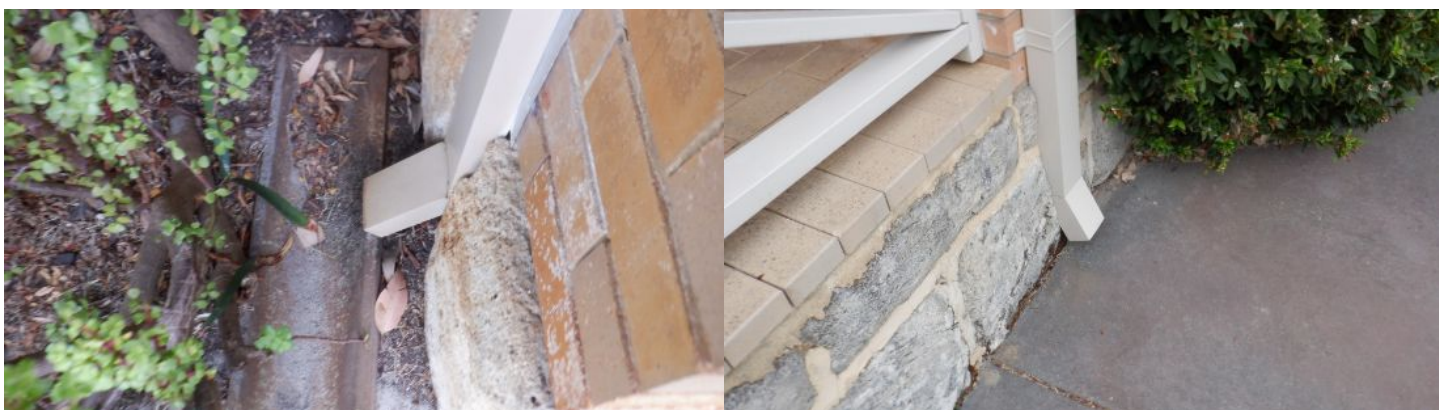
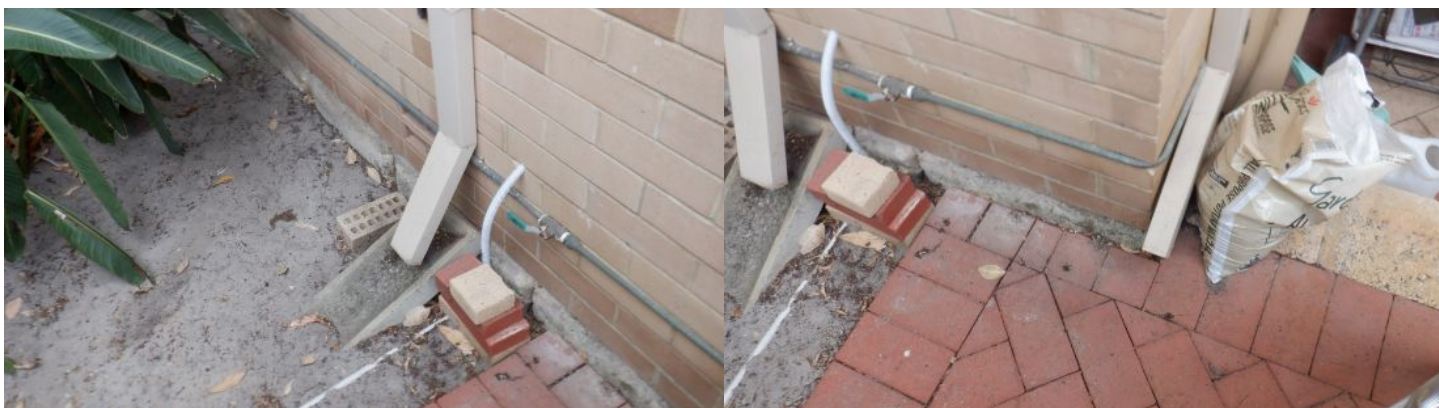
- Some of the down pipes do not have soak wells installed. This allows water discharged to pool beside the external walls and soak in adjacent to the structure. This can cause foundation settlement, dampness in external walls and can create an ideal environment for termites. It is recommended that either soak wells be installed at least 3 meters away from the building for all down pipes or alternatively all water is directed at least 3 metres away from the external walls.

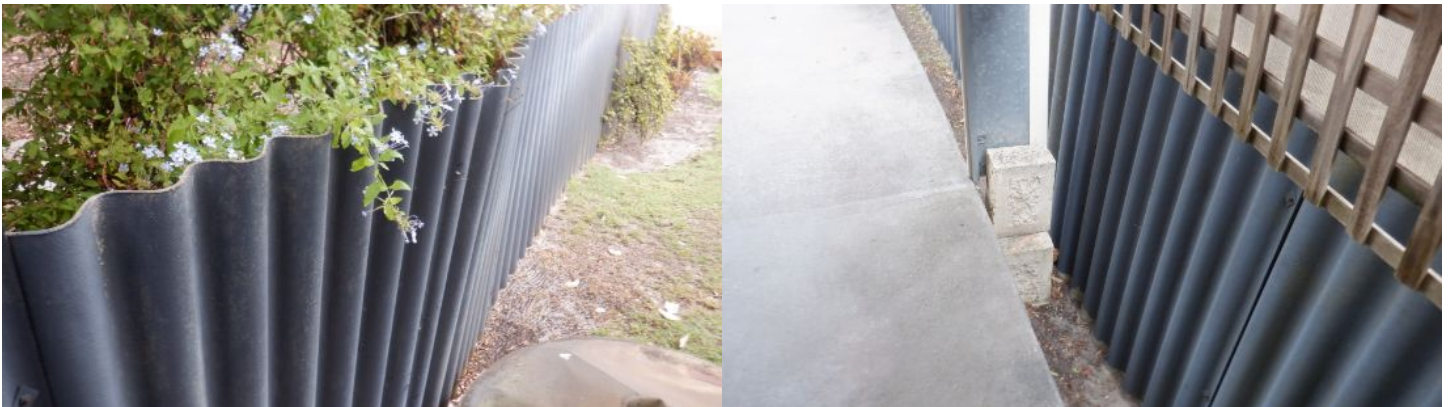
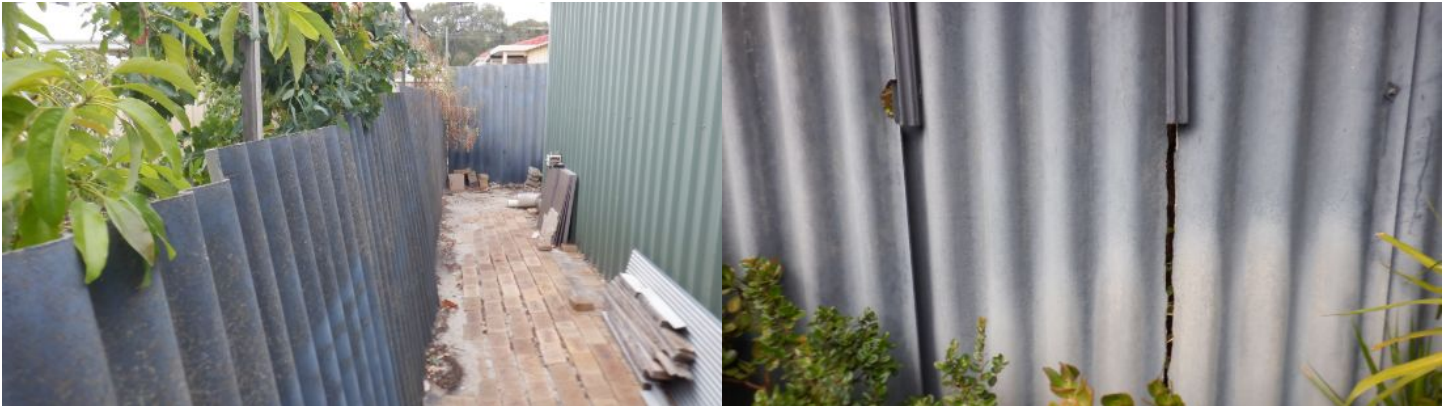
- The boundary fence is leaning in areas. Some maintenance will be required to bring the fence back to the vertical.
- Fence damaged in areas. Some maintenance will be required.

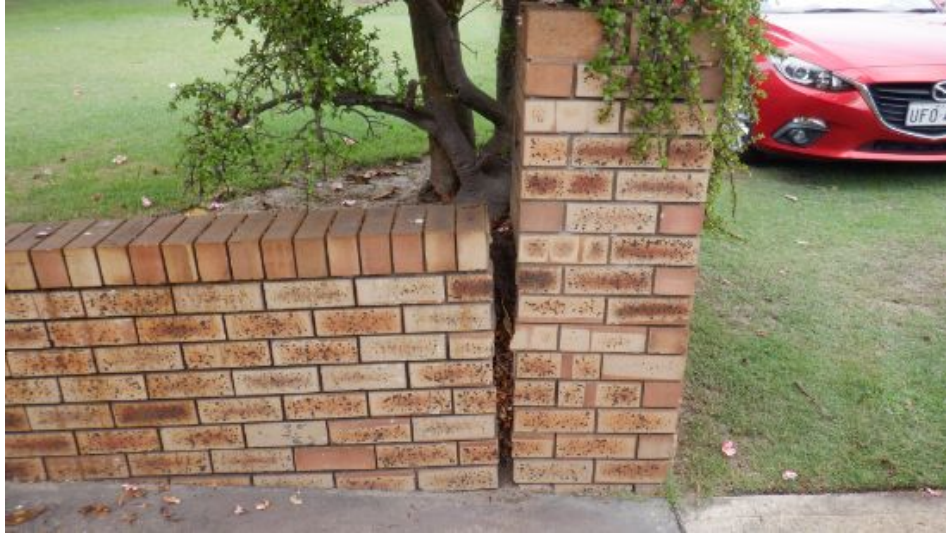
- The yard wall at the west side of the property is leaning, and it should be evaluated by an appropriate trades person. Recommend removing this tree to prevent further movement.
- Evaluation of retaining wall strength, adequacy, and drainage falls outside the scope of a Resicert building inspection. Such evaluation will require the services of a geotechnical engineer. Our evaluation is limited to reporting significant defects that are visible and apparent at the time of the inspection.

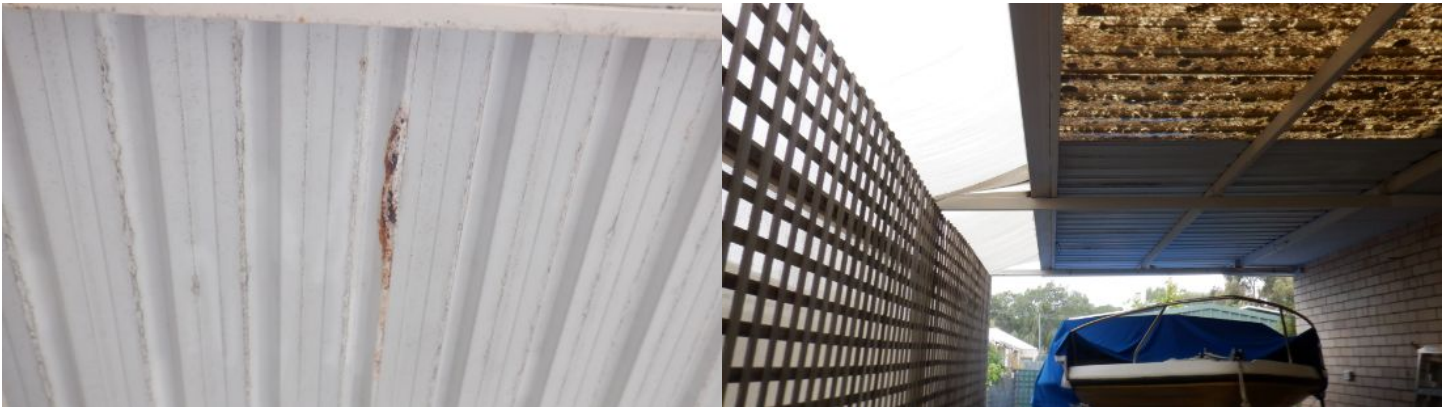
- Some of the metal sheeting on the carport has corroded. This should be reviewed for maintenance or replacement as required.

Noted some corrosion below the roof sheets, maintenance
