# Property Inspection Report

Inspection prepared for: Sample Report  
Date of Inspection: 15/3/2022 Time: 12:00PM  
Weather: Cloudy 26C

Inspector: Resicert Property Inspections  
Sample Report

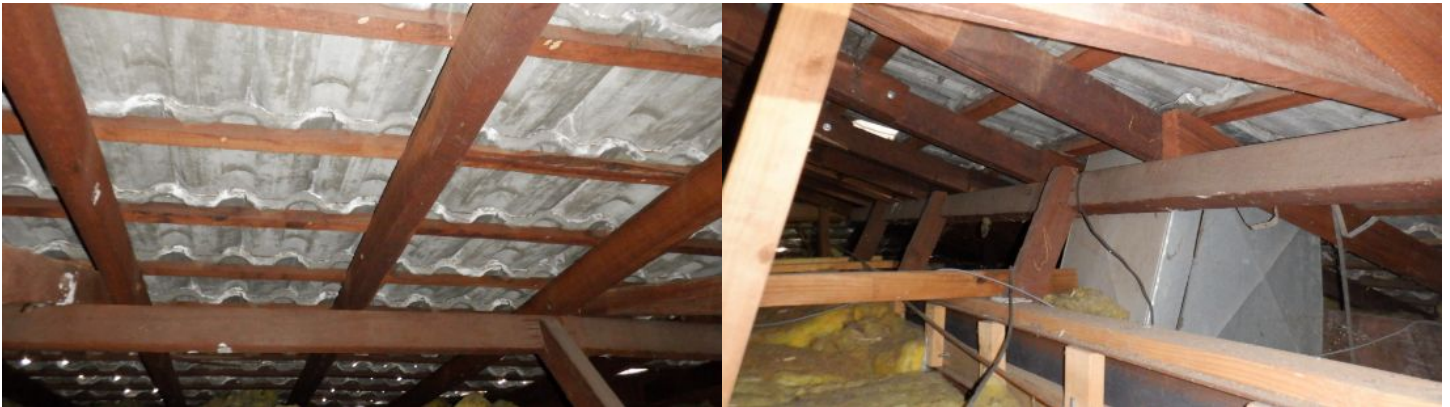
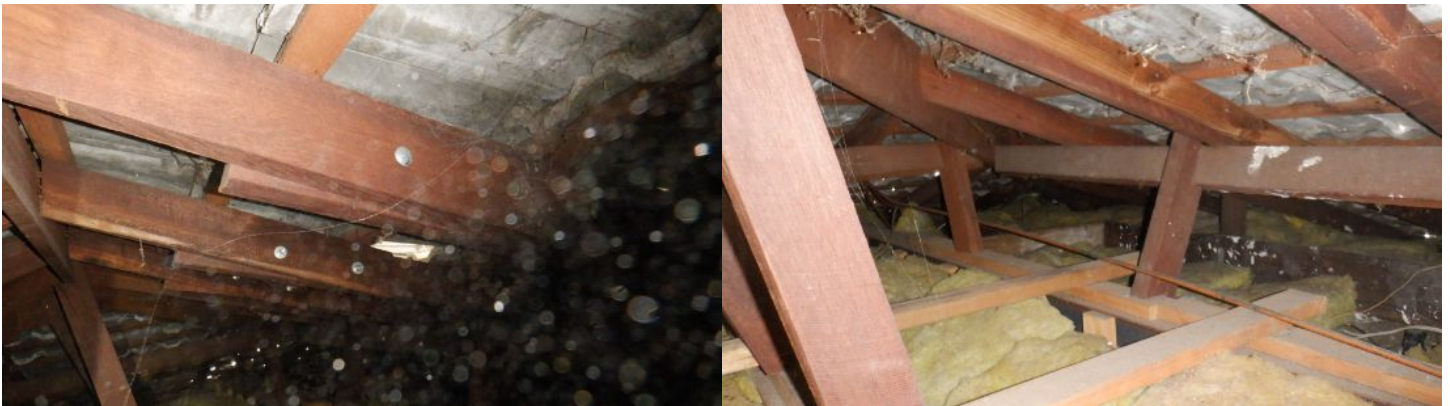
Repair noted, appears sound

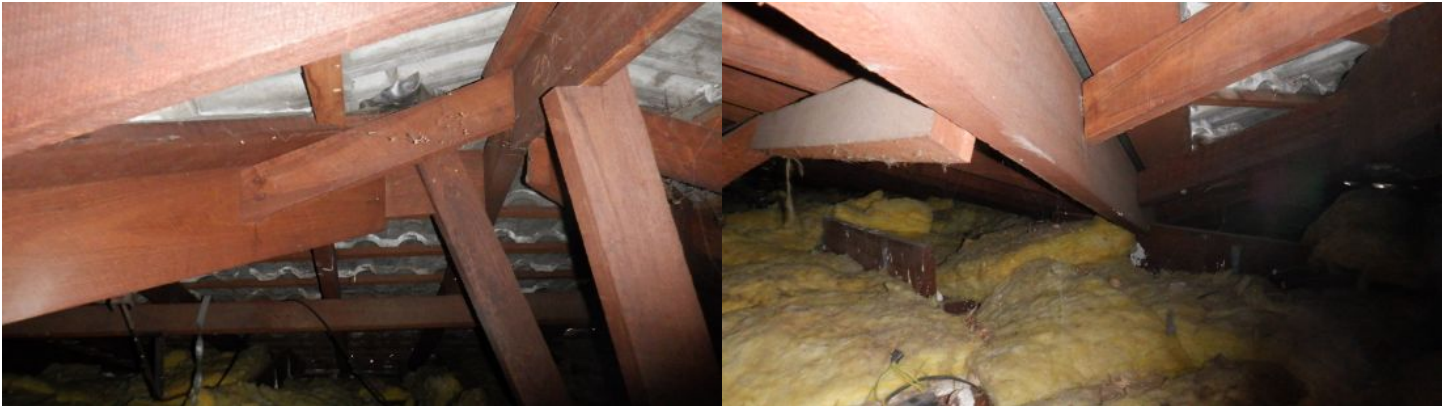
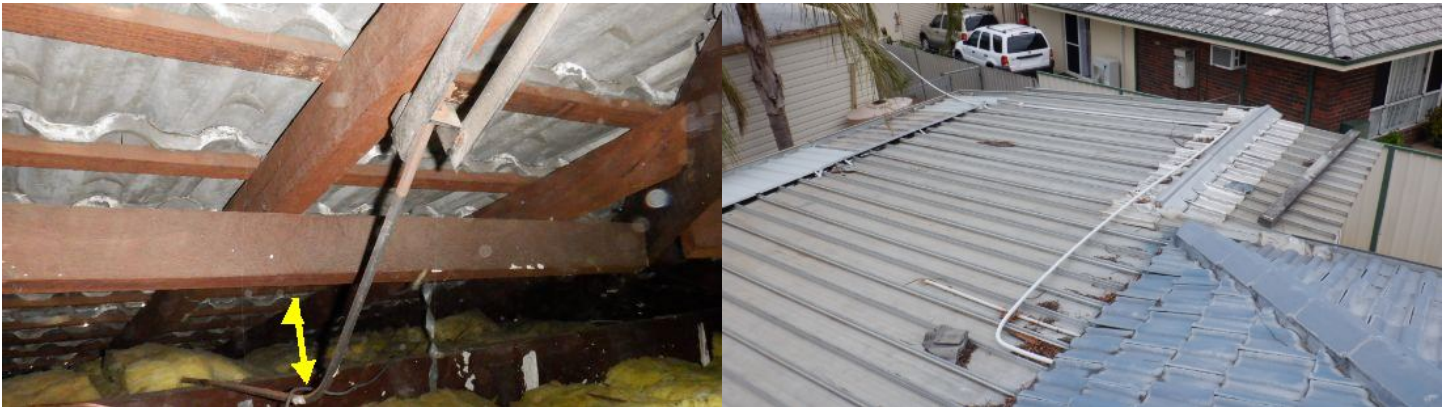
Side extension roof

- Noted one missing steel brace on the front steel support bar. Recommend this is replaced. Maintenance

Noted steel support brace is missing

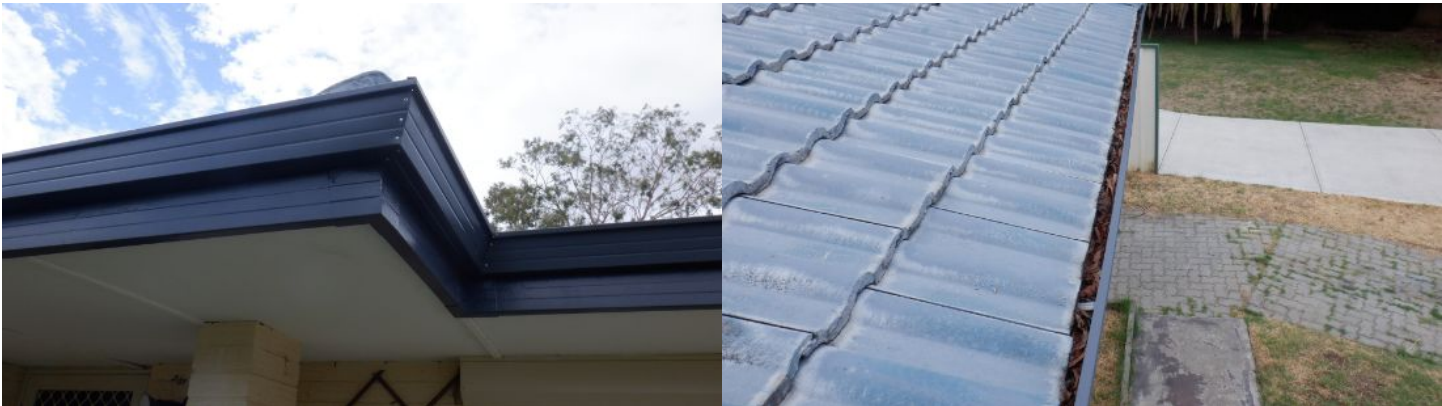
Gutters appear to be new

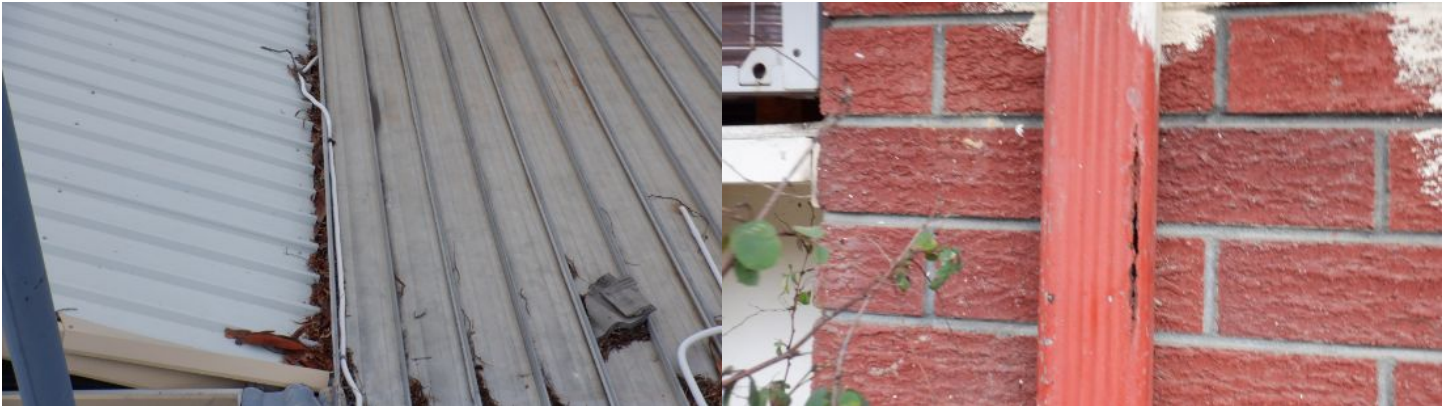
Monitor the gutter here for maintenance

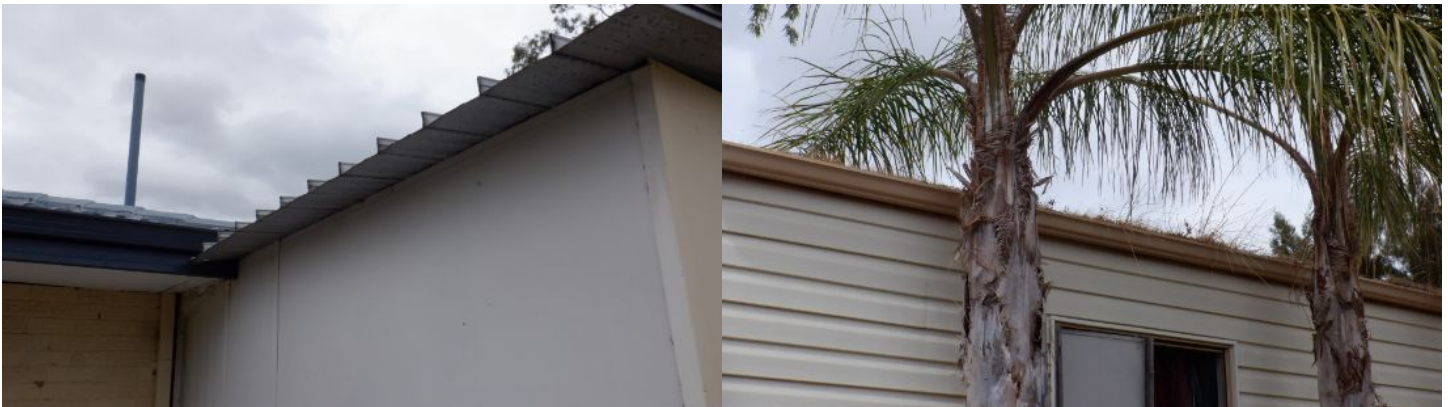
Side extension has no guttering fitted

Granny flat gutters need clearing

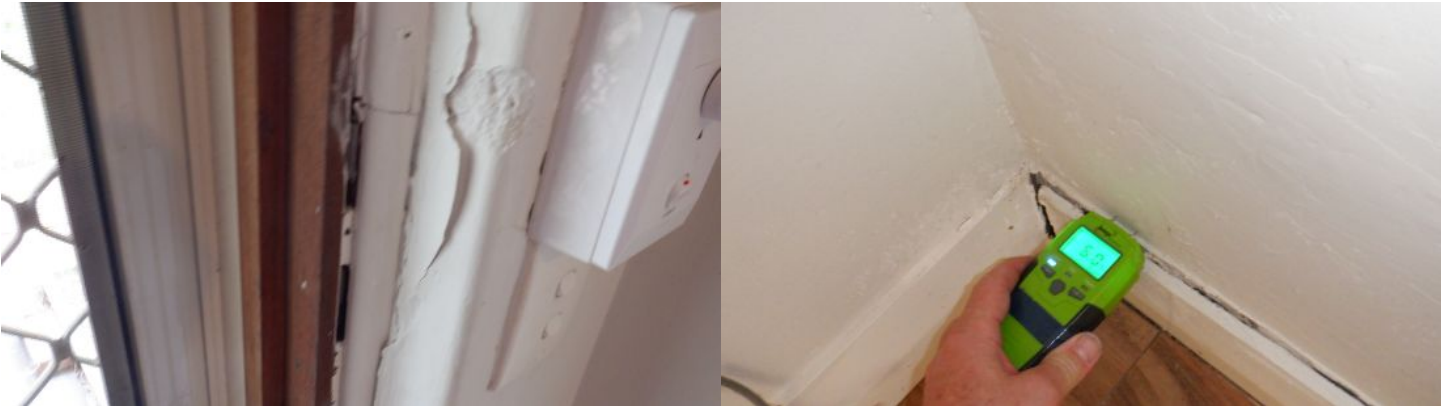
- Very minor shrinkage cracks in the wall plaster in some locations. This is not a structural issue and can be repaired normally.
- There are marks and imperfections to the interior walls at various locations. These can be repaired normally.

Next to the front door frame, maintenance

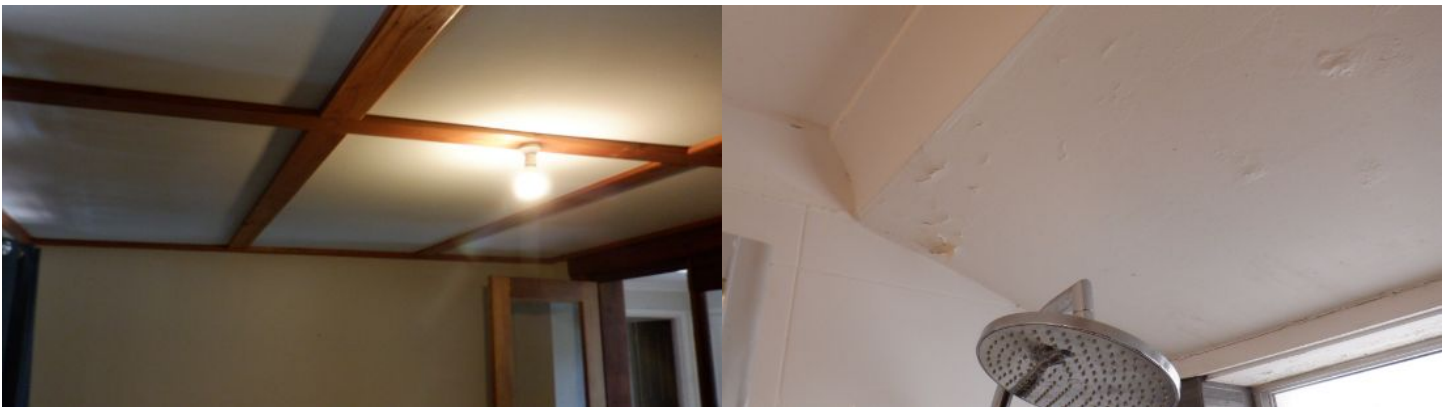
Rear games room extension

- There is minor cracking which has occurred at the interface between the ceiling cornice and the wall at various locations. This can be a result of foundation settlement and/or movement in the roof structure. This does not appear to have affected the structural integrity of the home and can be repaired normally.

- The ceiling has minor hairline joint cracks between the joints of the sheets. This is normally due to minor movement in the roof structure and can be repaired normally. This does not appear to have affected the structural integrity of the ceilings but may require some maintenance in the future.

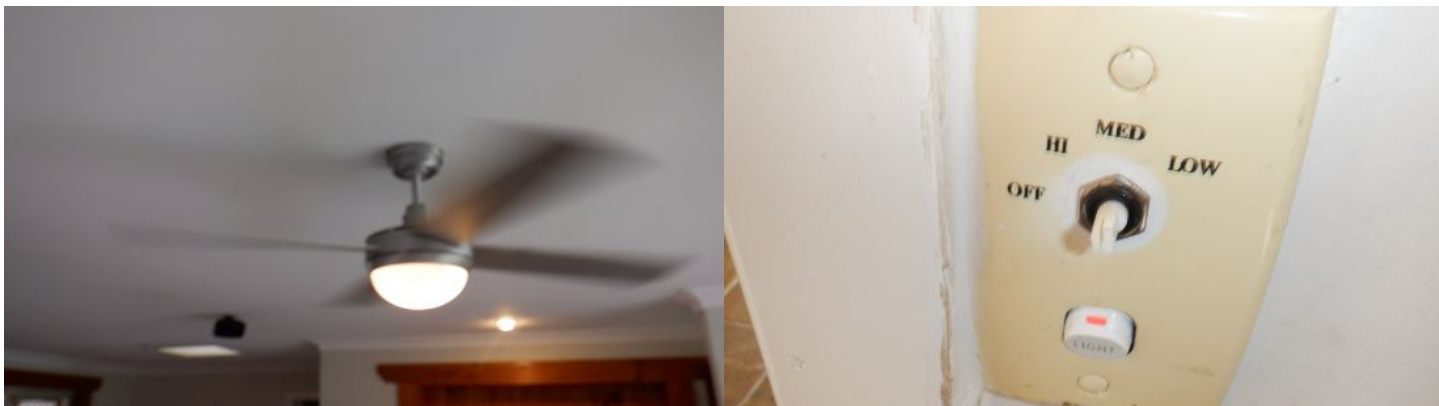
Noted missing control knob

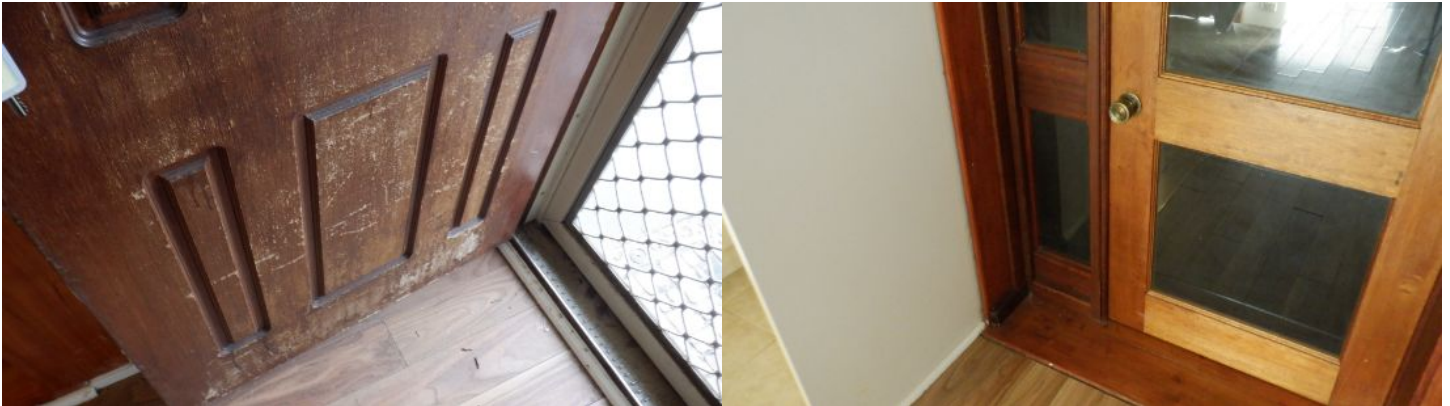
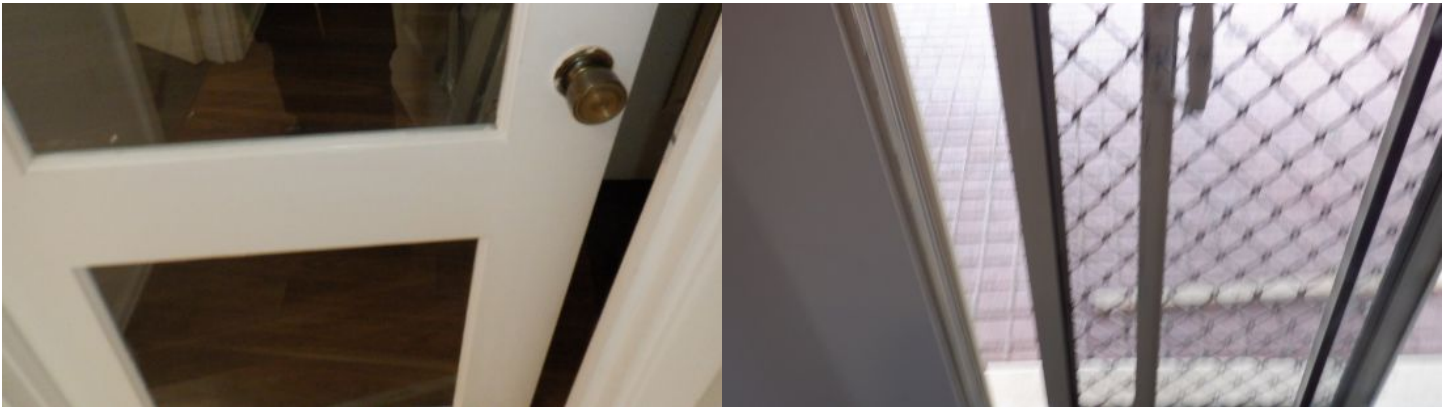
- The exterior doors function satisfactorily.
- The interior doors function satisfactorily.
- Back door missing a deadbolt lockset.
- The bedroom door is not closing properly due to the loose hinge.
- The exterior of the front door is weathered.

Side extension bedroom door hing needs maintenance

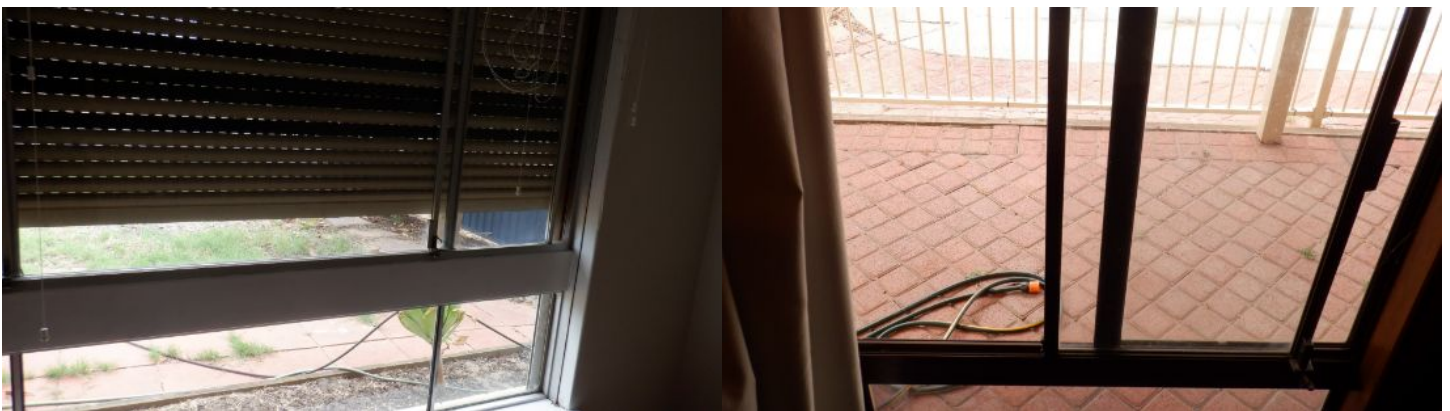
Some fly screens not present

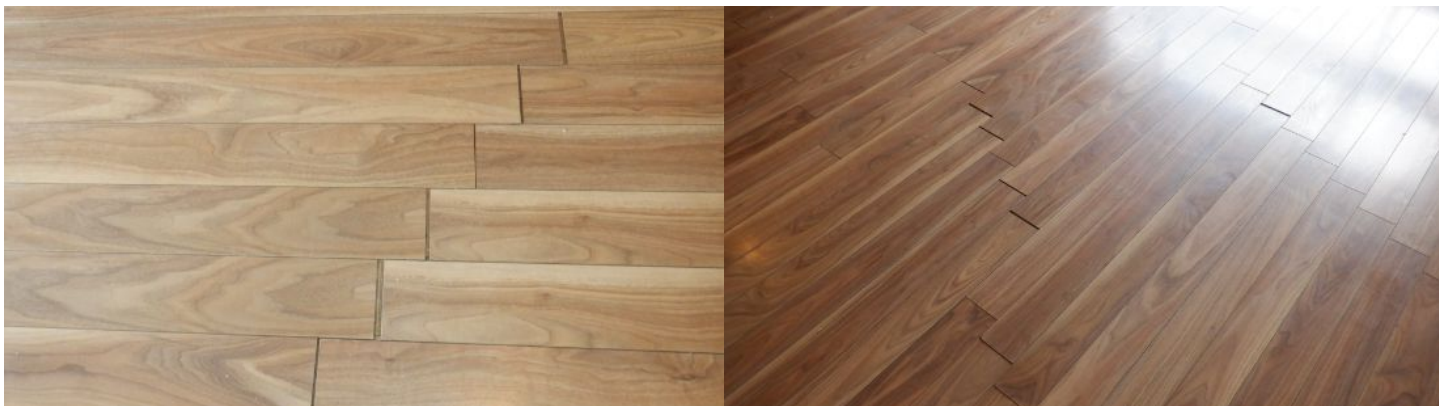
Noted in the lounge room

- Noted gaps have opened up in the floor joints in the lounge room.
- Maintenance

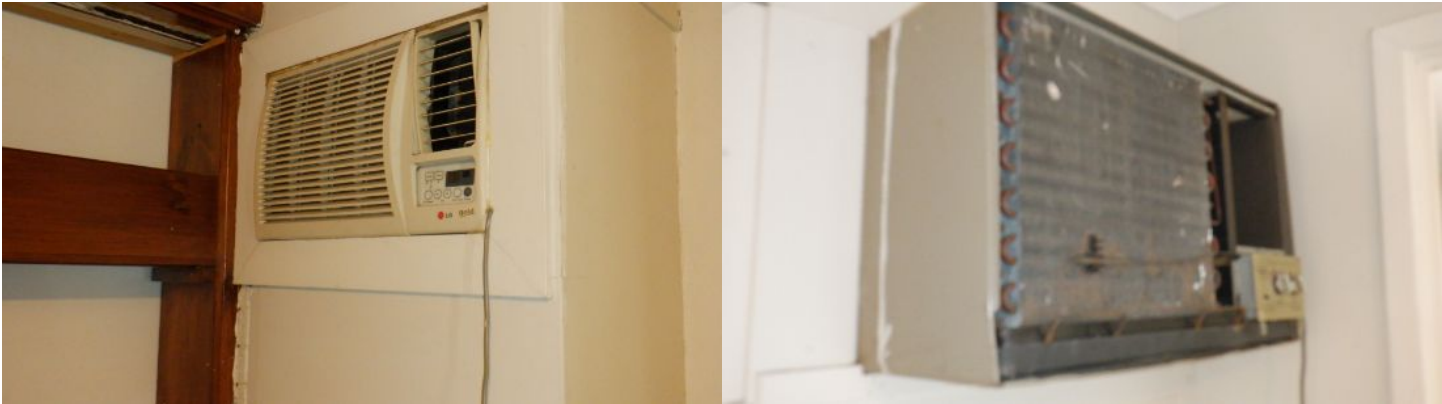
- The games room wall AC unit was unplugged with no available power nearby, did not test.
- The laundry room wall ac unit responded. This has no cover present.

Could not test

Noted the cover was missing, unit responded

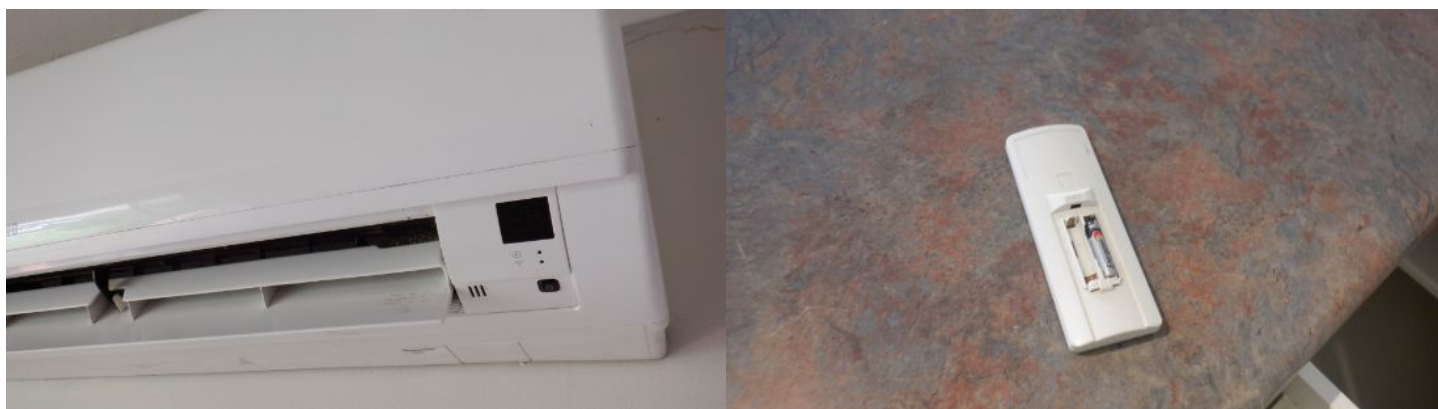
Noted missing batteries to ac control, tested with the override switch

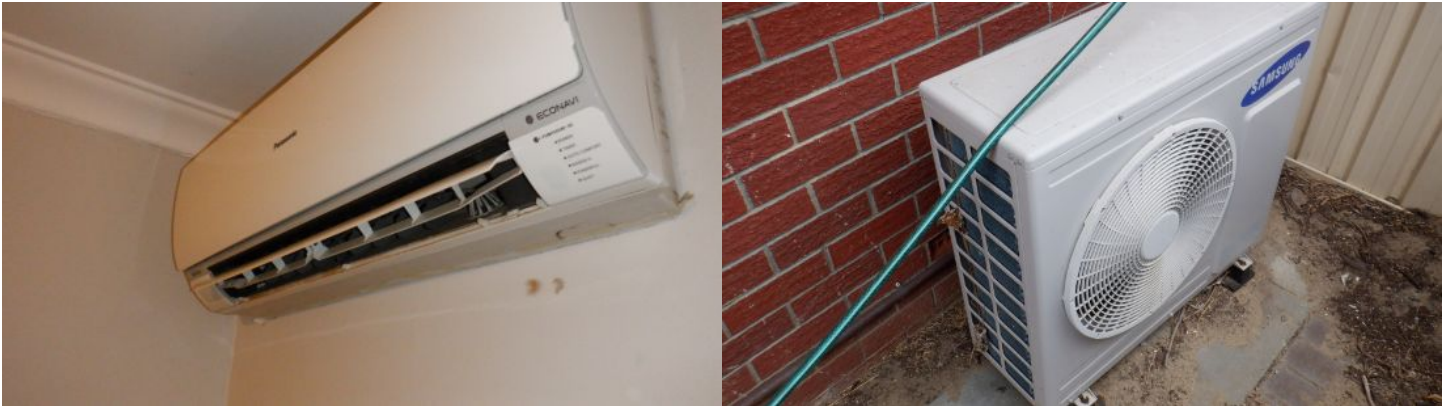
Operated from the manual override switch. No remote presenty

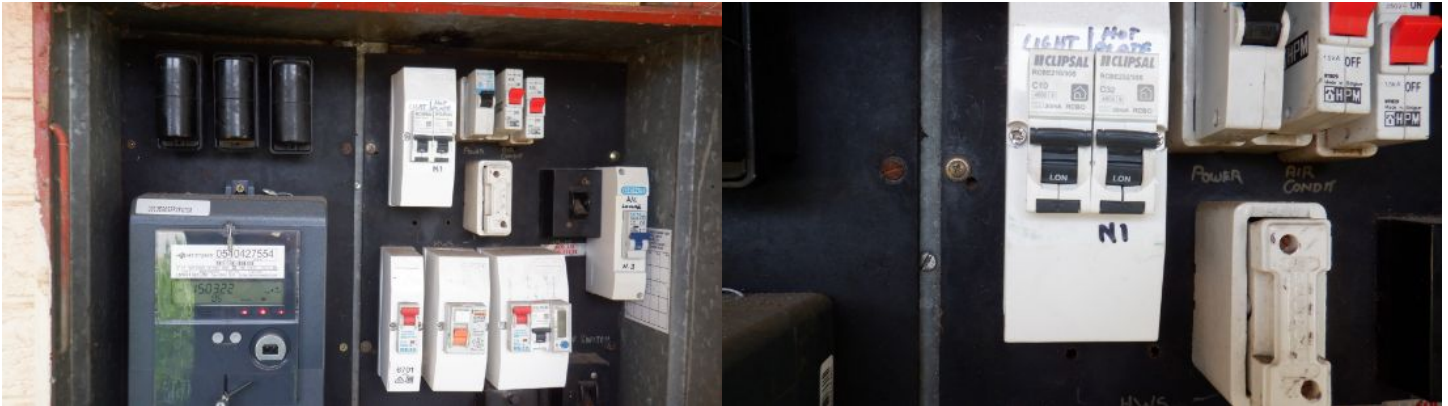
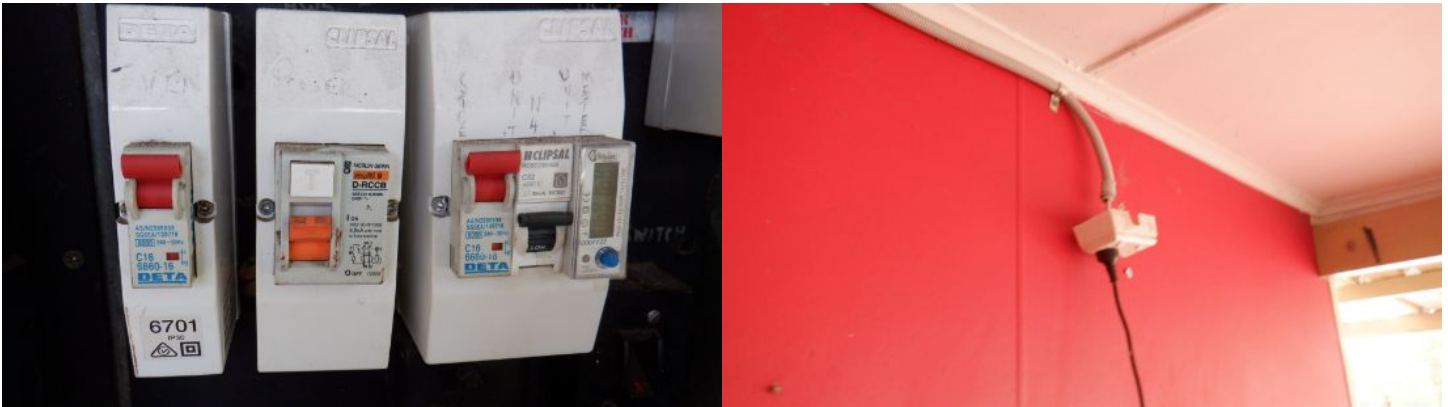
The external wall outlet needs re fixing

- There is a power point in the exterior area that needs refixing to the wall.
- There is a power point in the bedroom area with loose switches noted.

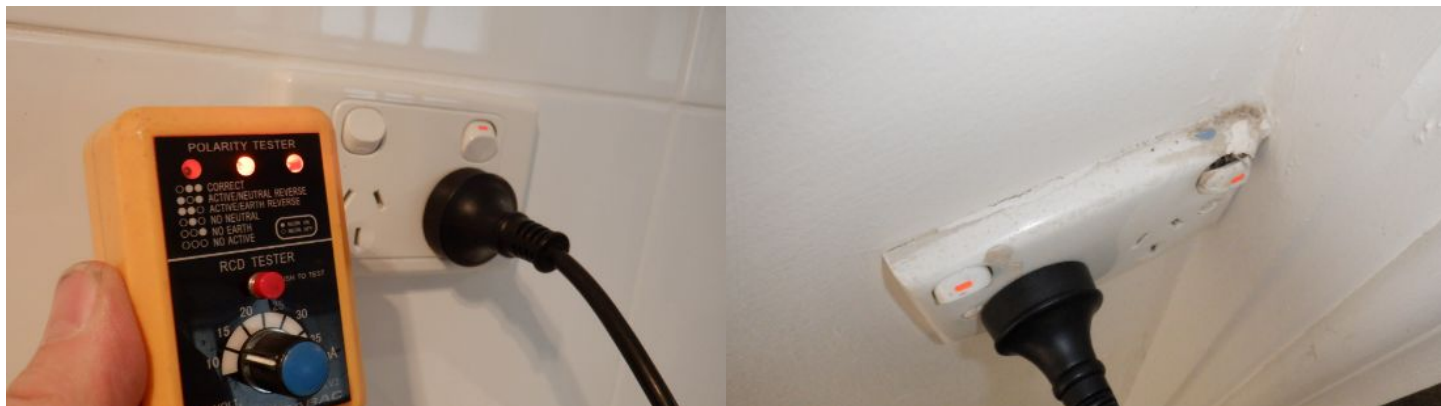
Noted loose rocker switch, side extension.

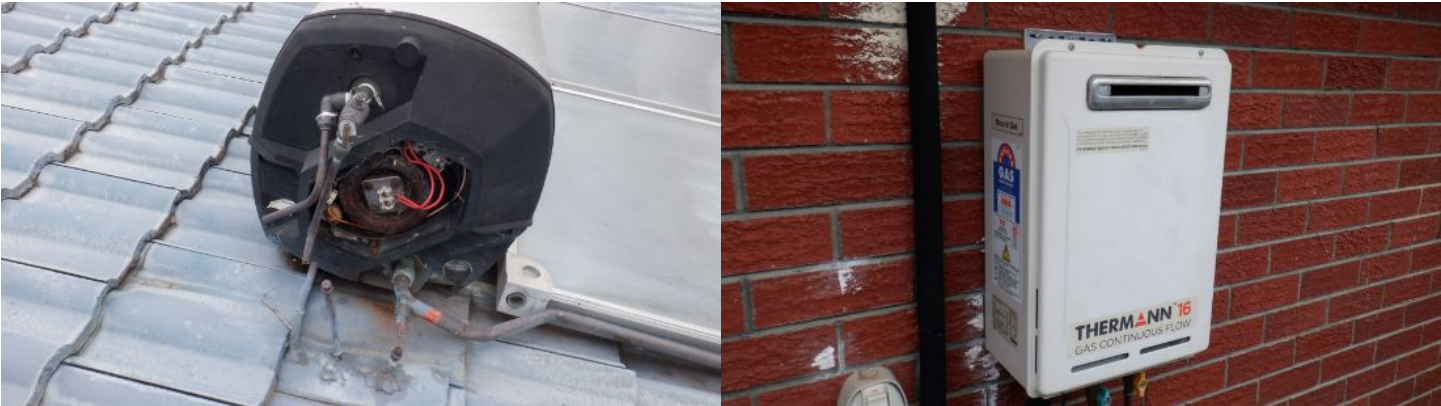
- Please note that we only inspect & comment on the operational and safety issues of the hot water system. Issues relating to compliance to relevant codes and standards, and/or installation compliance is excluded from the scope of the inspection.
- No major system safety or function concerns noted at time of inspection.
- A disused solar hot water system was noted on the roof. You may wish to have this removed at some point.

Disconnected solar tank and panels are present on the roof

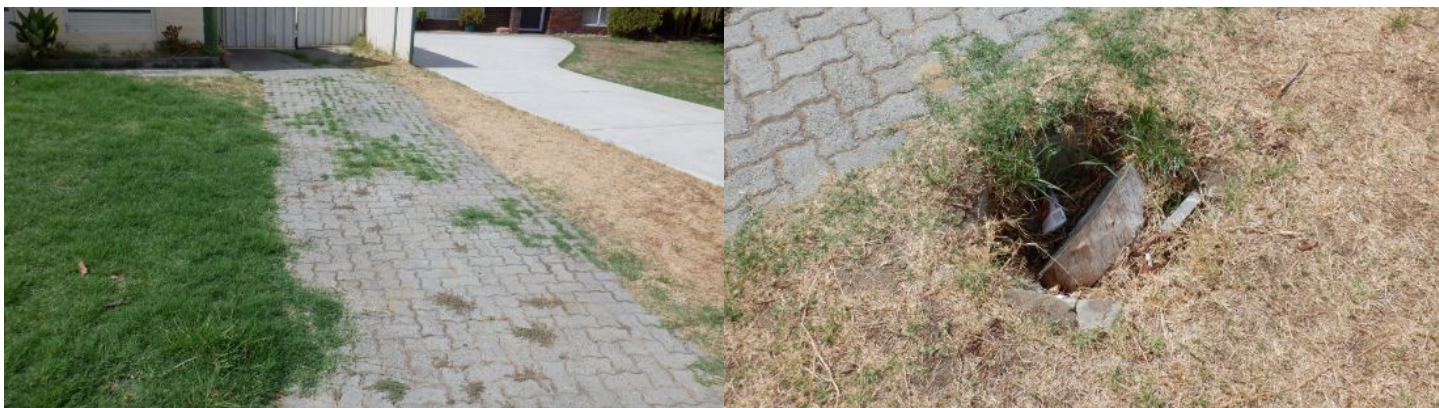
Driveway needs weeding

Noted concrete open chamber next to the driveway, recommend a lid is installed

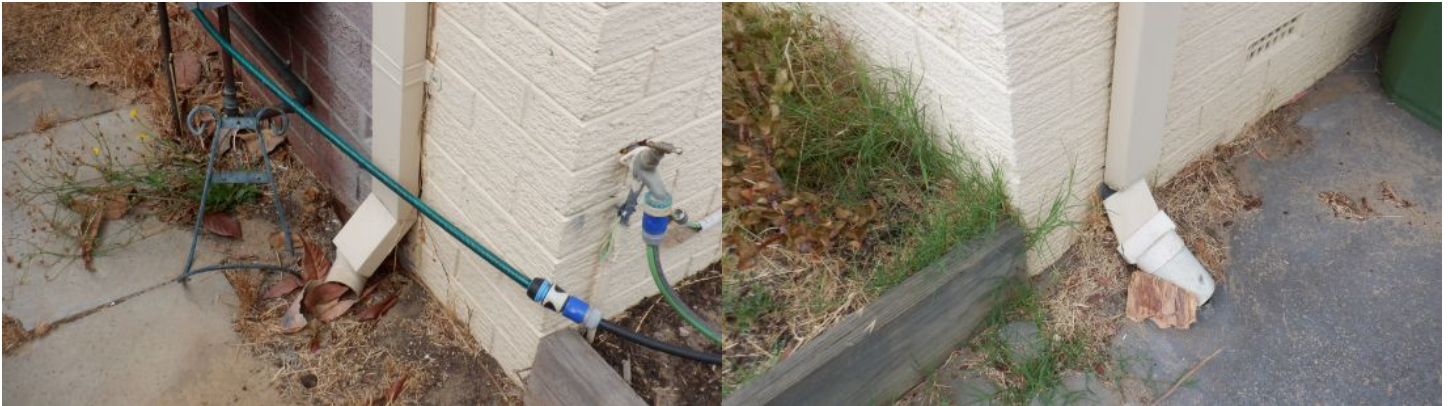
- Surface drainage conditions within 3 metres of the inspected structure appeared satisfactory.
- Some broken connectors noted, maintenance.

Noted broken connector, maintenance

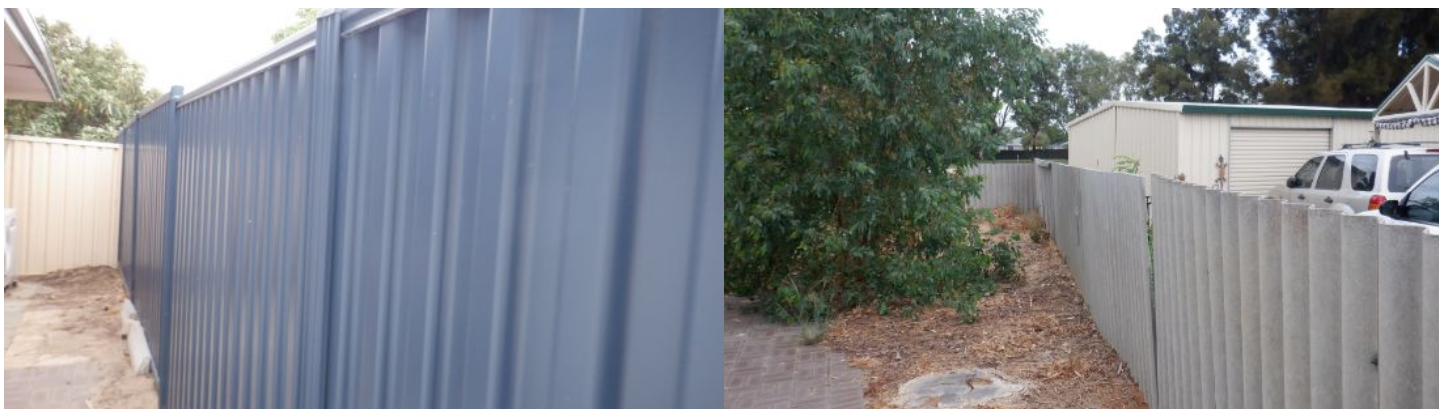
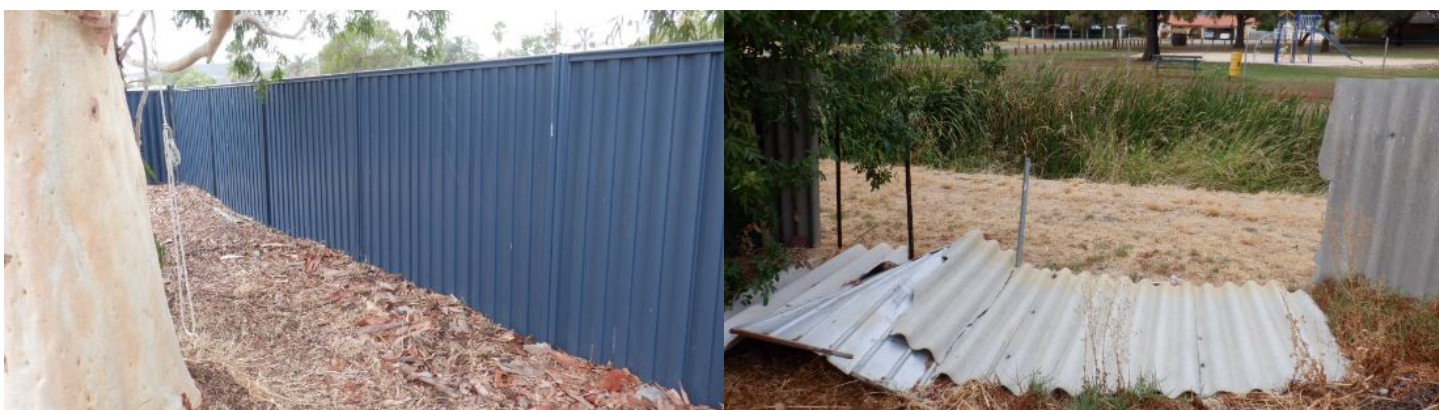
- Rear boundary fence damaged has collapsed in one area. This fence protects the pool area and should be replaced as soon as possible.
- One section of the rear boundary fence is damaged, has collapsed in one area. This fence protects the pool area and should be replaced as soon as possible.

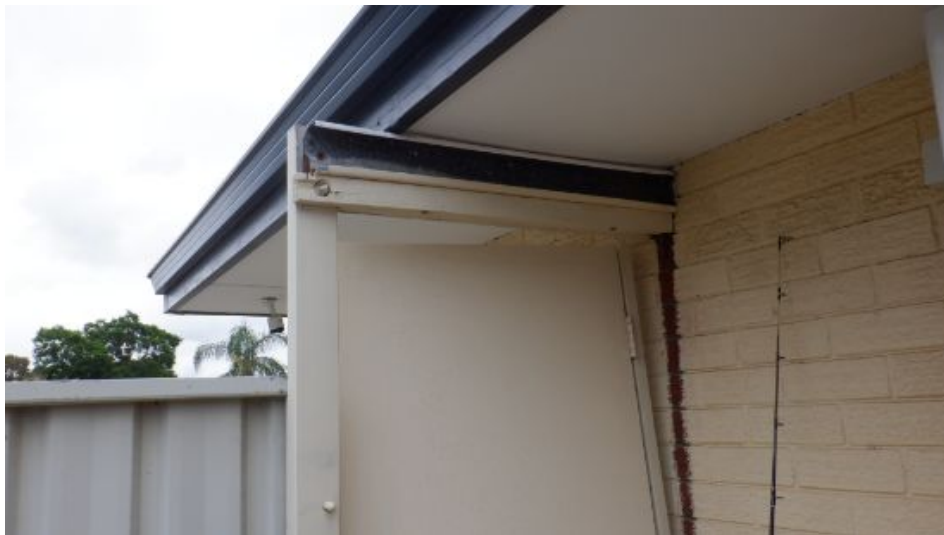
- Damaged gate / door observed.

The gate needs maintenance

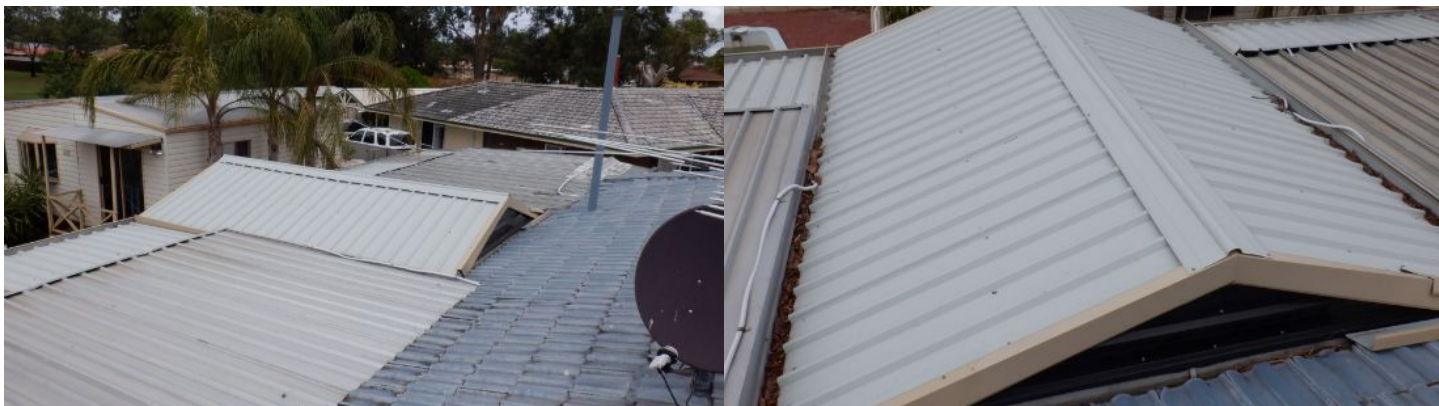
Rear games room and patio roof

- Patio appears in satisfactory and functional condition with normal wear for its age. Appears to be structurally sound.
- The granny flat appears in satisfactory and functional condition with normal wear for its age. Appears to be structurally sound. The services were not checked in our inspection on this structure.

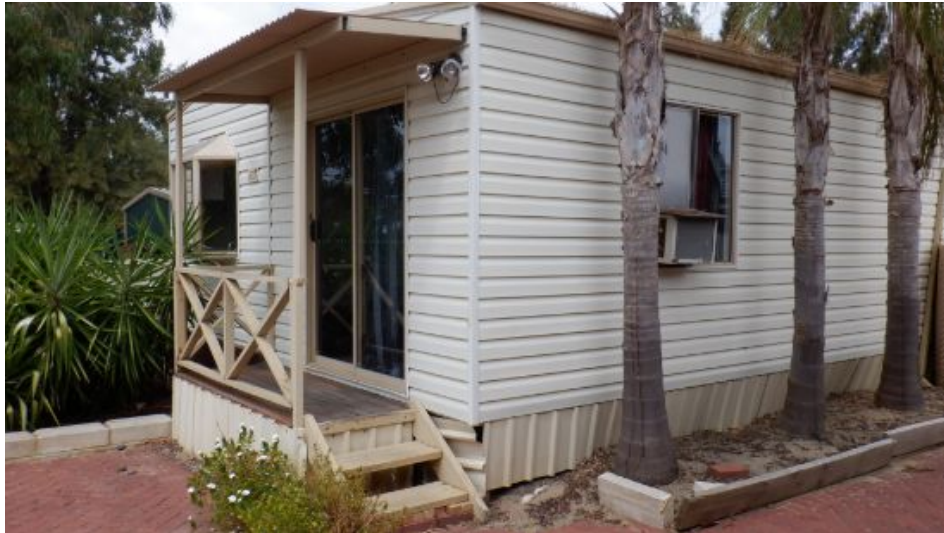
Granny flat services not inspected.

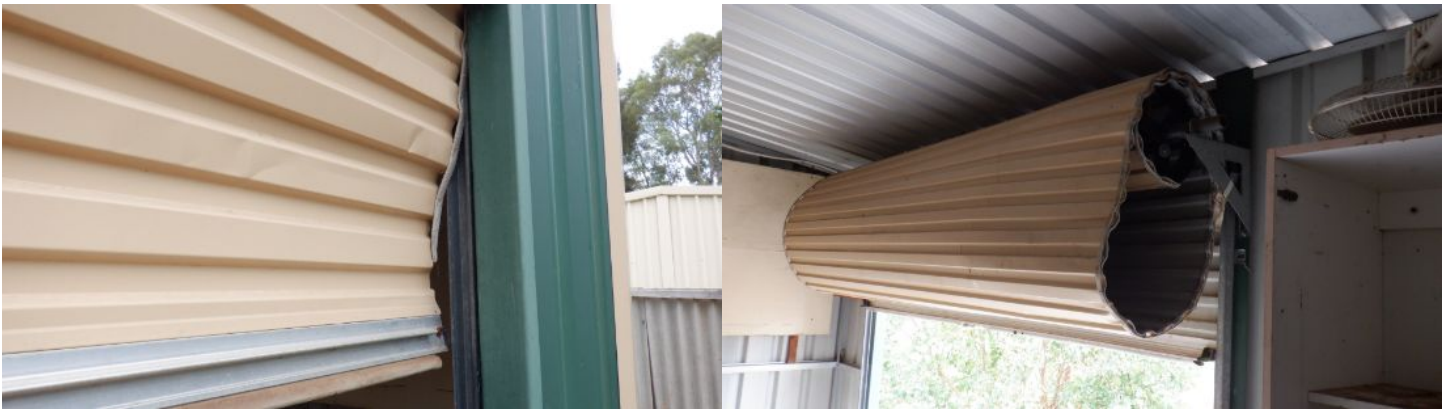
- The door has jammed and needs servicing

Workshop roller door needs maintenance, servicing
