Property Inspection Report

Sample Report, WA

Inspection prepared for: Sample Report
Date of Inspection: 21/12/2021 Time: 09:00 AM
Weather: Fine 24C

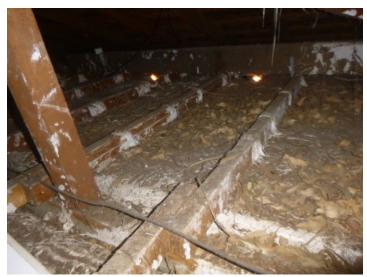
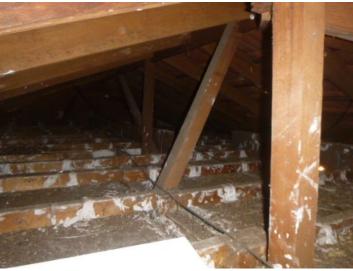
2. Insulation Issues

• There is no insulation on the ceiling in the roof space. Expect higher heating and cooling energy costs. It is recommended that insulation be added to improve the thermal efficiency of the home.

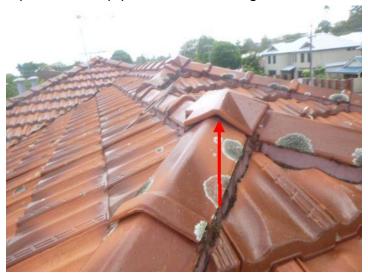
3. Roof Issues

• A number of capping tiles are loose due to cracks in the bedding cement. This is not unusual for a tiled roof, and is often caused by normal movements in the roof frame. It is recommended that maintenance work is carried out on the roof so that the loose tiles can be re-bedded using flexible bedding compound to help prevent re-cracking.

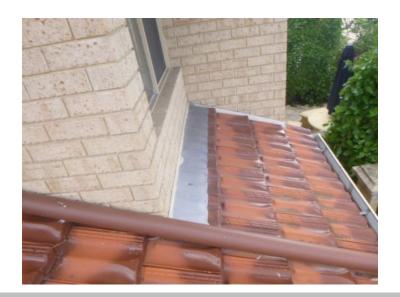
4. Flashing

- Flashing is an impervious material (usually galvanized sheet metal) that comes in a variety of shapes and sizes and is used to cover, waterproof, and direct water away from roof penetrations and from valleys and intersections between the roof covering and other materials.
- The roof flashing, where visible, appears to be in satisfactory condition.
- Some of the <u>valley flashing</u>s have some leaf debris which should be cleared out.

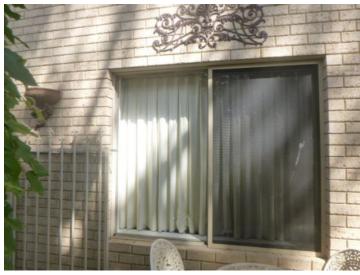
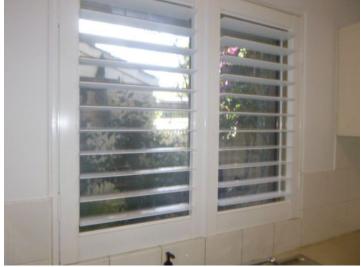
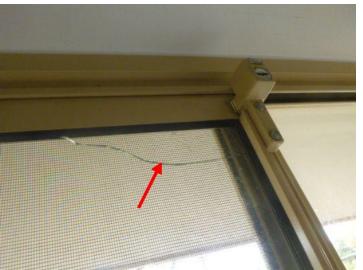
5. Window Condition

- Windows operated during the inspection appeared functional.
 Cracked glass noted in the 2nd floor bedroom. Requires maintenance.

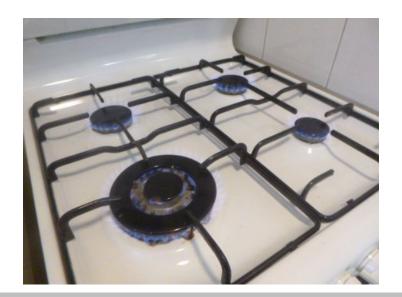
1. Cook top condition

- Gas cook top noted and operated normally when tested.
- The self igniter is not working correctly and needs to be serviced or replaced.

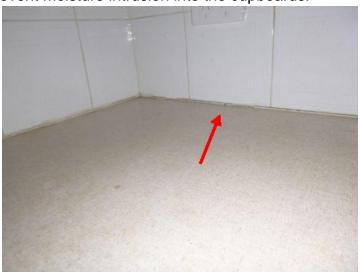
4. Counters

- Appeared functional at the time of inspection.
- Plastic laminate tops noted.
- The gap between the counter and the splashback requires sealing to prevent moisture intrusion into the cupboards.

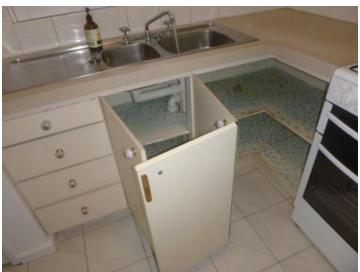
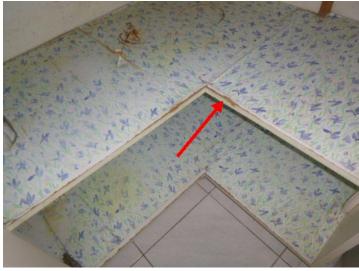
5. Cabinets

- Appeared functional and in satisfactory condition.
 Some moisture damage was noted on the shelving under the kitchen sink. No leaks were noted at the time of the inspection and the area tested dry. Some maintenance is required. Monitor for any signs of water ingress.

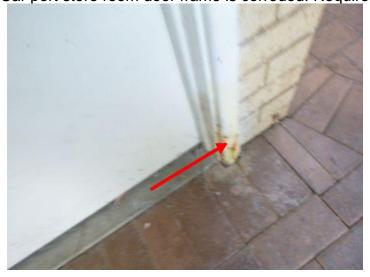
1. Doors

- Operated exterior doors were functional at the time of the inspection unless otherwise noted.
- Car port store room door frame is corroded. Requires maintenance.

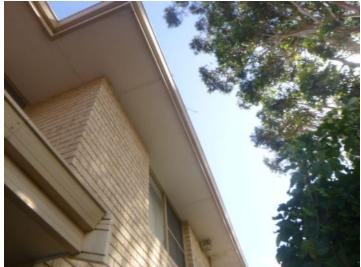
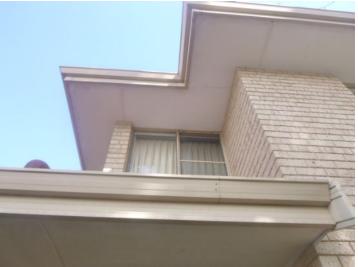
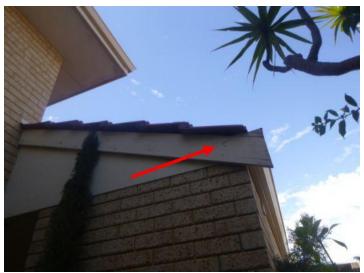
2. Eaves & Fascia

The eaves are in satisfactory condition.
Some weathered timber noted. Recommend review for maintenance as required.

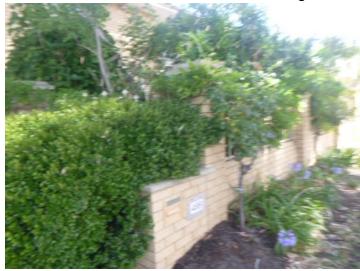
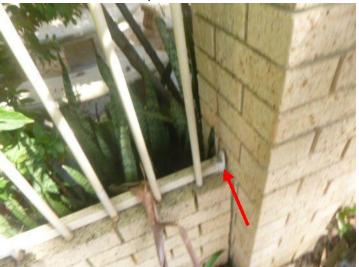
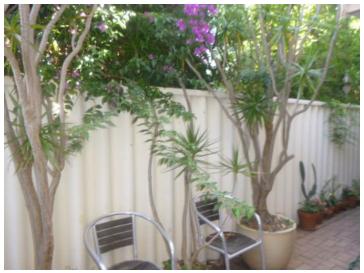
3. Fence Condition

• Front metal railing needs reattched to the brick pier on one section.
