# Owner Builder Defects Report (Section 137B)

Sample Report

Date of Inspection: 1/3/2022 Time: 10:30AM

# Owner Builder Warranty Inspection

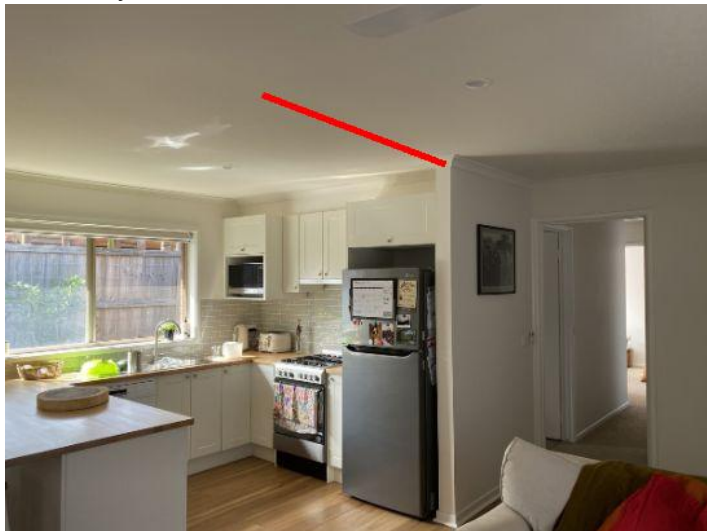
- The internal non-load bearing plasterboard wall was reduced in size to create an open living space. This appears to have been completed to a satisfactory standard. No visible defects or unfinished work observed.

Red line indicates where the internal wall was originally located

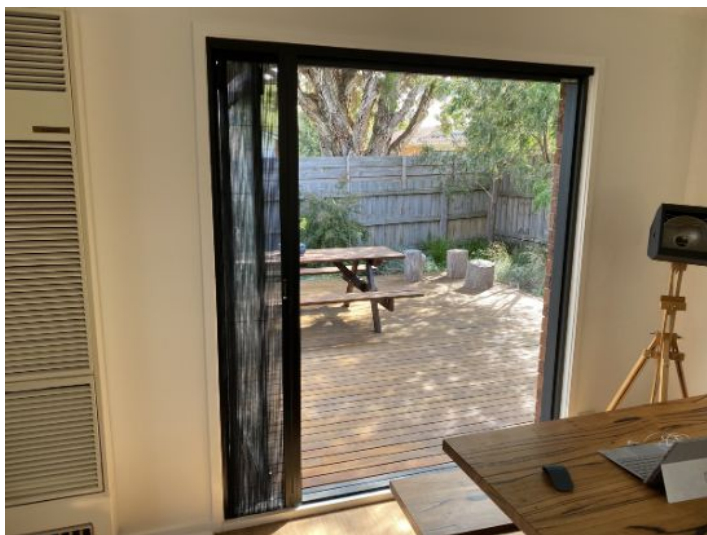
- A large window was removed and an external aluminium door was installed in the original space. This appears to have been installed to a satisfactory standard. No visible defects or unfinished work observed.

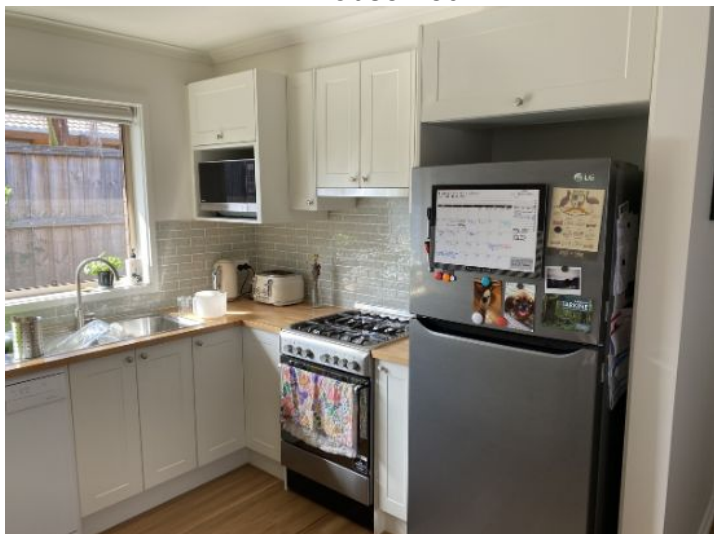
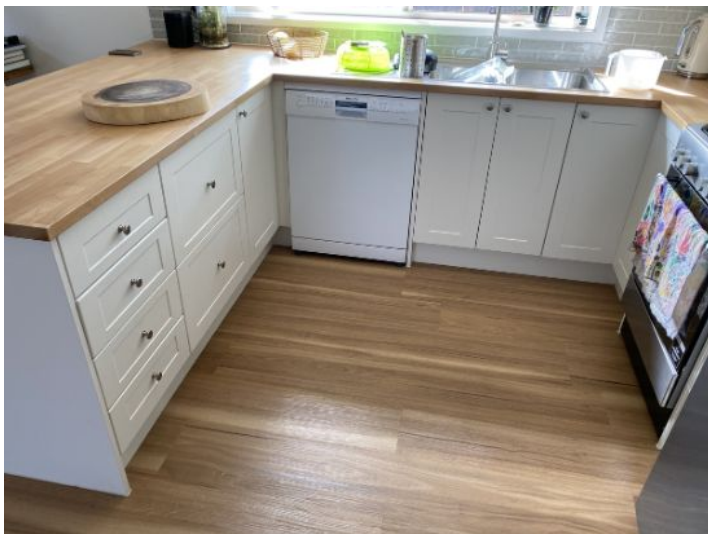
- The kitchen and relevant components appear to have been installed and completed to a satisfactory standard. No visible defects or unfinished work observed.

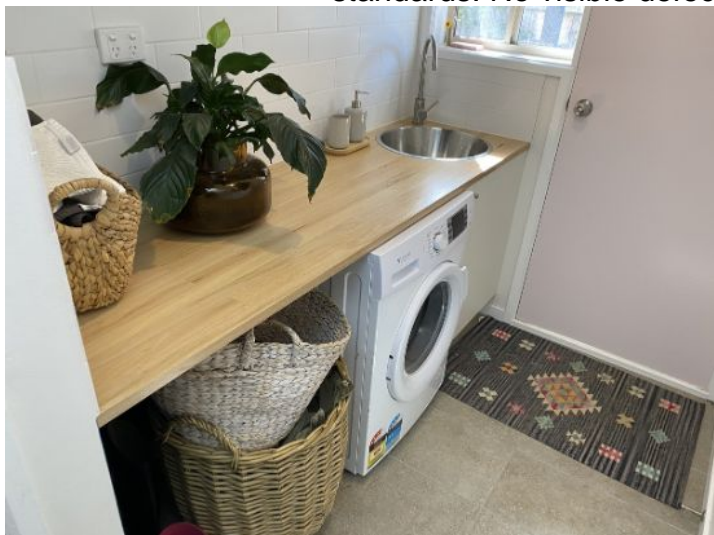
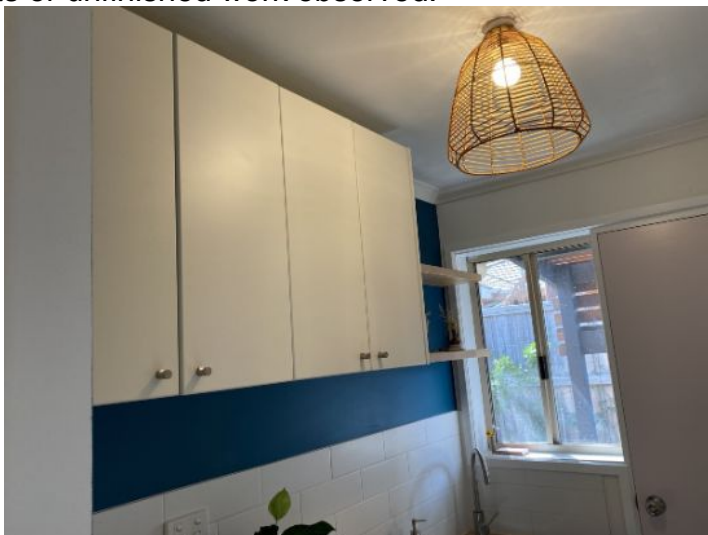
- The laundry installation appears to have been installed to satisfactory standards. No visible defects or unfinished work observed.

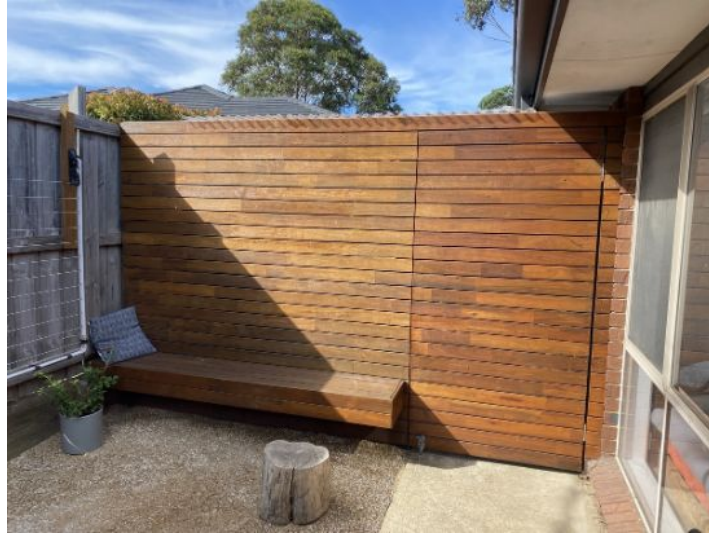
- The hardwood cladded fence appears to have been constructed to a satisfactory standard. No visible defects or unfinished work observed.

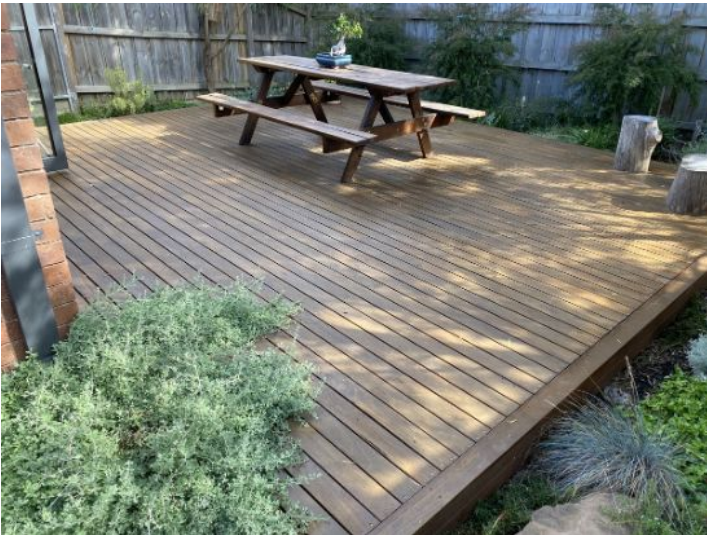
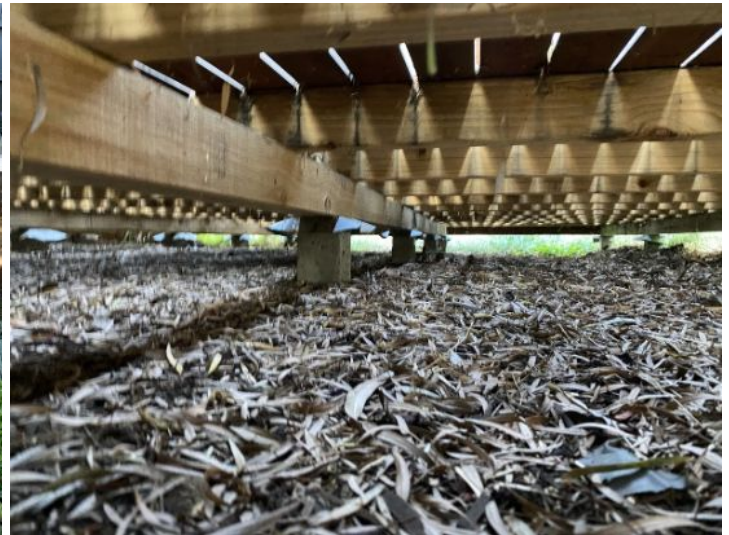
- The timber deck appears to have been constructed to a satisfactory standard. No visible defects or unfinished work observed.
