Property Inspection Report

Sample Report, WA

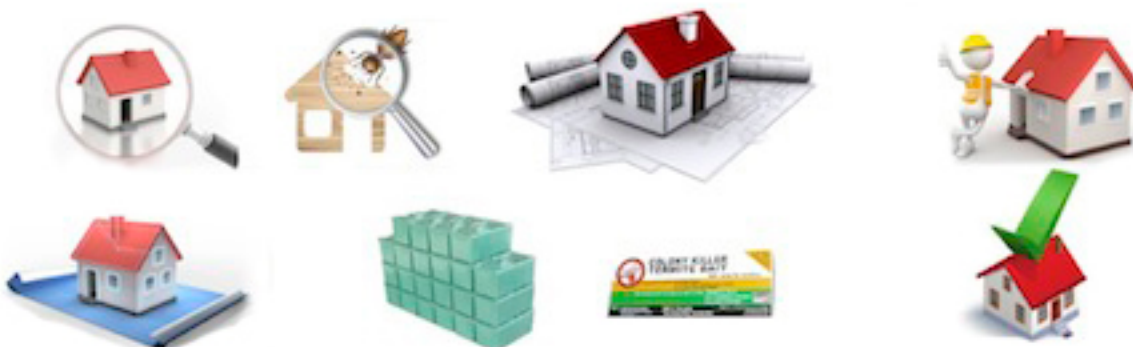
Termite Traps - DIY Termite Baiting System: This is a "do it yourself" termite control system - which is generally less than a third of the cost of others systems in the market place. This system will help prevent termites from attacking your home and also treat termite activity.

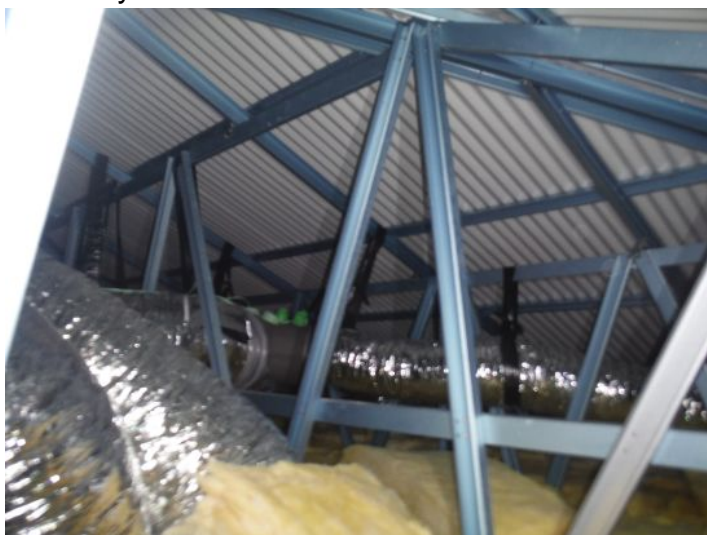
- Where visible, the air conditioning duct work appeared to be in a satisfactory condition.

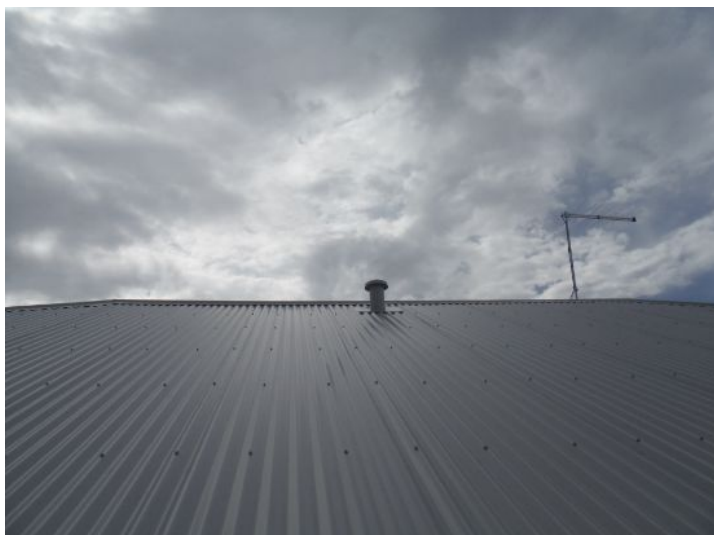
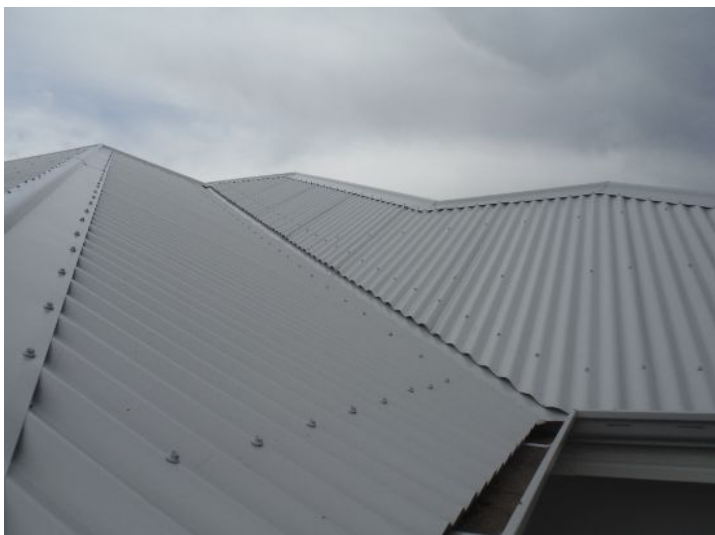
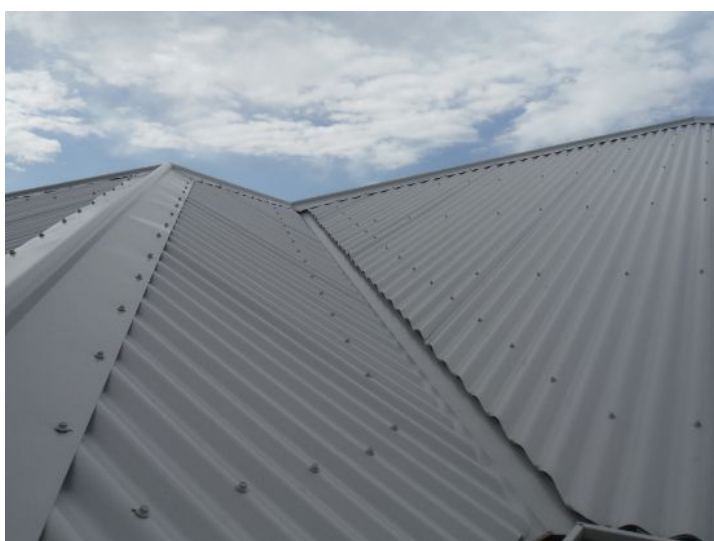
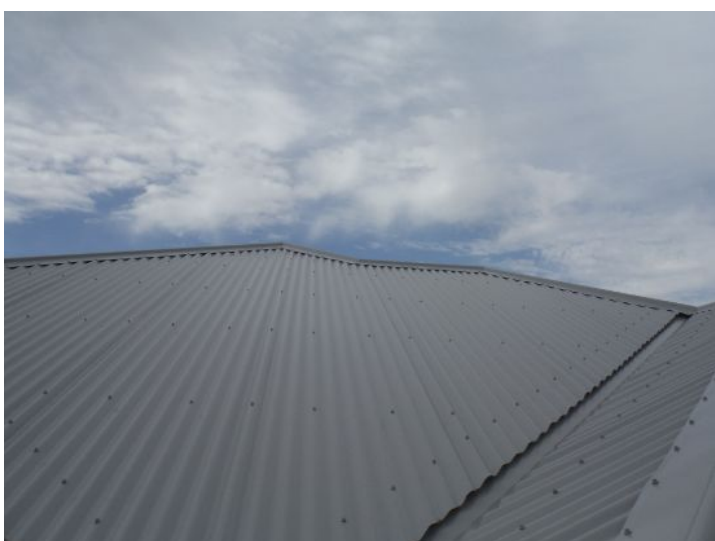
- The metal roofing material appears to be in satisfactory condition.

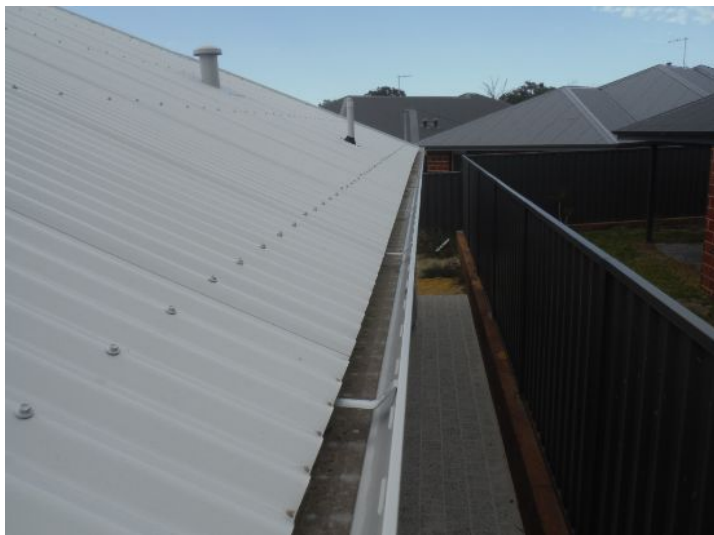
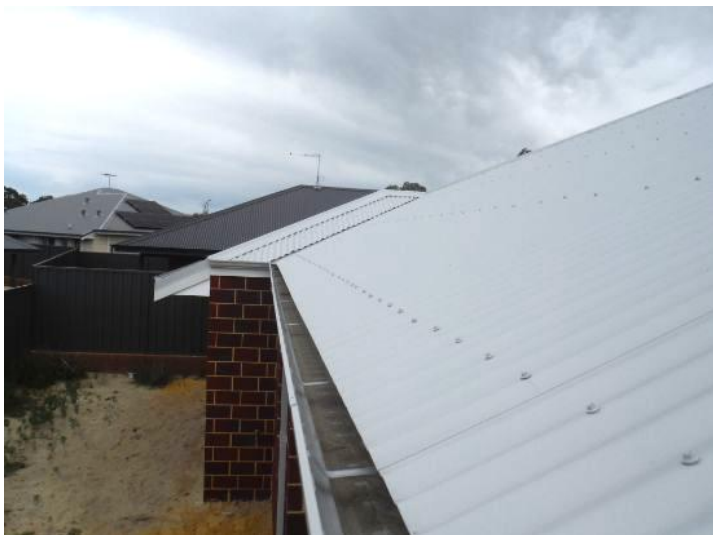
- No major function concerns noted at the time of inspection.
- The gutters should be regularly cleared of debris to ensure the proper flow of water from the roof.

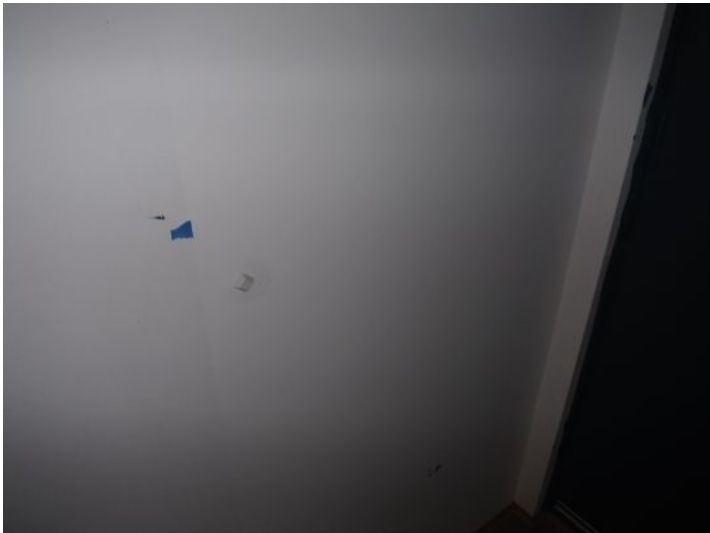
Paint marks at the front door wall to remove.

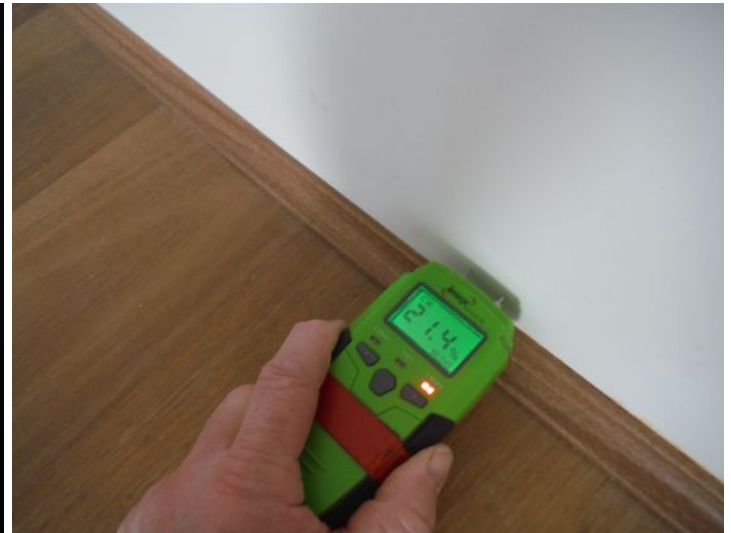
The lounge wall has moisture present at low level from the past ensuite sink leak. Monitor the flooring

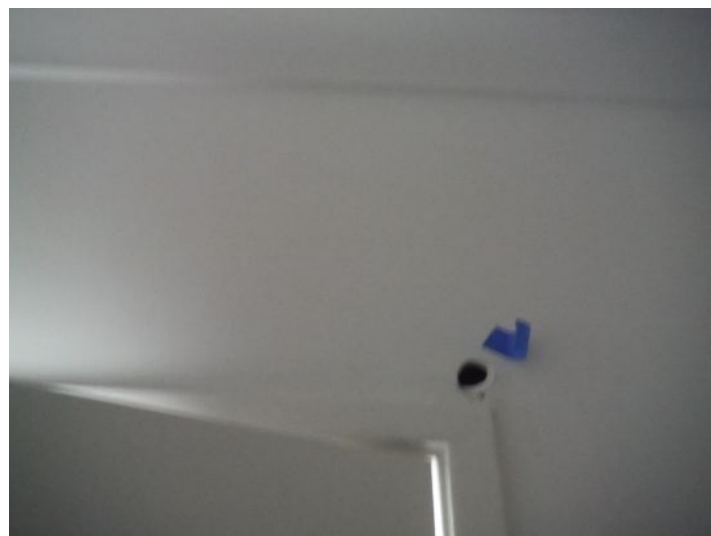
Noted hole in the master bedroom robe wall to be filled.

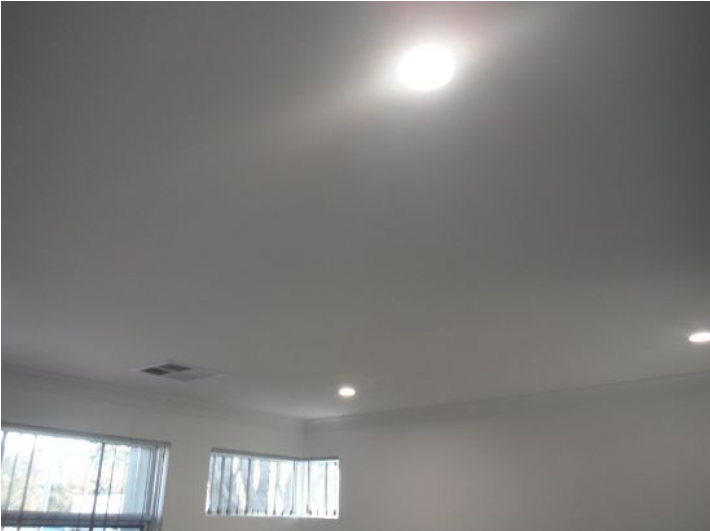
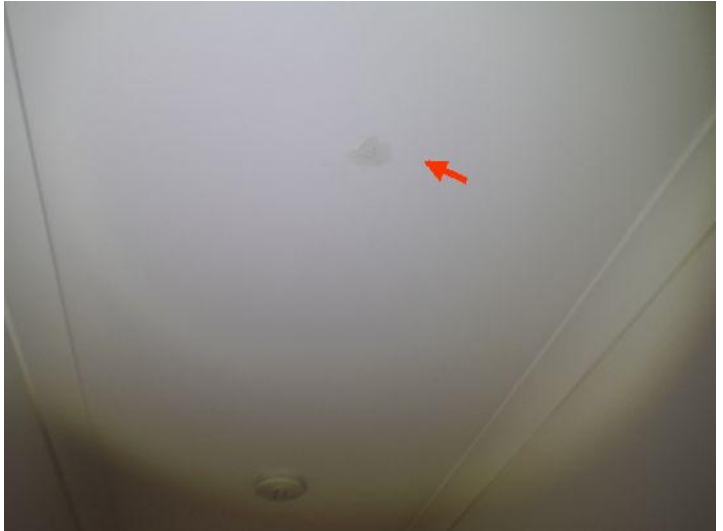
The entrance hall ceiling needs this patch sanded and painted.

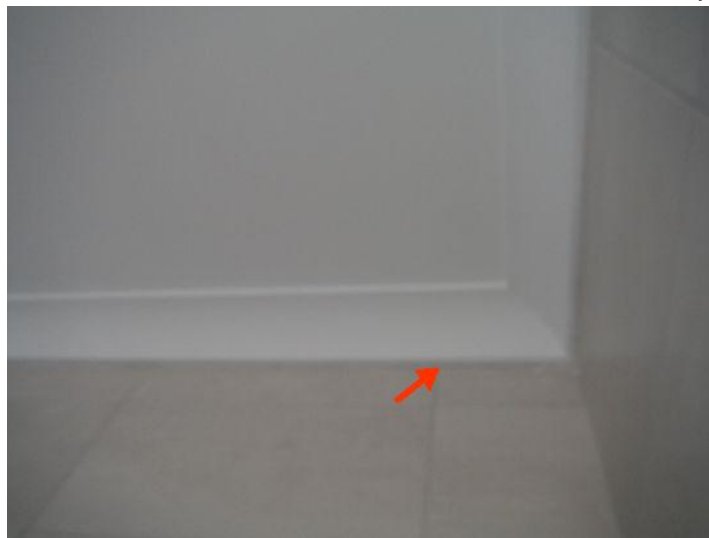
Some shrinkage cracking at the bathroom ceilings to gap fill.

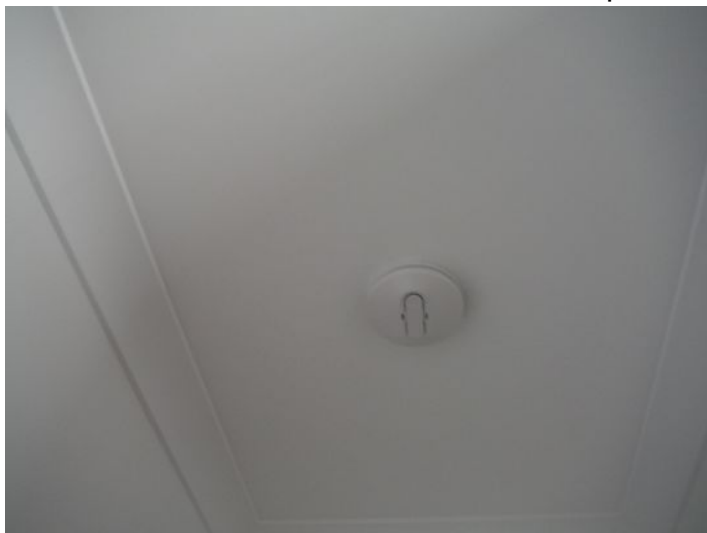
- Testing of smoke alarms is not included in this inspection. Pushing the "Test" button only verifies that there is power at the alarm--either a battery or hardwired to the house power--and not the operational workings of the alarm. The operational check is done by filling the sensor with smoke and is beyond the scope of this inspection. Battery operated smoke alarms should be checked routinely and the batteries changed frequently.
- There are hardwired smoke alarms installed in the bedroom hallway and the entrance areas. Smoke alarms due for replacement in 2033.

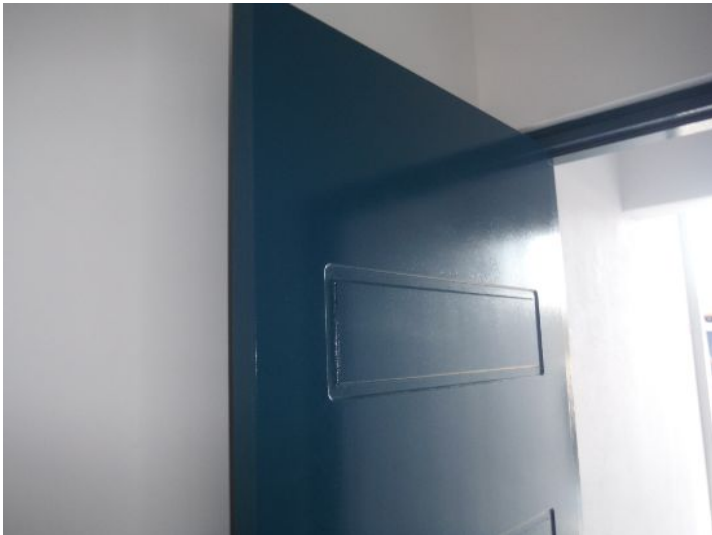
The front door paint has been requested to be touched up.

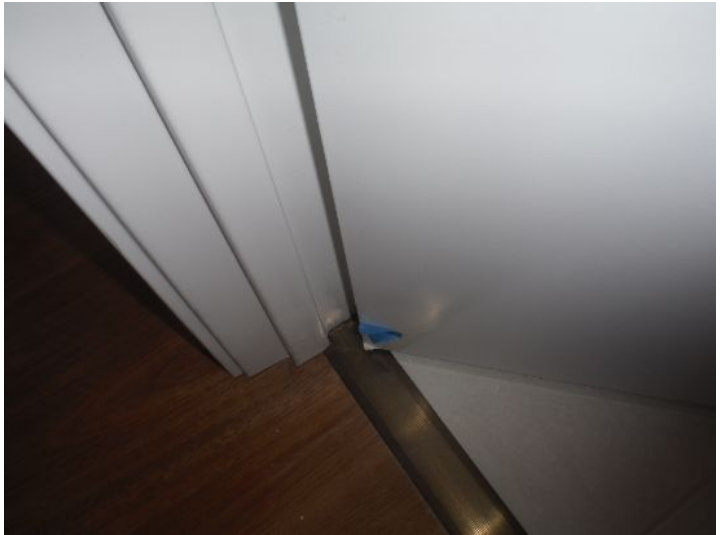
Noted the base of the laundry door needs trimming up.

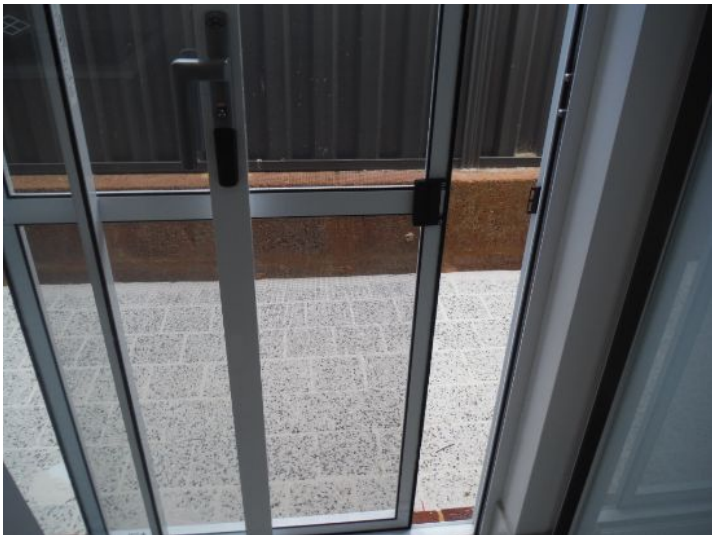
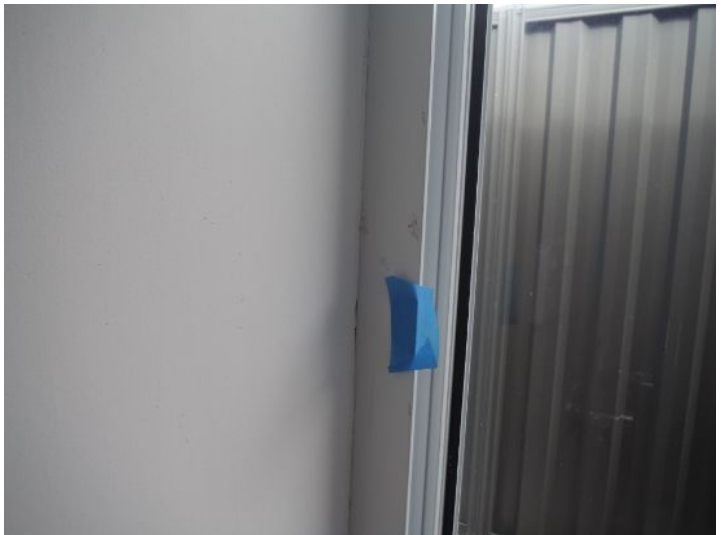
Some marks on the laundry door frame need cleaning off

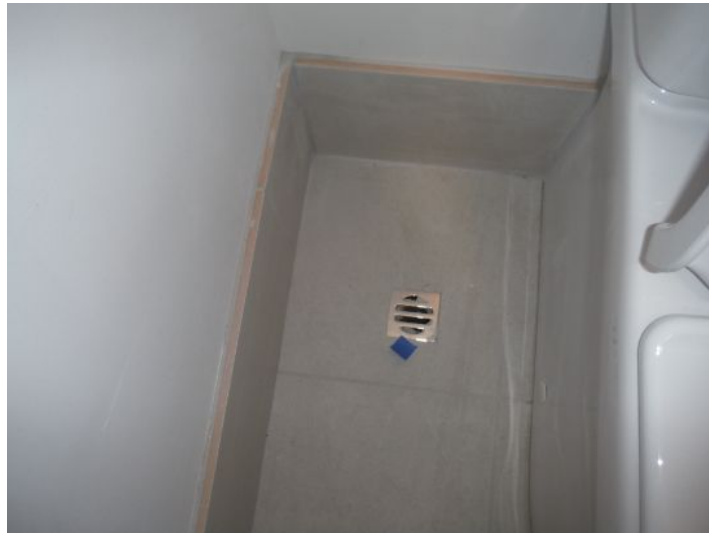
The dry floor wastes have grout present at the grills and inside the pipes that needs clearing.

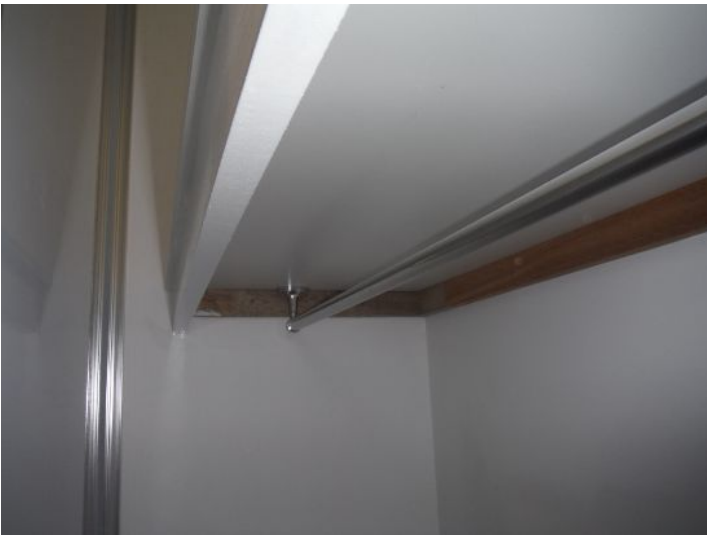
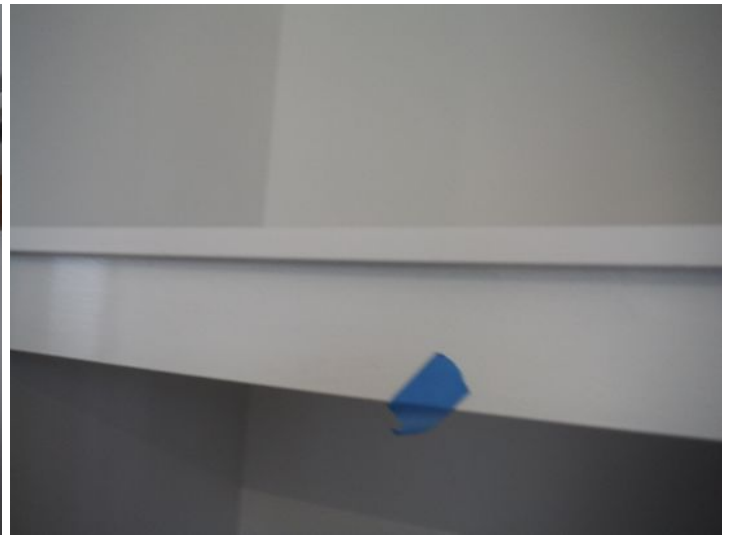
Some front rails need sanding and repainting.
Rough surfaces noted.

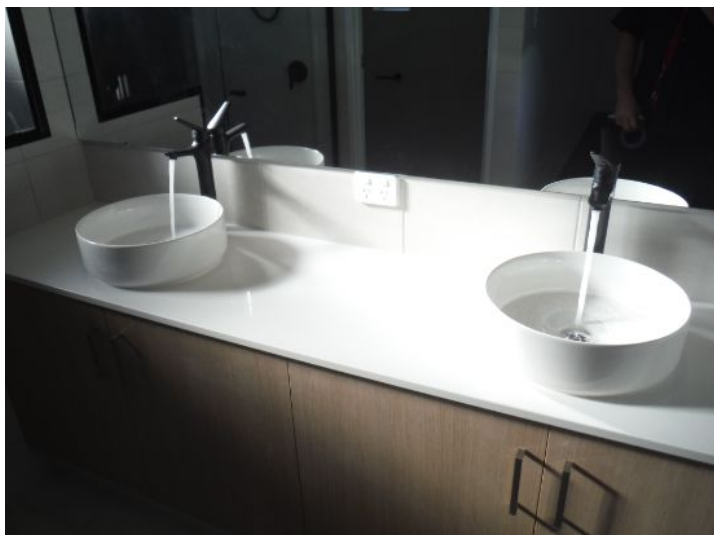
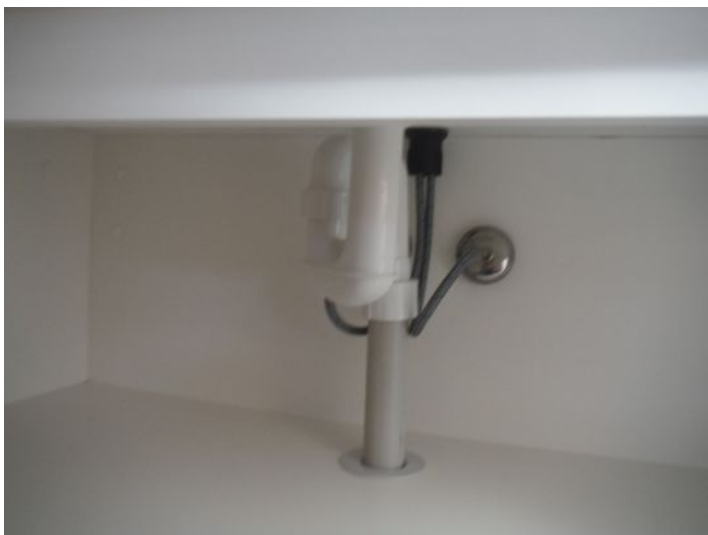
- The sinks and related components functioned normally when tested.
- Silicone needs repair at the main bathroom sink.
- Hole noted at the plumbing shroud in the main bathroom.

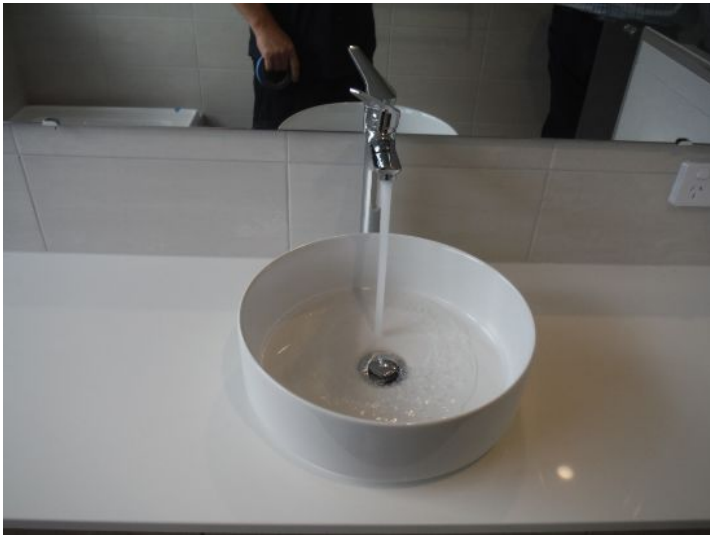
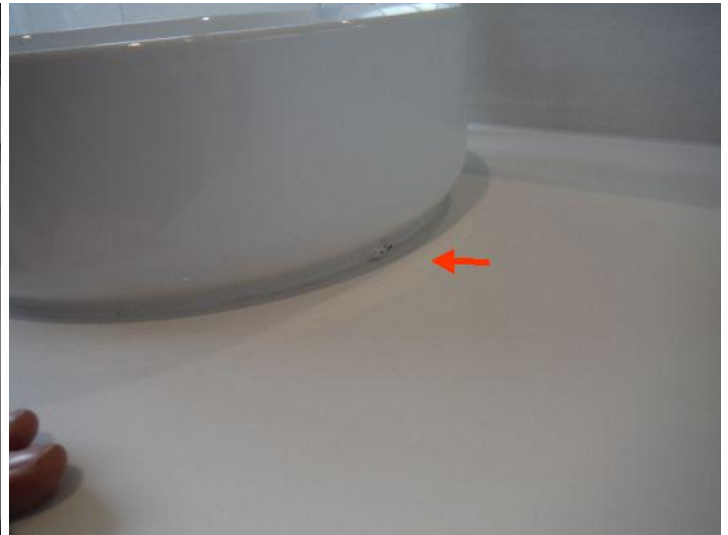
The silicone at the main bathroom sink needs repair.

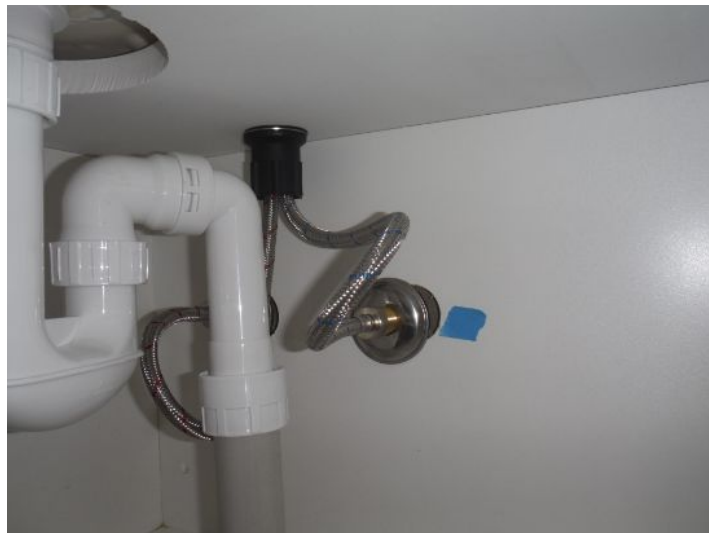
Noted hole at the main bathroom sink back. This needs covering.

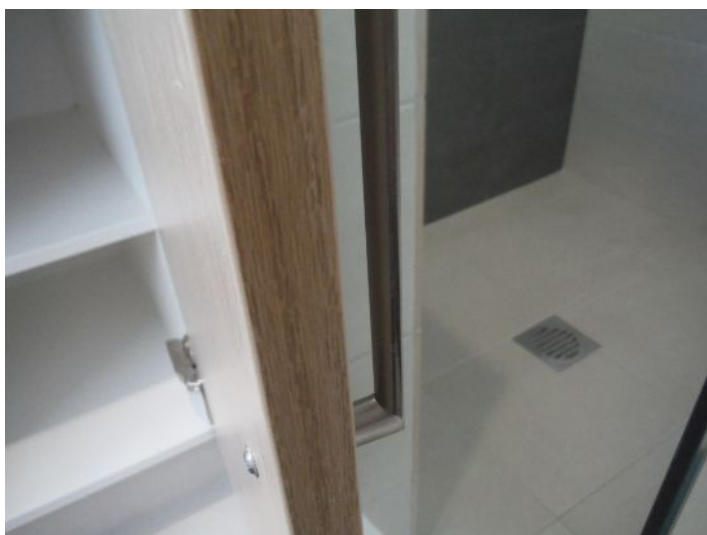
Recommend installing a rubber stopper to prevent the door handle hitting the shower glass.

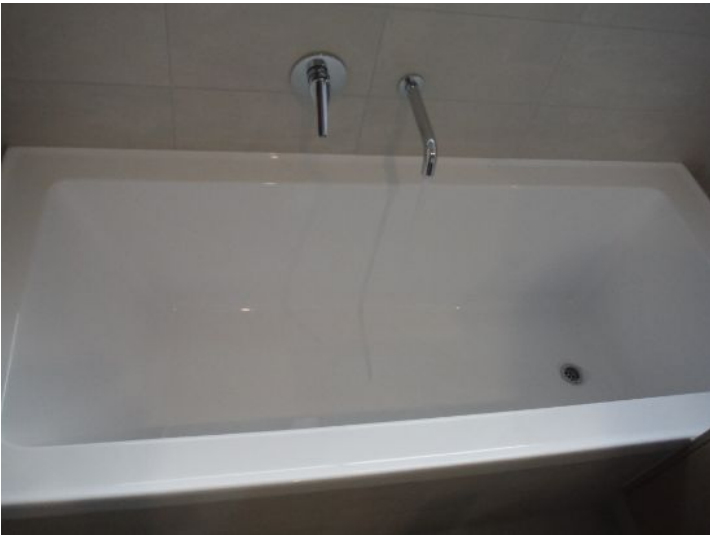
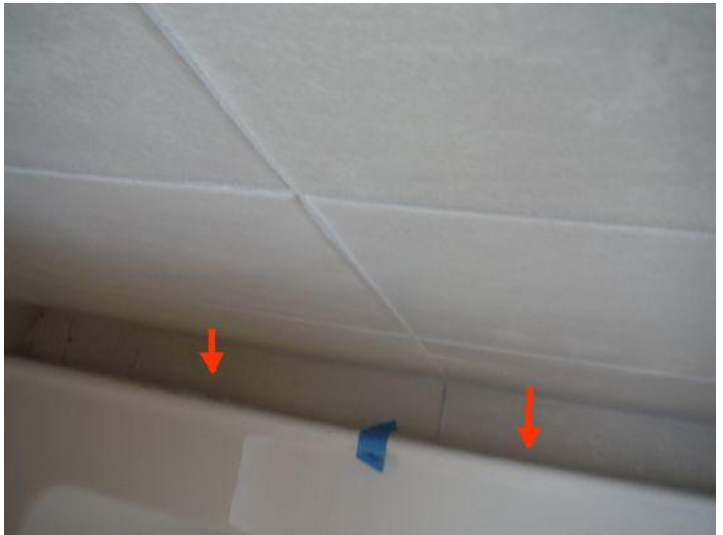
The end of the bath need the grout and sealer cleaned off

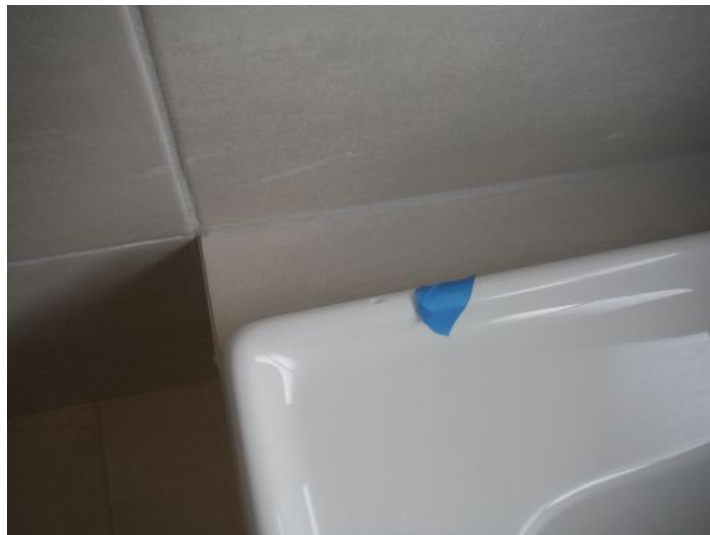
Small chip on the bath needs repair.

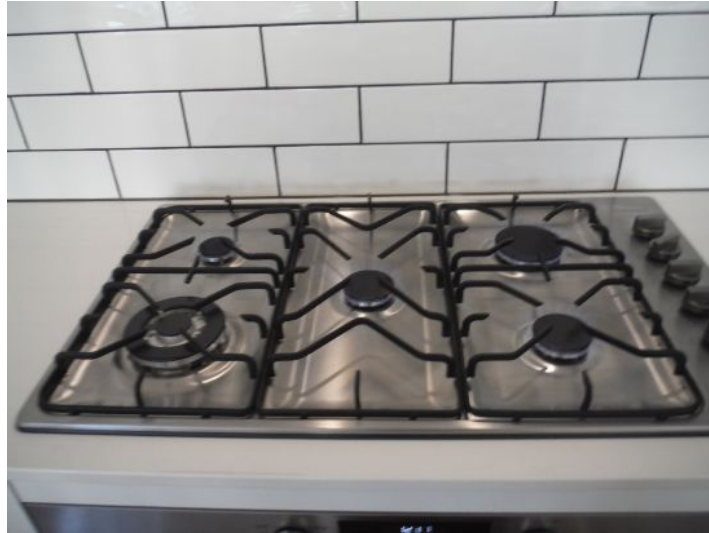
- Gas cook top noted and operated normally when tested.

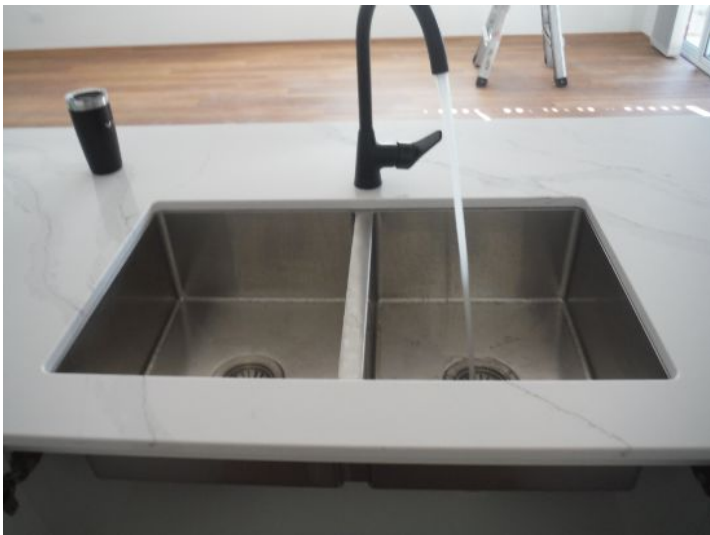
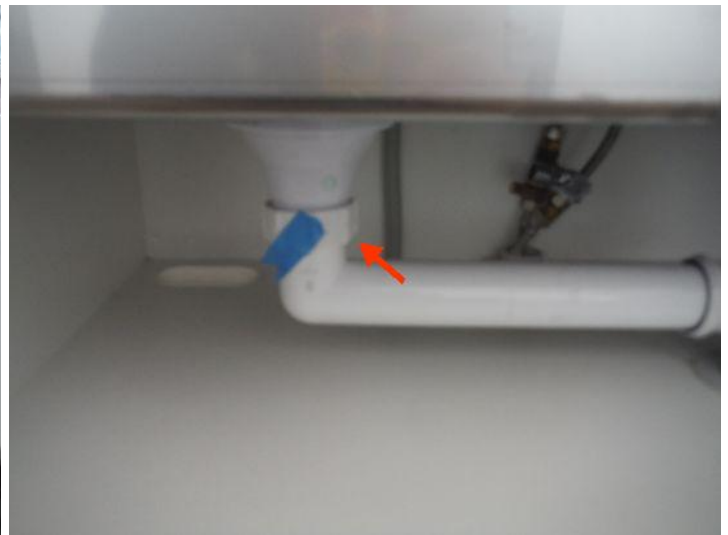
This waste is leaking and needs adjustment by the plumber.

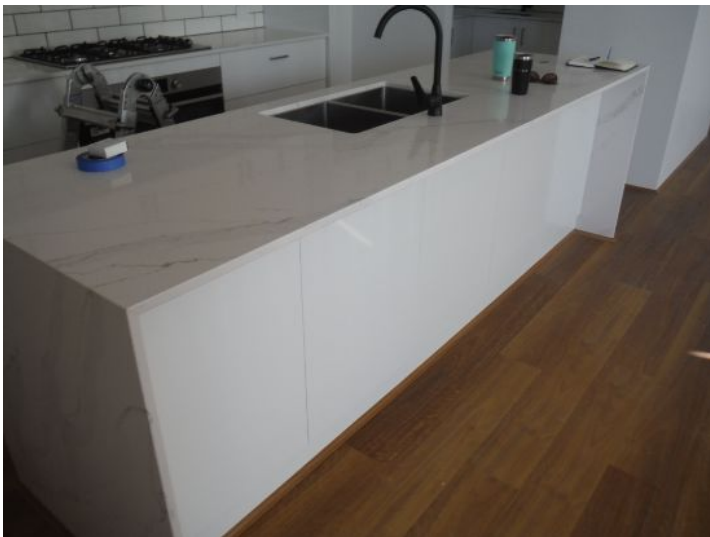
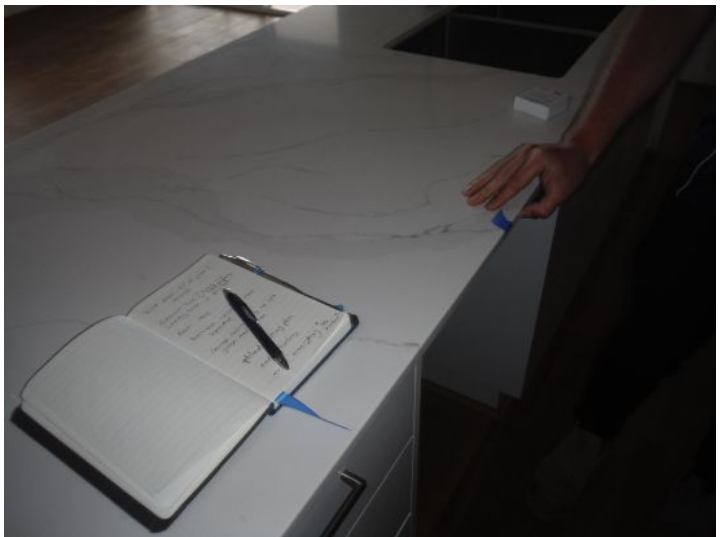
Some silicone to clean off the work top and edges.

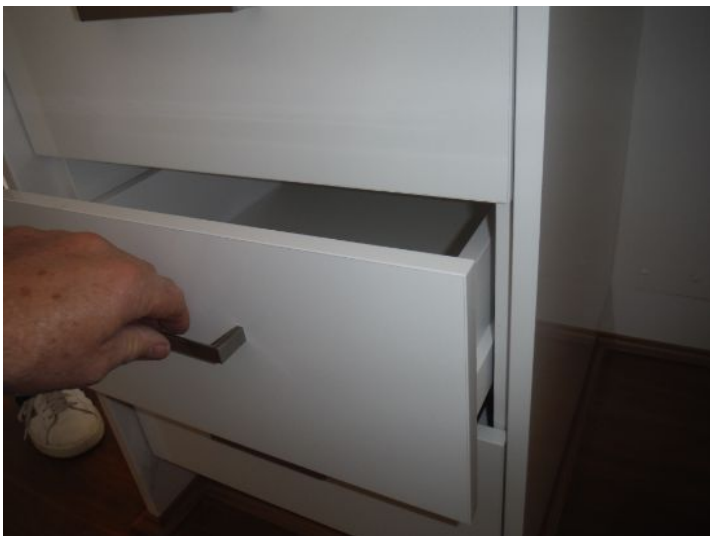
One draw needs adjustment to close.

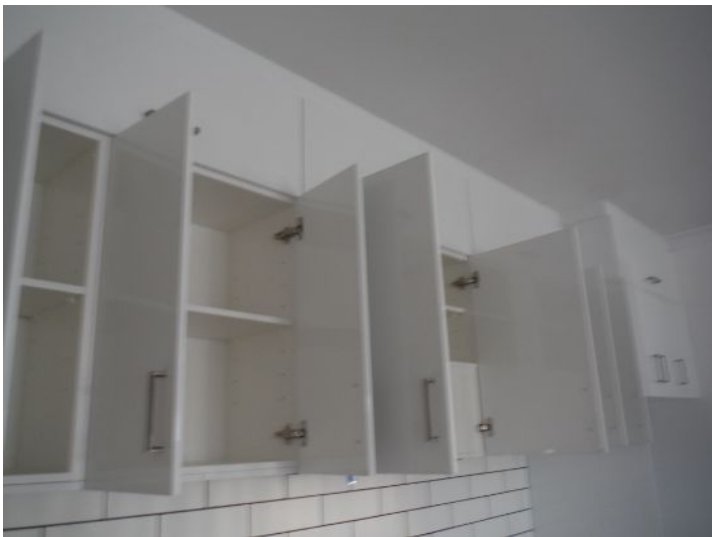
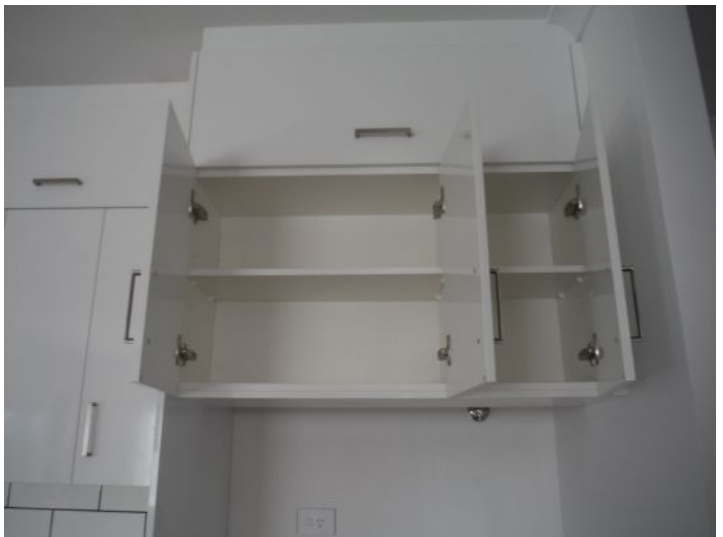
The pantry door timber has no edge trim fitted.

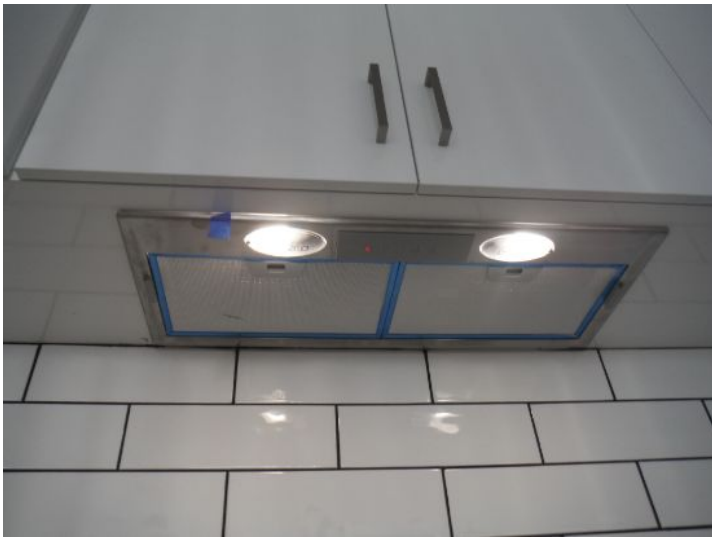
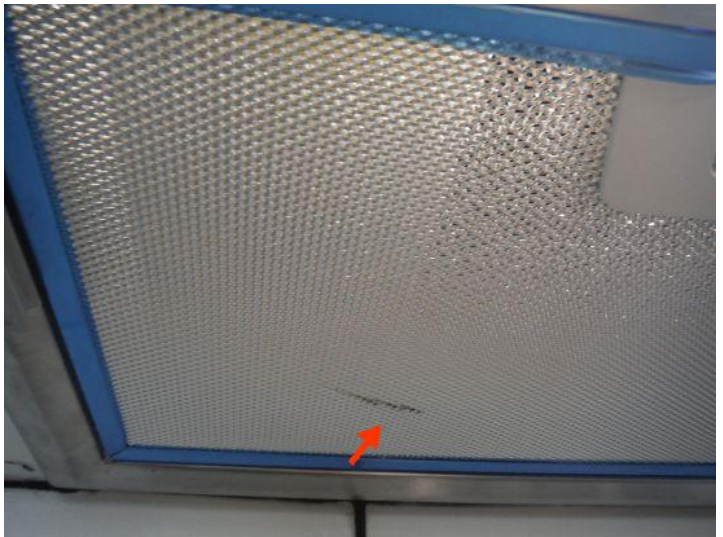
Mark / scratch on the vent mesh grill.

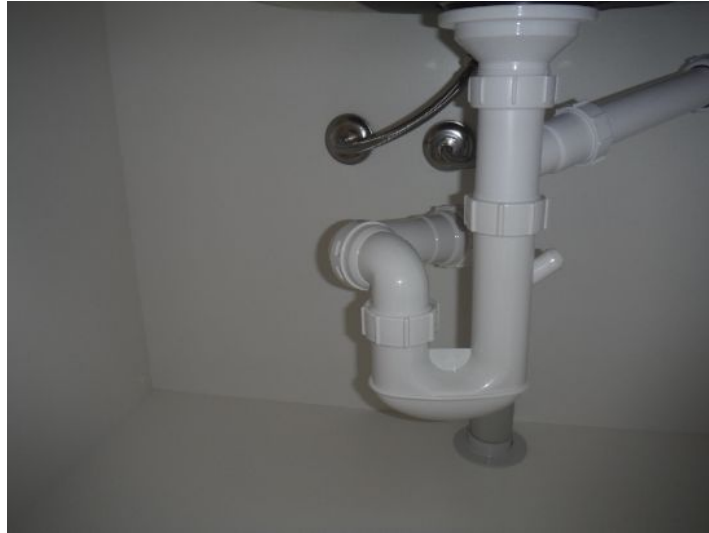
- Appeared functional and in satisfactory condition, at the time of inspection.

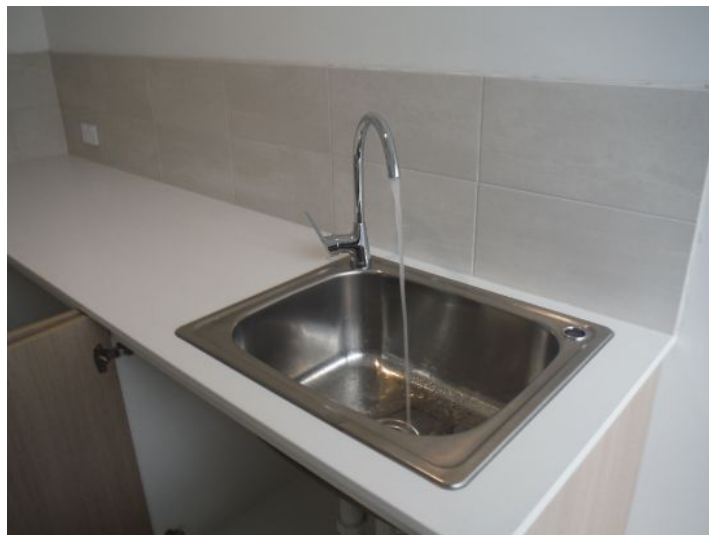
- The sink and related components are functional unless otherwise noted.

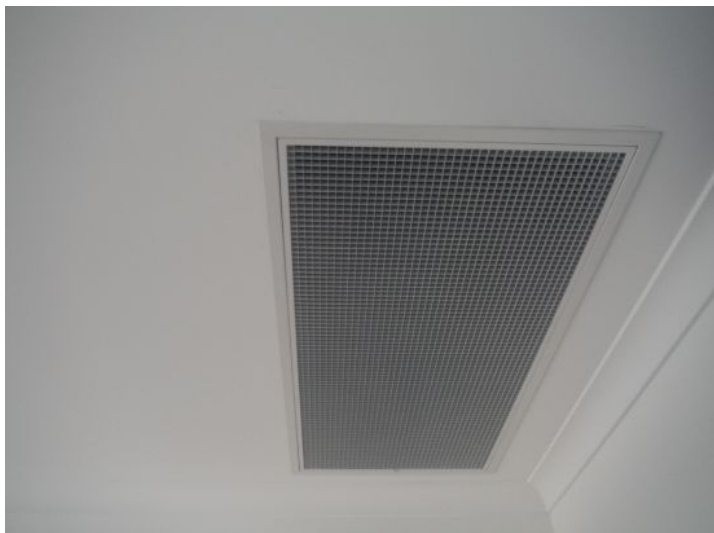
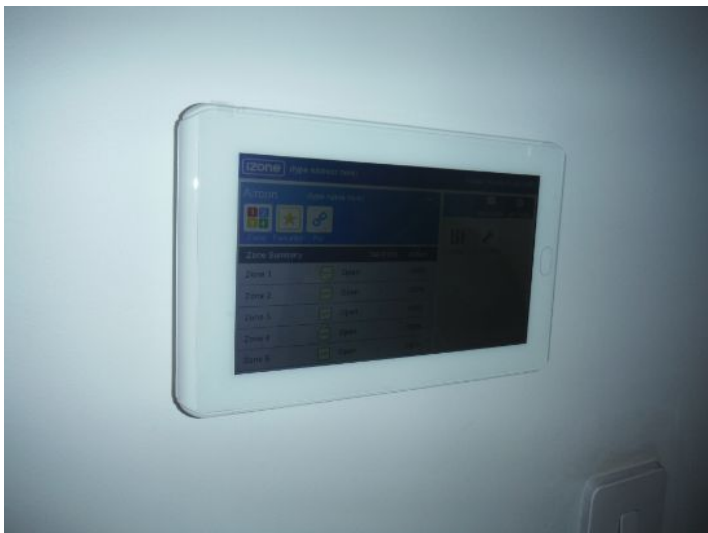
The zoning controller will soon be replaced.

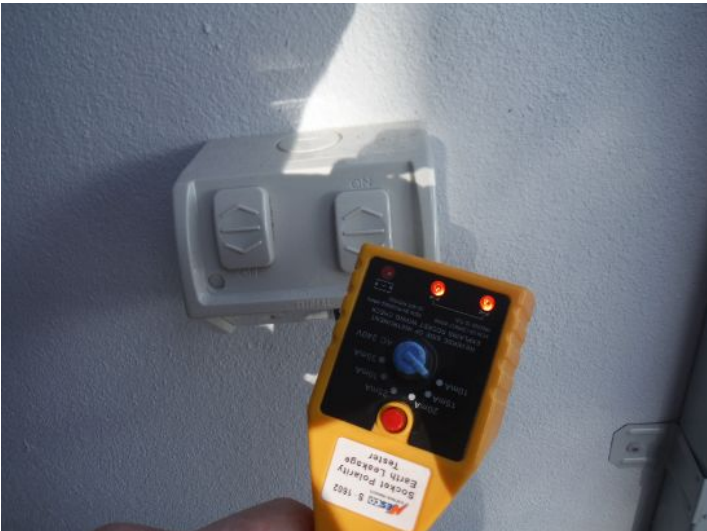
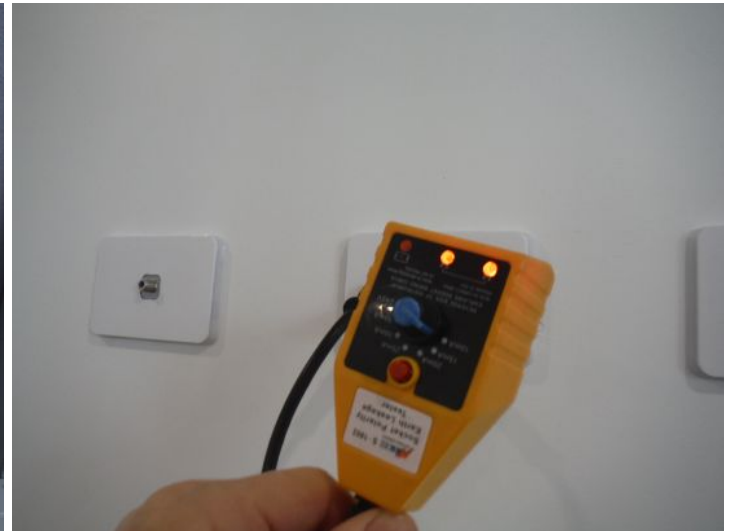
- All tested interior and exterior power points were functional unless otherwise noted.

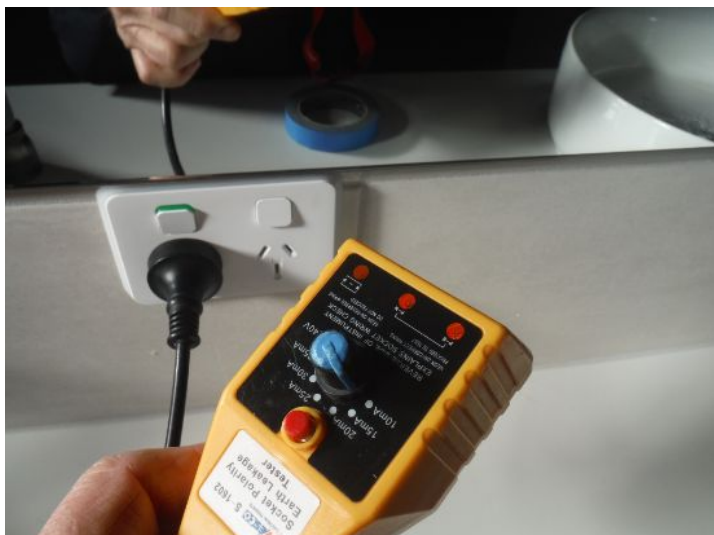
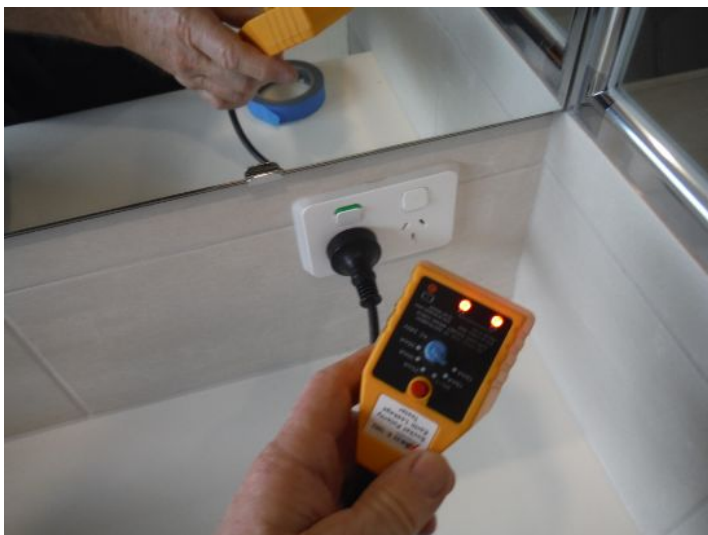
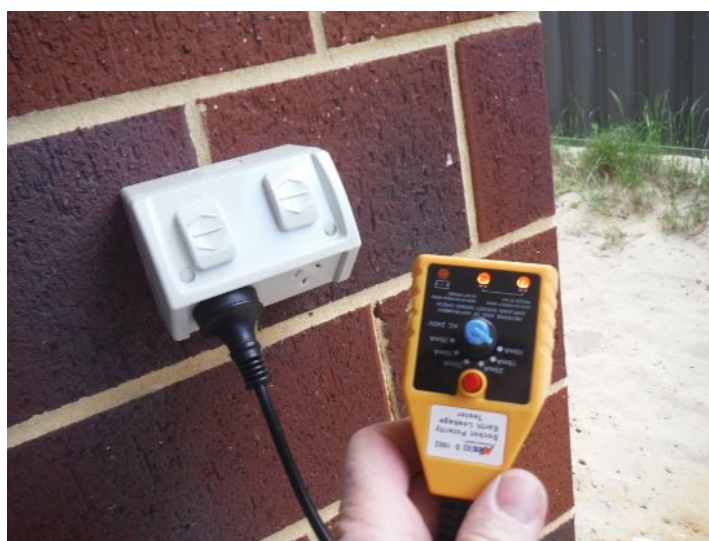
3. Lights and Switches

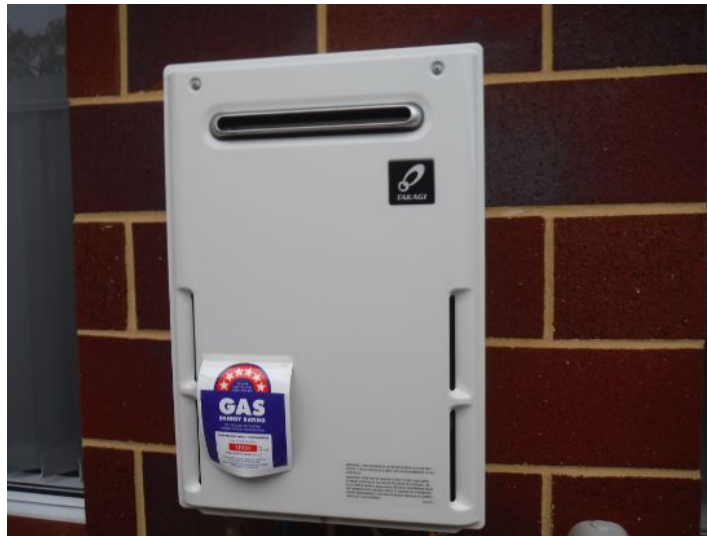
- Please note that we only inspect & comment on the operational and safety issues of the hot water system. Issues relating to compliance to relevant codes and standards, and/or installation compliance is excluded from the scope of the inspection.
- No major system safety or function concerns noted at time of inspection.

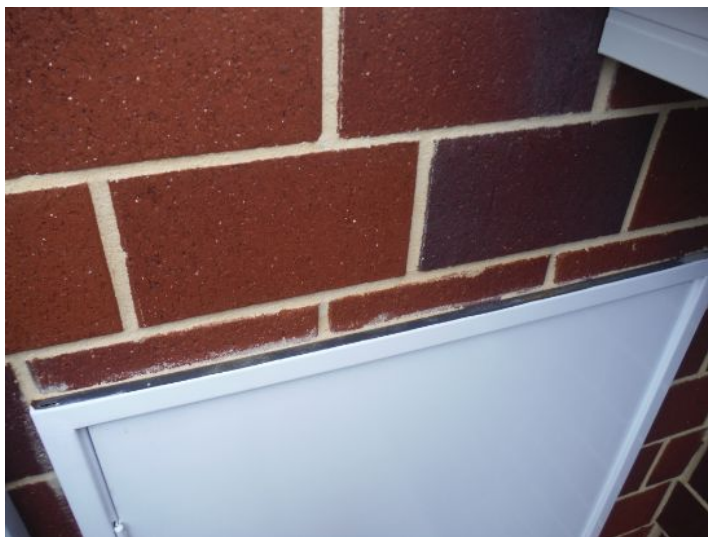
The garage access door head needs painting.

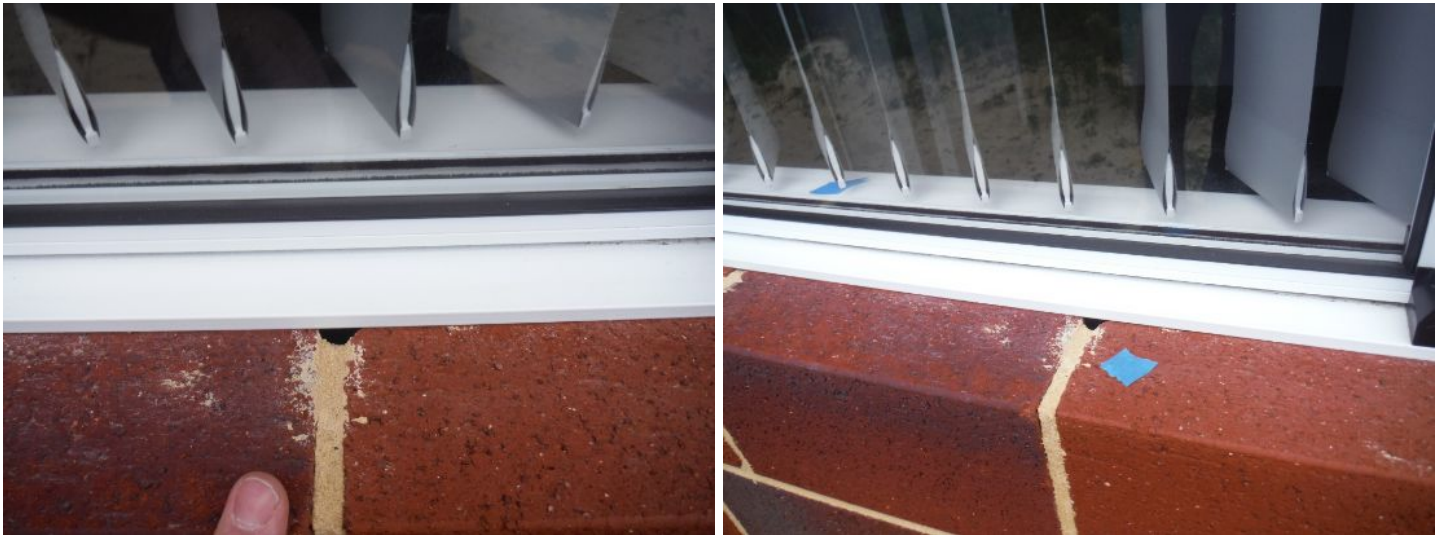
Some mortar on the window sills needs touching up.

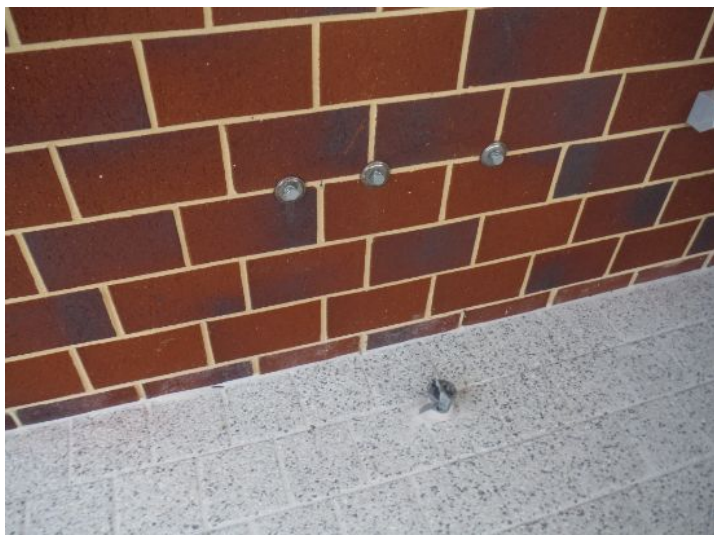
The shrouds are corroding at the patio sink position.

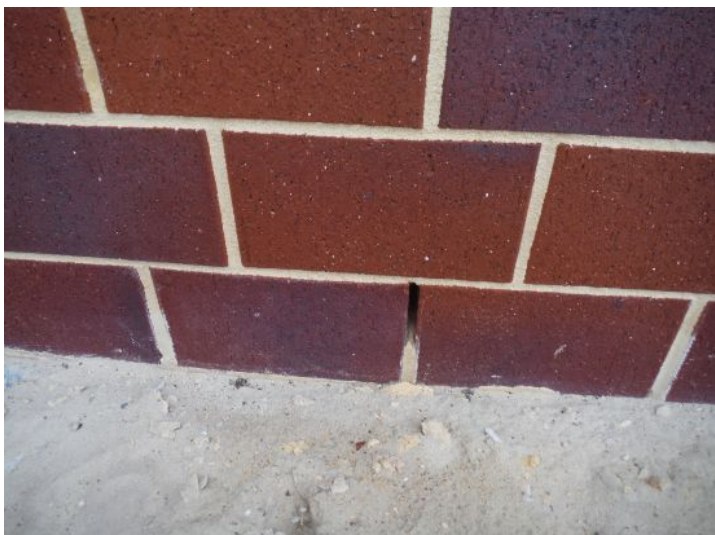
Some weep hole vents need adjustment or installing.

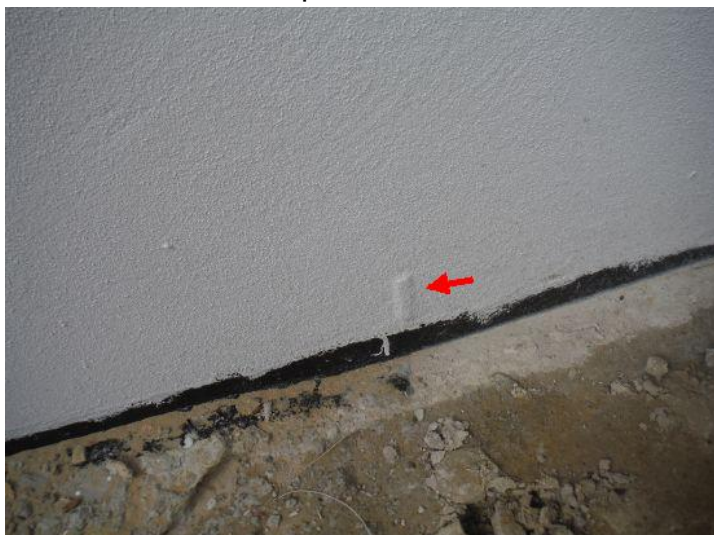
Noted the weep holes need uncovering at the front render.

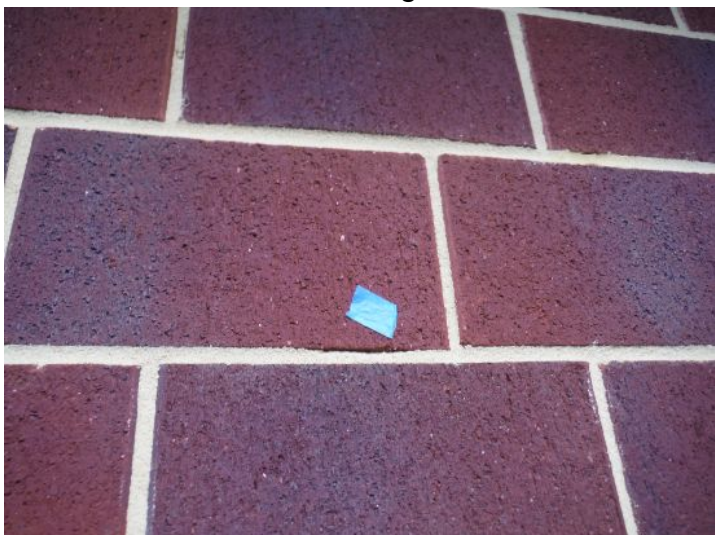
Mortar needs touching up on the East wall.
