Property Inspection Report

Sample Report, WA

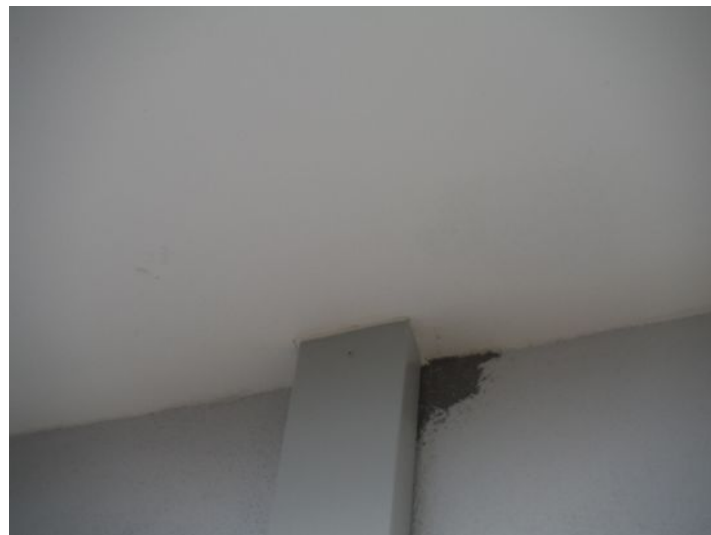
Noted the paint needs touching up at the front East side downpie

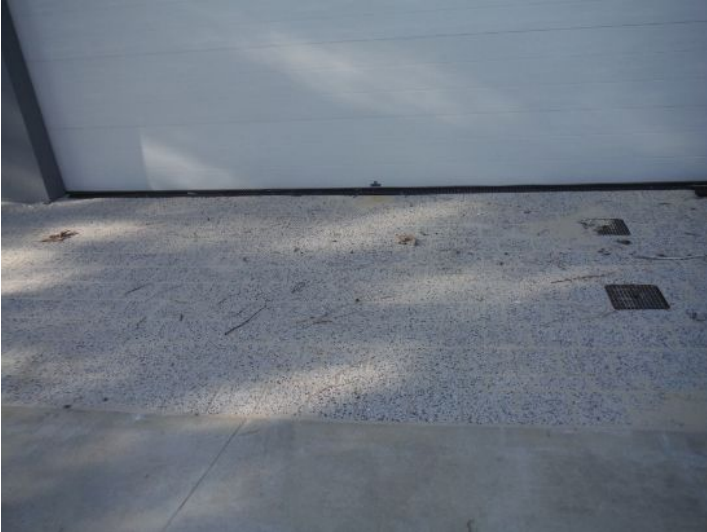
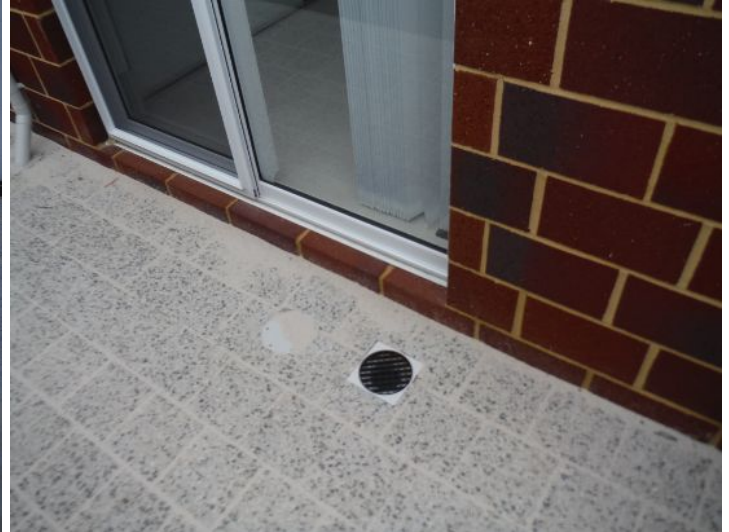
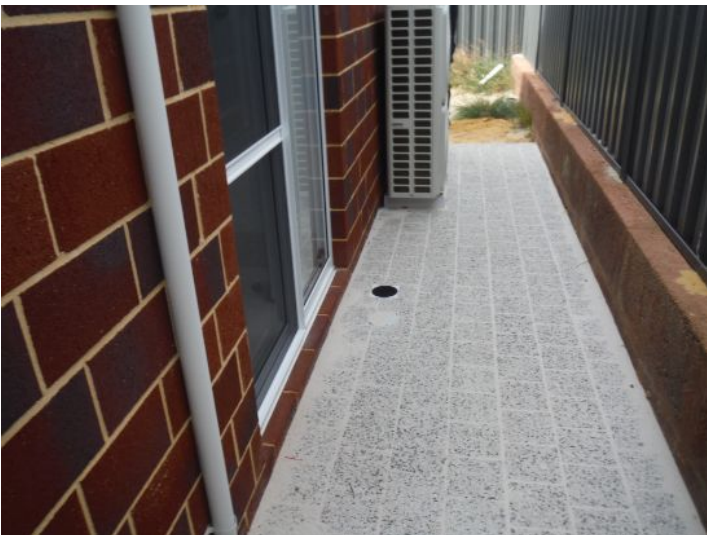
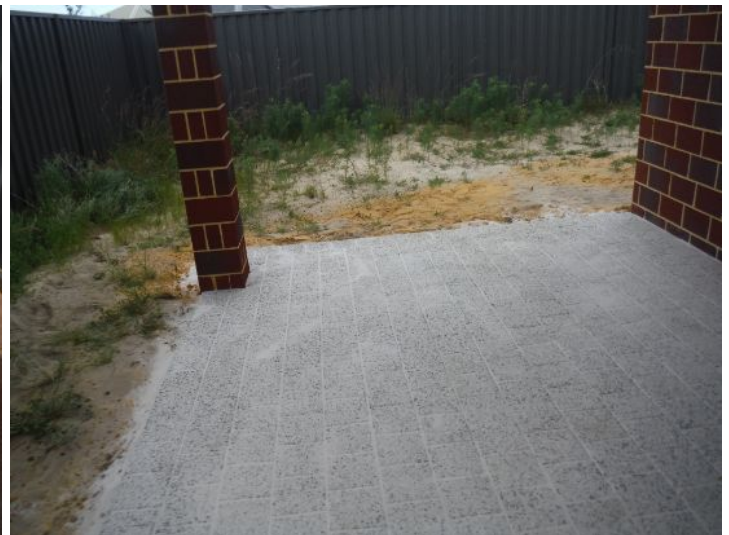
2. Grading and Drainage

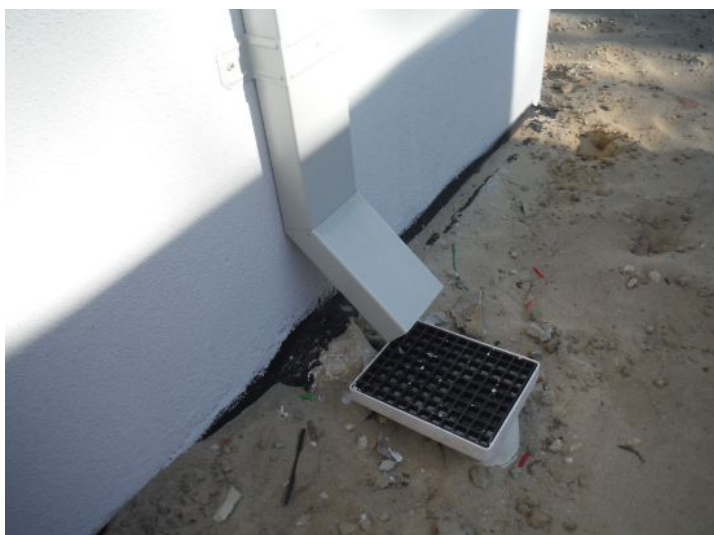
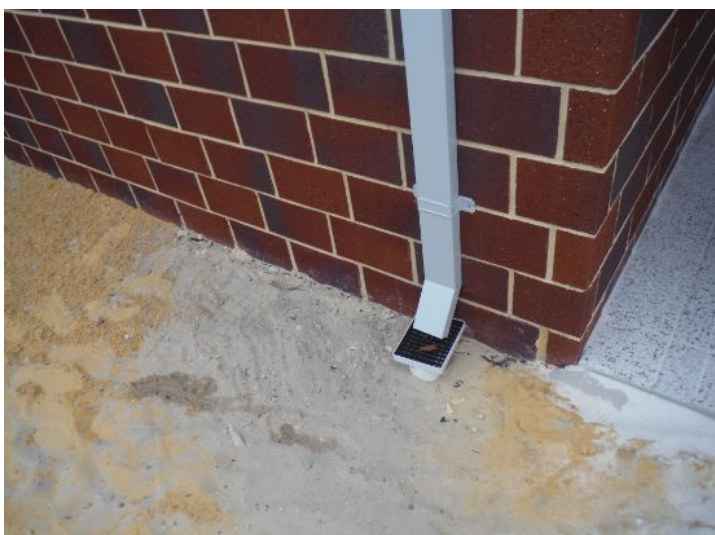
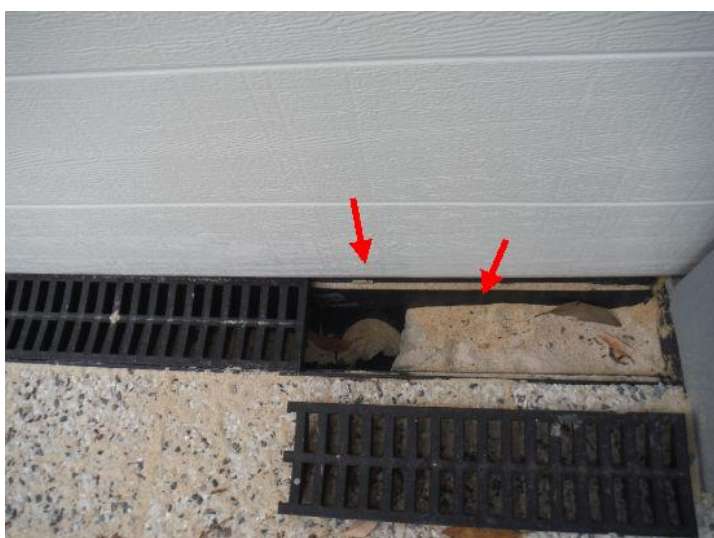
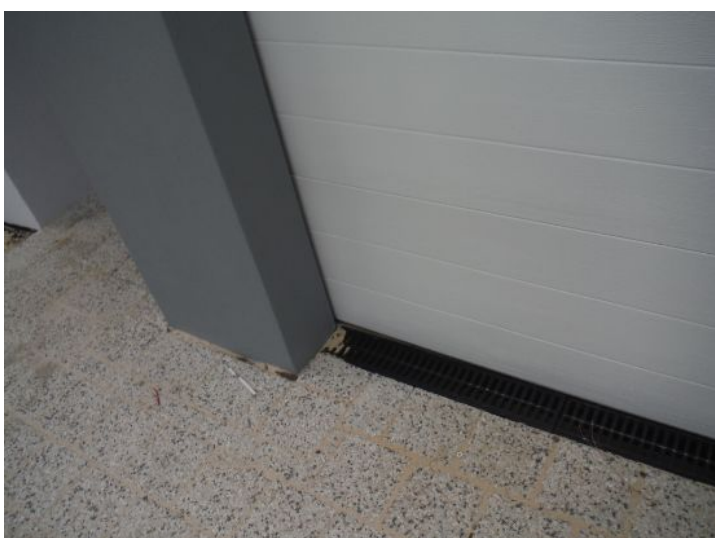
The front garage drain needs clearing of mortar and sand and testing that the water is draining correctly to this outlet.

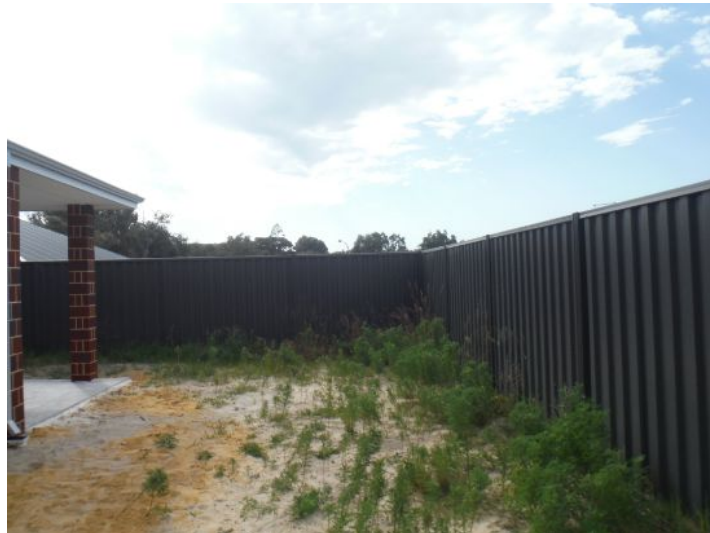
Mortar splashes needs cleaning off the fence / wall.

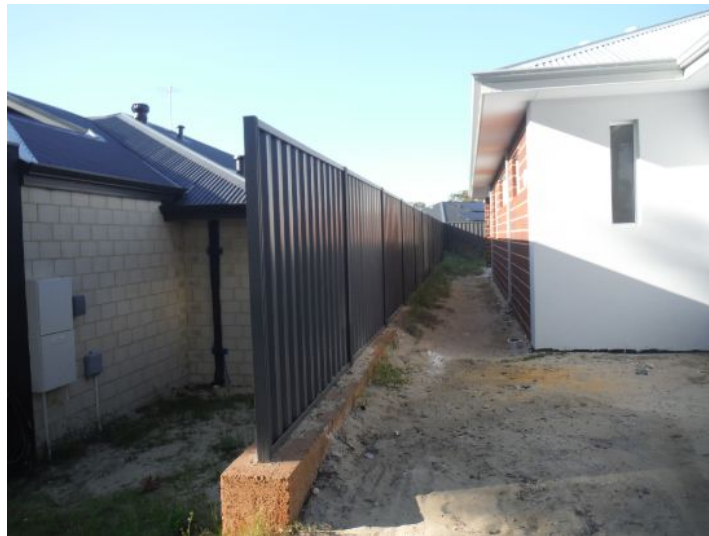
No side gate present.

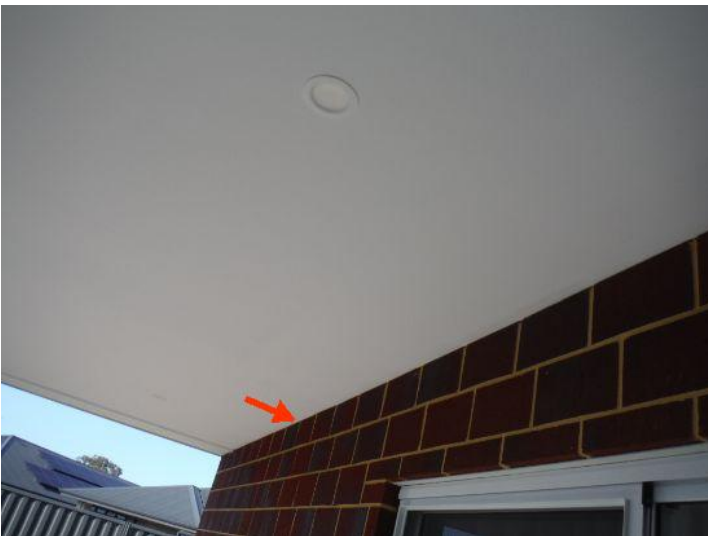
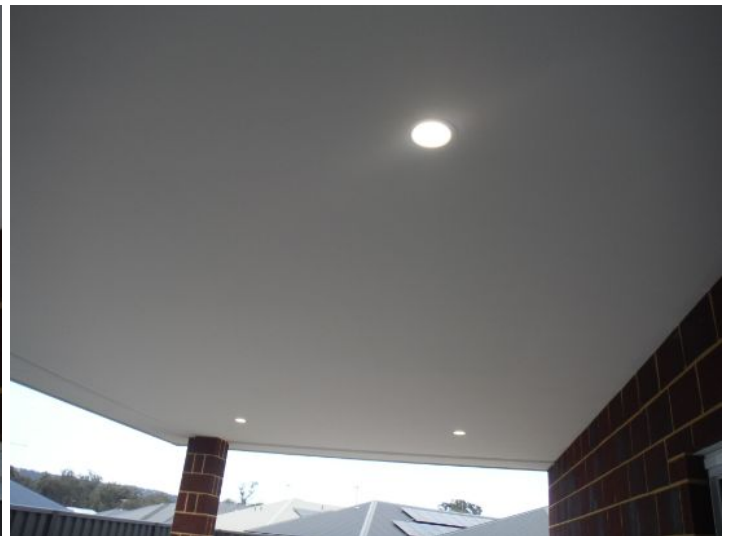
The patio ceiling needs a flat edge trim installed to finish this area.

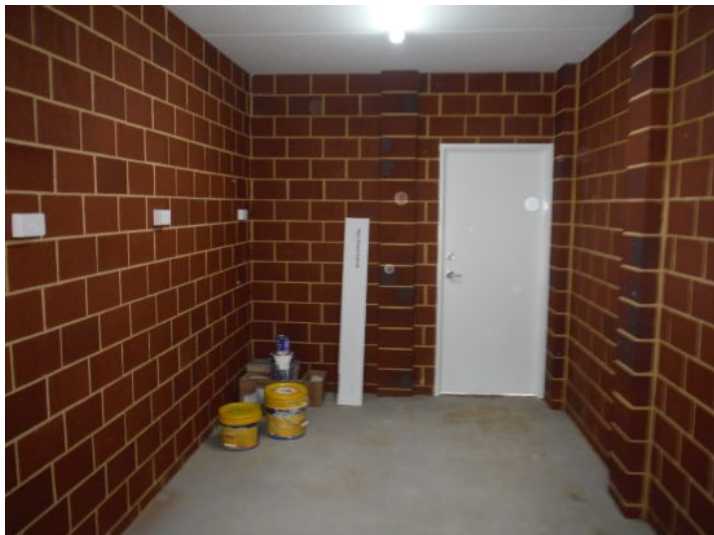
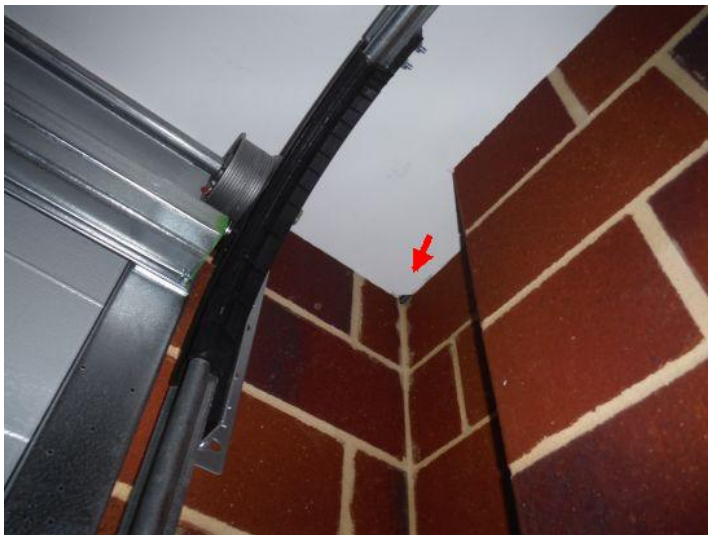
Small hole to fill at the front of the garage ceiling.

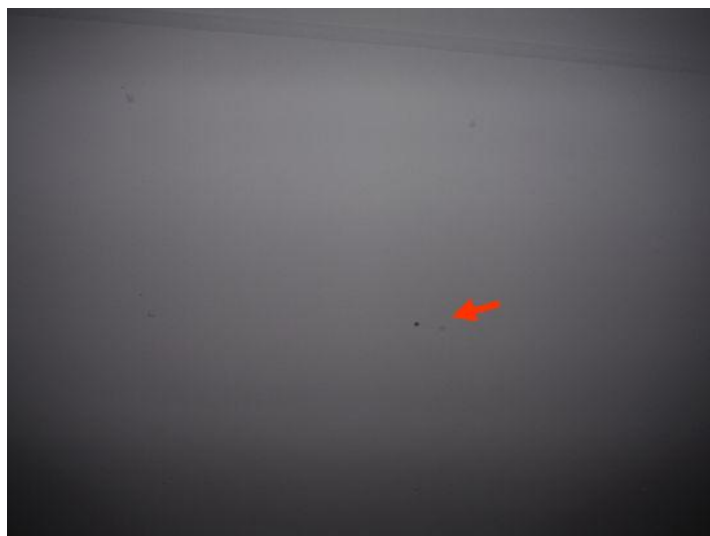
Screw hole to fill in the garage ceiling.

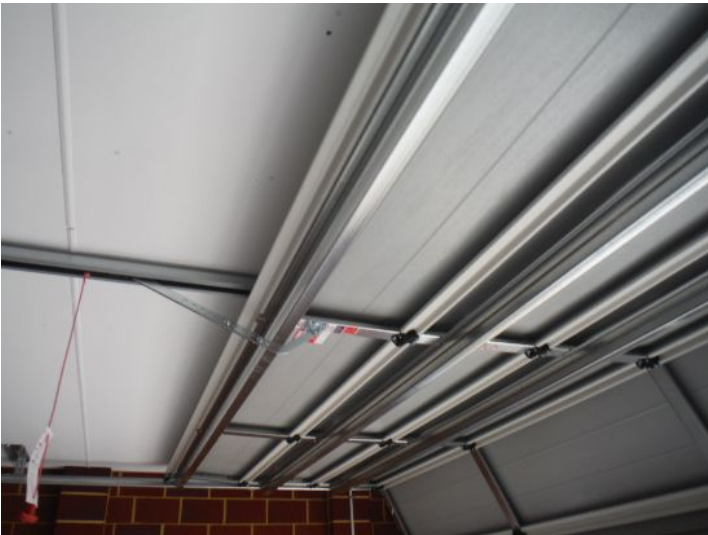
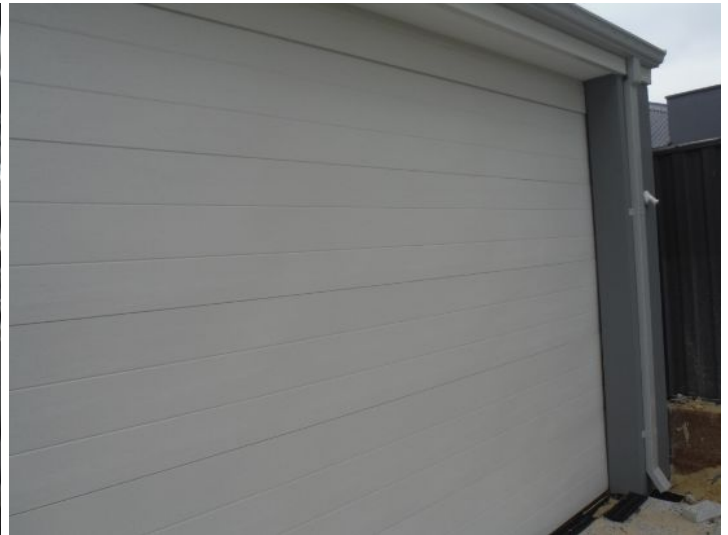
3. Garage Opener Status
