Property Inspection Report

4 Test Avenue, Testville, 9999

Inspection prepared for: Client Name
Date of Inspection: 18/2/2016 Time: 10:00AM
Weather: 26C, Sunny

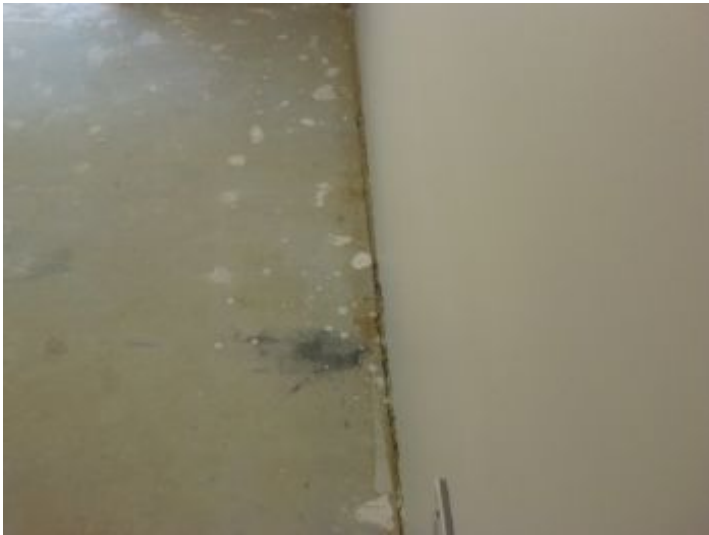
- Visible sections of the concrete slab appeared satisfactory.
- Most areas of the concrete slab not visible due to floor coverings.
- All concrete floor slabs experience some degree of cracking due to shrinkage in the drying process. The noted cracks in this home appear to fall within acceptable tolerance and do not appear to have affected the structural integrity of the home. No action required.
- Significant gap noted between the slab edge and the window in the Entertainment Room. Non-shrink grouting required.
- The gap between the slab edge and the wall in the Activity Room appears to have been filled with sand and cement which is breaking up. Non-shrink grouting required.

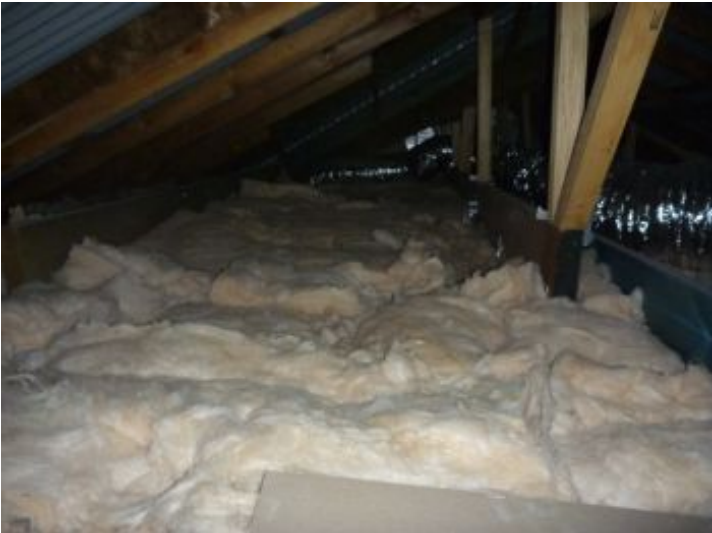
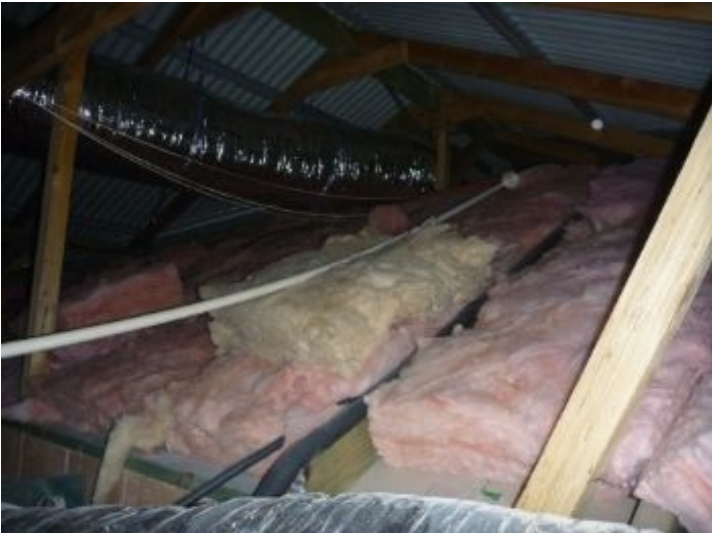
- Insulation averages about 150mm in depth.
- Insulation appears adequate.
- Insulation is in contact with down lights. See comment under electrical / internal roof wiring.

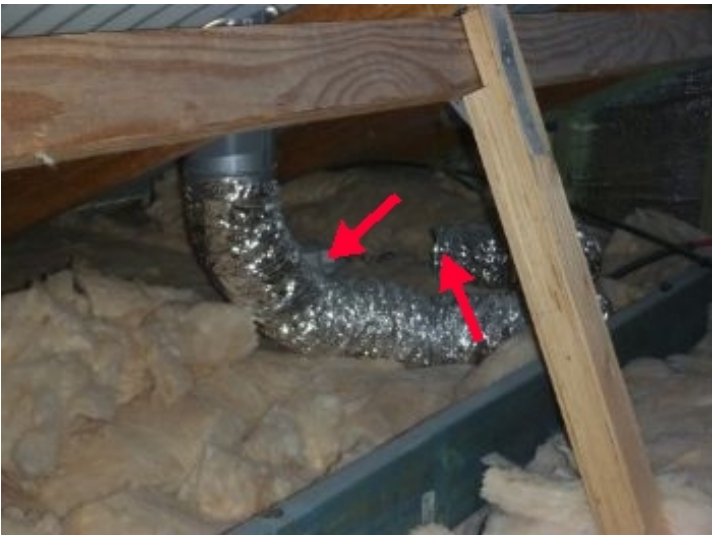
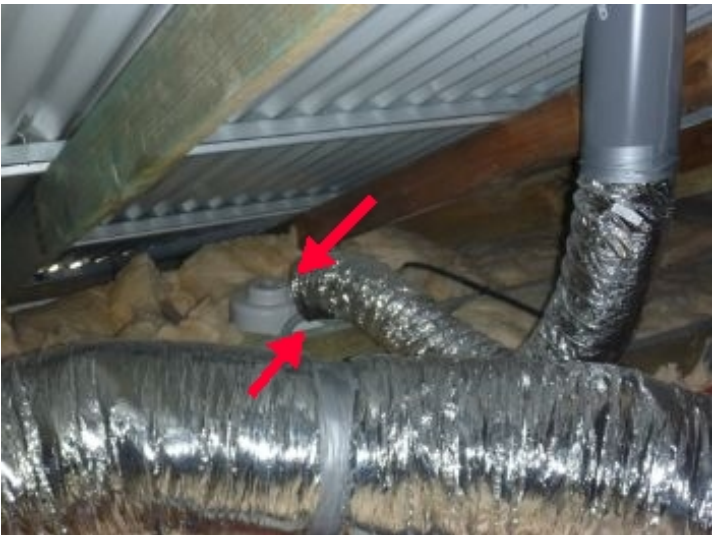
- Toilet exhaust fans have not been connected to the flue duct within the roof space.

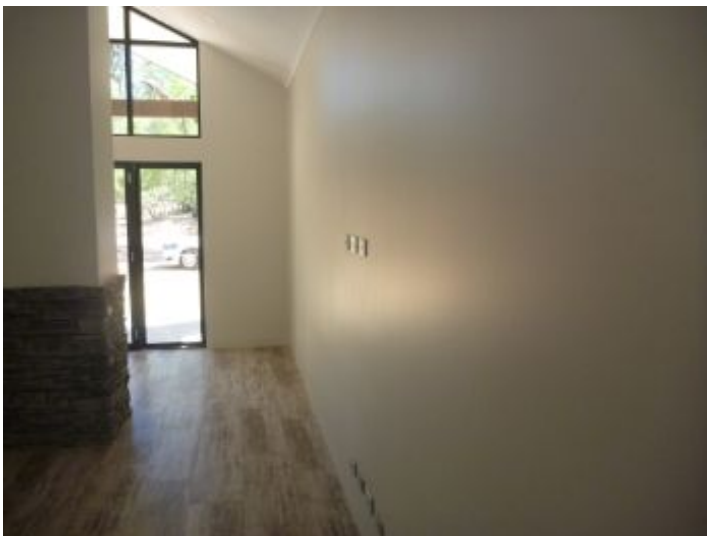
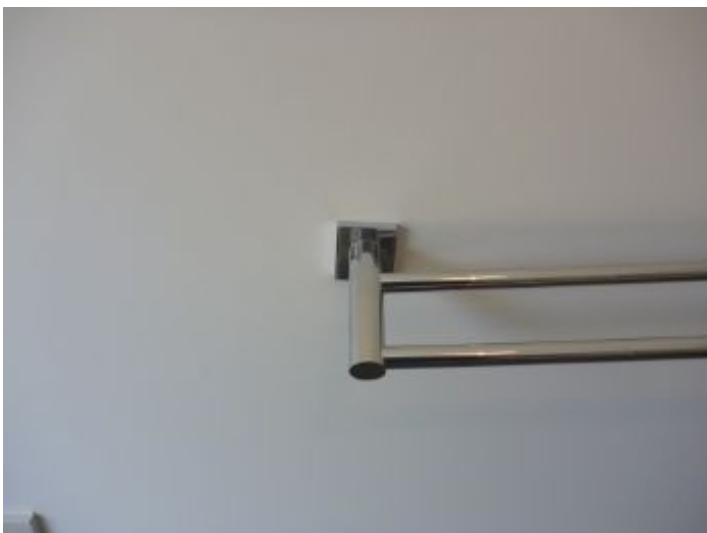
- Large mortar bed noted on one of the top Ledgerstone corners.
- The gyprock sheet adjacent to the kitchen area has the recessed edge exposed at the finished floor level.

- The towel rail fixing in the Bath room is not straight.
- The toilet roll holder in the Laundry WC is loose and hanging off the wall.

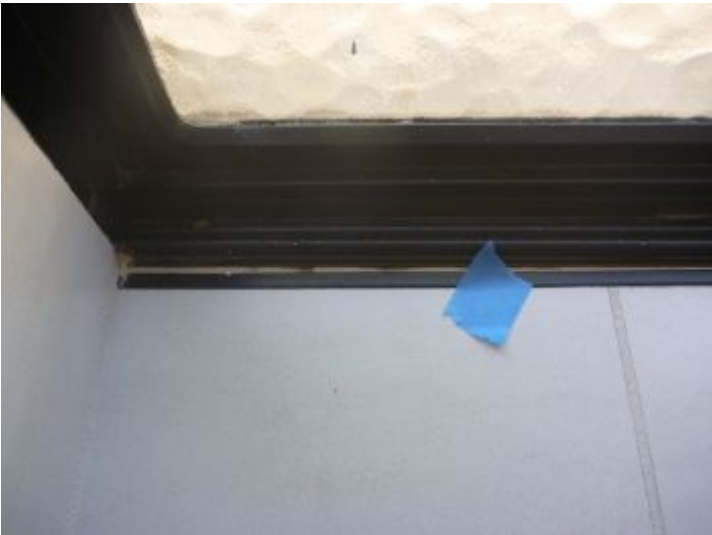
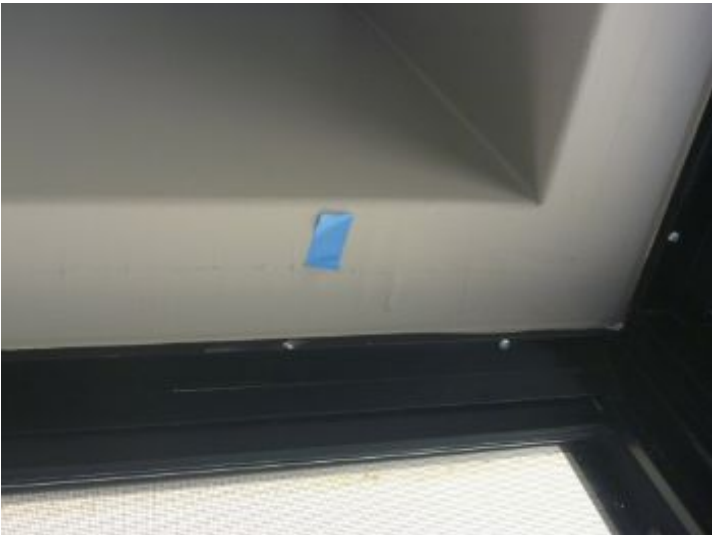
- Materials:
- Aluminum framed windows noted.
- Observations:
- Windows operated during the inspection appeared functional.
 - Chips and scratches noted on the aluminium window frames throughout.
 - The plaster around the window frames has not been completed satisfactorily with some cracking, gaps and blemishes noted. These have been marked with blue painters tape.
 - Grout noted in the Bath room window frame.

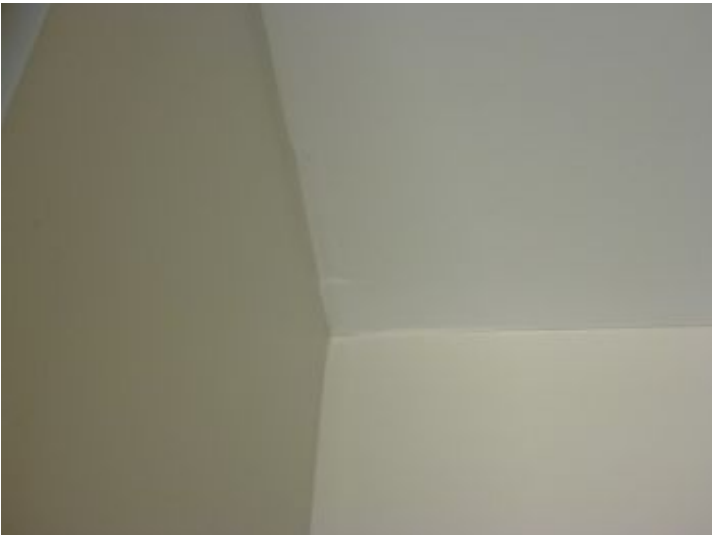
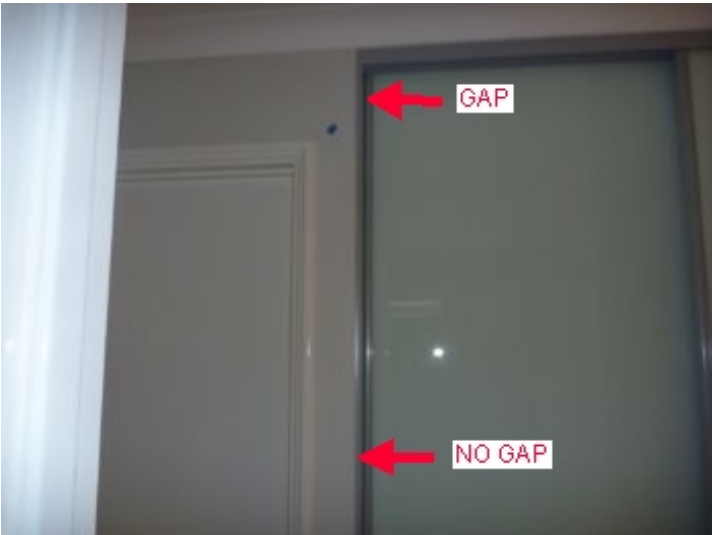
- Observations:
- Marks and scratches noted to the closet walls and ceilings. These have been marked with blue painters tape.
 - The Linen doors are out of square and require adjustment.
 - The Linen door has plaster noted in the runner.
 - Significant gaps and visible fixings noted within the closet / pantry shelving through out.

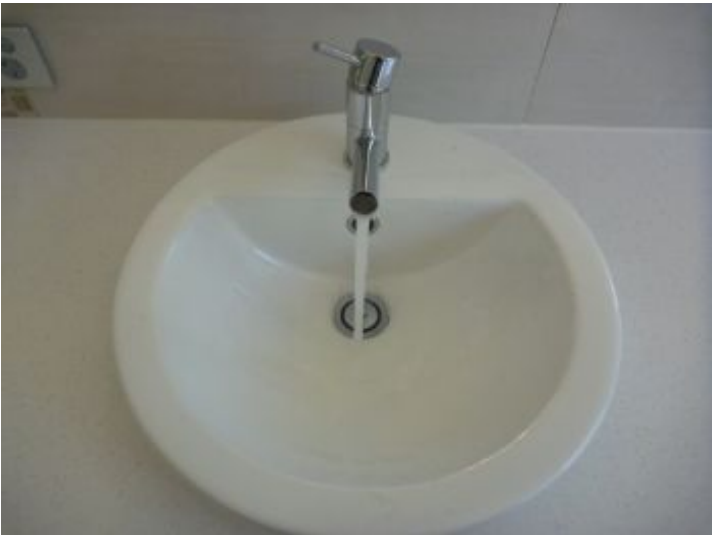
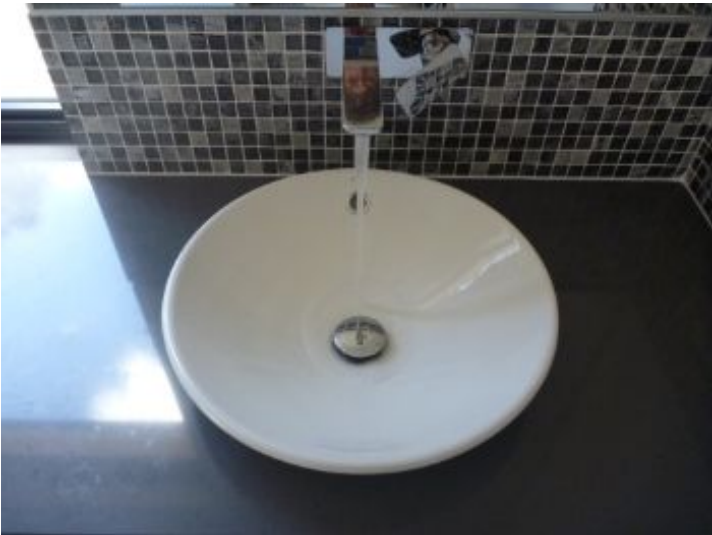
Observations:
• The sinks and related components functioned normally when tested.
• The left hand Ensuite vanity basin appears to have a crack in the bottom of the basin and is leaking.

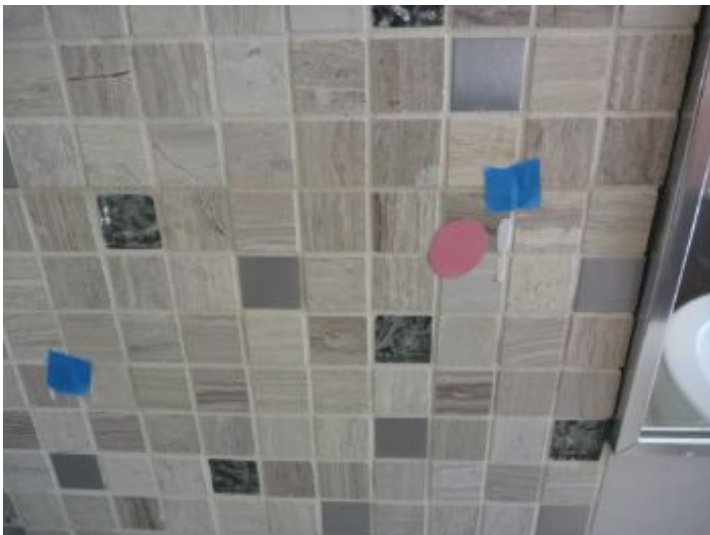
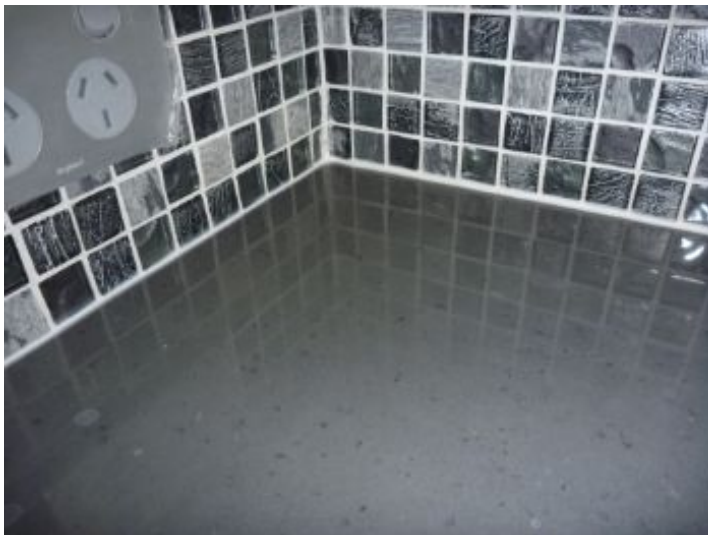
- No major discrepancies noted in the counter tops and surfaces.
- Paint drops noted on the Bath room vanity splashback.
- The silicone between the counters and the splashbacks vary in thickness and is of a poor finish.

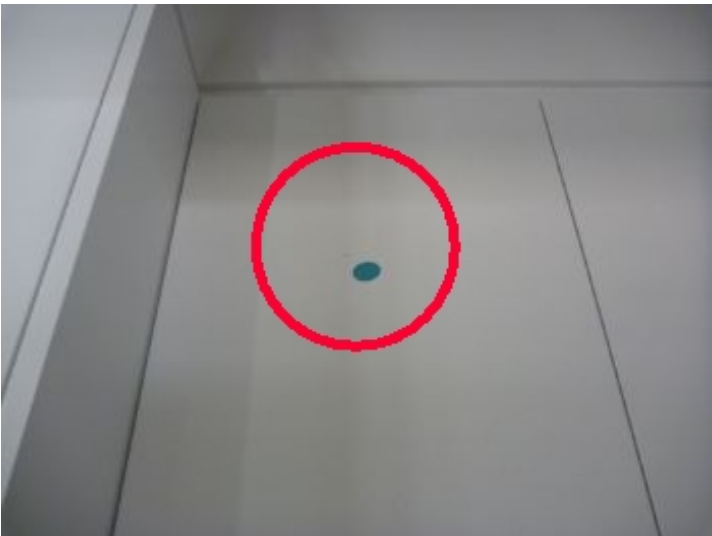
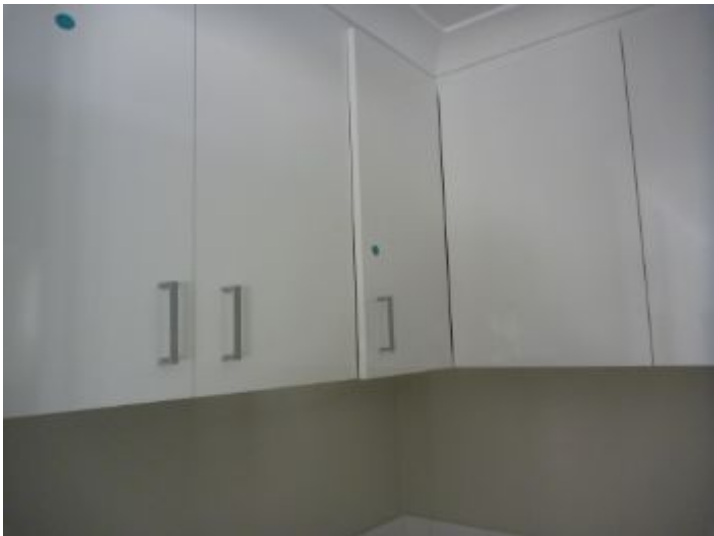
- Observations:
- Generally appeared functional and in satisfactory condition.
 - Some cabinet doors do not align properly. Some adjustment is required.
 - Mark/scratch noted to one of the overhead cupboard doors
 - The Appliance cupboard has visible bulging in the cabinet from the screws used.
 - Marks noted on the Kitchen WIP shelving.
 - The shelving on the left hand side of the rangehood has not been installed level and requires adjustment.

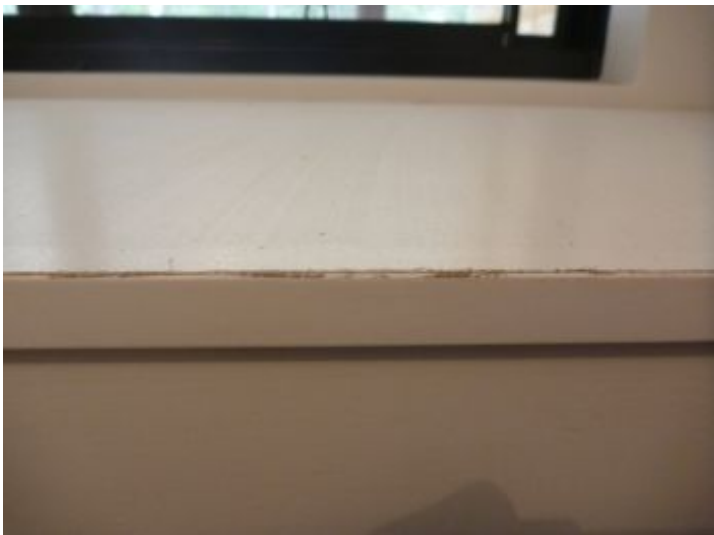
Marked Pantry Shelving

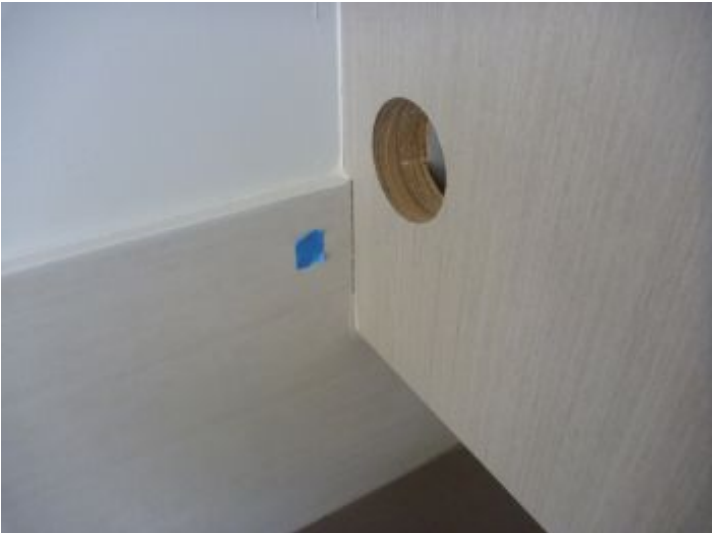
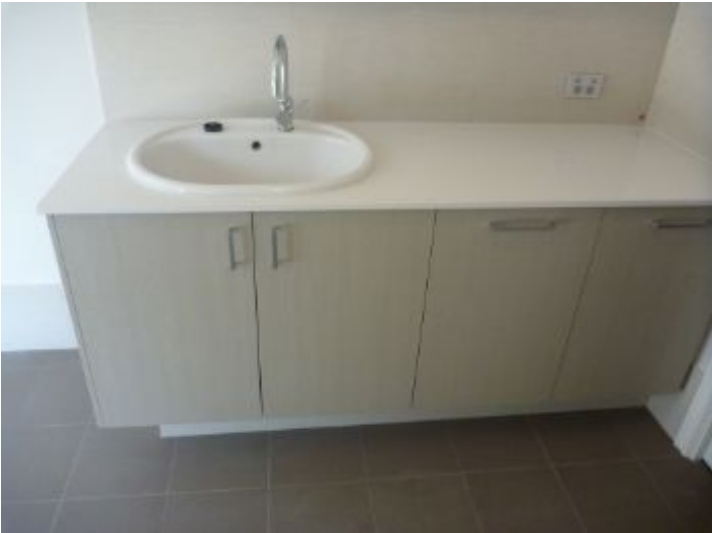
6. Vent Condition

- Observations:
- Appeared functional and in satisfactory condition, at time of inspection.
 - The joints between the cabinets and the wall/tiles are cracking and should be sealed with a suitable silicone.

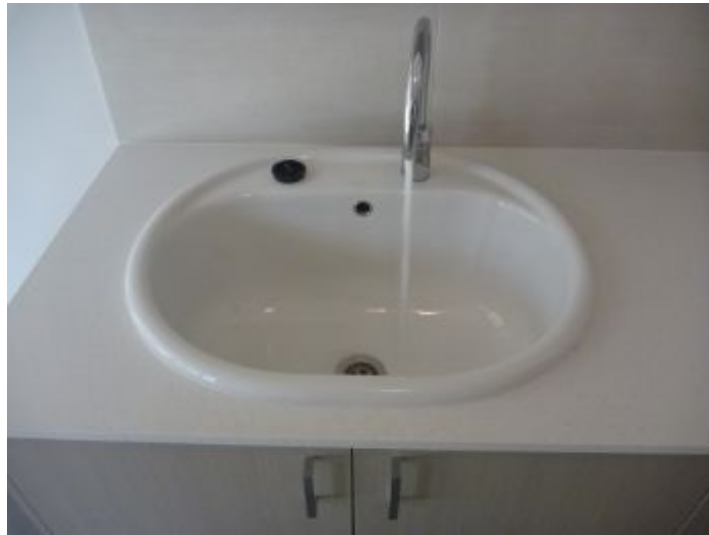
- Observations:
- Appeared functional and in satisfactory condition, at time of inspection.
 - The internal splashback tiled joint has been grouted and is starting to crack. This should be sealed with a suitable silicone.

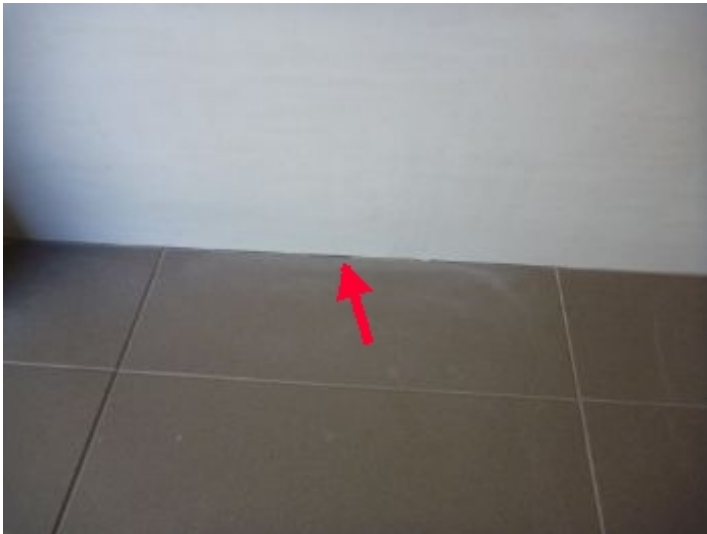
4. Floor Condition

- 'Lipping' noted throughout the tiled Laundry floor.
- The joint between the floor and skirting tile has been grouted and is cracking. This should be sealed with a suitable silicone.

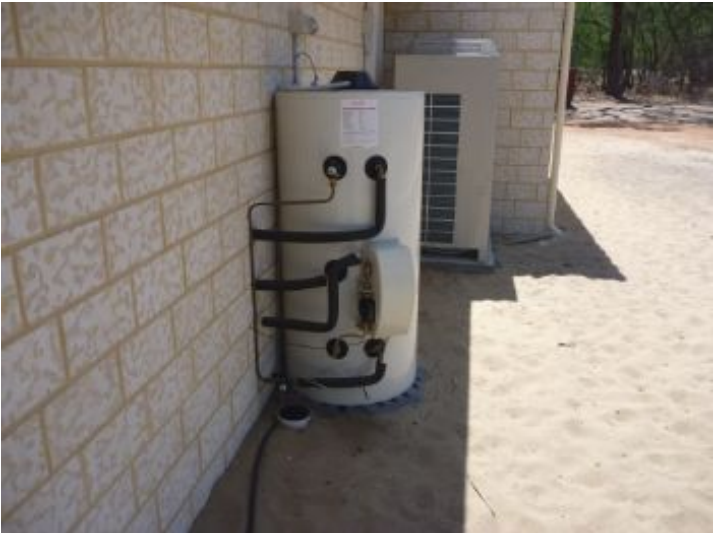
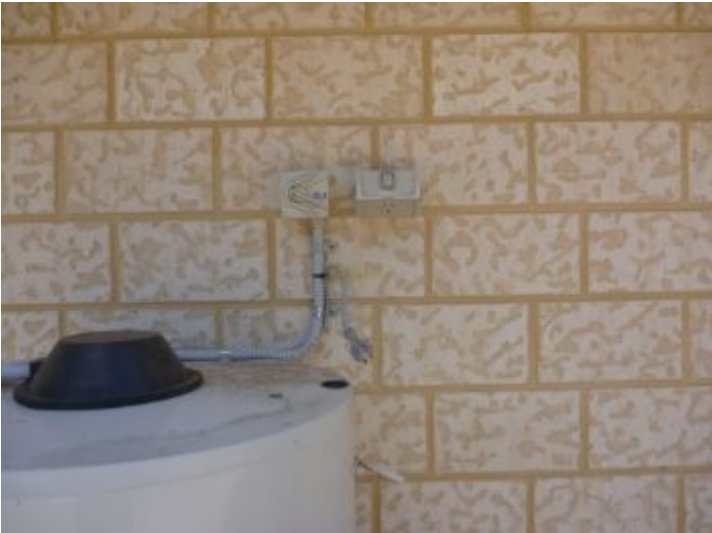
1. Water Heater Condition

Observations:
• The hot water heater was not turned on. It is recommended that this is turned on and operational prior to the final handover to confirm that the hot water system is operational.
• The top pipe joint between the 2 solar panels is leaking and requires repair.

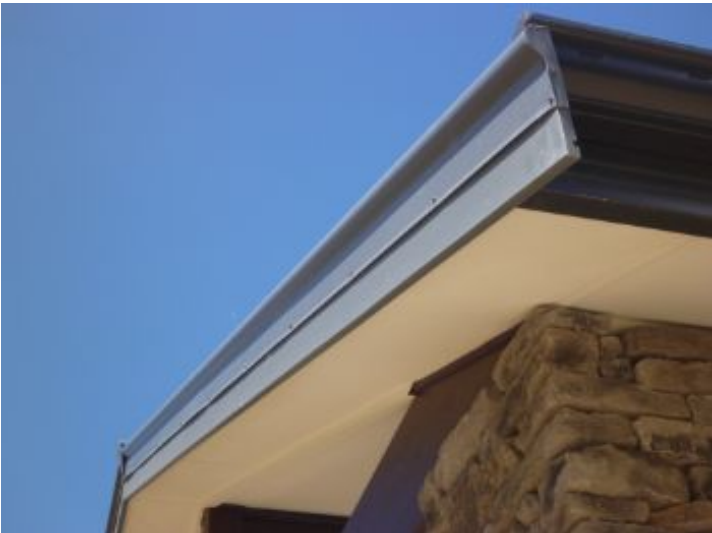
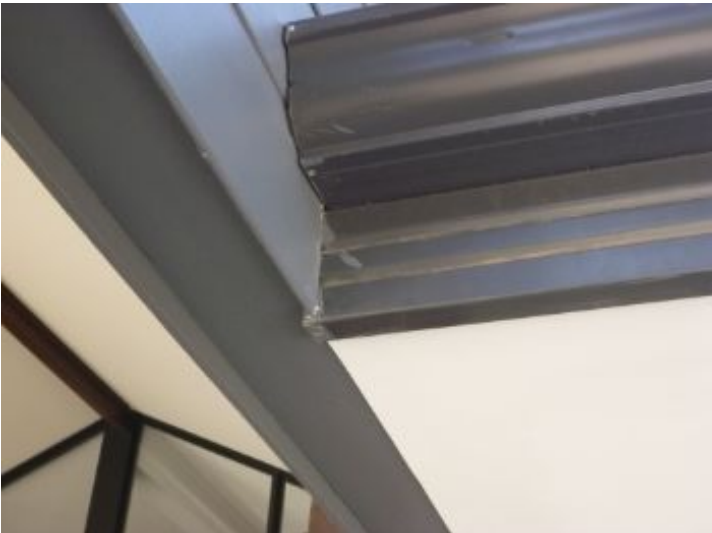
- Observations:
- The eaves are in satisfactory condition.
 - Paint and scratches noted on some of the fascia.

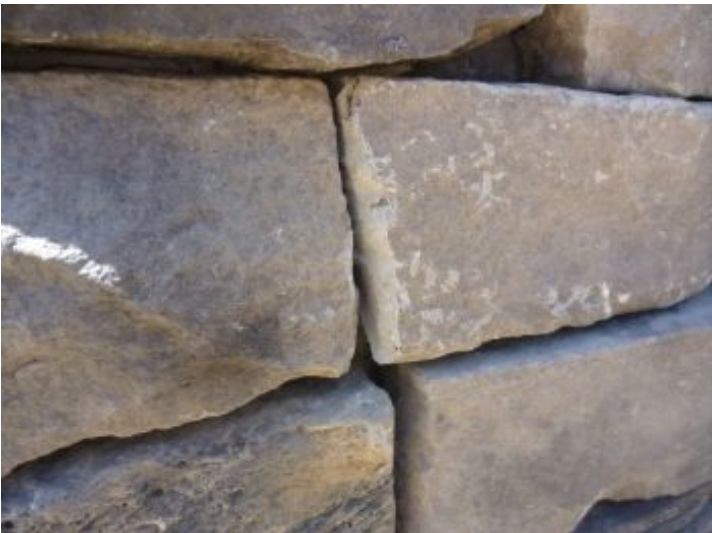
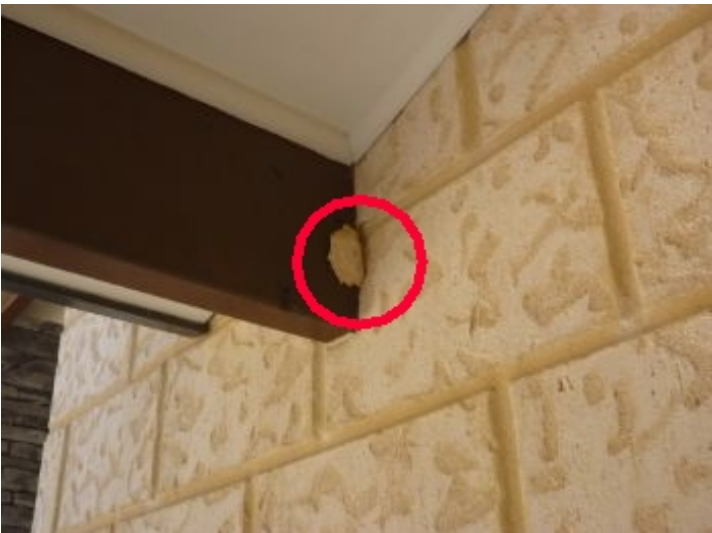
4. Walls

- Materials:
- The brick wall covering is in a satisfactory condition.
- Observations:
- The Ledgerstone walls have mortar noted on the stone throughout. Installer is to provide written confirmation that the stone cladding has been installed as per the manufacturers installation instructions.
 - Chipped brick noted on the brick wall adjacent to the Electrical panel.
 - Large gaps noted around some timber beams and the surrounding brickwork.
 - Some paint noted on the brick work.
 - The brick wall in the Alfresco area has been mortared up with what appears to be a different coloured mortar.

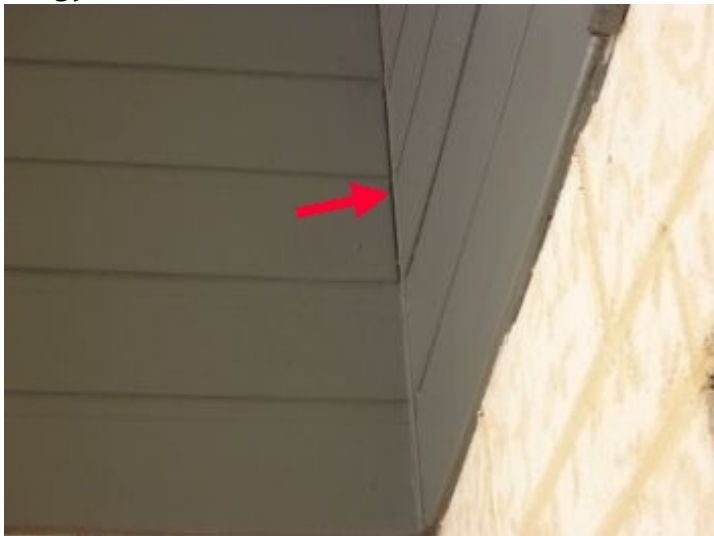
Gaps in Cladding Joints

- Generally the external cladding appears to be in satisfactory condition unless otherwise noted below.
- Gaps noted in the bottom joint of some cladding sheets.
- Large gaps noted between the timber posts and cladding. An attempt has been made to fill these gaps with a poor result.
- Gaps noted between the end of the cladding and the adjacent sheet at the internal corner in the Alfresco area.

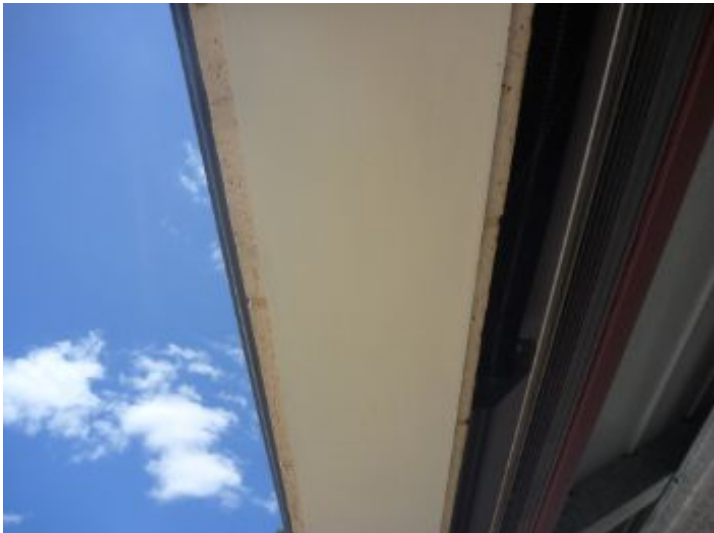
6. Exterior Paint

- Some starved paint areas noted on the external cladding in the Alfresco area and the lintel over the Garage door opening.

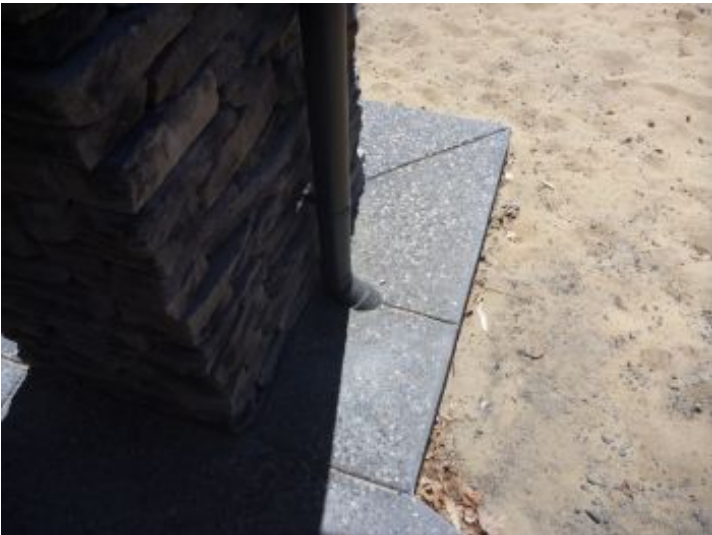
2. Grading and Drainage

- Observations:
- Surface drainage conditions within 3 metres of the inspected structure appeared satisfactory.
 - Some paint missing to the rear Alfresco downpipe.

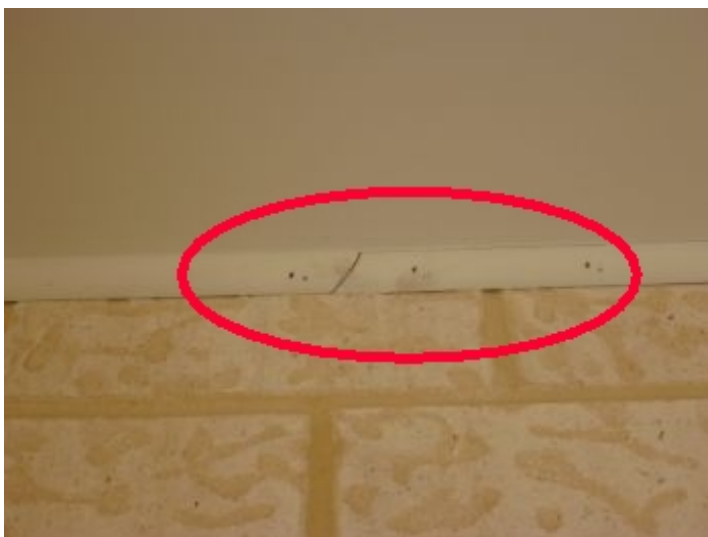
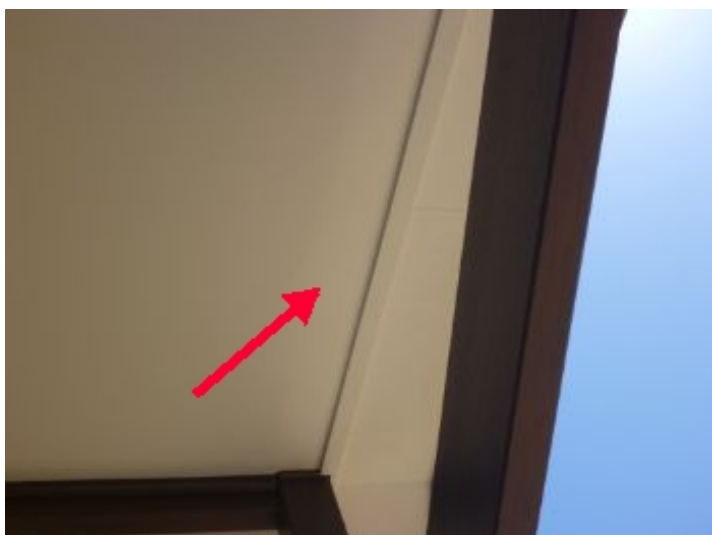
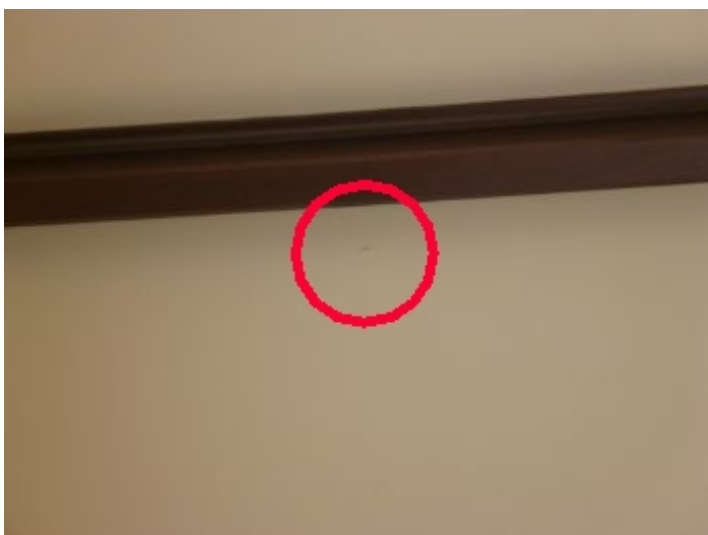
3. Patio & Pergola

- The Alfresco and Patio appear to be structurally sound.
- Patched painting and painting of some trims which are visible and also appear to be a different colour noted throughout the Patio, Alfresco and Verandah linings.
- Large gaps noted around all the the timber posts and the Patio, Alfresco and Verandah linings.
- The external corner mouldings around the rear Verandah linings have gaps and are not finished flush.
- The rear Alfresco clad timber framed areas have nails visible and the joint between the cladding is quite large and of a poor finish.
- Cracking cornice noted on the rear Alfresco.
- The front Verandah lining have some cracks in the sheet joints and some trims noted with marks and gaps in the trim joints.
