# Property Inspection Report

2 Sample Drive, Sampleville, 9999

Inspection prepared for: Client Name  
Date of Inspection: 23/2/2016 Time: 3:00PM  
Weather: 20C Cloudy

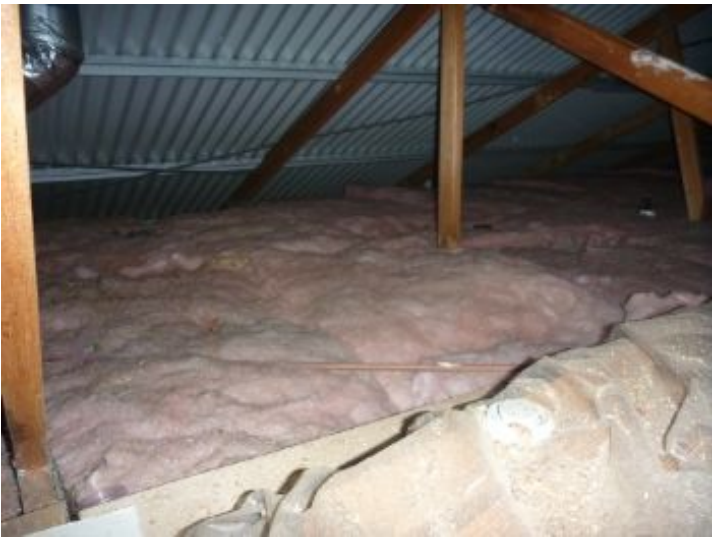
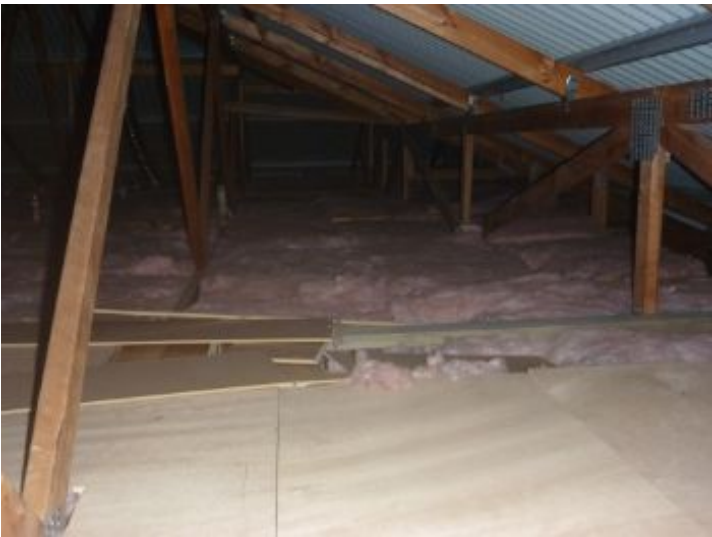
2. Insulation

- Materials:
- Fibreglass batts insulation noted in the accessible ceiling space.
- Observations:
- Insulation averages about 125 to 150mm in depth.
  - Insulation appears adequate.

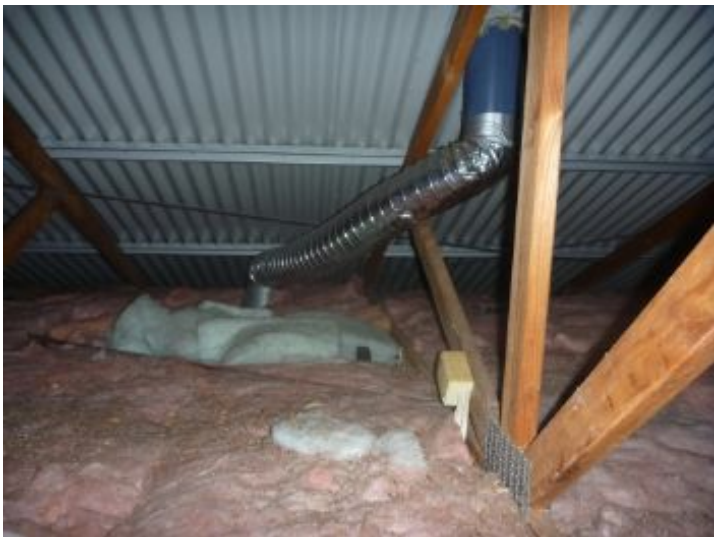
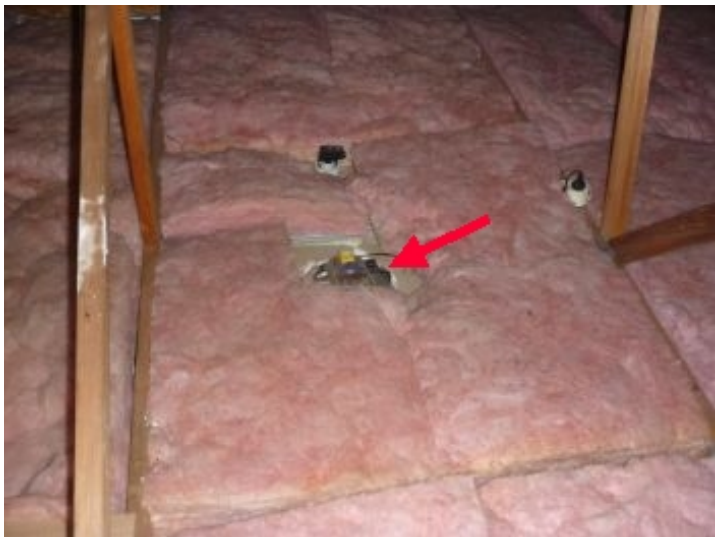
3. Exhaust Vent

- Observations:
- Bathroom exhaust fan terminates in the attic space. May wish to flue to outside air.

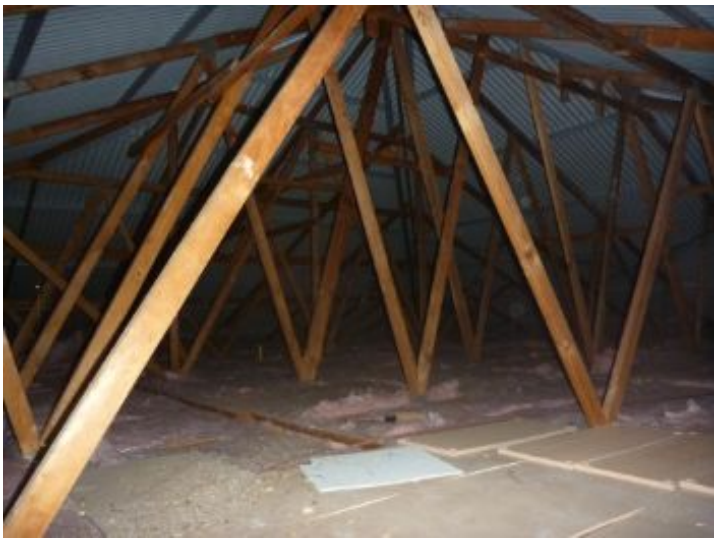
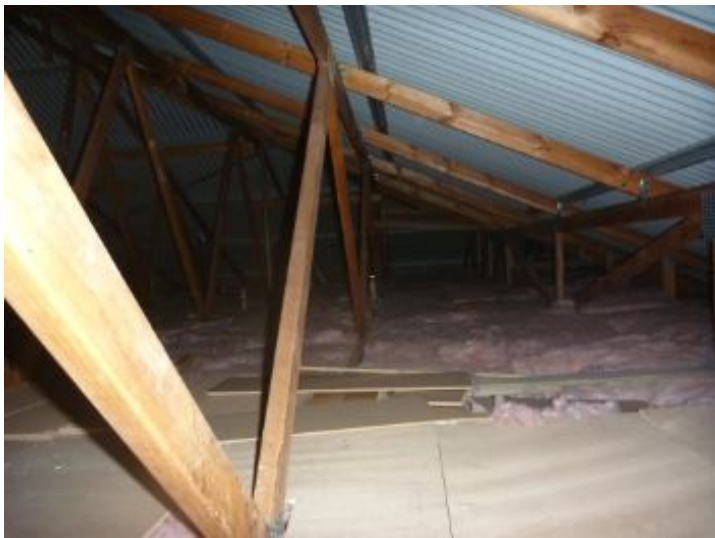
1. Roof Structure

Comments:  
• The timber roof structure appears sound.

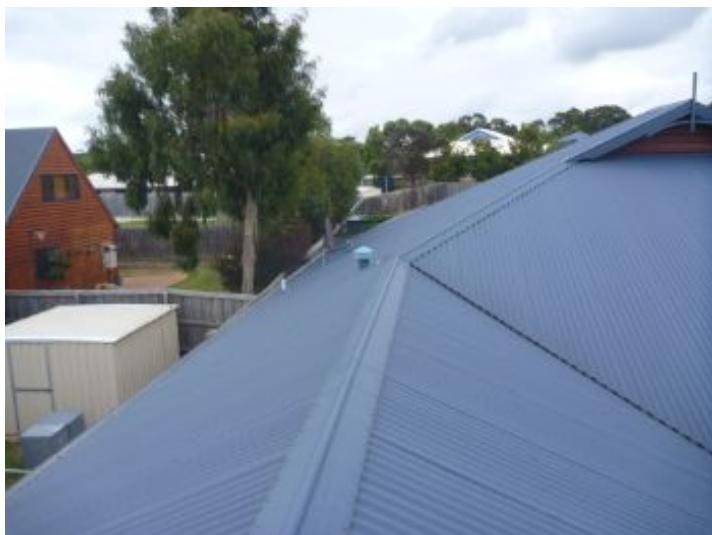
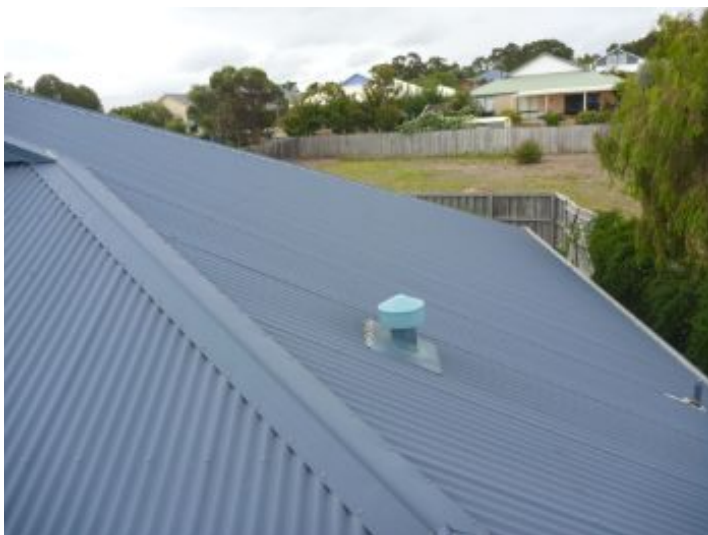
2. Roof Covering

Materials:  
• Roof was walked upon for the inspection  
Observations:  
• TV satellite dish noted on the roof.  
• The colourbond iron roof sheeting appears to be in satisfactory condition.

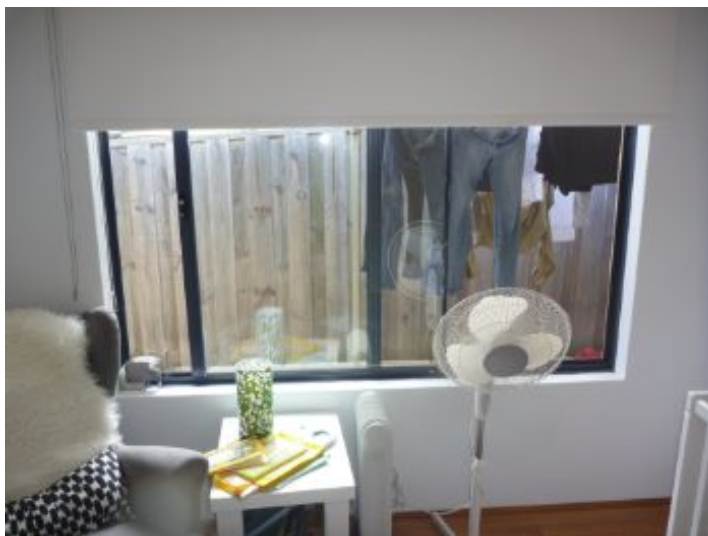
#### 5. Window Condition

- Windows operated during the inspection appeared functional.
- One or more windows were locked and could not be tested at the time of the inspection.

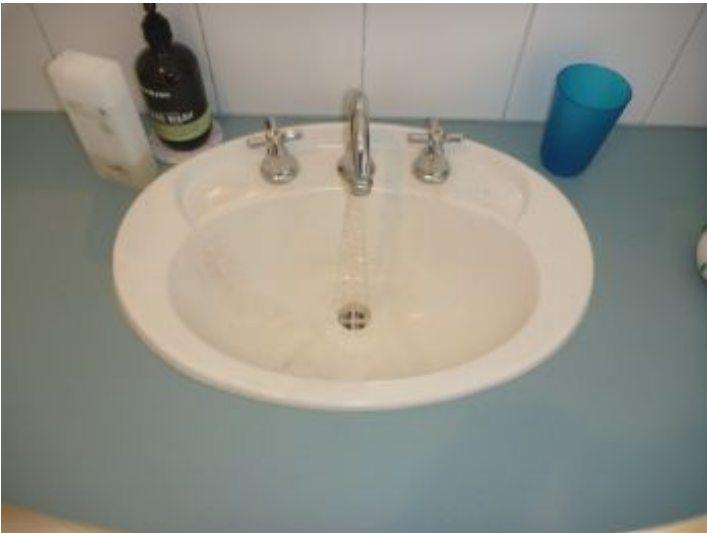
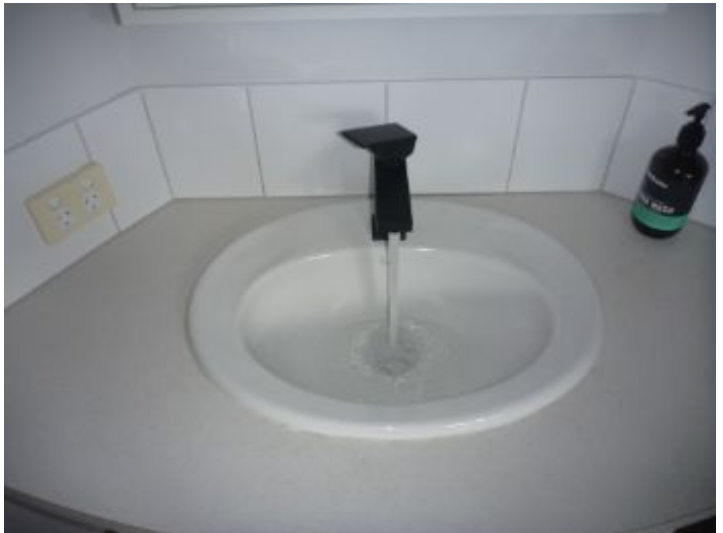
- The sinks and related components functioned normally when tested.

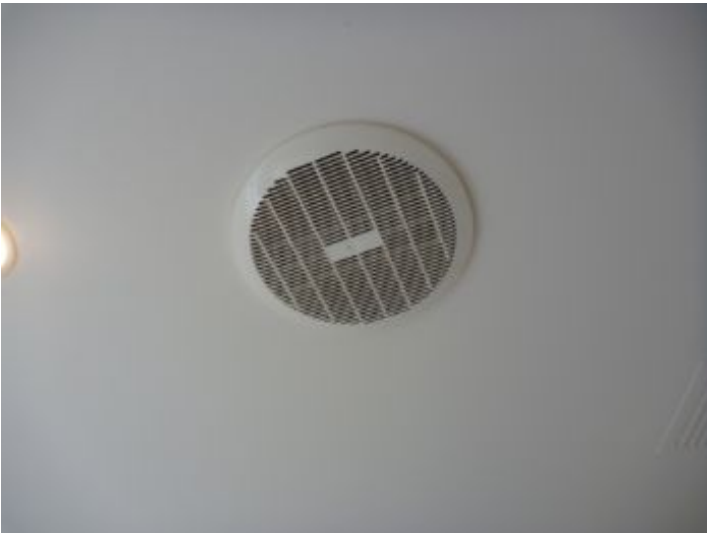
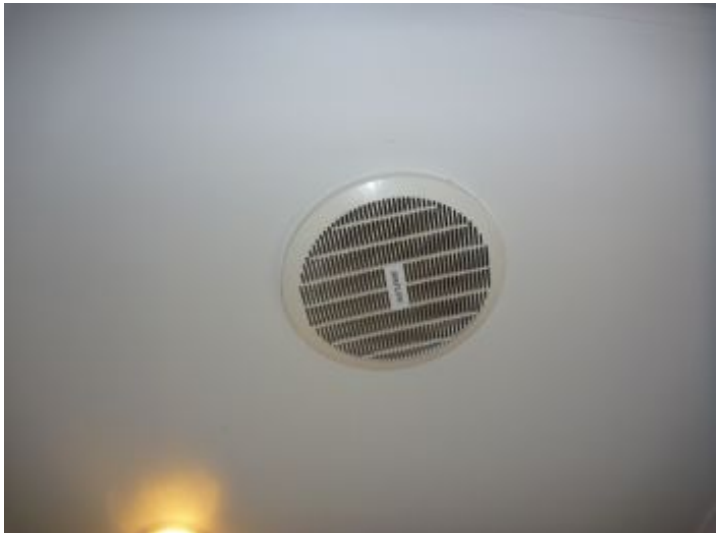
## 3. Exhaust Fan

- The bathroom exhaust fans responded to normal user controls.

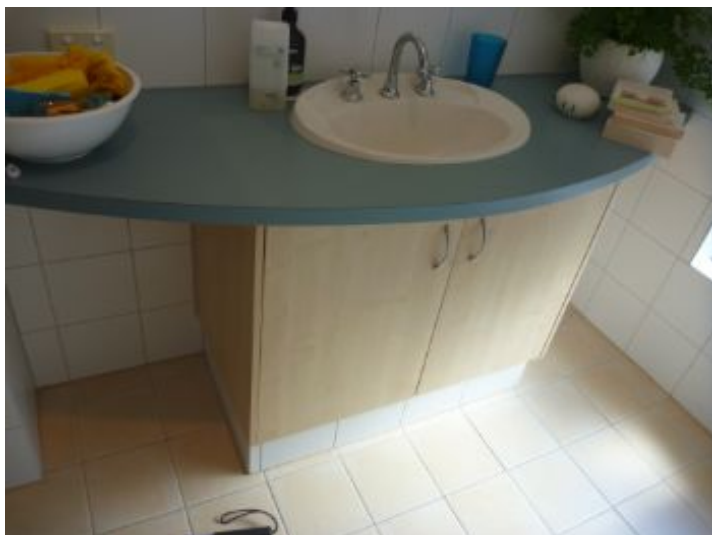
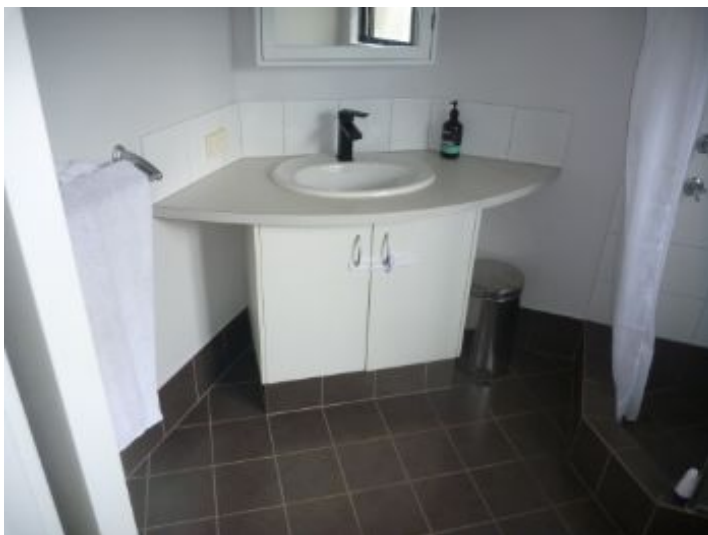
## 4. Cabinets

- Appeared functional and in satisfactory condition, at time of inspection.

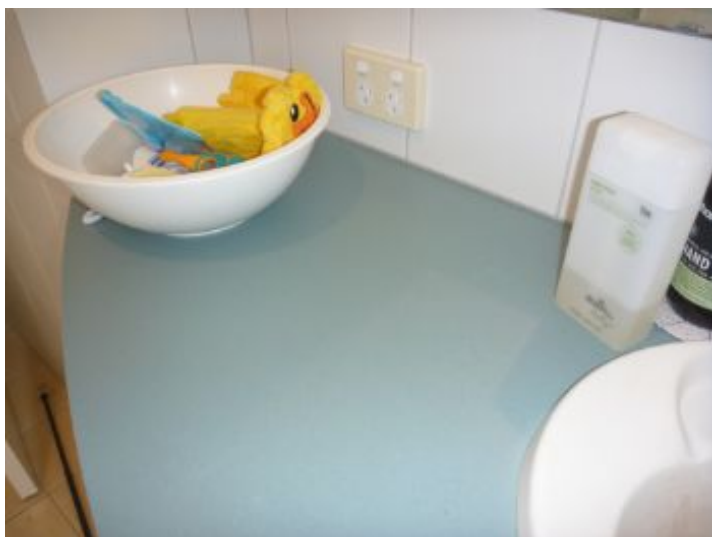
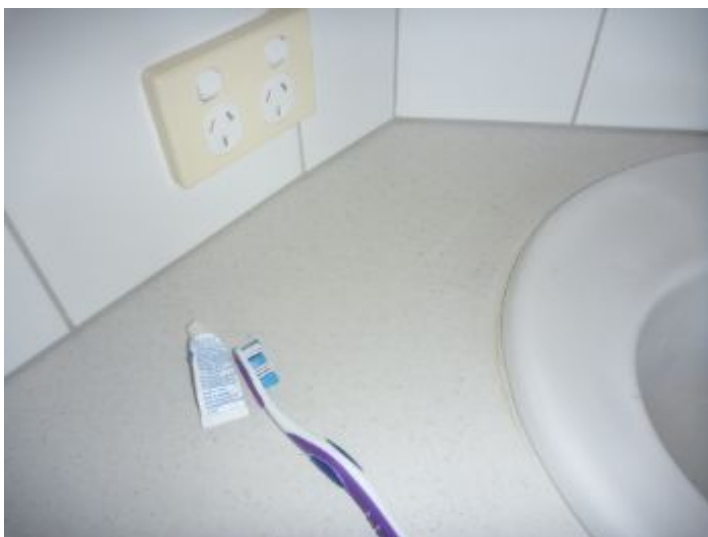
### 5. Counters

- No major discrepancies noted in the counter tops and surfaces. There is normal wear, consistent with their age.

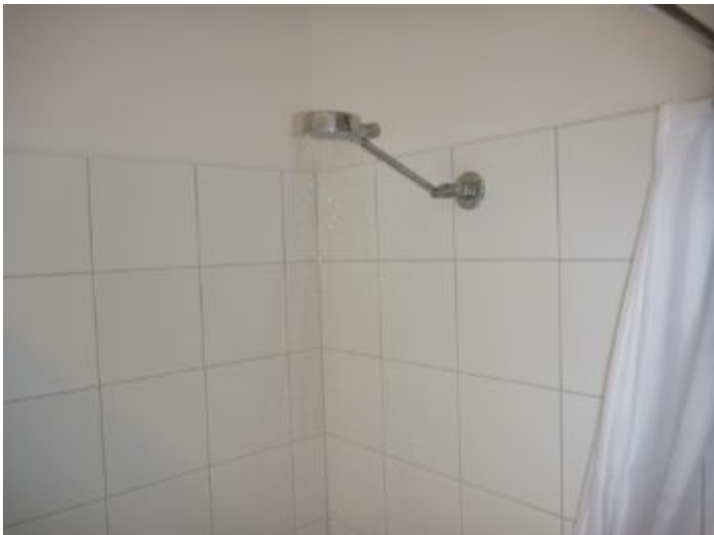
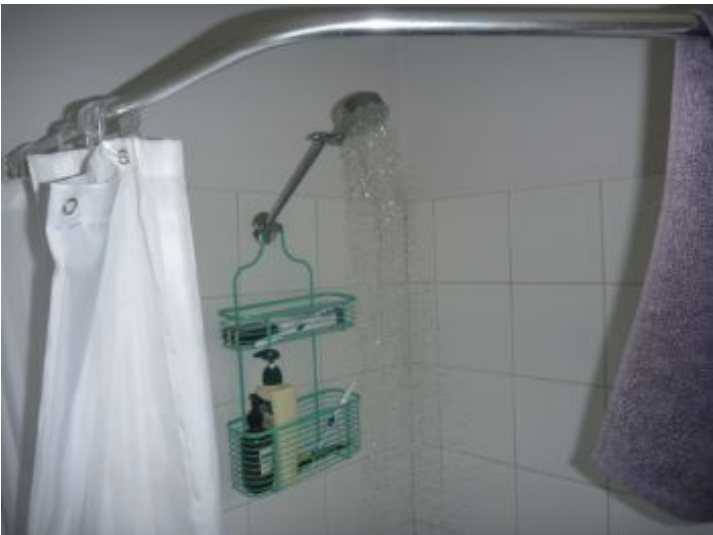
- The showers and related components operated normally when tested.

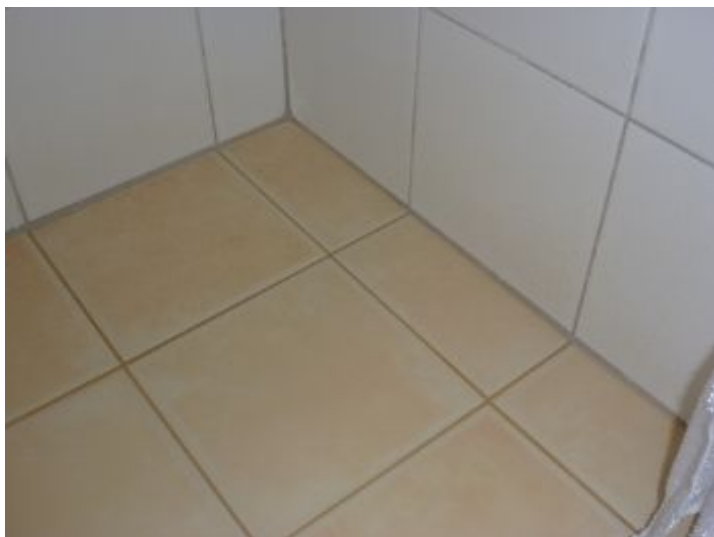
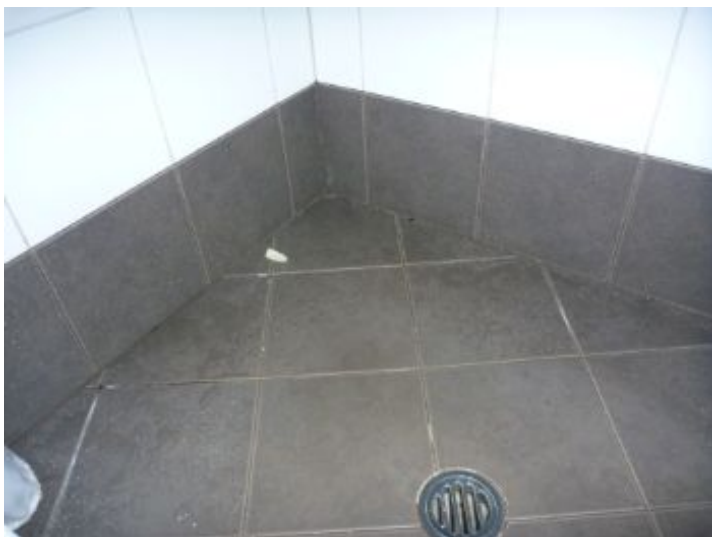
8. Shower Walls

- No discrepancies noted in the shower wall and tiled floor surfaces.

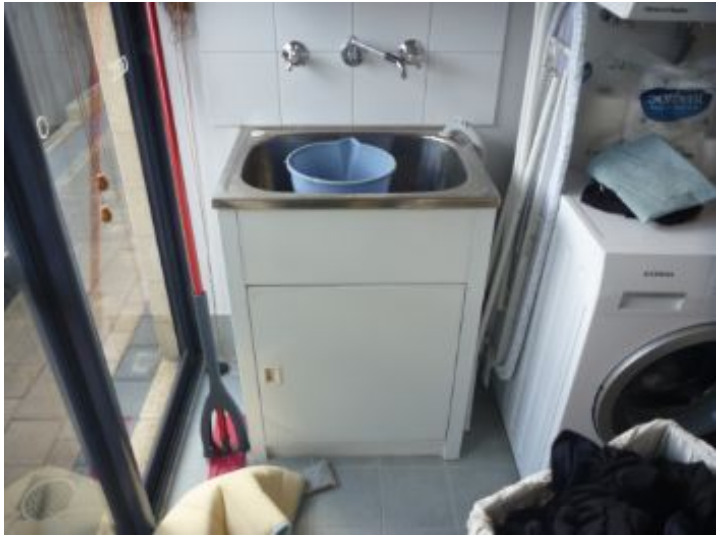
1. Cabinets

Observations:  
• Appeared functional and in satisfactory condition, at time of inspection.

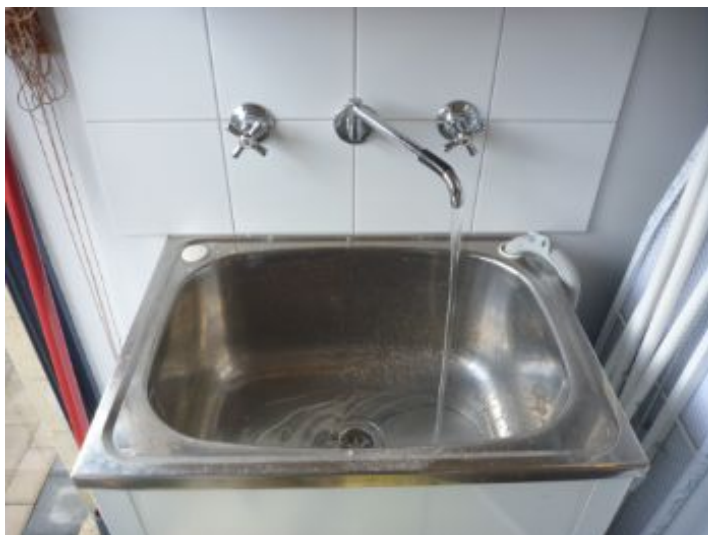
2. Wash Basin

Observations:  
• The trough and related components are functional unless otherwise noted.

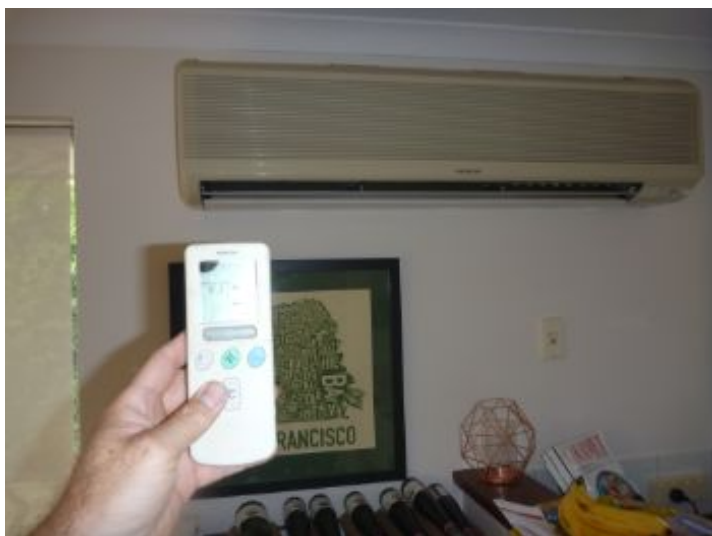
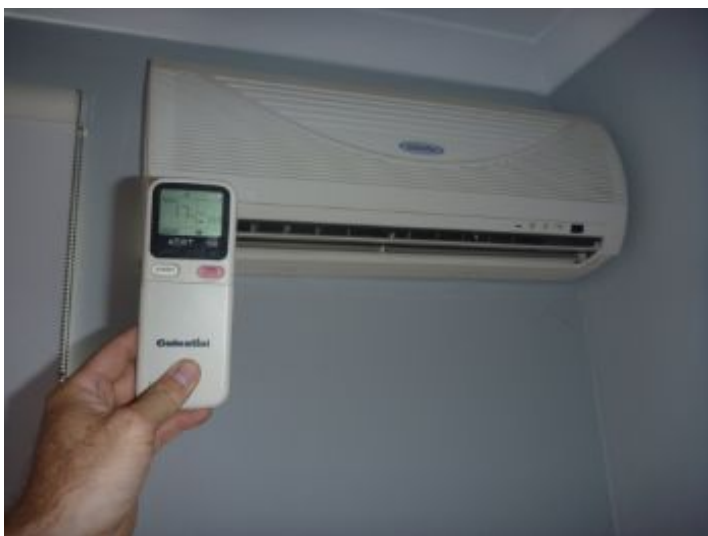
### 1. Reverse Cycle Air Conditioner

- The split-system wall mounted A/C units responded to normal user controls at the time of the inspection.

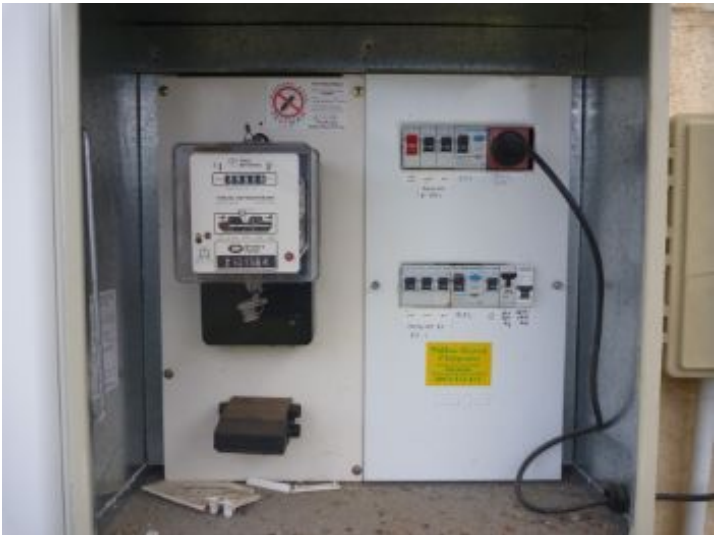
### 1. Electrical Panel

- There are at least 2 RCD's installed which protect both the powerpoint and light circuits. This complies with current regulatory requirements.

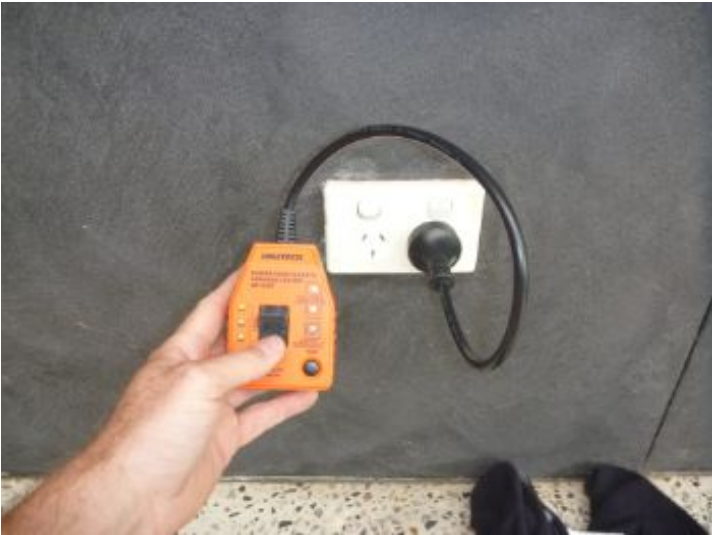
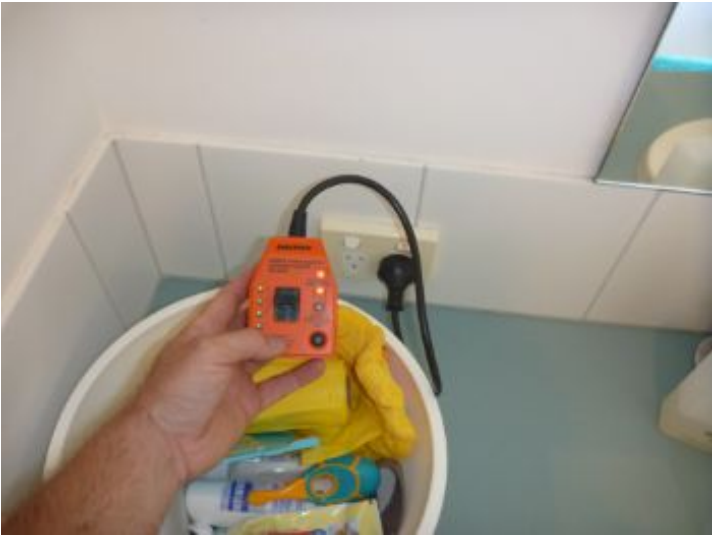
2. Power points

- All tested interior and exterior power points were functional unless otherwise noted.
- Our inspection was limited to visible and accessible outlets only. Those outlets that were concealed or inaccessible due to stored items, furniture, etc. were not tested or inspected. Only a representative sampling of outlets were tested.

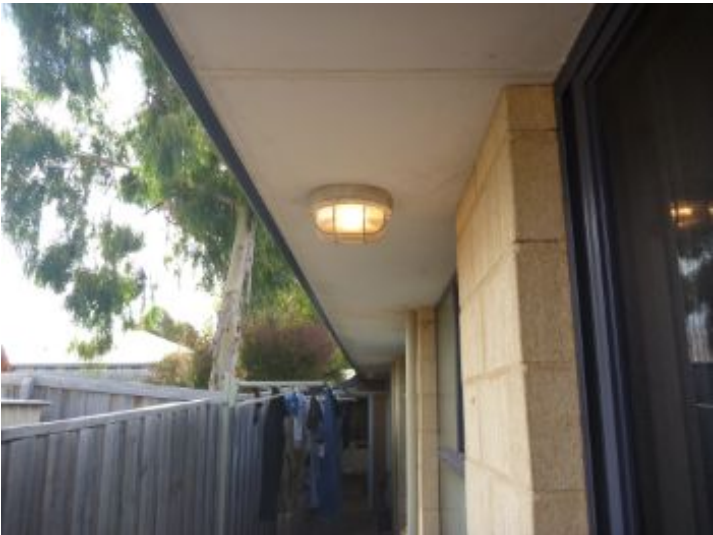
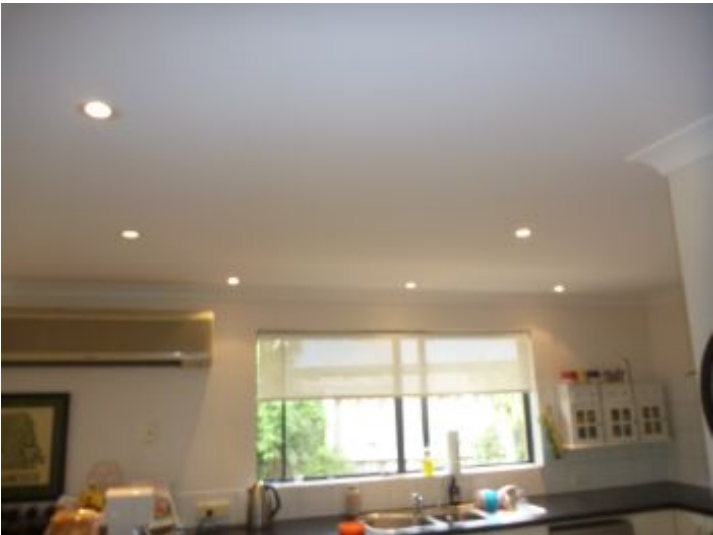
3. Lights and Switches

- All tested interior and exterior light fixtures and switches were functional unless noted.
- Some low voltage halogen lights were noted in the property.

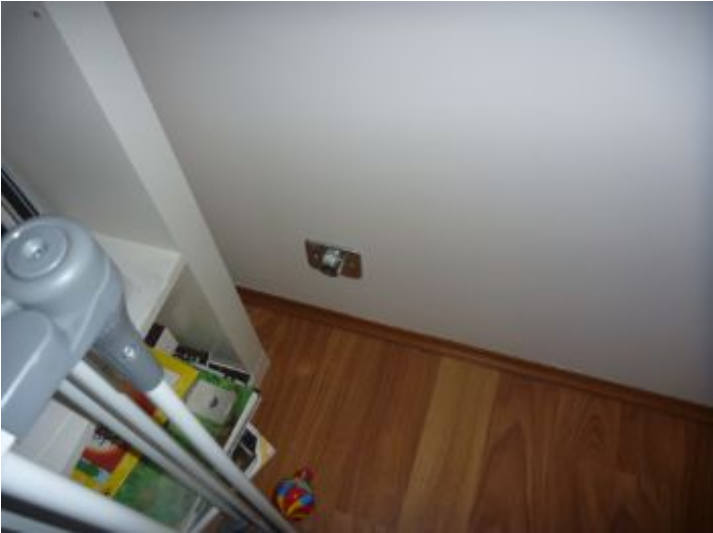
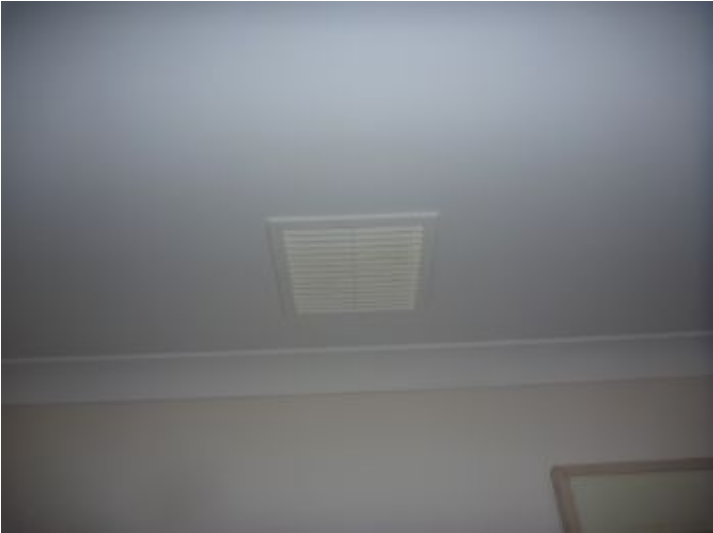
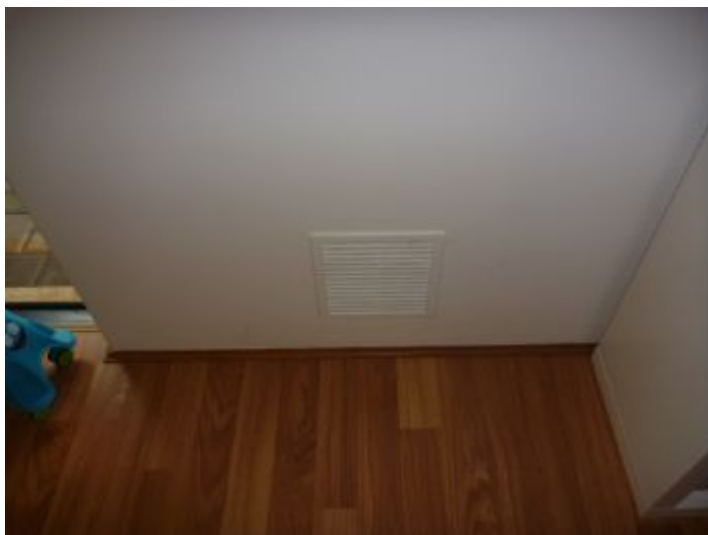
- Gas bayonet and both low and high vents are installed. The bayonet is located in the lounge room.

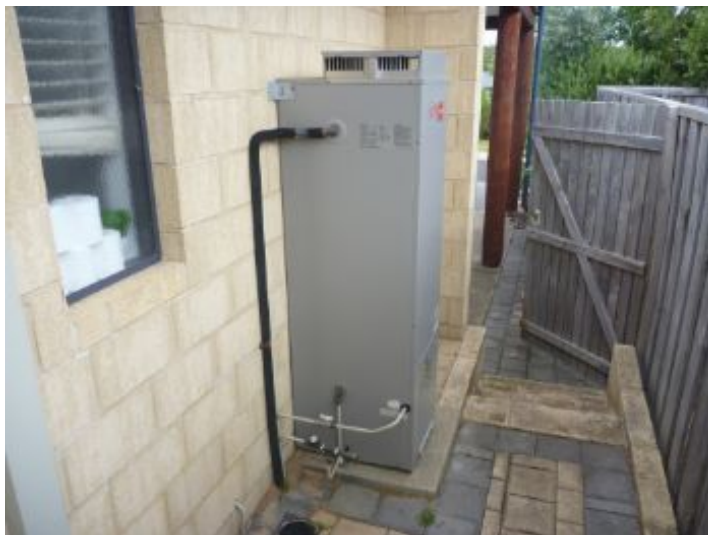
### 1. Water Heater Condition

- No major system safety or function concerns noted at time of inspection.

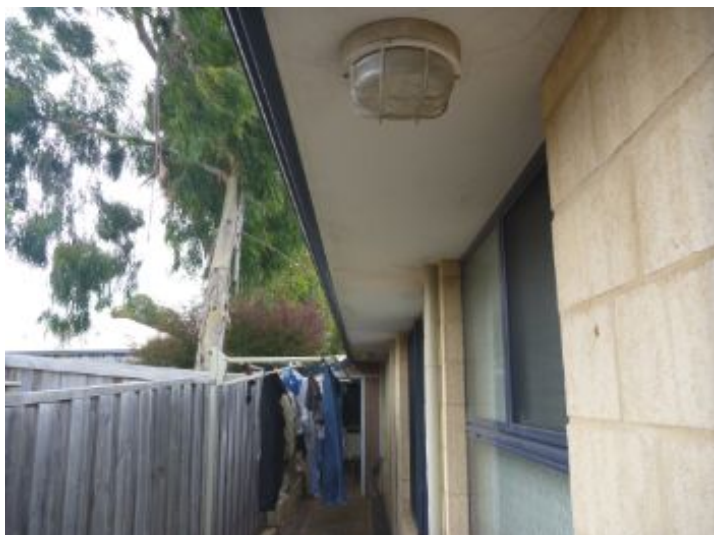
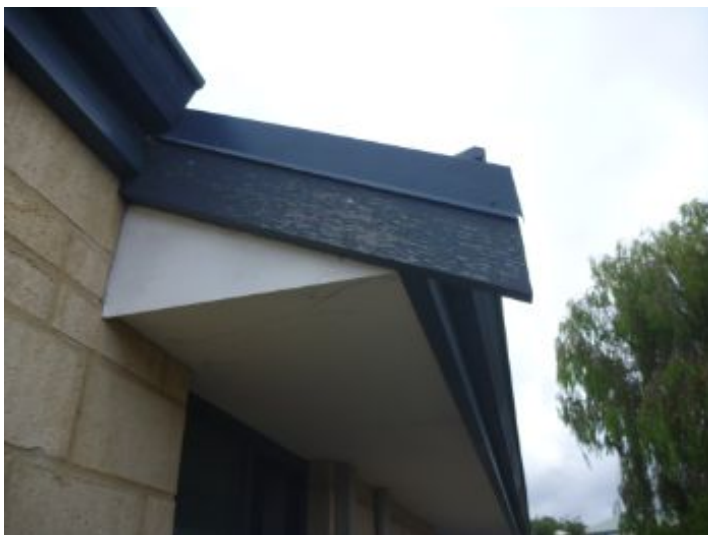
### 1. Eaves & Fascia

- The eaves are in satisfactory condition.
- Fascia covering the ends of rafter or truss tails appeared to be in generally serviceable condition at the time of the inspection. Notable exceptions will be listed in this report.
- Peeling paint observed, suggest scraping and painting as necessary.

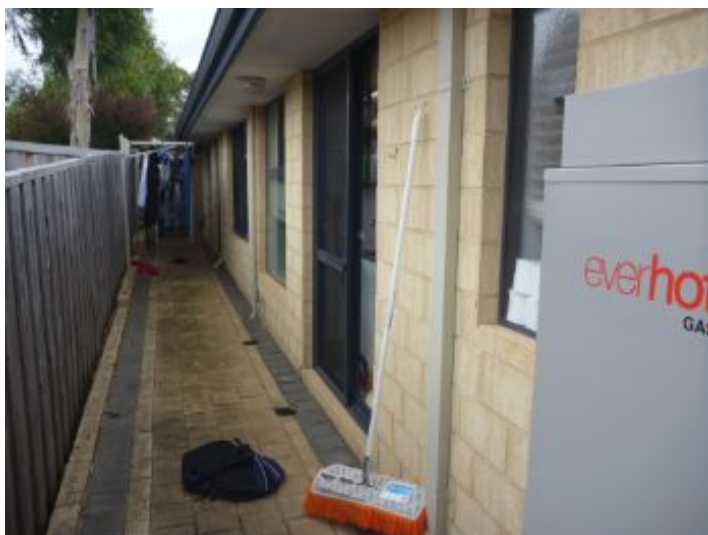
## 2. Walls

- The brick wall covering is in a satisfactory condition.

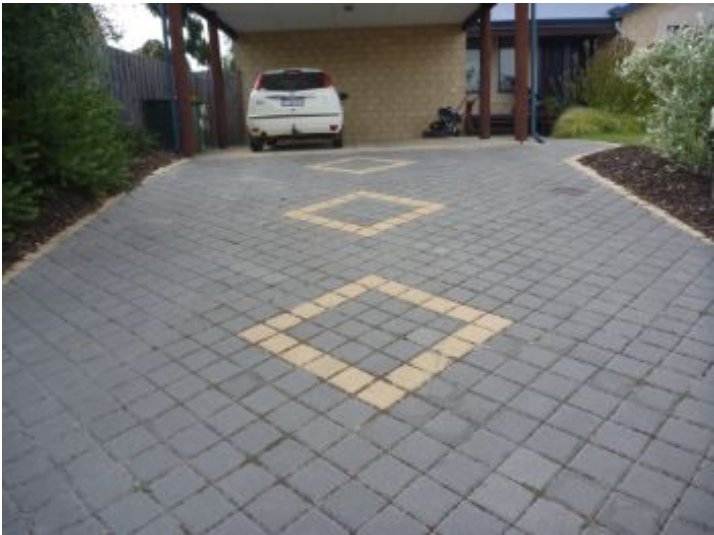
1. Driveway and Walkway Condition

- Materials:
- Brick paved driveway noted.
  - Driveway in reasonable shape for age and wear. No major deficiencies noted.

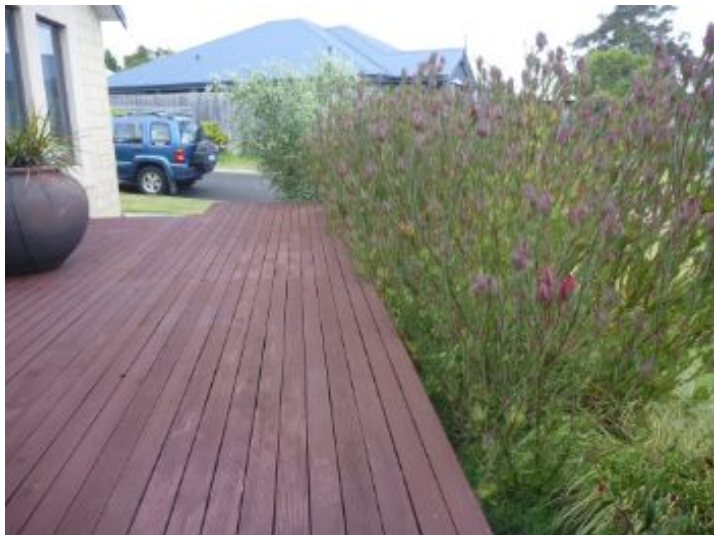
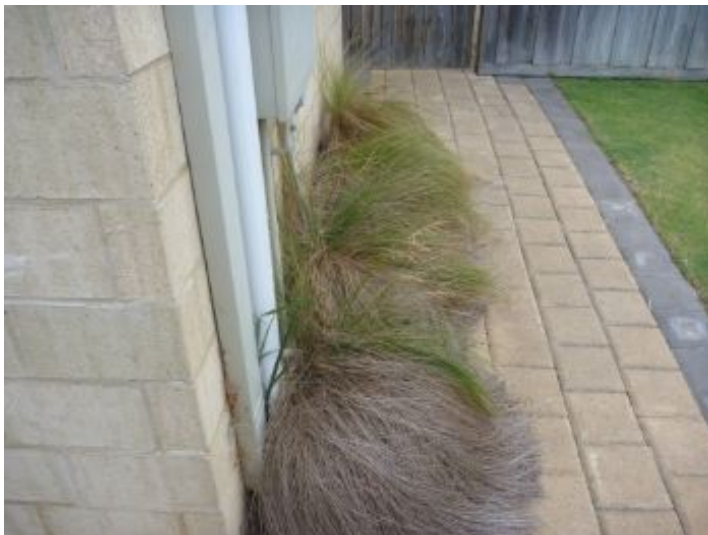
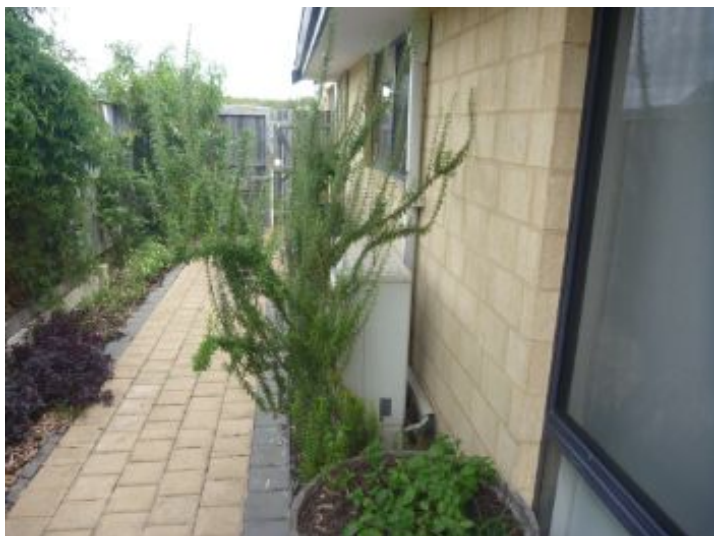
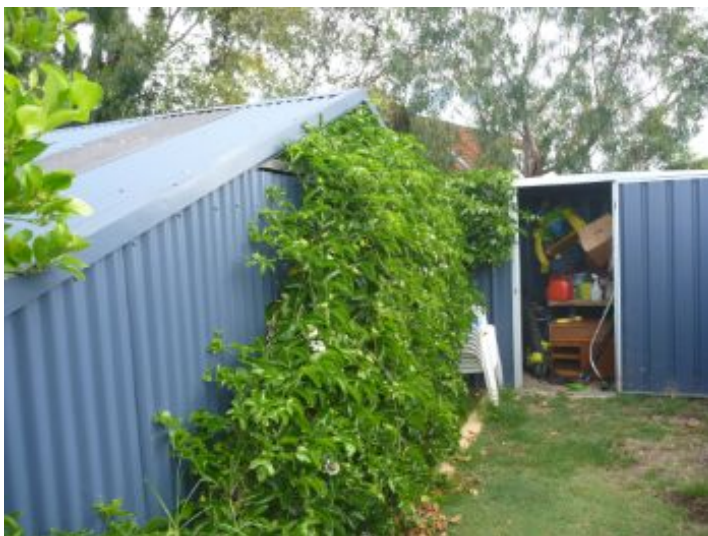
- Trees that begin to grow too close to or overhang property should be trimmed back; this will help reduce the frequency of having to clean out the gutters which should be done on a regular basis.
- Prune or remove any plants that are in contact or proximity to home to eliminate pathways of wood destroying insects.

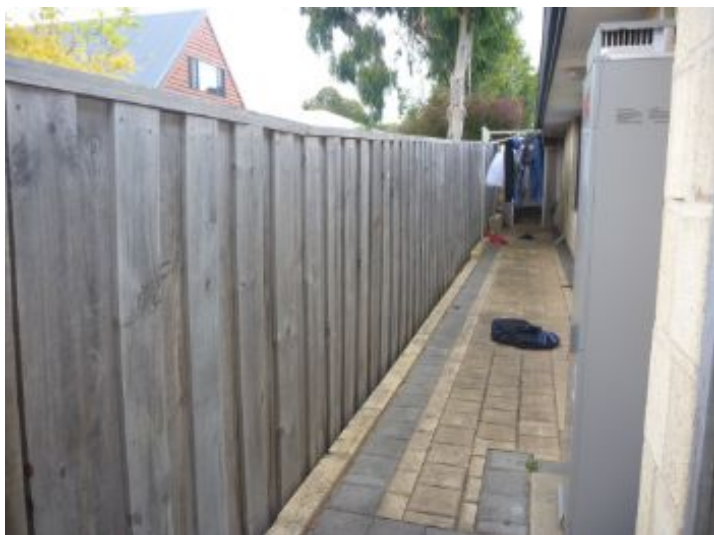
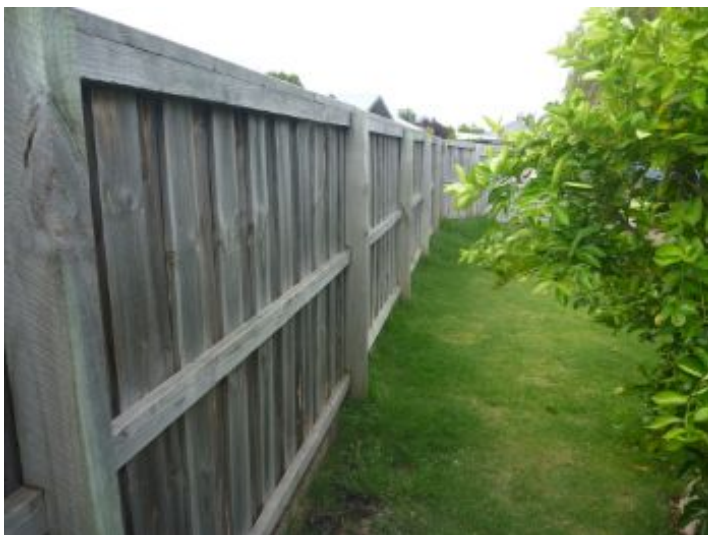
### 4. Fence Condition

- Timber
- Unless otherwise noted, the perimeter fence appeared functional at the time of the inspection.

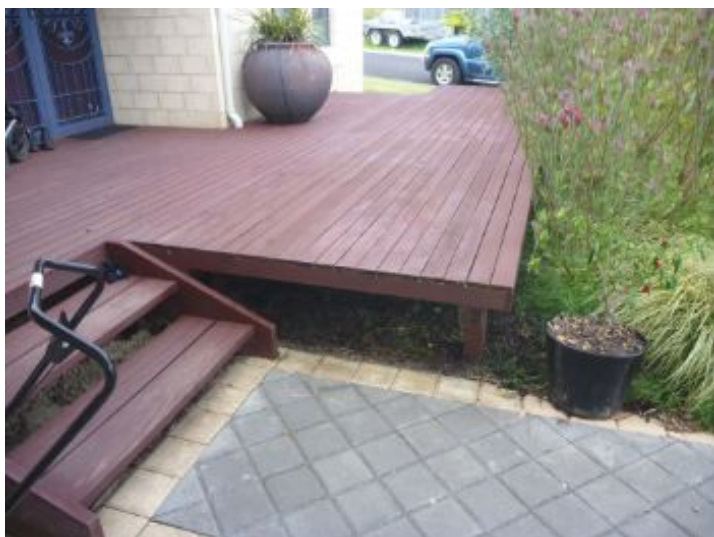
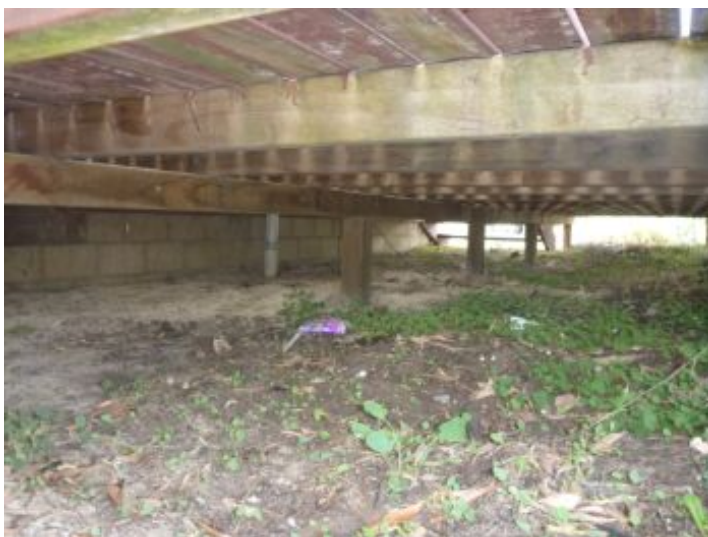
### 5. Patio and Porch Decks

- Deck was examined and appears in satisfactory and functional condition with normal wear for its age. Appears to be sound structure.

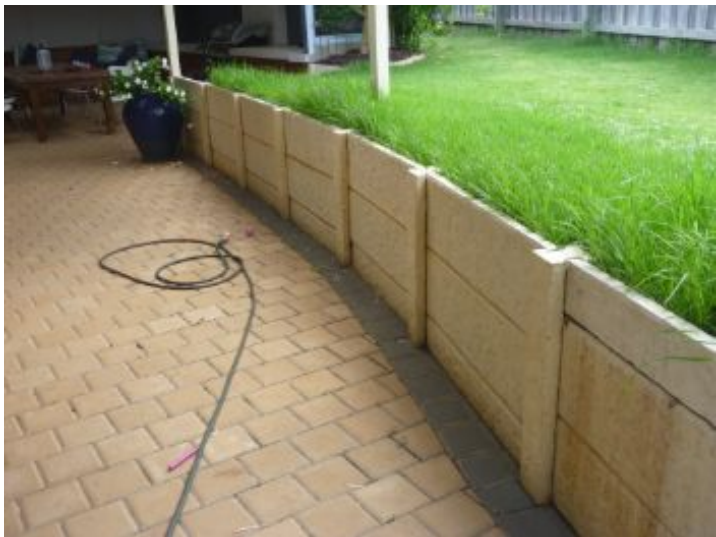
- The yard walls appear to be functional and structurally sound.
- Evaluation of retaining wall strength, adequacy, and drainage falls outside the scope of a Resicert building inspection. Such evaluation will require the services of a geotechnical engineer. Our evaluation is limited to reporting significant defects that are visible and apparent at the time of the inspection.

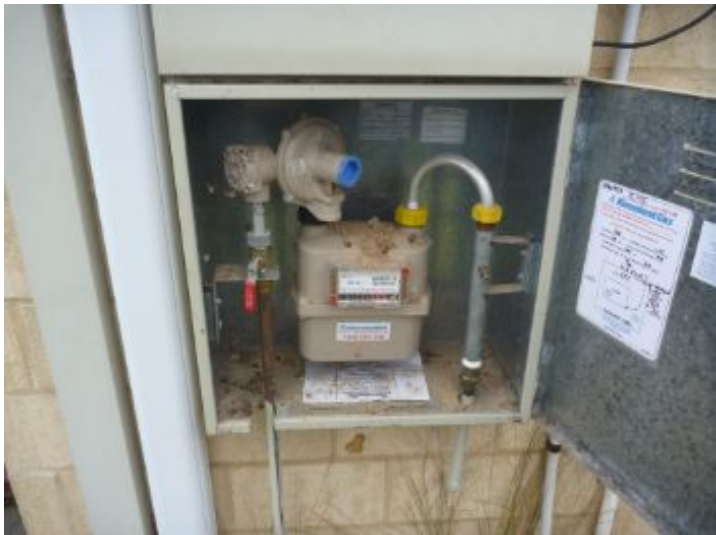
9. Main Gas Valve Condition

Location:  
• Main gas shut off located at the side of the structure

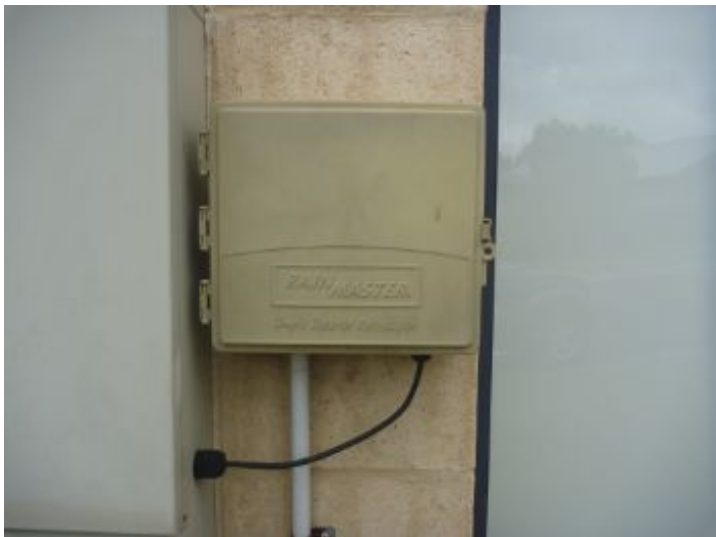
10. Sprinklers

Observations:  
• Sprinkler system was noted. It is not tested as part of the inspection. This should be tested at the final walk through inspection.

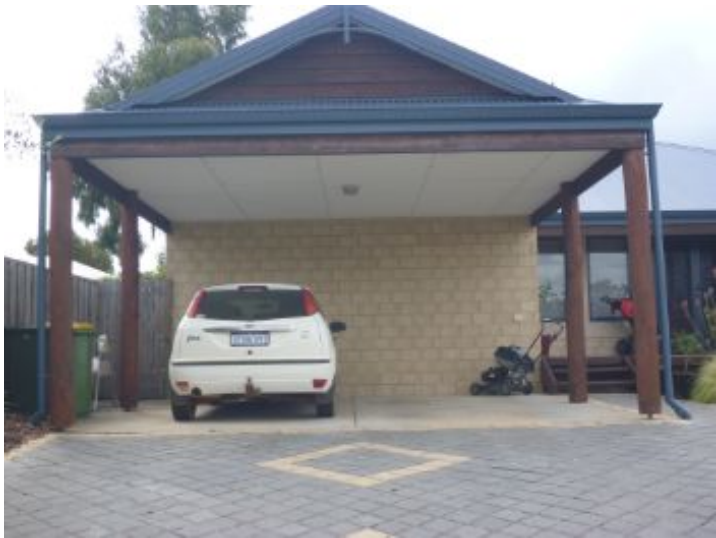
## 1. Garage and Shed

- The attached carport appears functional and structurally sound.
