Property Inspection Report

Sample Report, WA

Inspection prepared for: Sample Report
Date of Inspection: 8/2/2024 Time: 8:30am
Weather: Fine 24C

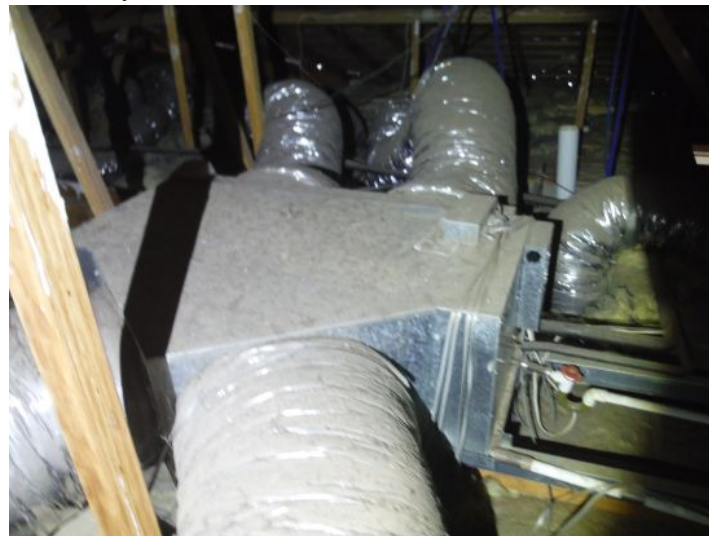
2. Duct Work

- Where visible, the air conditioning duct work appeared to be in a satisfactory condition.

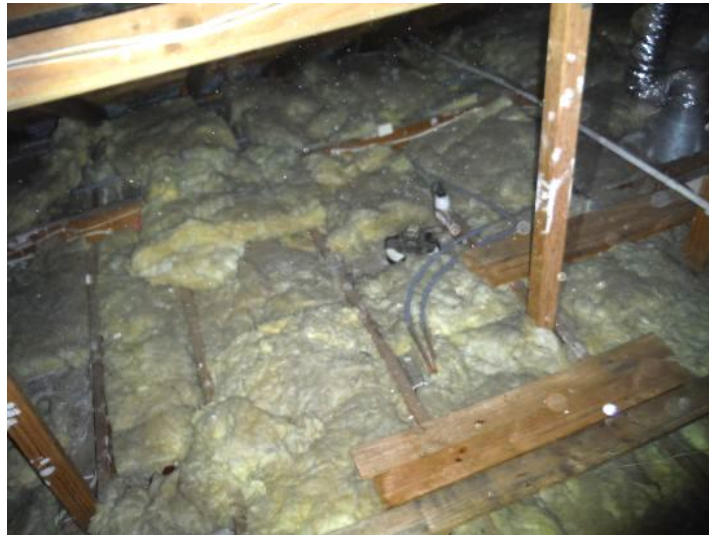
3. Insulation

- Fibreglass batts insulation noted in the accessible ceiling space.

- Insulation averages about 100mm to 125mm in depth.
- Insulation appears adequate.

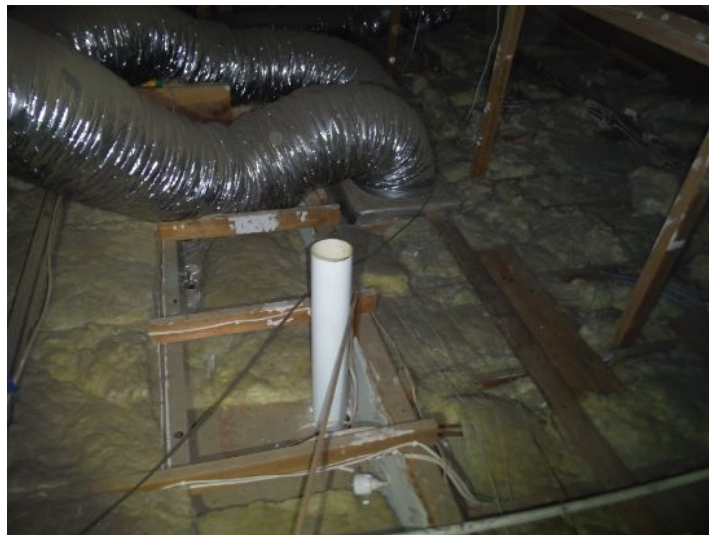
4. Exhaust Vent

- Kitchen exhaust fan terminates in the roof space. You may wish to flue to the outside air to reduce grease buildup in the roof space.
- Bathroom exhaust fan terminates in the roof space. You may wish to flue this to the outside air.

Kitchen extractor pipe.

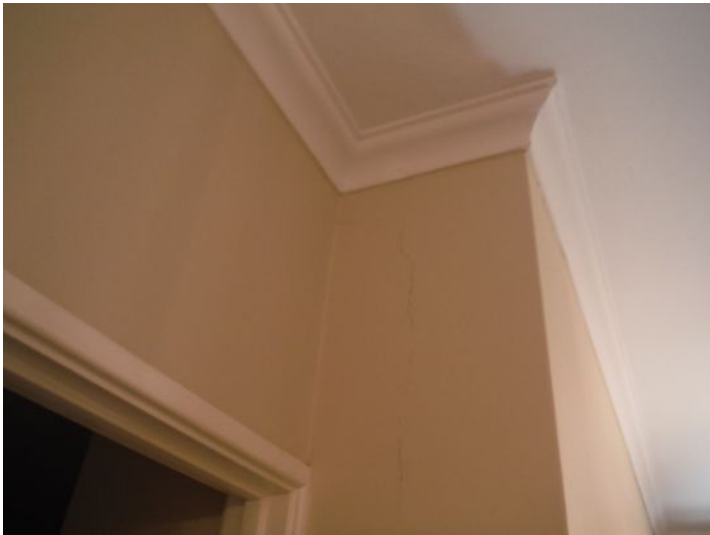
1. Wall Condition

- Very minor shrinkage cracks in the wall plaster in some locations. This is not a structural issue and can be repaired normally.
- There is evidence of dampness in the wall which is adjacent to the ensuite shower. This is most likely as a result of the seals and tile joints not functioning correctly. The tiles and joints should be checked for leaks and resealed to prevent any further dampness. Then the wall should be allowed to dry out fully before being sanded/repainted as required. This does not appear to have affected the structural integrity of the wall.

Adjacent to the ensuite shower.

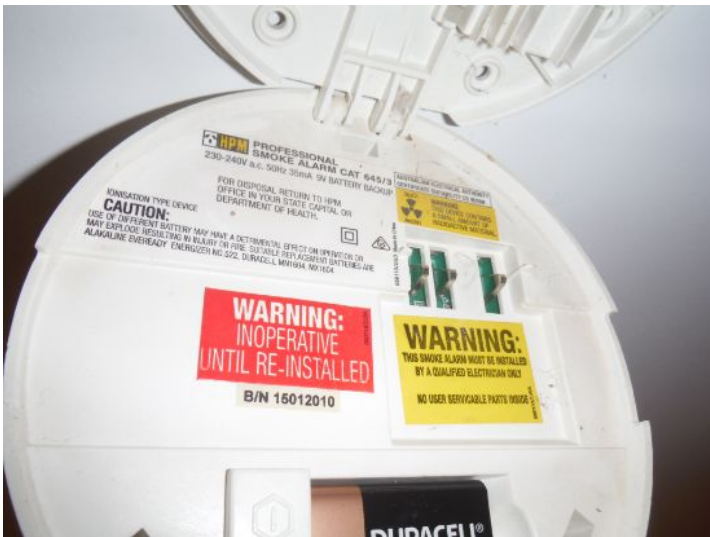
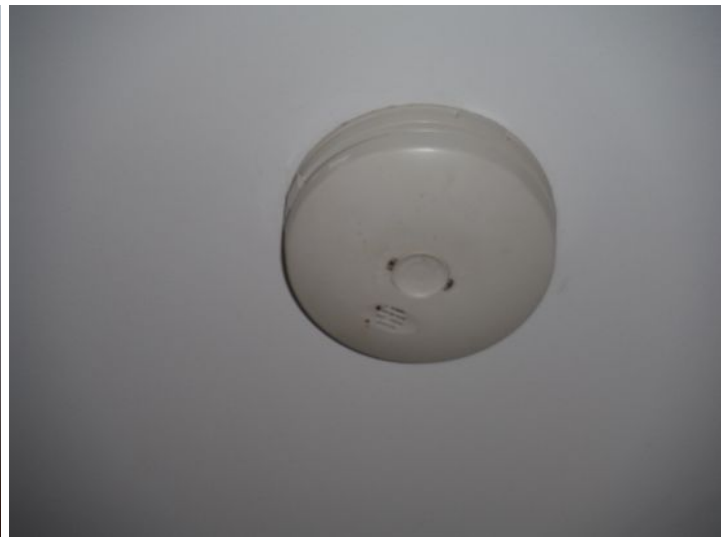
4. Smoke Alarms

Interior Areas		
Page 24 Item: 4	Smoke Alarms	<ul style="list-style-type: none">• Smoke alarms are out of date 2020 and need to be replaced. Legislation now states that hardwired smoke alarms must be under 10 years old and positioned relative to living and sleeping areas. Installation of new smoke alarms is required to be carried out by the vendors.

- Testing of smoke alarms is not included in this inspection. Pushing the "Test" button only verifies that there is power at the alarm--either a battery or hardwired to the house power--and not the operational workings of the alarm. The operational check is done by filling the sensor with smoke and is beyond the scope of this inspection. Battery operated smoke alarms should be checked routinely and the batteries changed frequently.
- **Smoke alarms are out of date 2020 and need to be replaced. Legislation now states that hardwired smoke alarms must be under 10 years old and positioned relative to living and sleeping areas. Installation of new smoke alarms is required to be carried out by the vendors.**

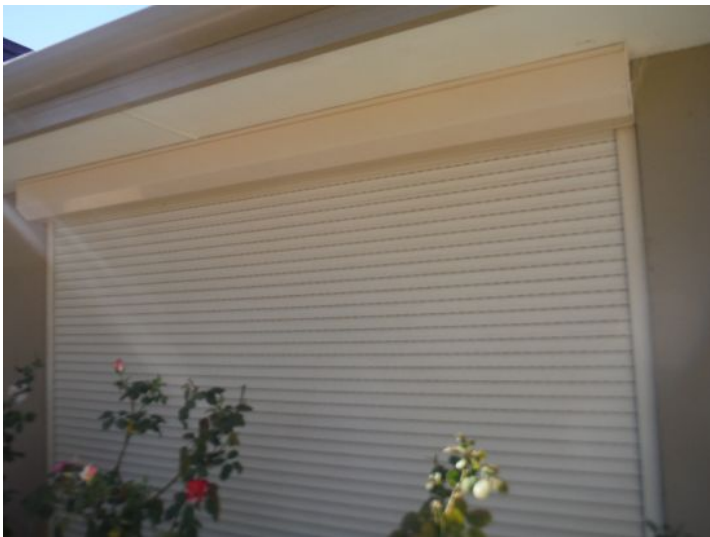
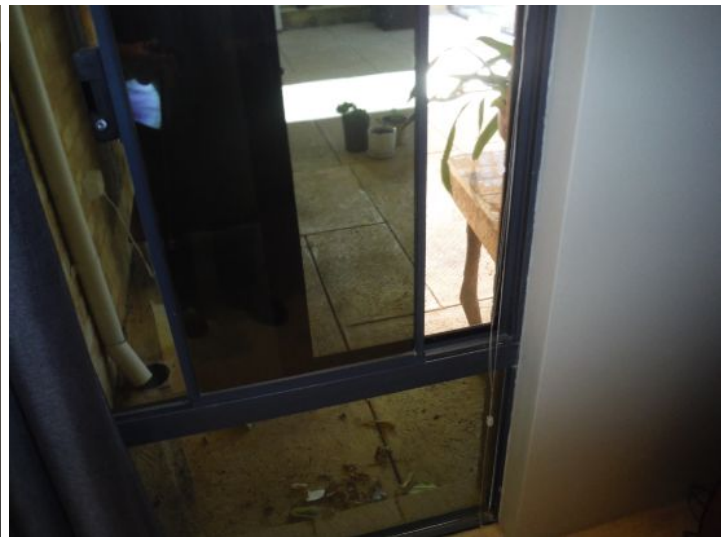
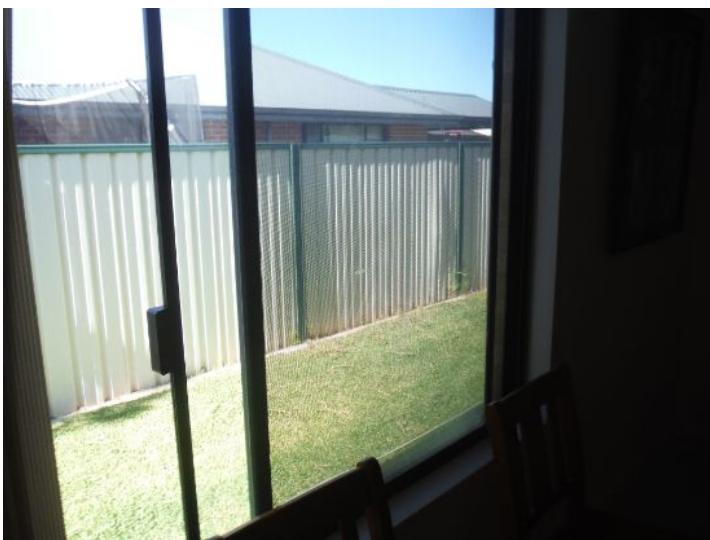
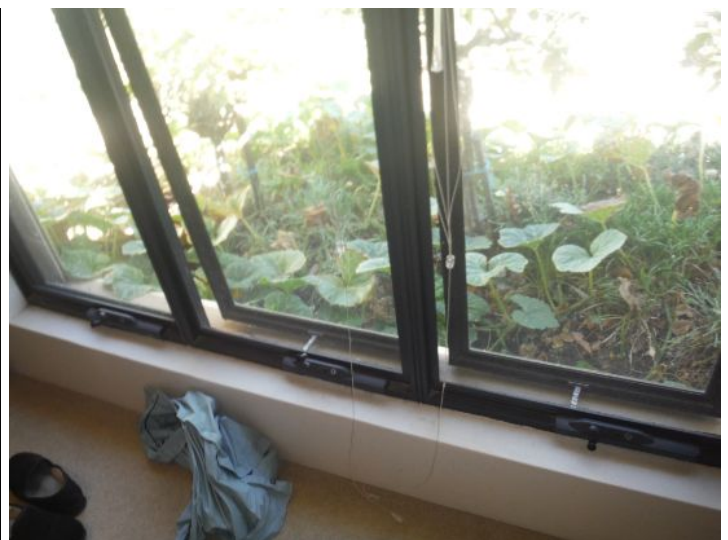
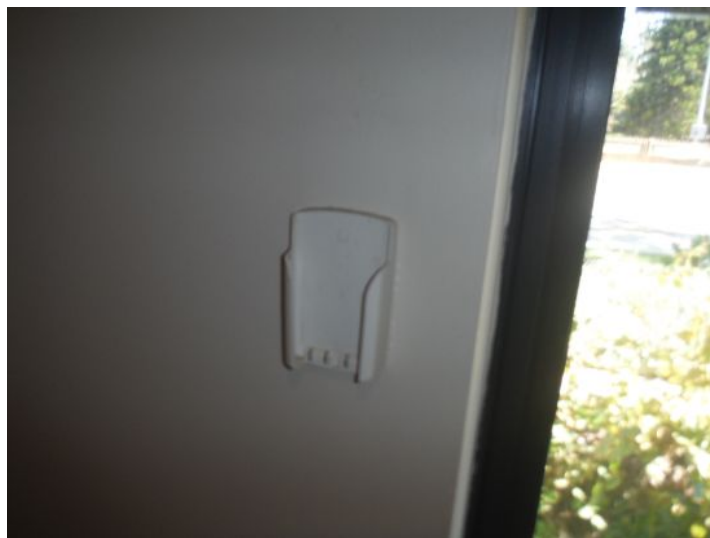
6. Window Condition

- Aluminum framed windows noted.
- Motor driven window shutters were noted.

- Windows operated during the inspection appeared functional.
- Window shutters operated during the inspection appeared functional. One controller battery pack present for these shutters.

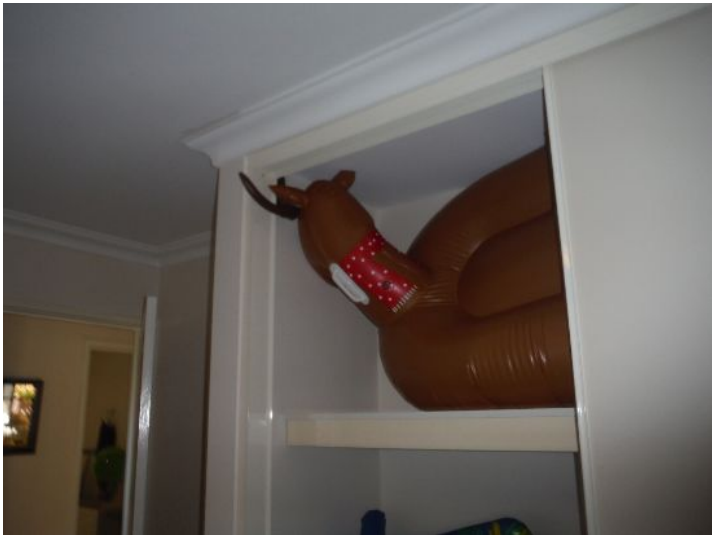
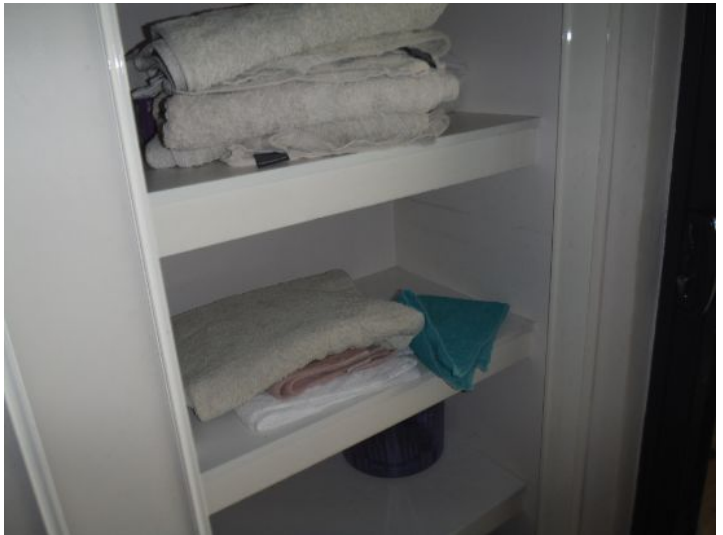
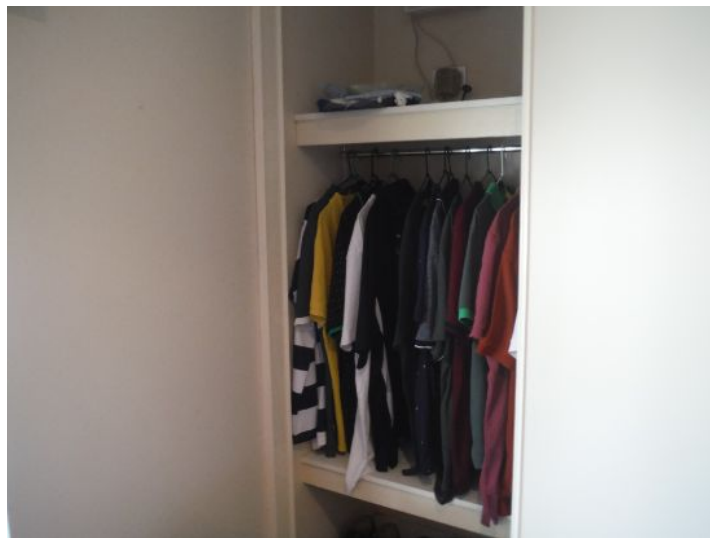
7. Closets

- The closets were in serviceable condition at the time of the inspection.

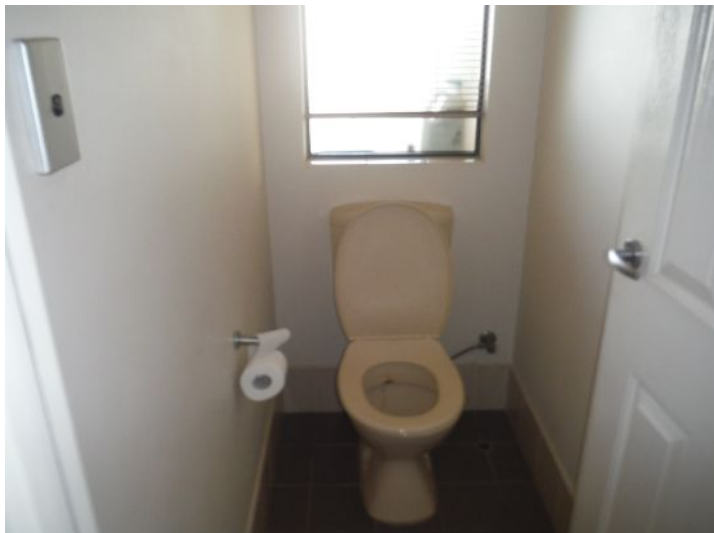
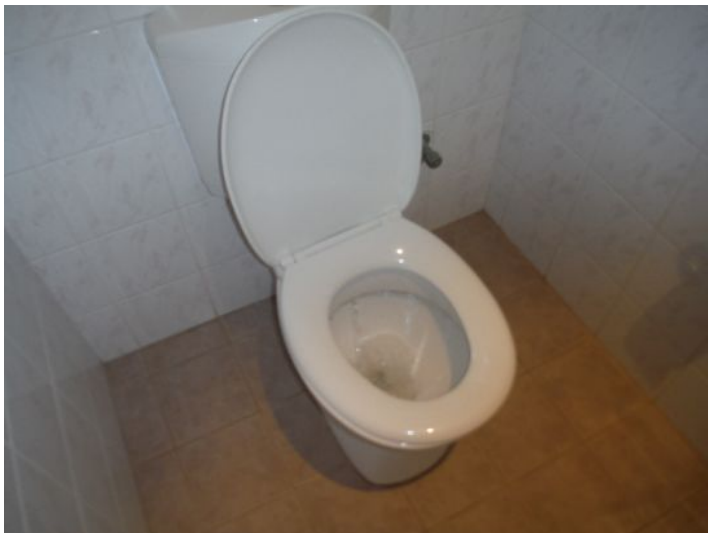
1. Toilets

- Operated when tested. No deficiencies noted.

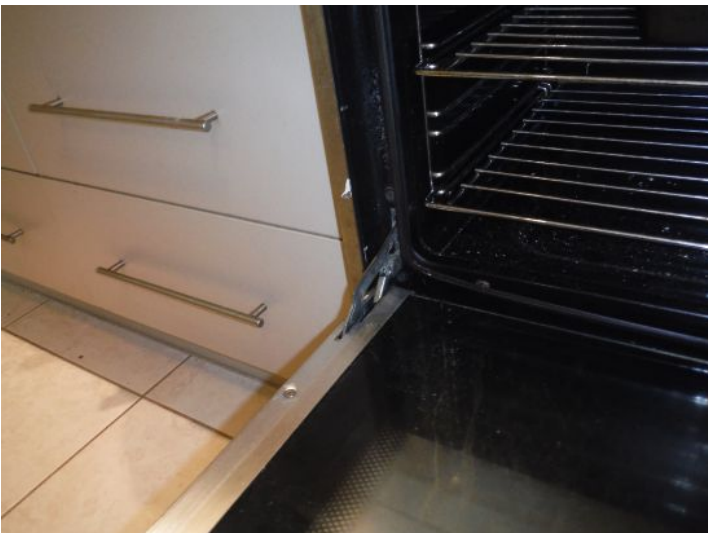
- The electric oven elements were tested at the time of inspection and appeared to function properly.
- The oven door does not seal properly and requires maintenance.
- The oven door opens fast. Recommend maintenance to the hinges to slow the door down.

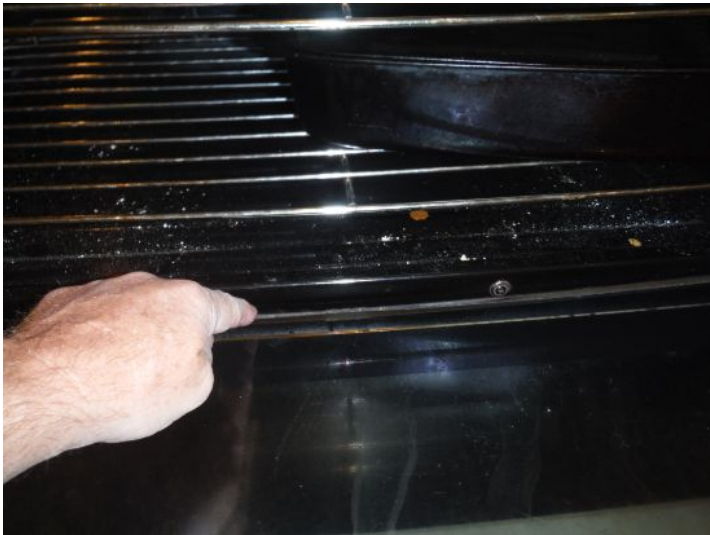
The rubber door seal is loose. maintenance

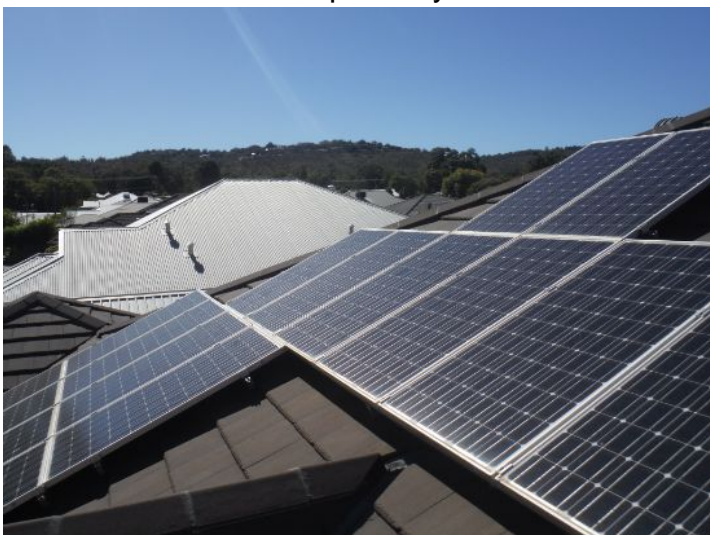
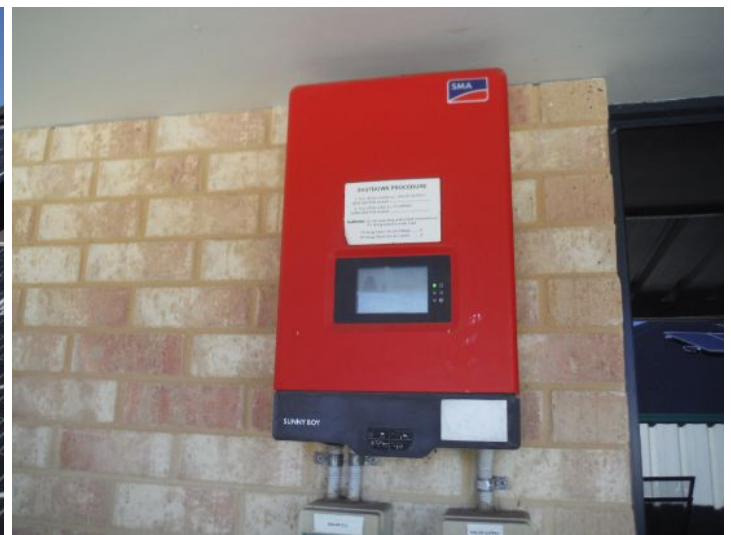
2. Photo Voltaic Panels

- The inverter for the PV system was located on the exterior west side of the home and appears to be functioning.
- As part of the inspection we can not confirm the effectiveness of the solar panel system.

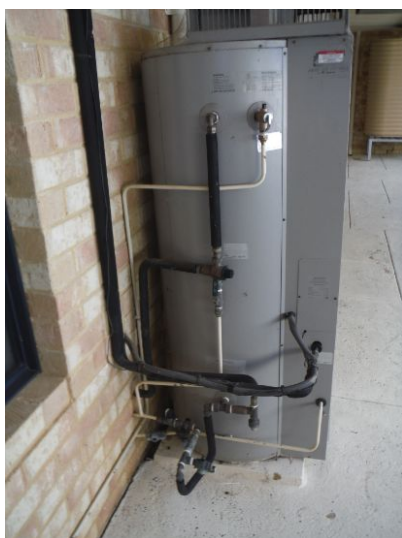
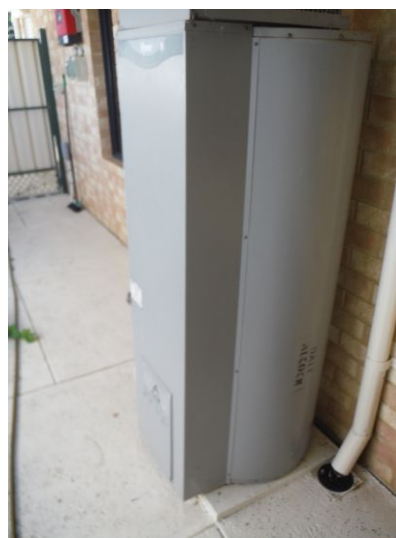
Noted small moisture stain, monitor this are. May be condensation.

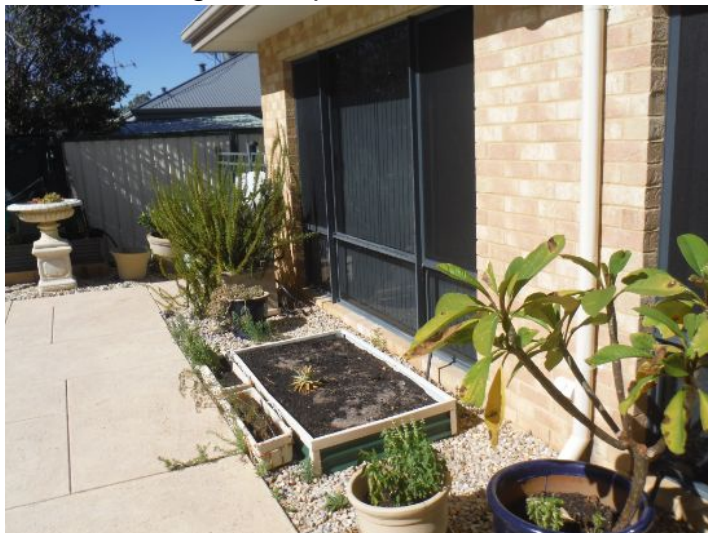
- There are a number of garden beds which are adjacent to the external walls. This can result in water moisture affecting the structure over time. If these beds are retained it is important that any watering is directed away from the building and kept to an absolute minimum and is controlled.

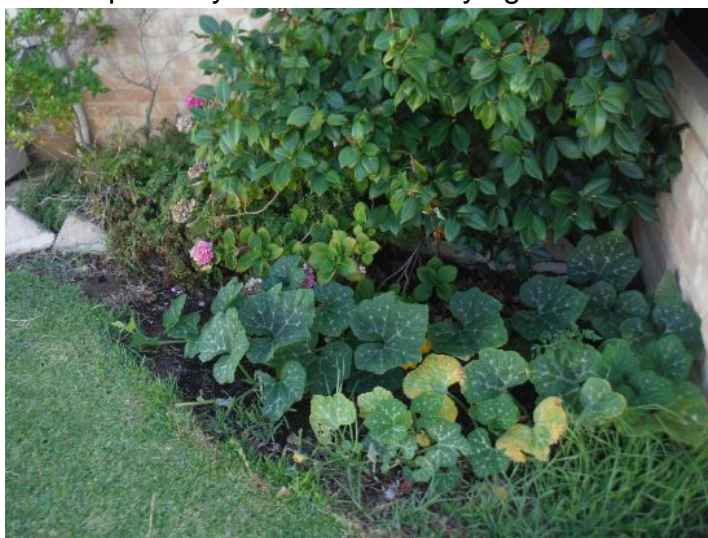
3. Vegetation Observations

- Prune or remove any plants that are in contact or proximity to home to eliminate pathways of wood destroying insects.

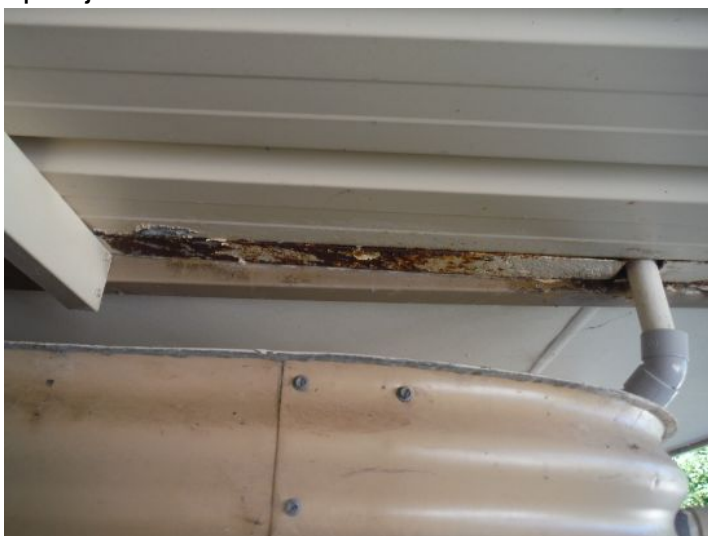
- One area of the patio frame has surface rust and require maintenance.
- Noted that the external alfresco ceiling is gyprock sheeting. It is important to keep this material well sealed and painted to prevent the ingress of moisture into the sheet material and taped joints.

Some corrosion noted at the patio outside the laundry. Recommend maintenance.

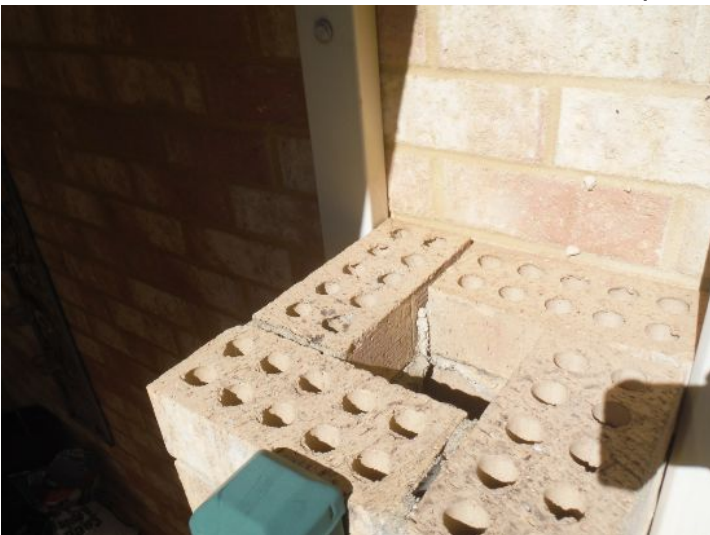
Noted the gate post pier is open at the top. You may wish to cap this with a slab

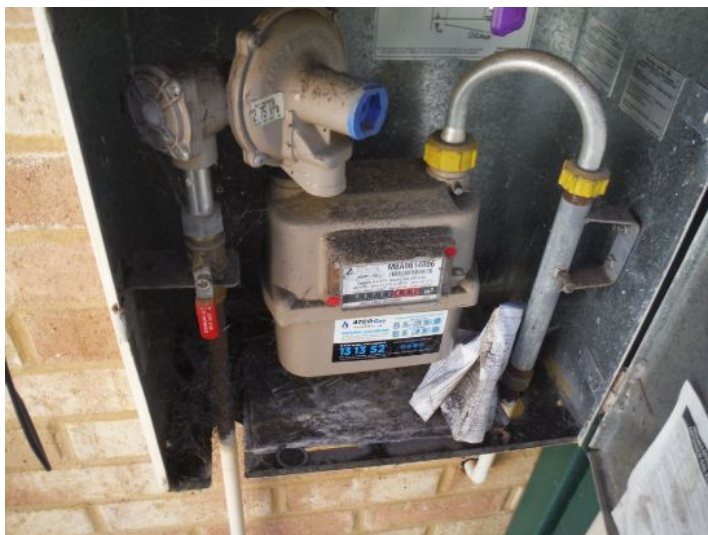
9. Main Gas Valve Condition

- Main gas shut off located at outside meter.

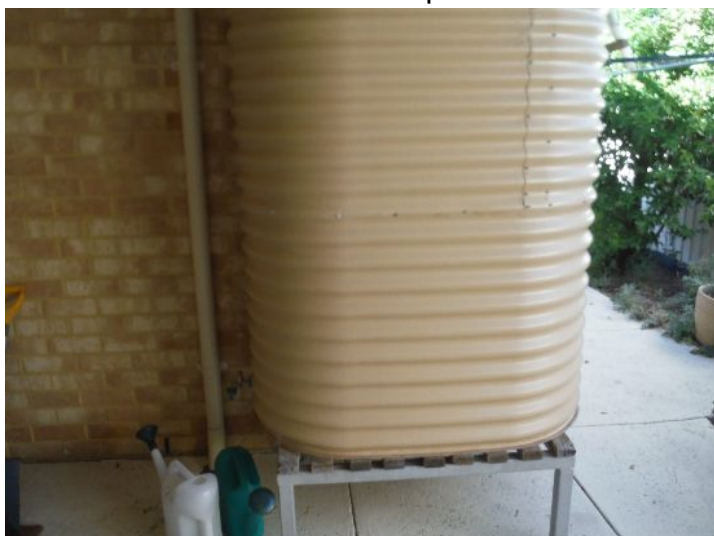
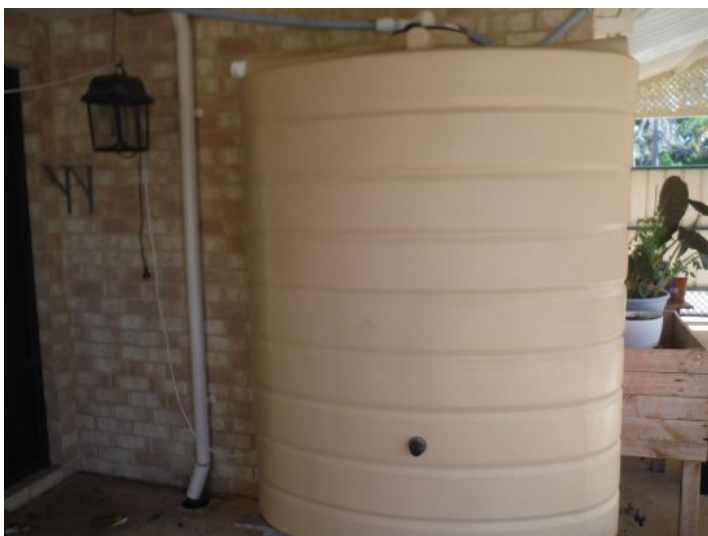
10. Plumbing

- Water tanks noted on the property.

- The water tank appeared serviceable and in good condition at the time of the inspection.

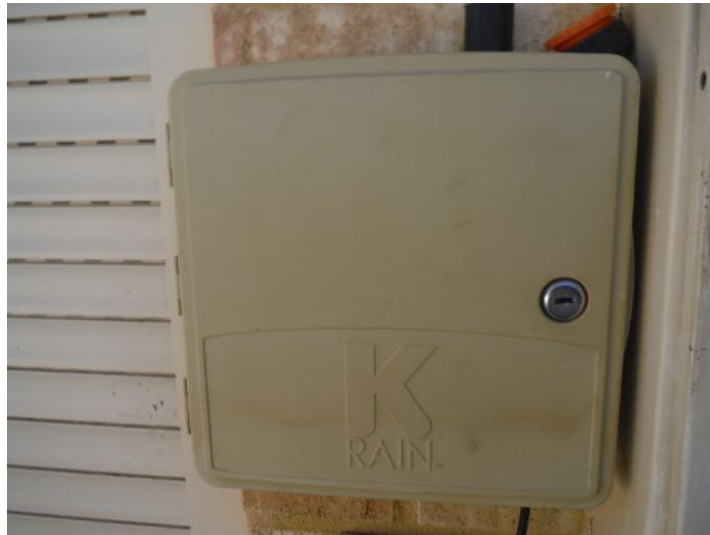
11. Sprinklers

- Sprinkler system was noted. It is not tested as part of the inspection. This should be tested at the final settlement inspection.

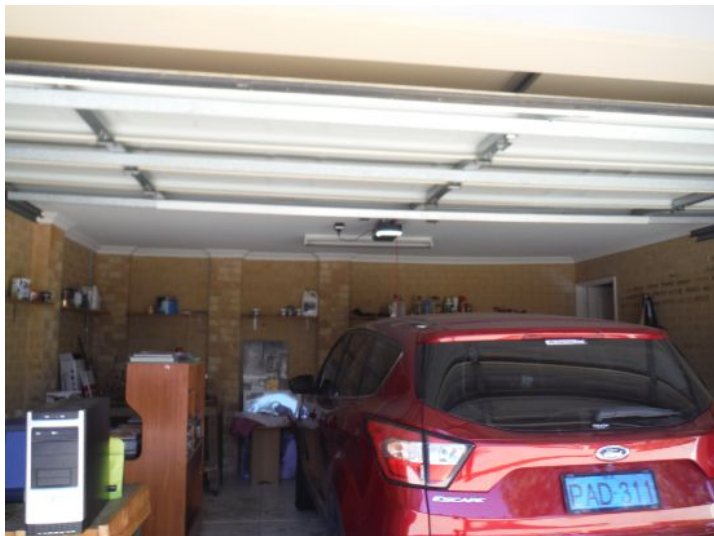
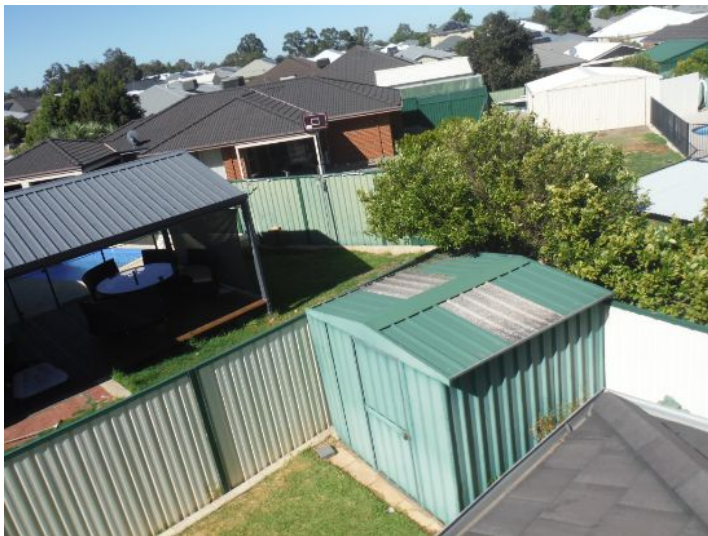
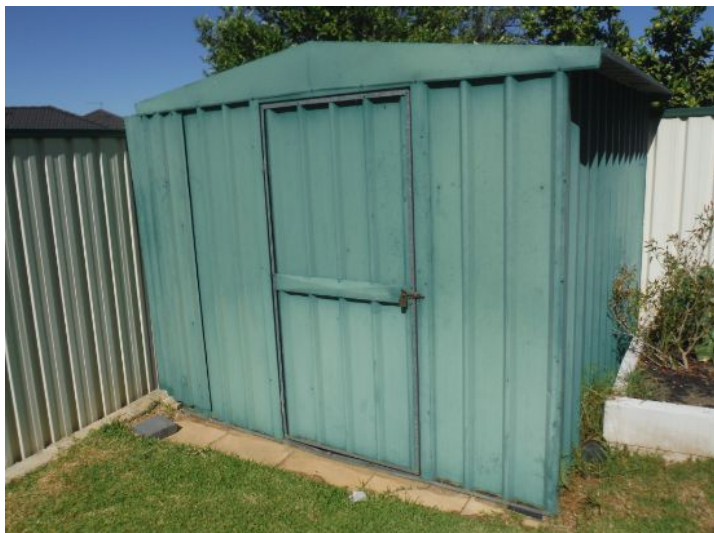
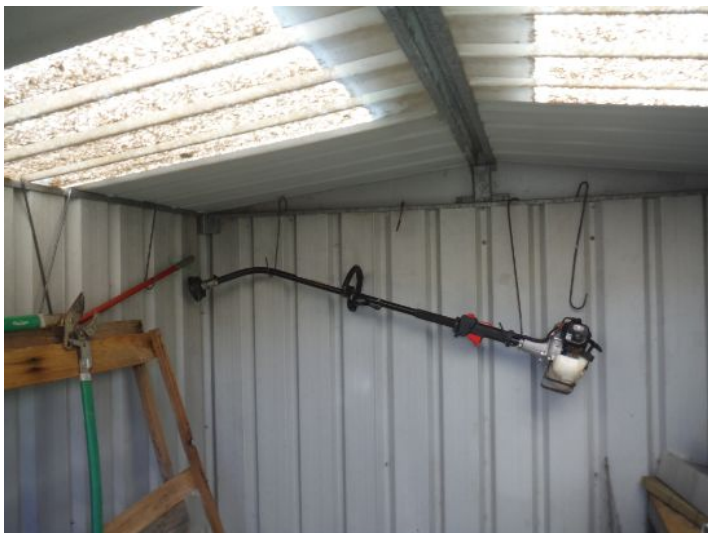
1. Garage and Shed

- The attached brick garage appears structurally sound.
- The rear metal shed appears to be structurally sound.

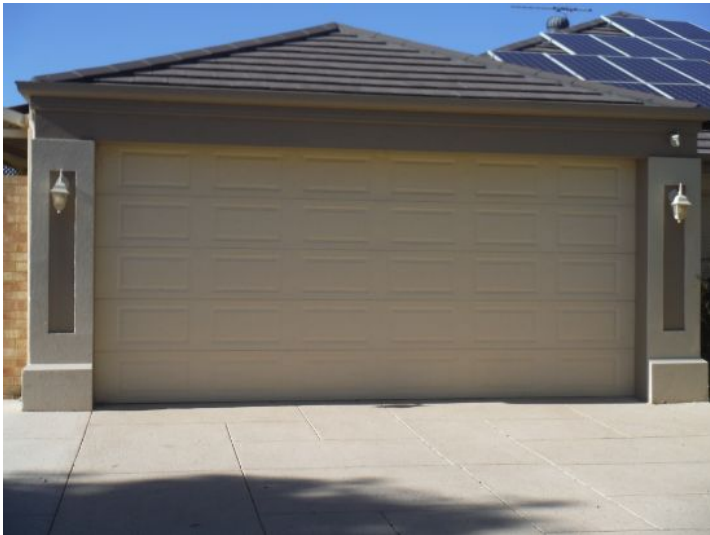
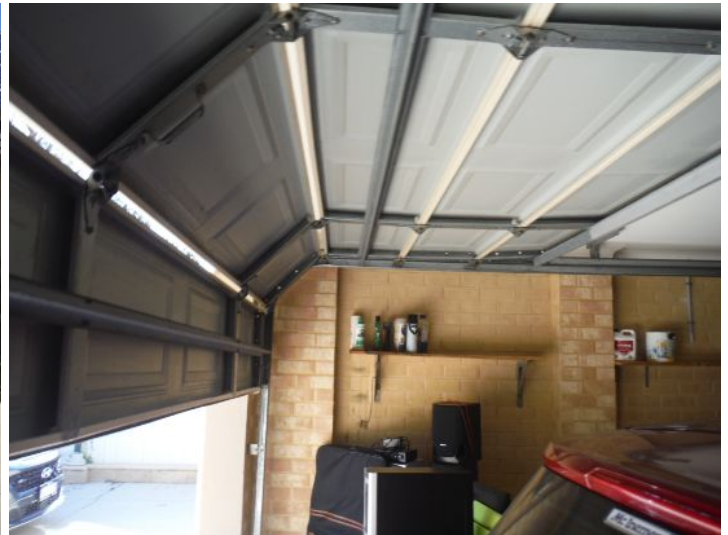
2. Garage Door Condition

- Sectional door noted.

- No deficiencies observed.

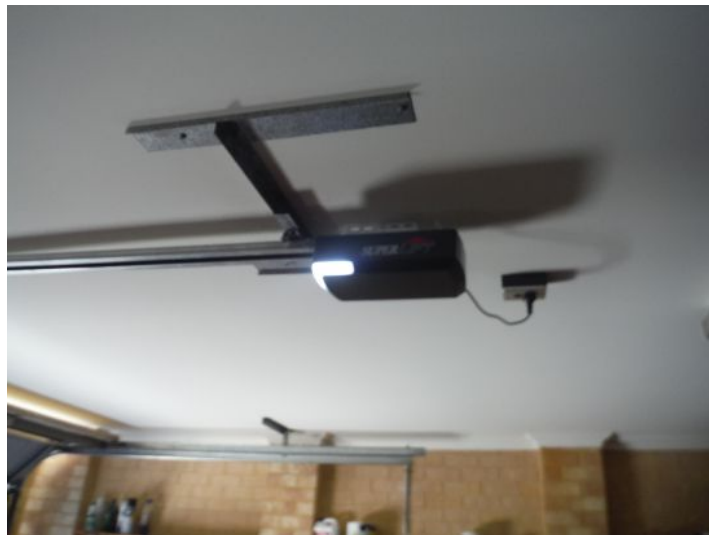
3. Garage Opener Status

- Appeared functional using normal controls, at the time of inspection.

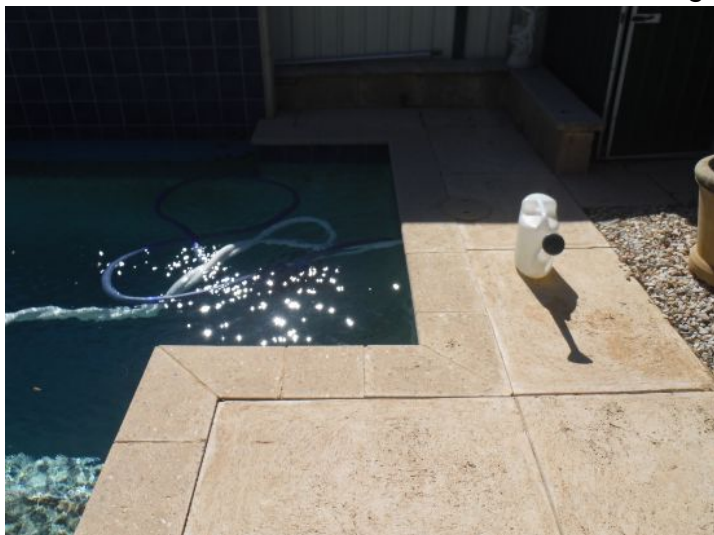
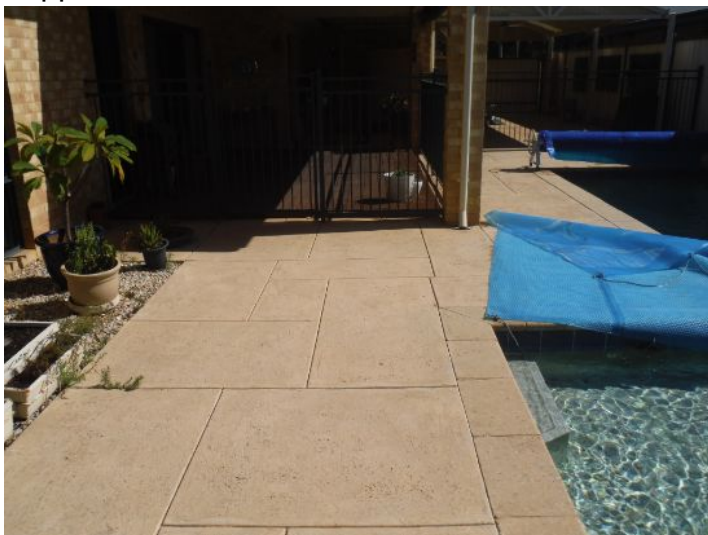
1. Deck Condition

- Deck was examined and appears in satisfactory and functional condition with normal wear for its age. Appears to be a sound structure.

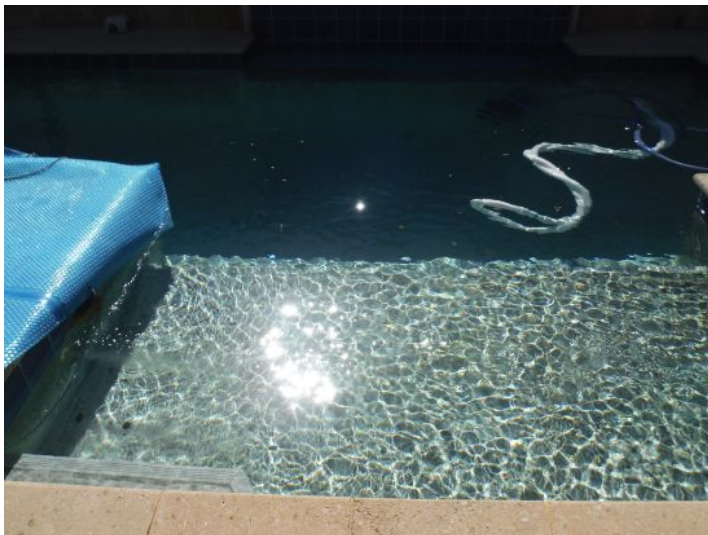
2. Structure Condition

- Some surface staining was noted on the walls.

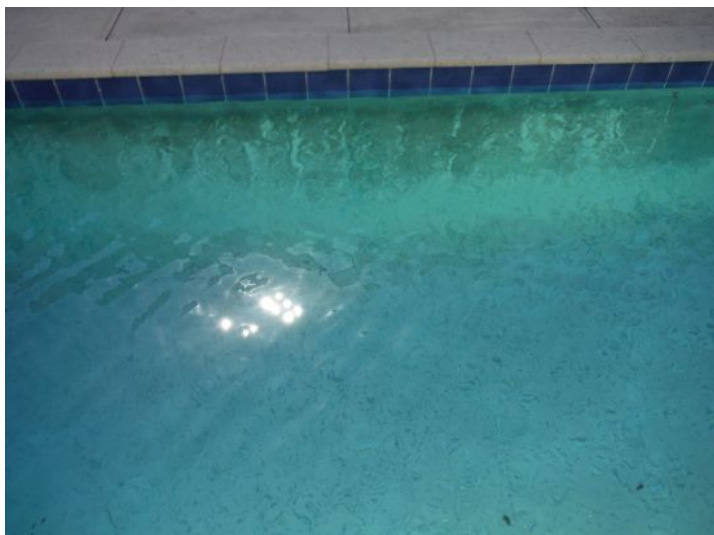
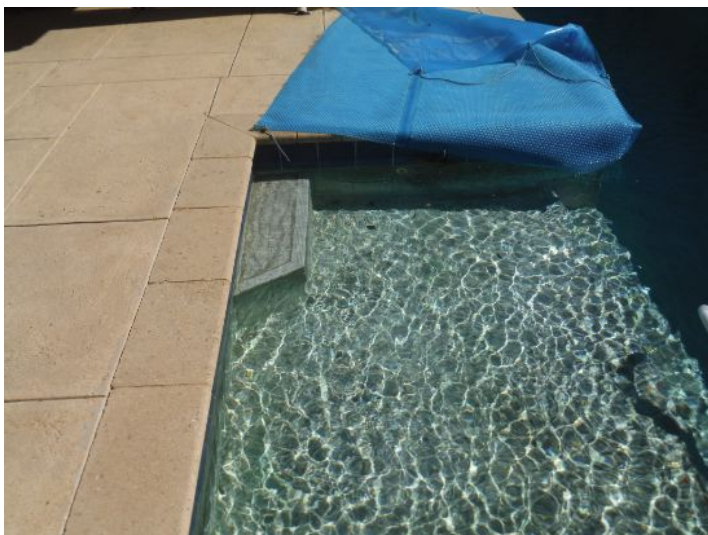
3. Water Condition

- Clear.

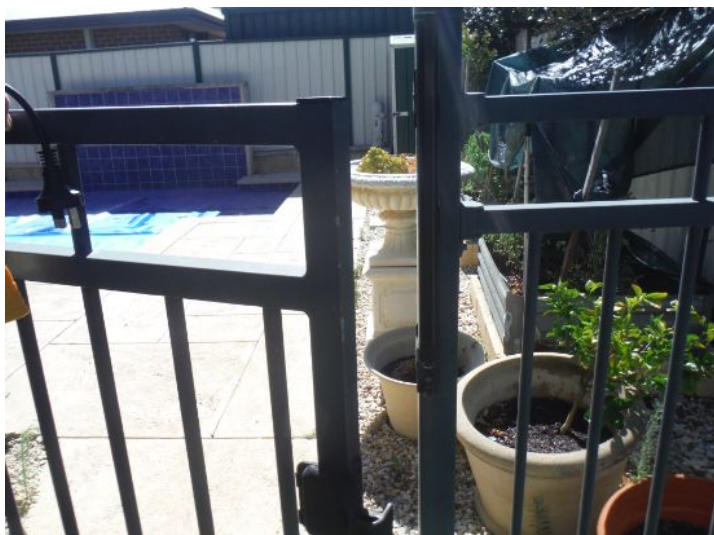
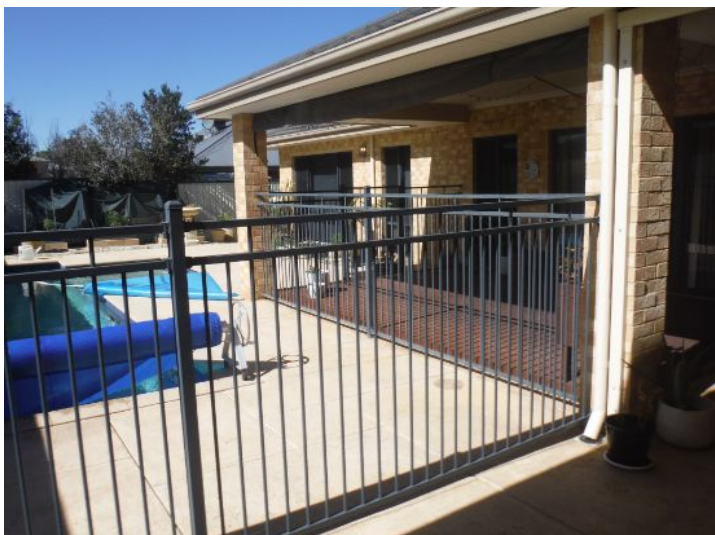
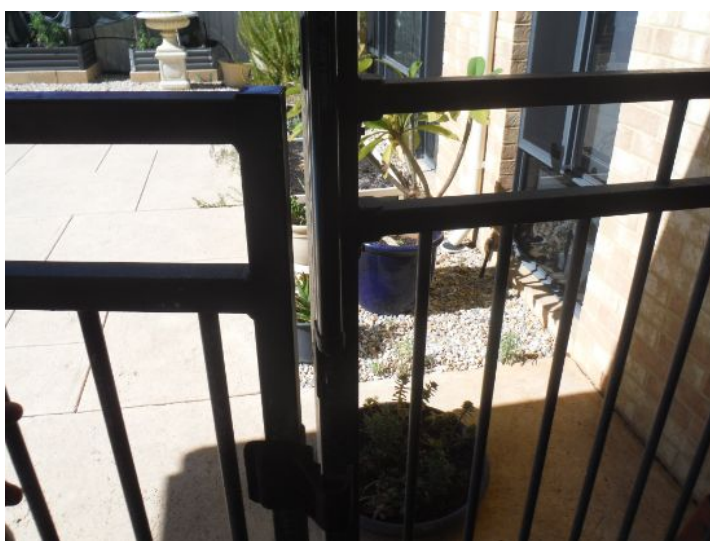
4. Pool Barrier Condition

- The pool barrier appears to be satisfactory and to comply with the required regulations. For confirmation, please consult with a pool fencing specialist.

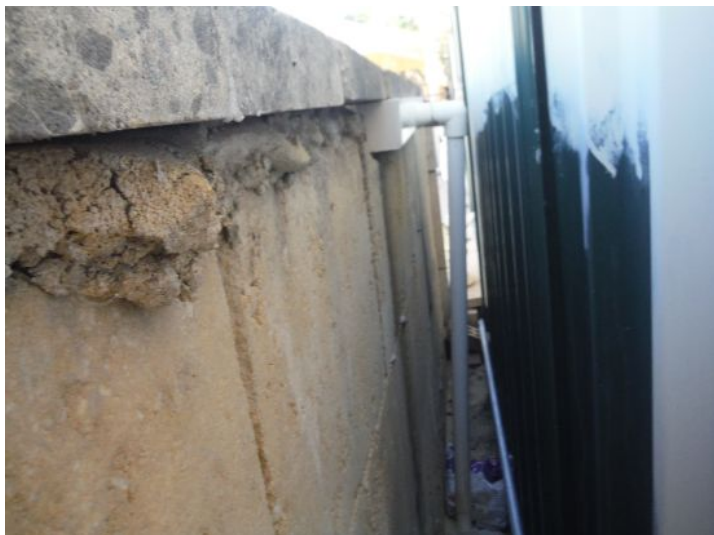
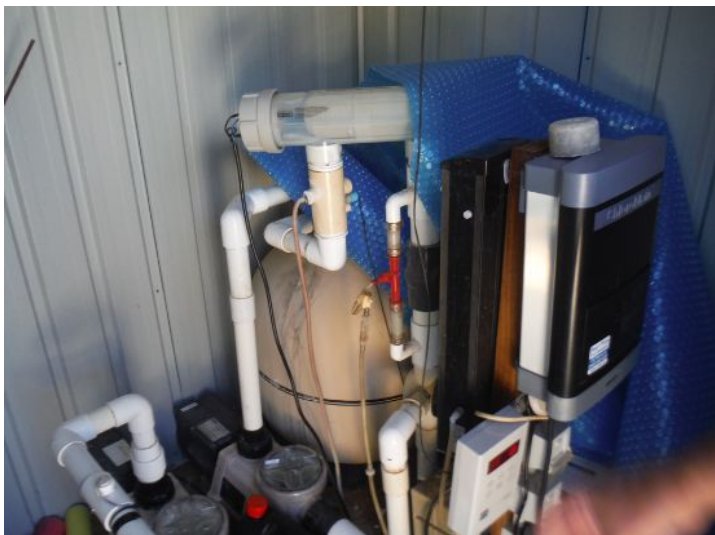
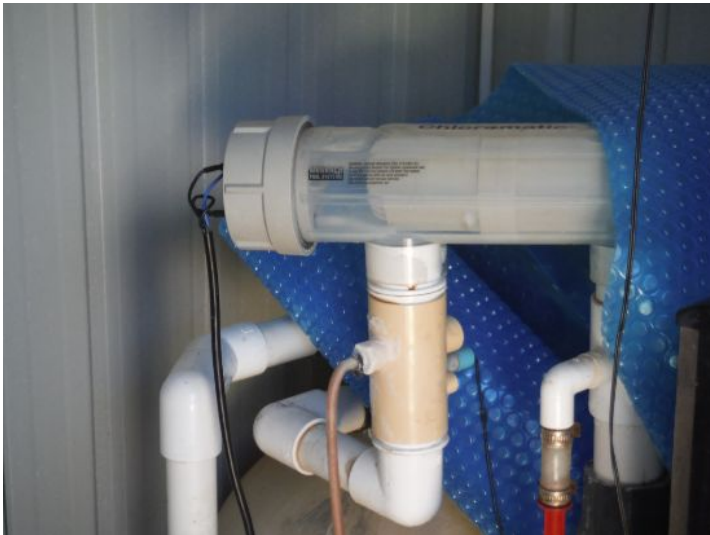
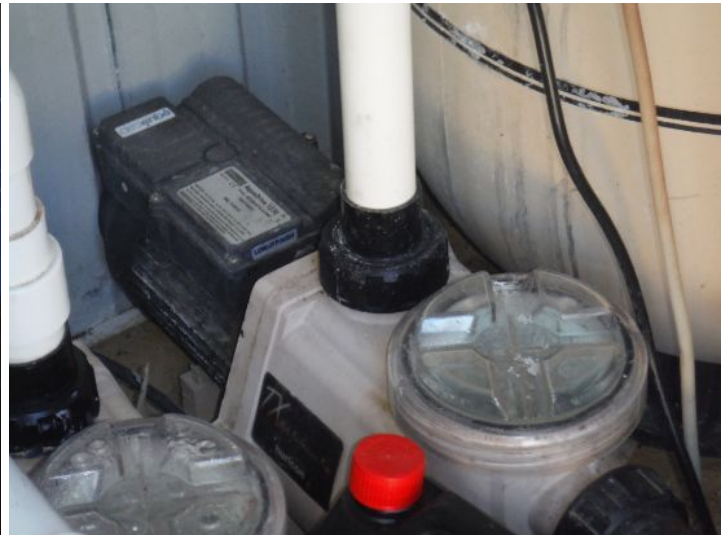
5. Pumps

- Operated normally when tested.
- The main pool pump and the chlorinator controller have been replaced the seller stated.

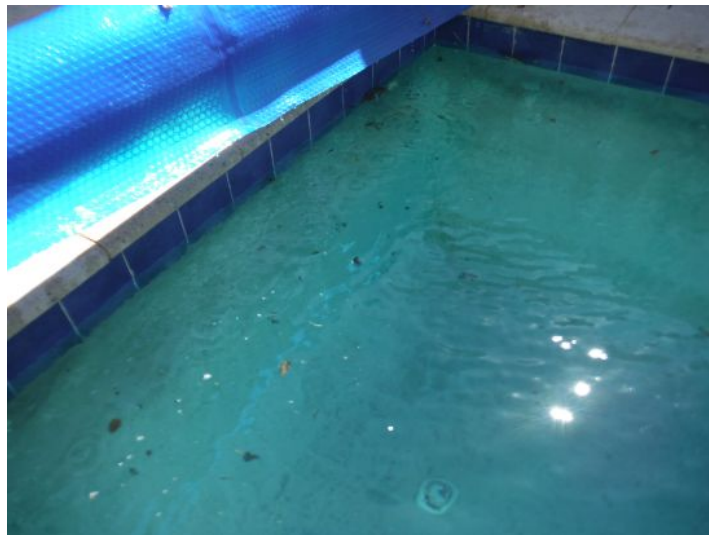
6. Jets

Observations:
 • Operated.

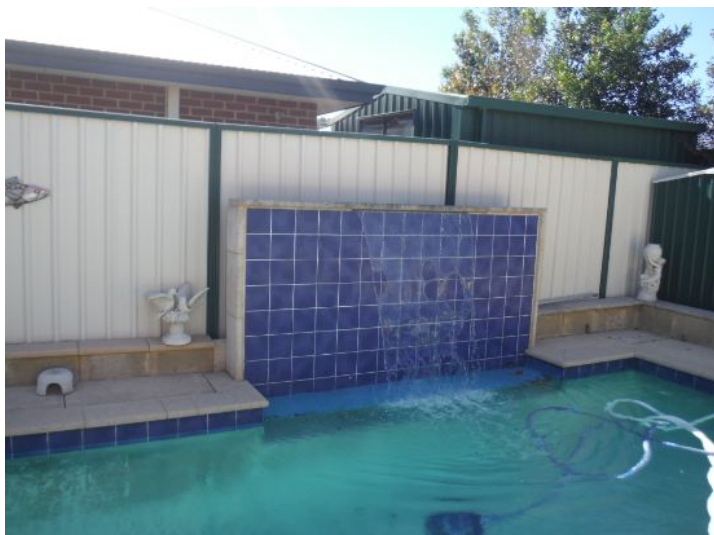
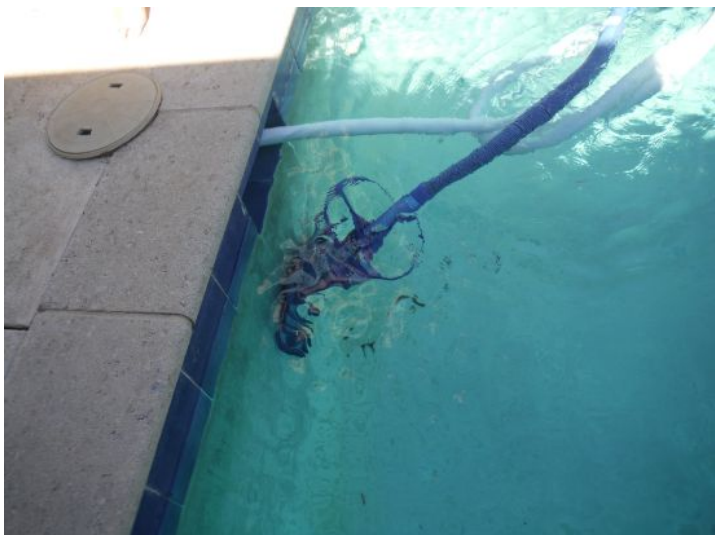
7. Return System Observations

Materials:
 • A water recirculation system in a swimming pool with a depth of water more than 300mm must:
 i. for a spa pool, comply with AS 1926.3 except the specified distance between two outlets connected to a common line may be not less than 600mm; and
 ii. for all other swimming pools, comply with AS 1926.3.
 Observations:
 • The return was noted to be in satisfactory condition.

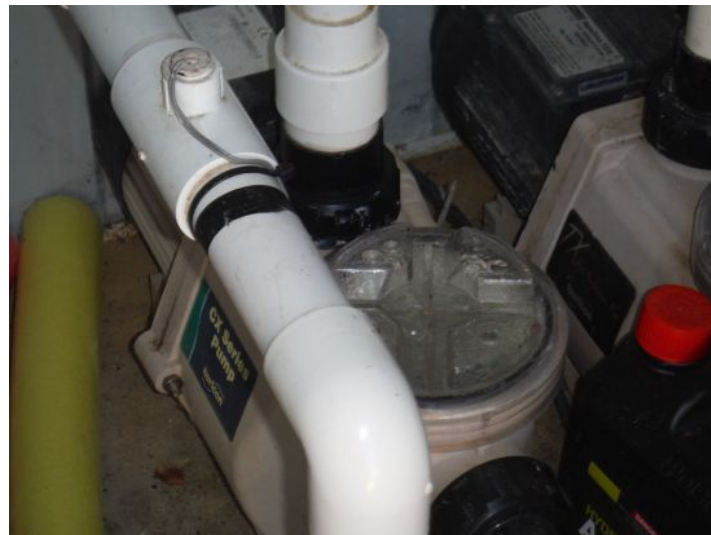
8. Pool Heater

New heater tubing system has been installed in the last two years. Monitor for leaks as this carries salt water.

Old system still present.

Not tested in our inspection.

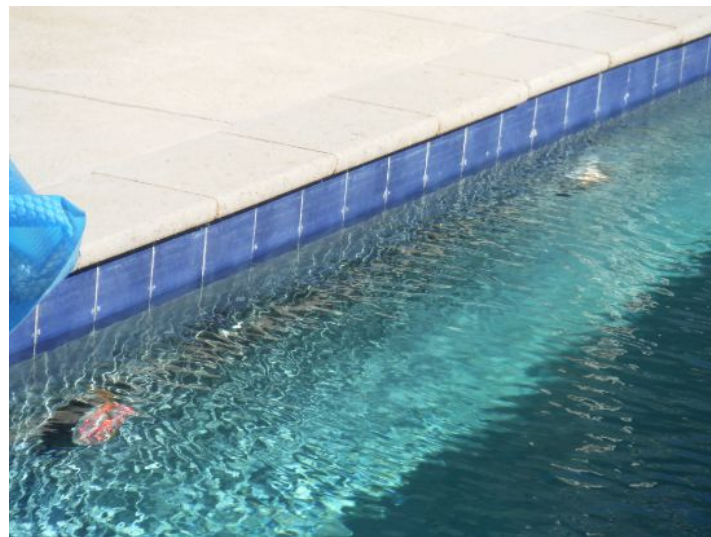
9. Lights

- Operated at the time of the inspection.

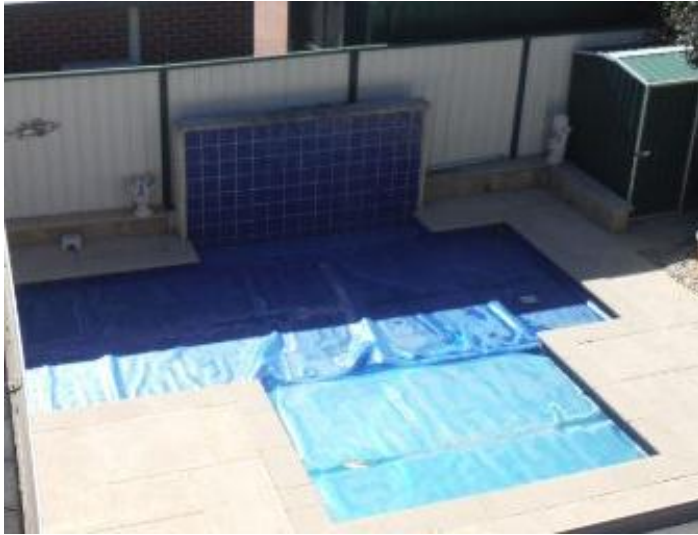
10. Pool Cover Observations

- The pool cover appears to be in satisfactory condition for its age. Noted three pieces.
- The pool cover should have an external white cover fitted when stored on the roller to prevent sun damage.
