Property Inspection Report

Sample Report, WA

Inspection prepared for: Sample Report
Date of Inspection: 20/10/2023 Time: 8:30am
Weather: Fine 20C

- Dilapidation Inspection

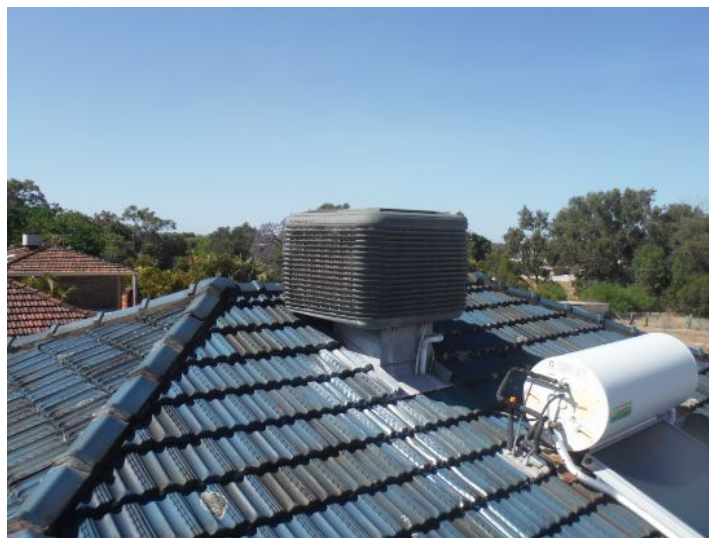
Monitor the AC unit when in use. Stains noted. This may be leaking.
