Property Inspection Report

Sample Report, WA

Inspection prepared for: Sample Report
Date of Inspection: 13/9/2023 Time: 9:00 AM
Weather: 15C Rainy

Type:
• Standard Handover Defects Inspection
Reason:
• New Home Construction Handover

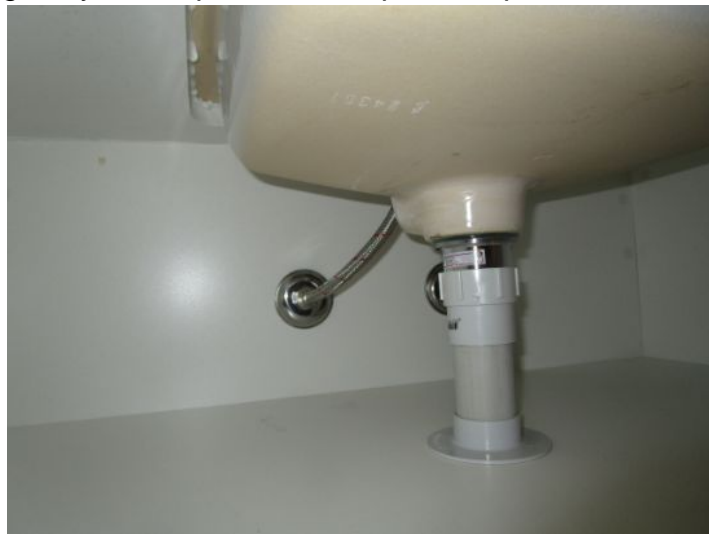
- We recommend all braided flexible water hoses in the property be checked regularly and replaced as required to prevent water damage.

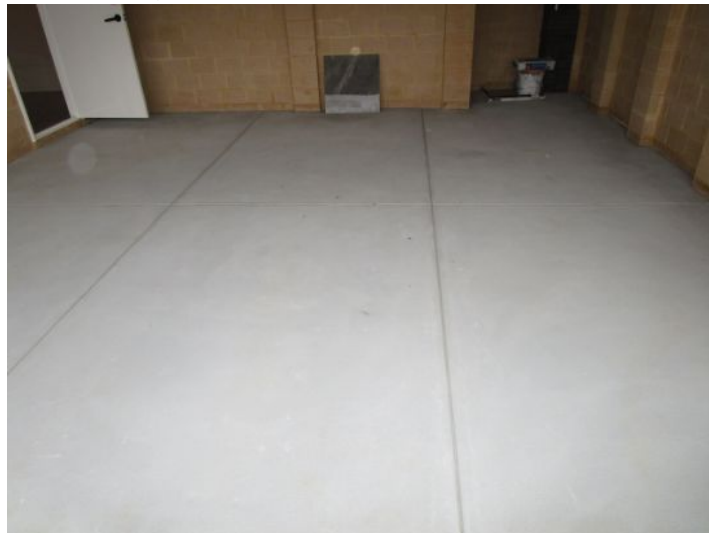
- Visible sections of the concrete slab appeared satisfactory.
- Most areas of the concrete slab not visible due to floor coverings.
- All concrete floor slabs experience some degree of cracking due to shrinkage in the drying process. In most instances floor coverings prevent recognition of cracks or settlement in all but the most severe cases. Where carpeting and other floor coverings are installed, the materials and condition of the flooring underneath cannot be determined.

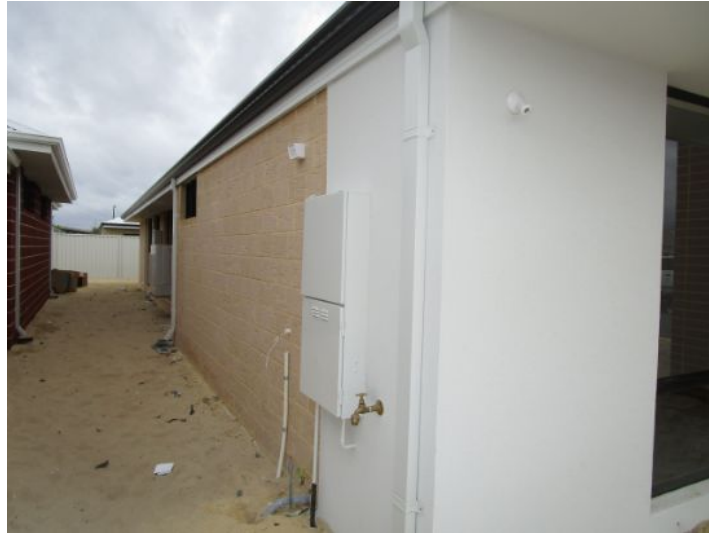
- The wall structure components appeared functional.
- The external walls of the home are of a double brick construction, which contains an internal cavity.

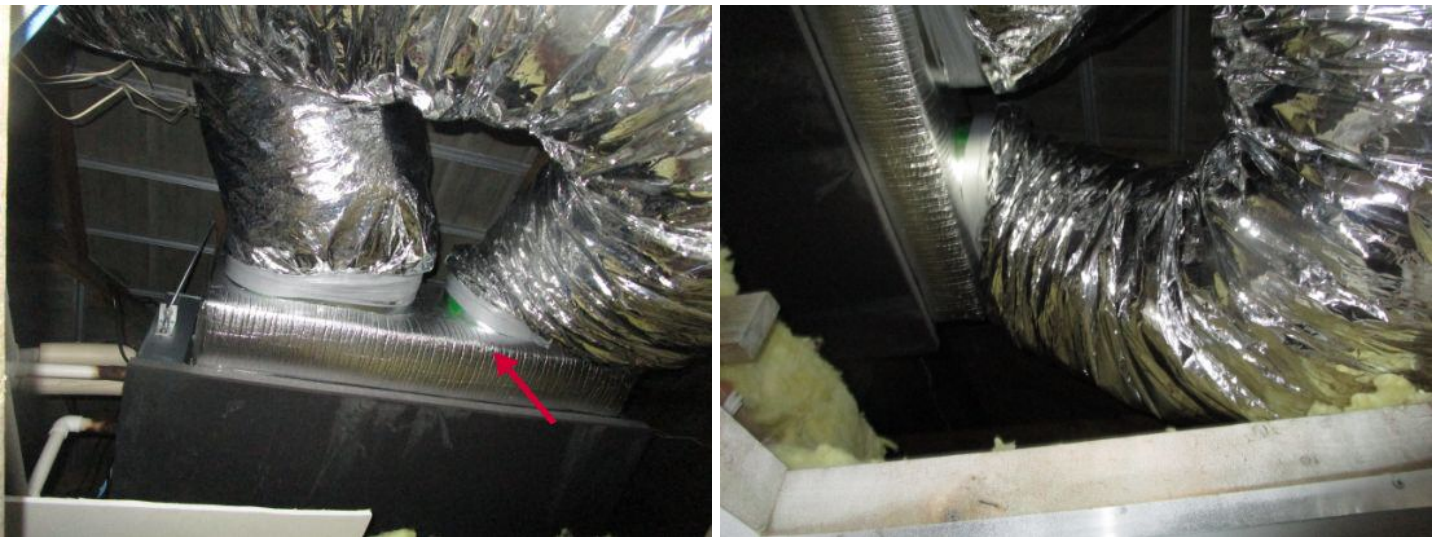
- Did not inspect, unable to access roof space due to air-conditioning unit blocking access. Recommend sealing the current manhole and making another one in garage.

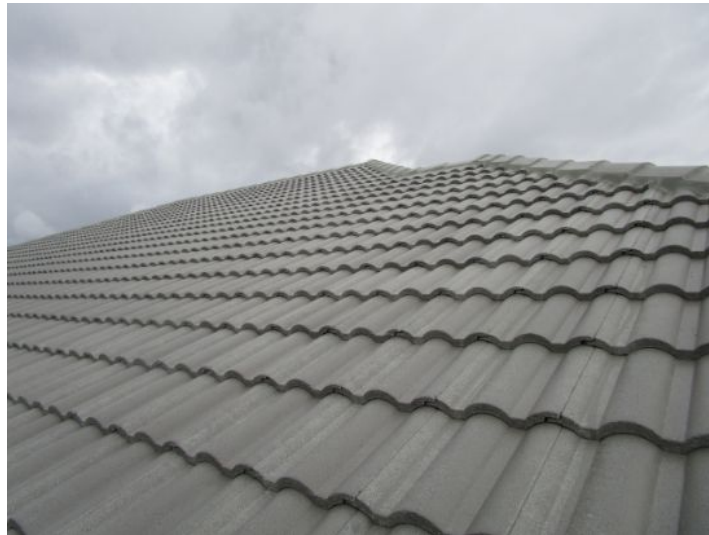
- The concrete tile roofing material appeared to be in satisfactory condition other than noted.

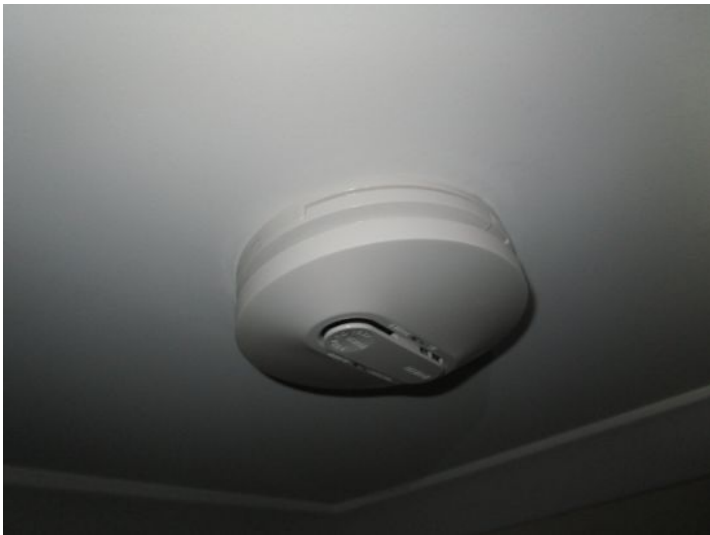
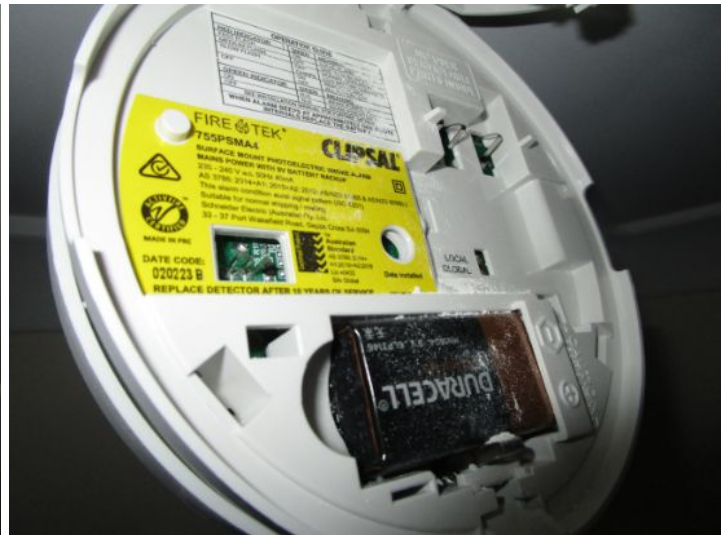
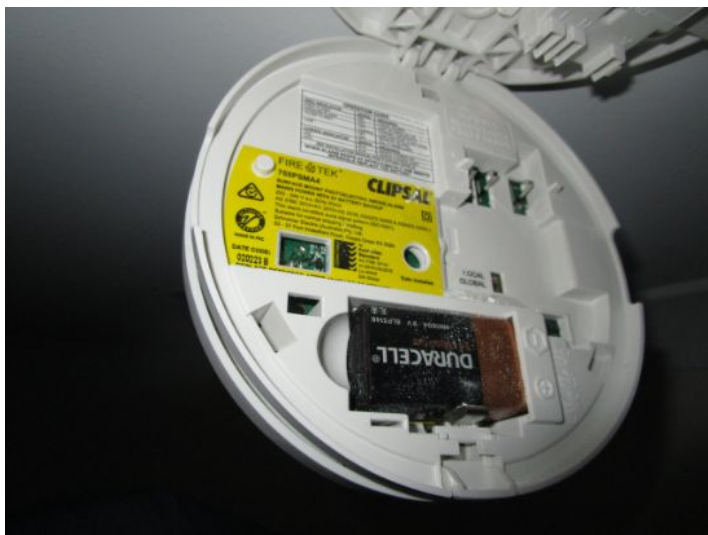
- Testing of smoke alarms is not included in this inspection. Pushing the "Test" button only verifies that there is power at the alarm--either a battery or hardwired to the house power--and not the operational workings of the alarm. The operational check is done by filling the sensor with smoke and is beyond the scope of this inspection. Battery operated smoke alarms should be checked routinely and the batteries changed frequently.
- There are two hardwired smoke alarms installed in the bedroom hallway areas. They are due for replacement in 2033.

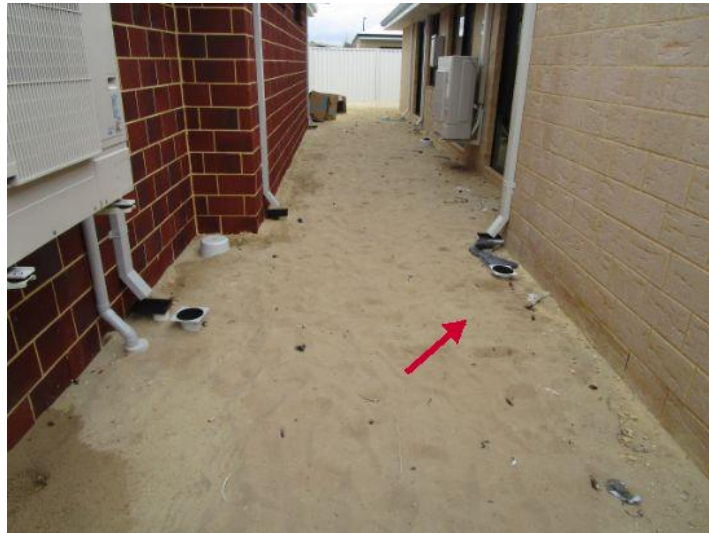
- Lot grading and drainage have a significant impact on the building, simply because of the direct and indirect damage that moisture can have on the foundation. It is very important, therefore, that surface runoff water be adequately diverted away from the home. You should consider paving around the home or laying grass with a slope away from the foundations to prevent water from soaking in adjacent to the foundations.
