# Property Inspection Report

Inspection prepared for: Sample Report  
Date of Inspection: 18/3/2022 Time: 12:00PM  
Weather: Cloudy 27C

Inspector: Resicert Property Inspections  
Sample Report

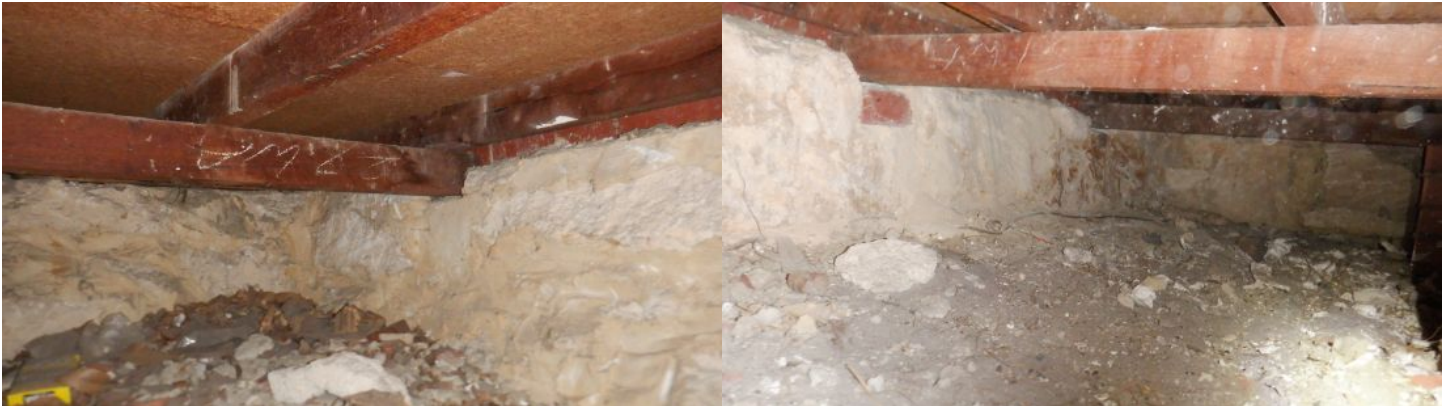
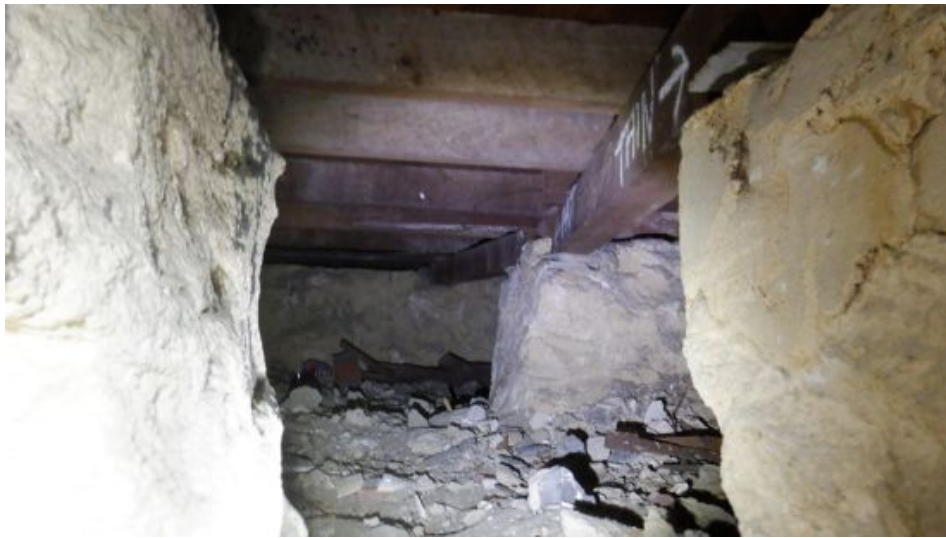
- Posts and Girders:**
- Brick piers
  - Limestone foundations.
- Observations:**
- The foundations appear to be performing satisfactorily.
  - Some low areas could not be accessed. Recommend these areas have hatches cut in the floor above for future inspections.

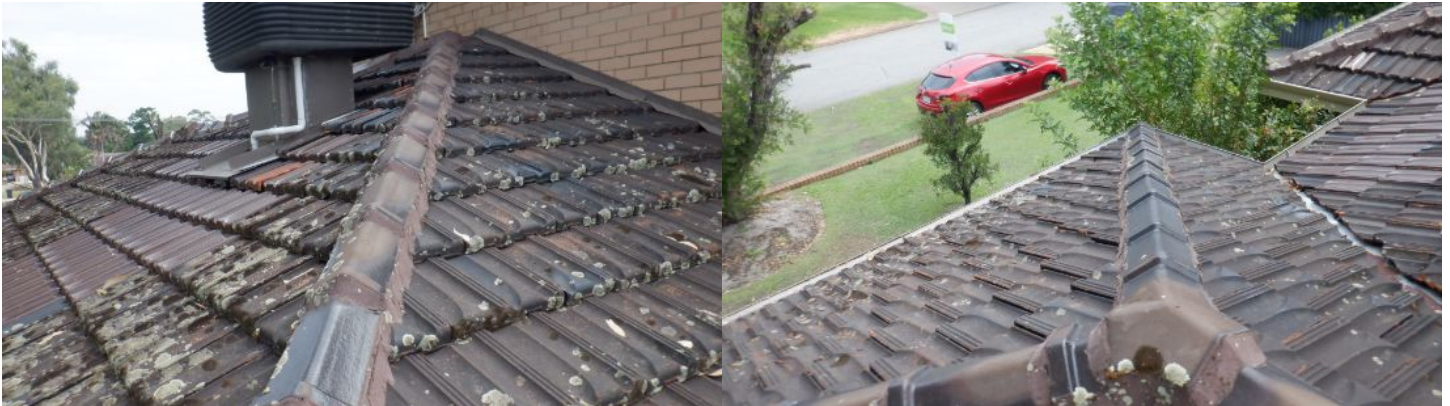
- The clay tile roof covering appears to be in satisfactory condition other than noted.

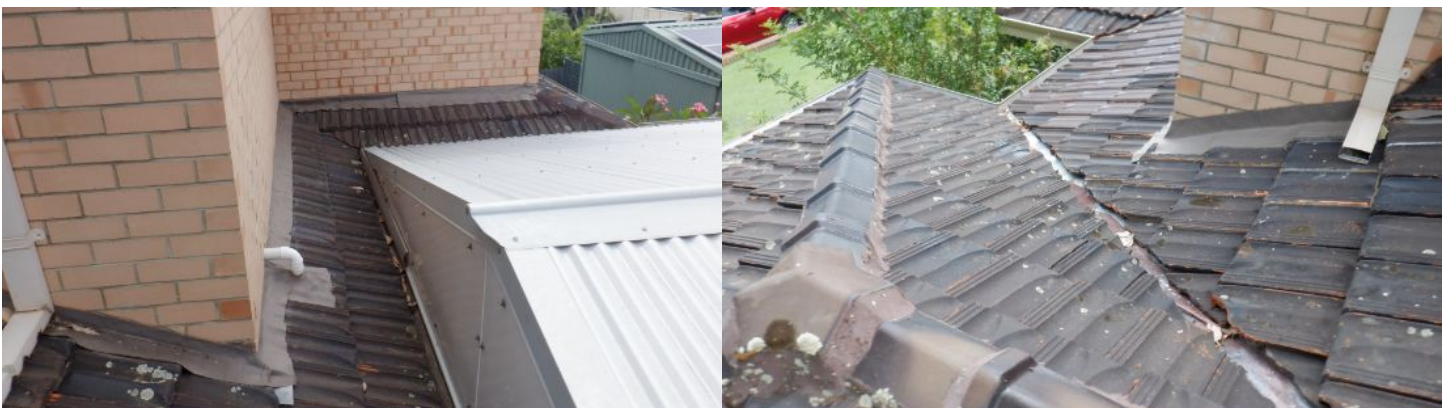
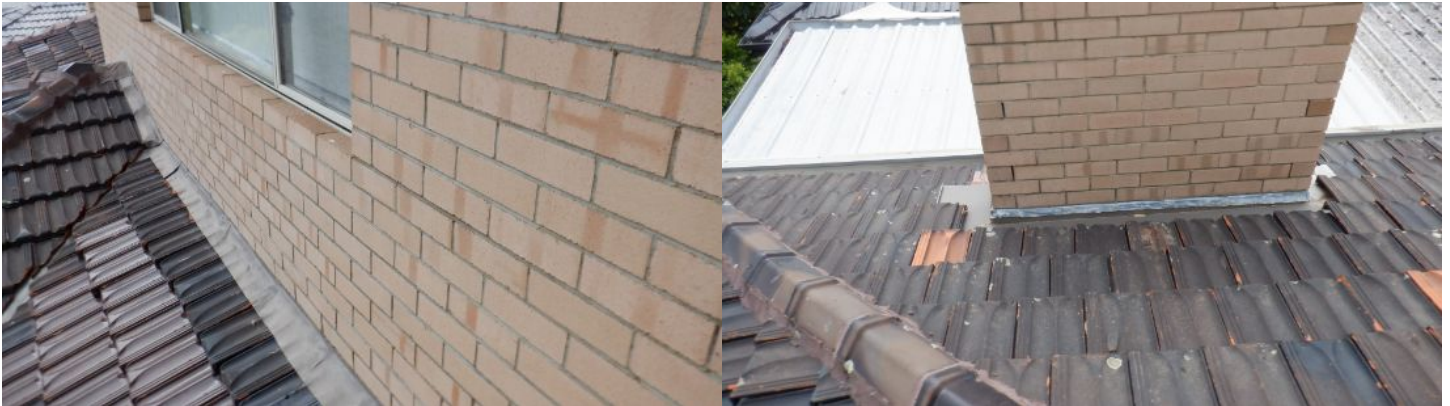
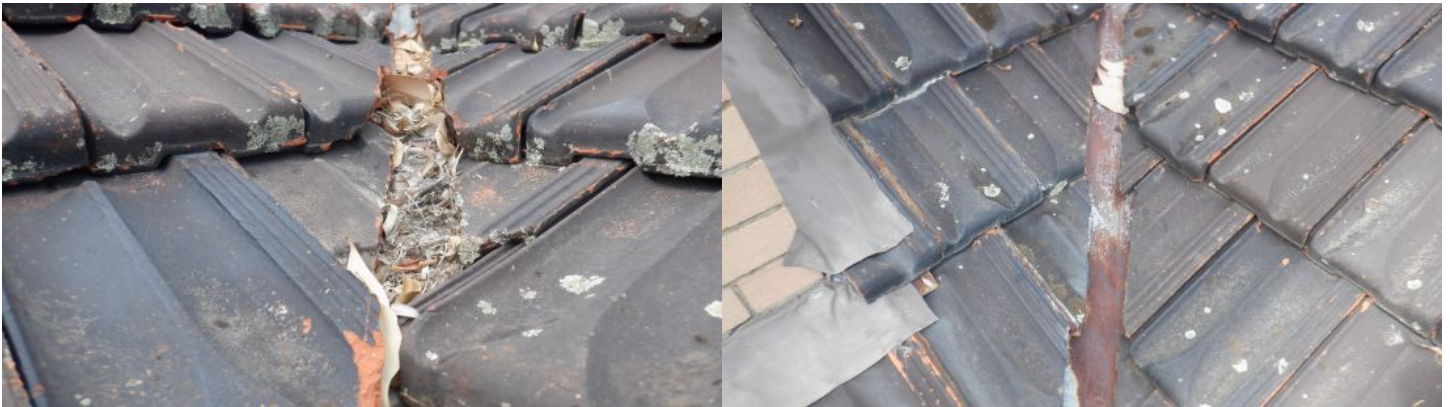
- Flashing is an impervious material (usually galvanized sheet metal) that comes in a variety of shapes and sizes and is used to cover, waterproof, and direct water away from roof penetrations and from **valley**s and intersections between the roof covering and other materials.
- The roof flashing, where visible, appears to be in satisfactory condition.
- Some of the **valley flashing**s have some leaf debris which should be cleared out.
- Some of the valley flashing has some rust and should be painted with a rust guard paint to prevent further rust and prolong the life of the valley.

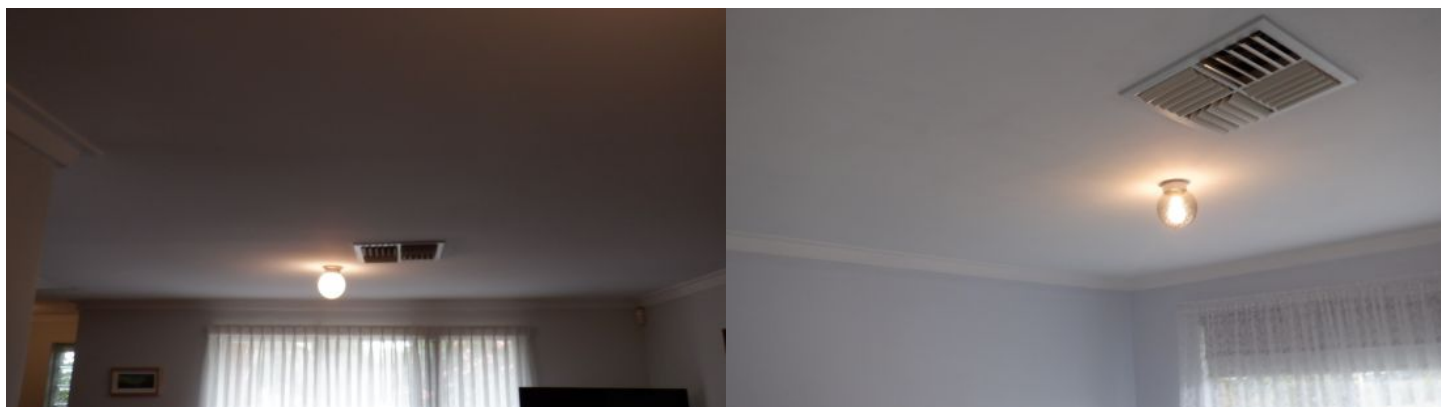
- Some minor sagging was noted in the bedroom ceiling. This did not appear to have affected the overall structural integrity of the ceiling but might require some maintenance in the future. We recommend that you monitor this area for any further sagging and engage an appropriately qualified tradesperson if the condition worsens.

Slight sagging noted in the front bedroom ceiling, monitor

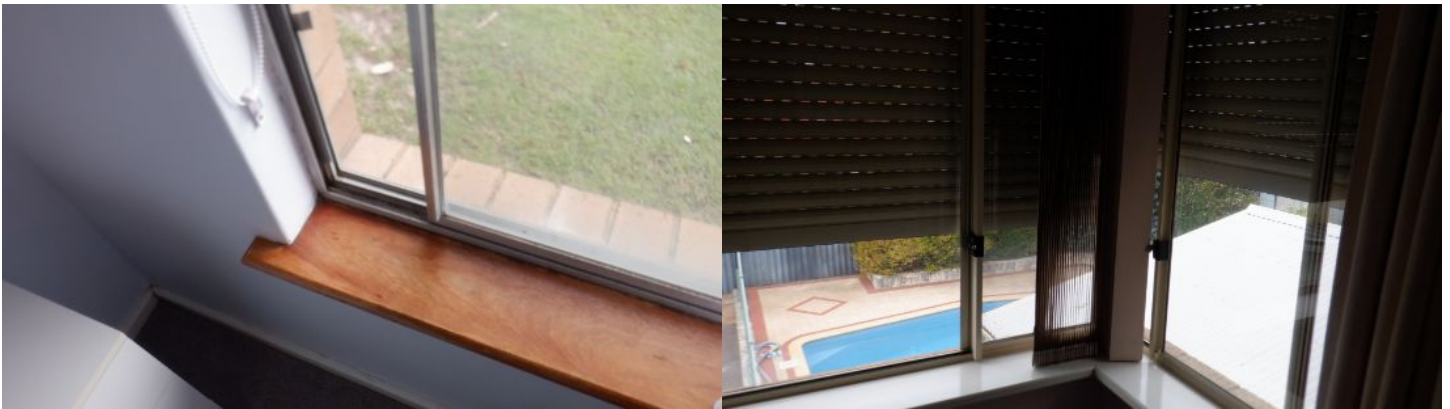
Some fly screens were not installed

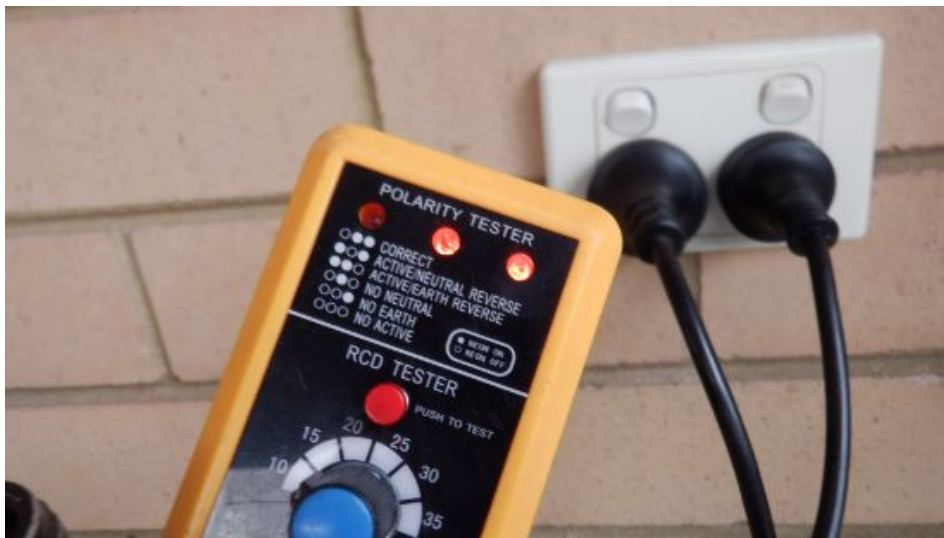
- All tested interior and exterior light fixtures and switches were functional unless noted.

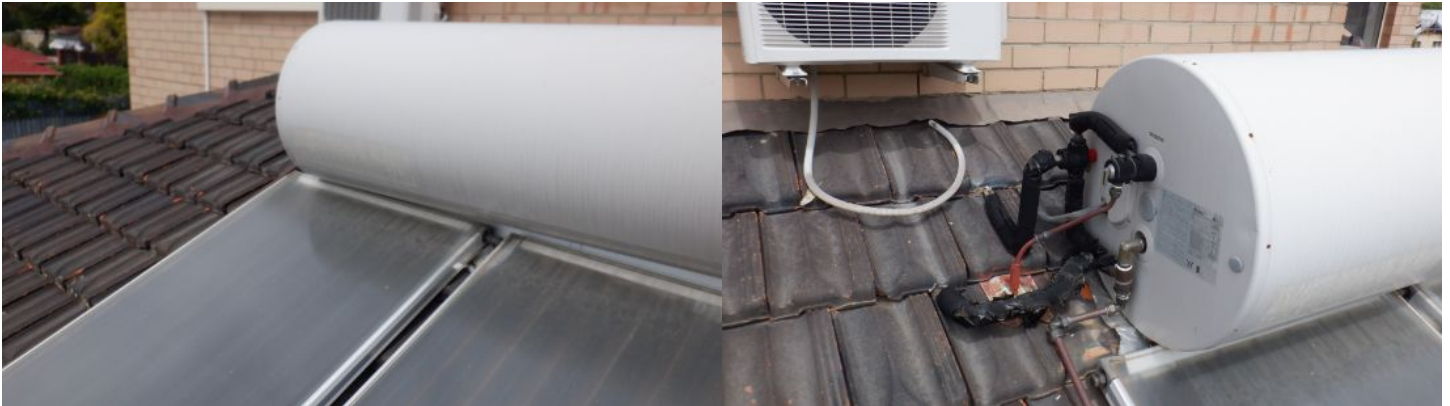
- Please note that we only inspect & comment on the operational and safety issues of the hot water system. Issues relating to compliance to relevant codes and standards, and/or installation compliance is excluded from the scope of the inspection.
- No major system safety or function concerns noted at time of inspection.

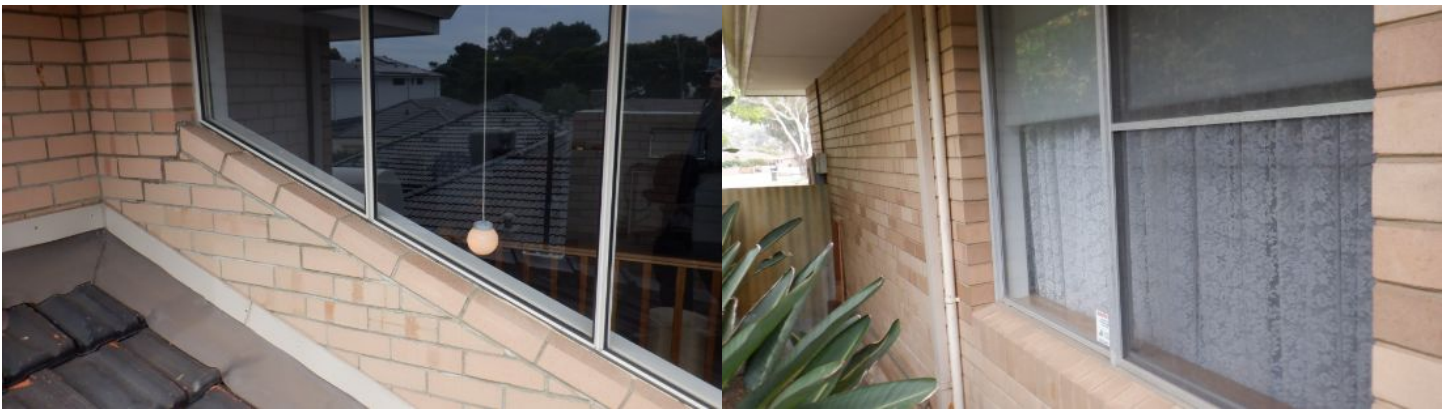
- Components appeared in satisfactory condition at the time of inspection.

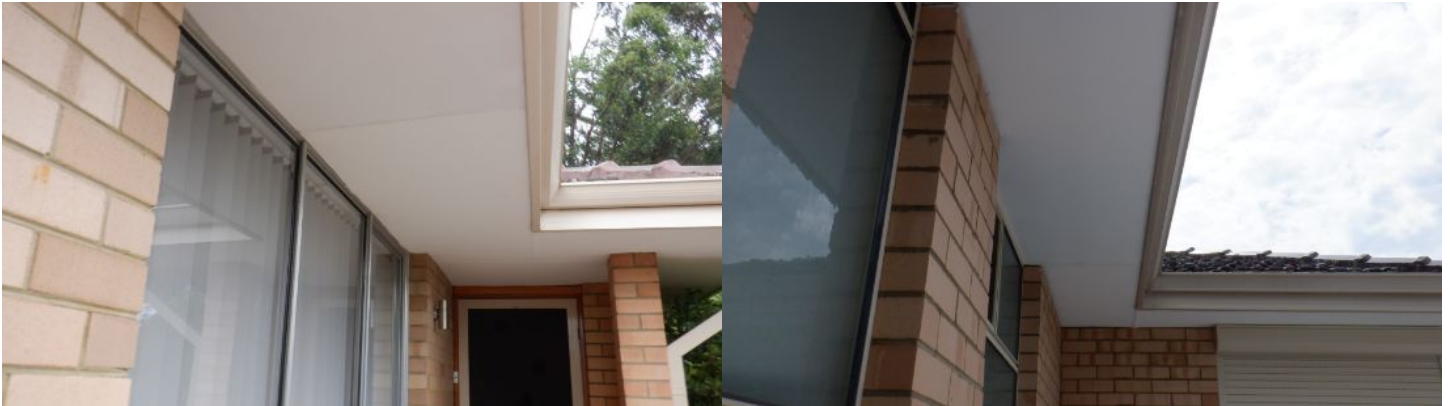
- The eaves are in satisfactory condition.

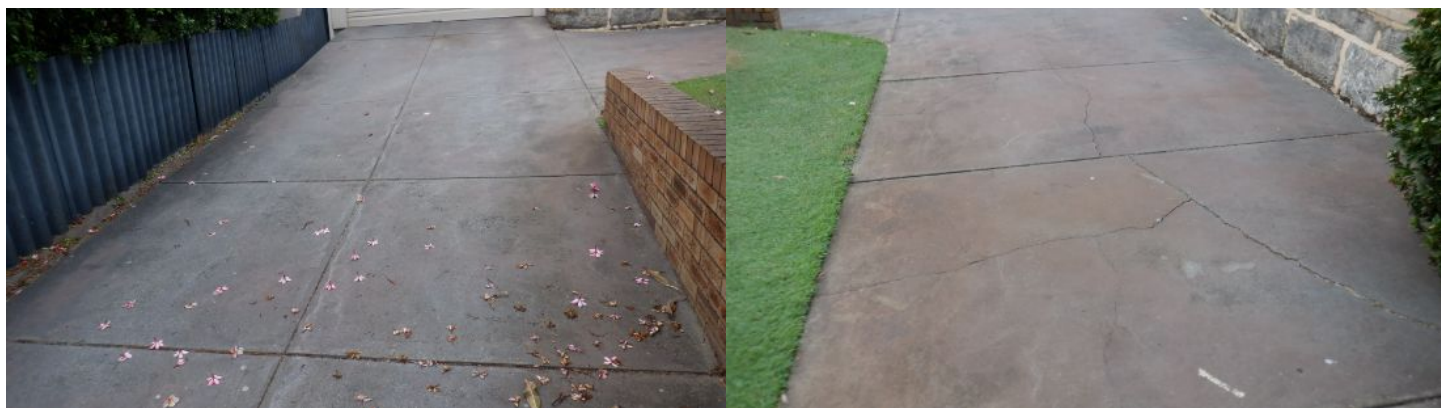
- Minor settlement or "hairline" cracks in driveways are normal to properties of any age. They should, however, be monitored for expansion and sealed as necessary.

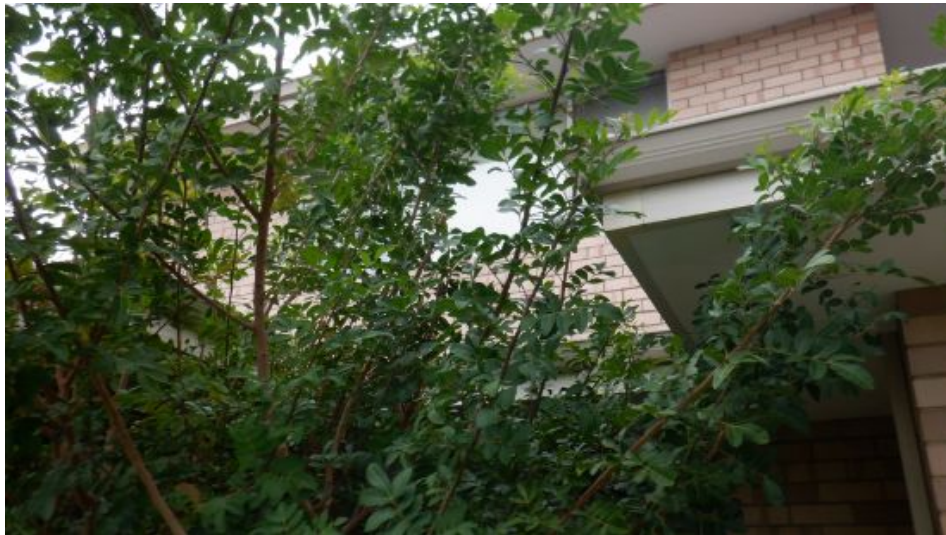
- Trees that begin to grow too close to or overhang property should be trimmed back; this will help reduce the frequency of having to clean out the gutters which should be done on a regular basis.
- Prune or remove any plants that are in contact or proximity to home to eliminate pathways of wood destroying insects.
- Tree limbs within 3 metres of roof should be trimmed away to provide air and sunlight to roof, while minimizing debris, dampness and abrasion damage.

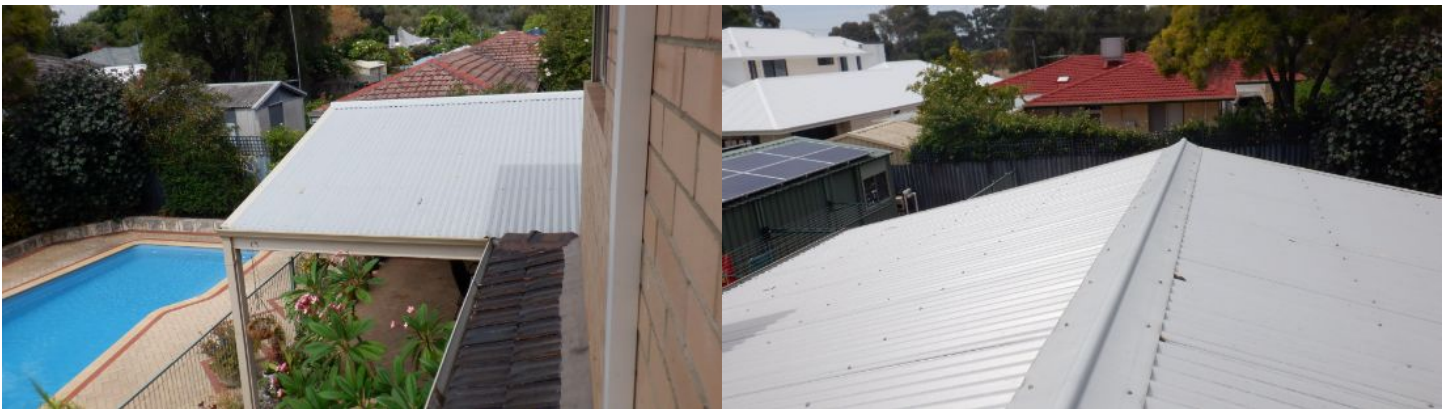
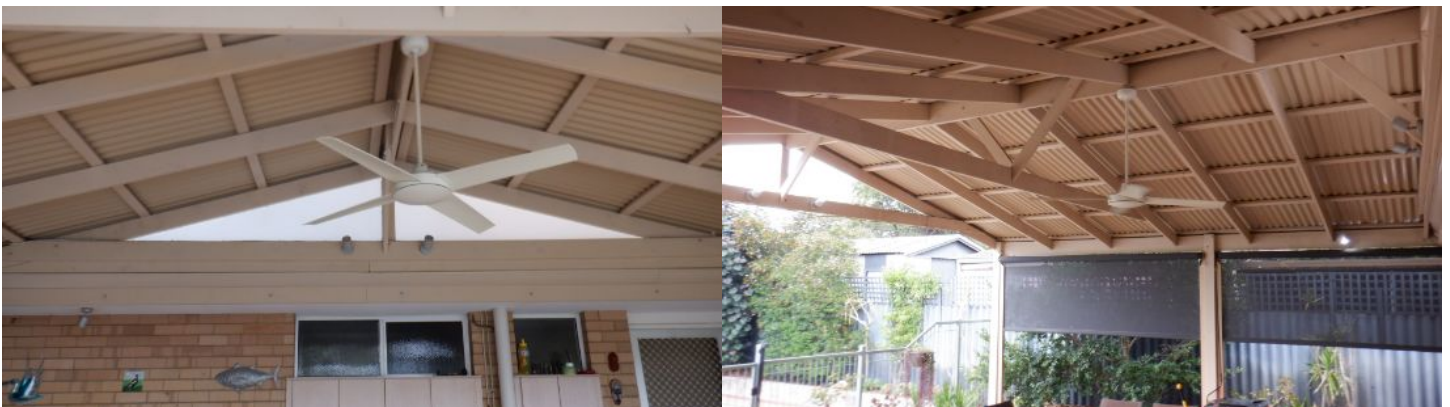
- Patio appears in satisfactory and functional condition with normal wear for its age. Appears to be structurally sound.

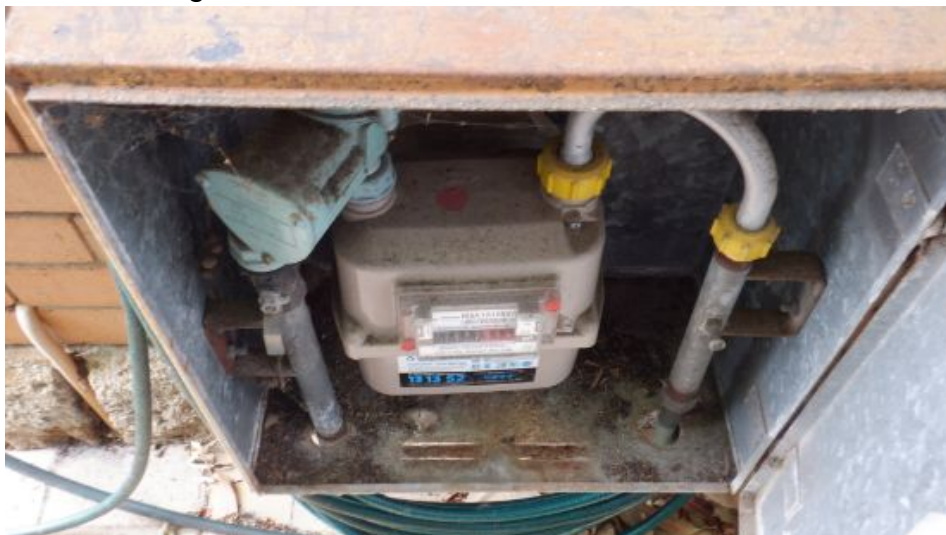
- Main gas shut off located at outside meter.

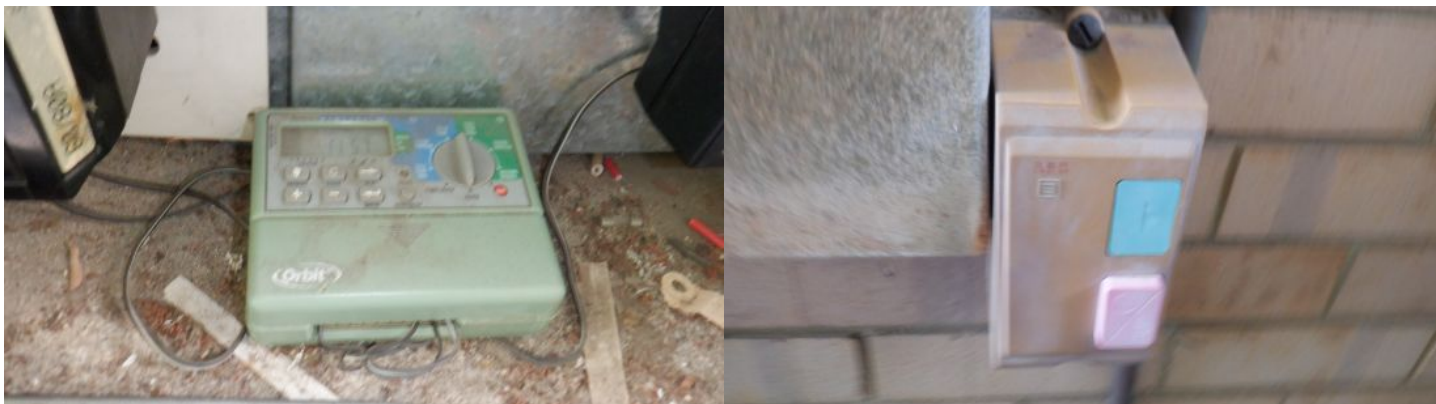
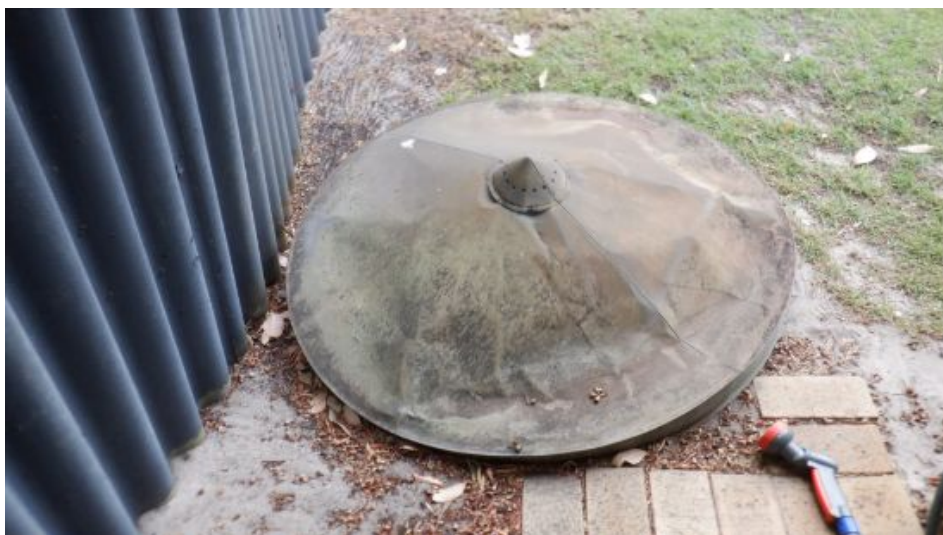
- Sprinkler system was noted. It is not tested as part of the inspection. This should be tested at the final settlement inspection.
- A water pump and water bore located at the southwest side of the property. The function of the water pump has not been tested as part of the inspection process and should be checked at final inspection.

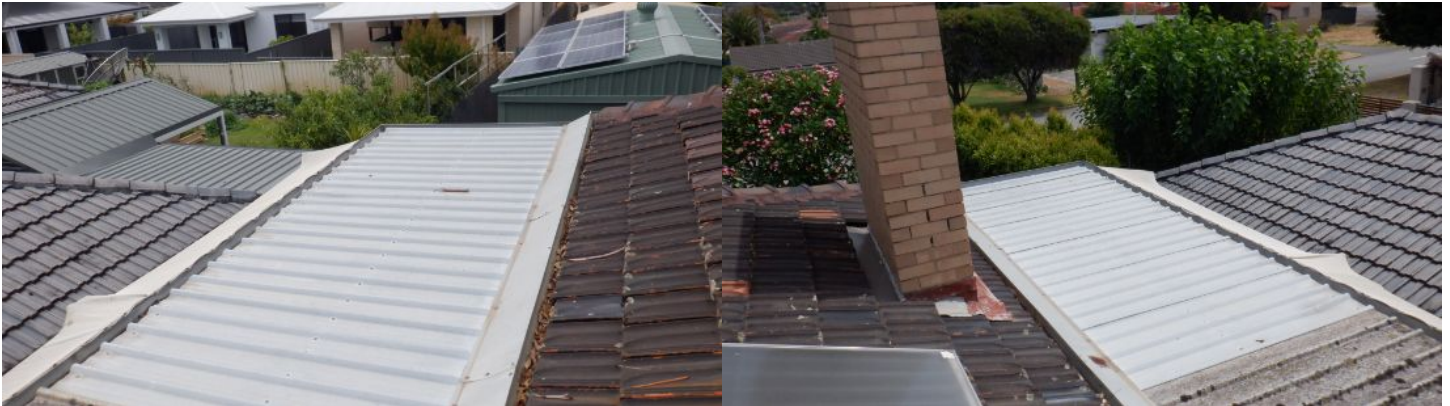
- Some of the metal sheeting on the carport has corroded. This should be reviewed for maintenance or replacement as required.

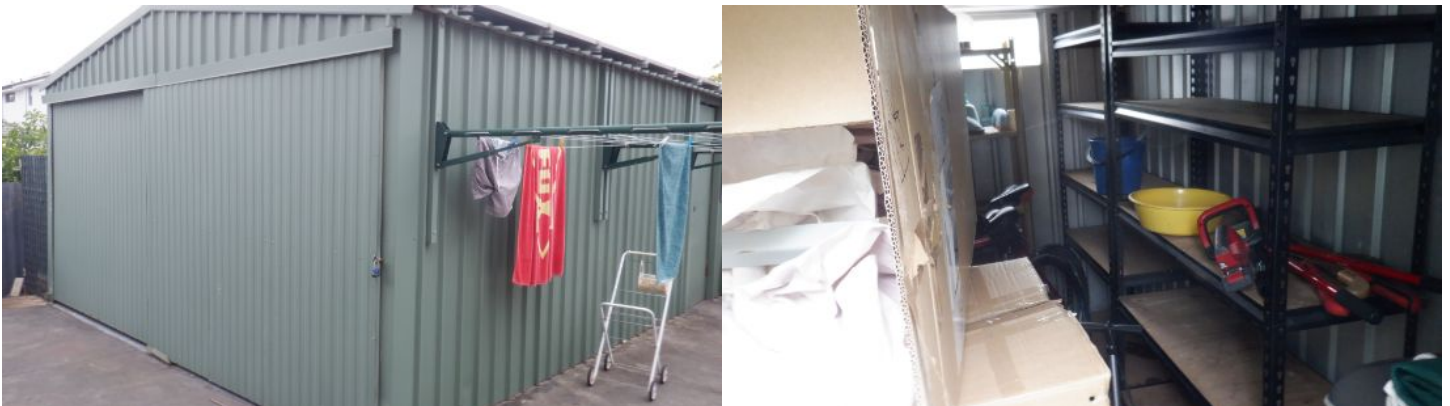
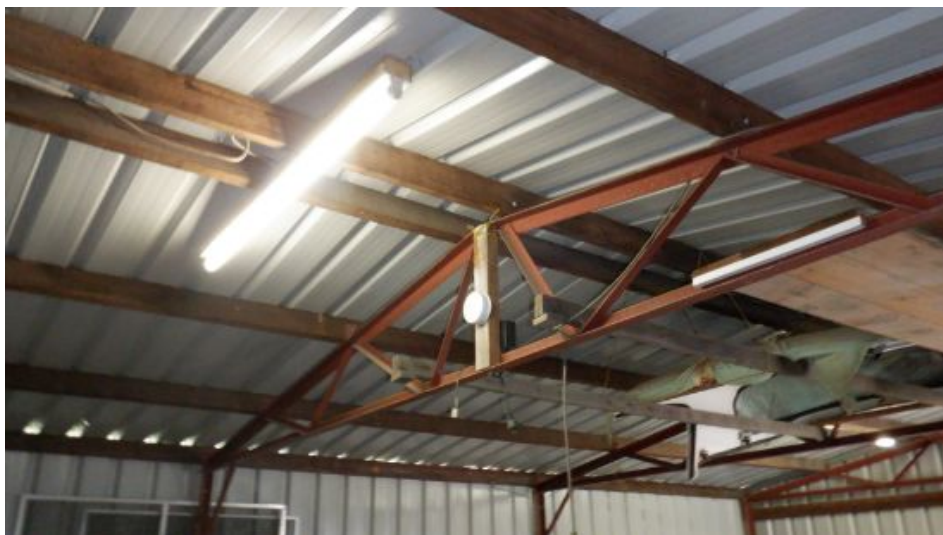
Noted some corrosion below the roof sheets, maintenance

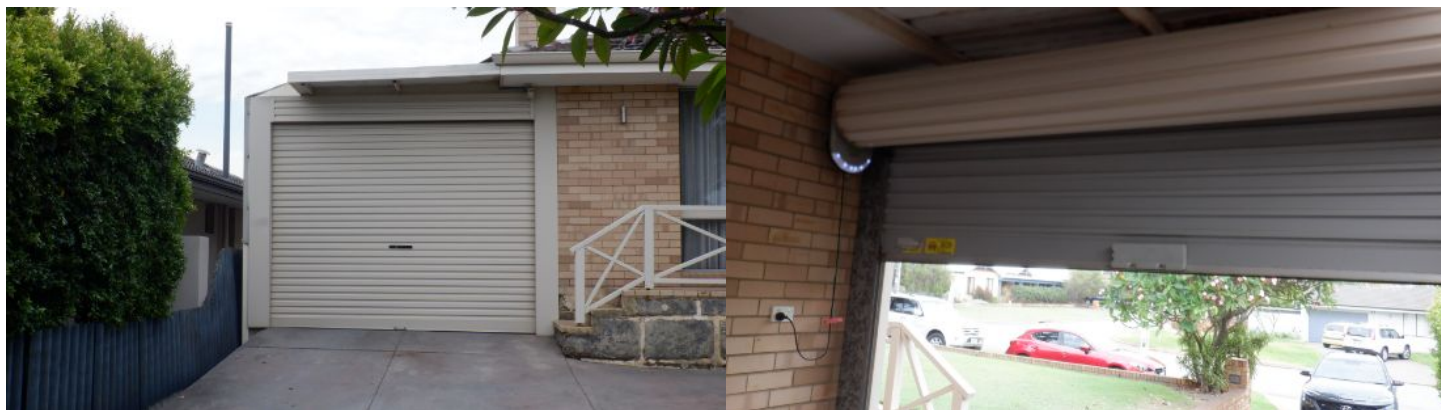
- No deficiencies observed.

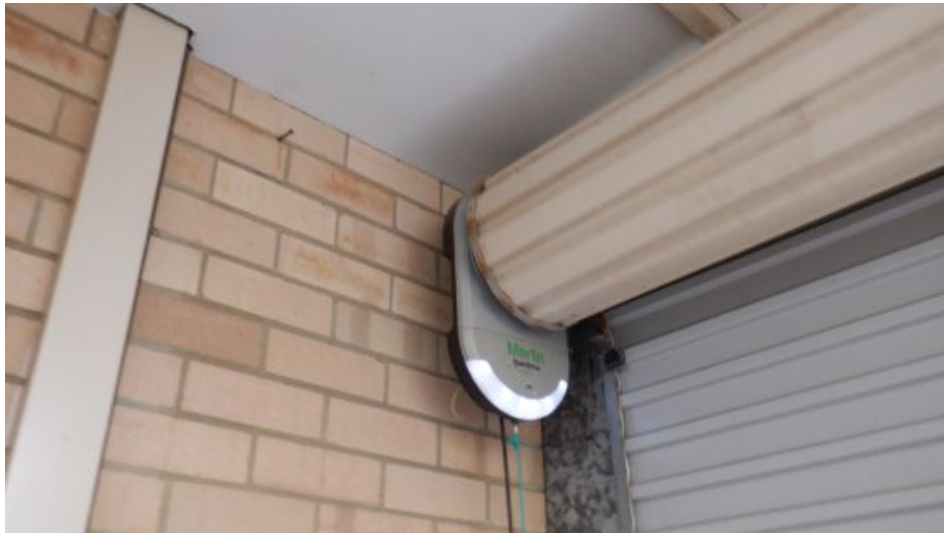
- Appeared functional using normal controls, at the time of inspection.
