Property Inspection Report

Sample Report, WA

Inspection prepared for: Sample Report
Date of Inspection: 20/10/2023 Time: 8:30am
Weather: Fine 20C

- Dilapidation Inspection

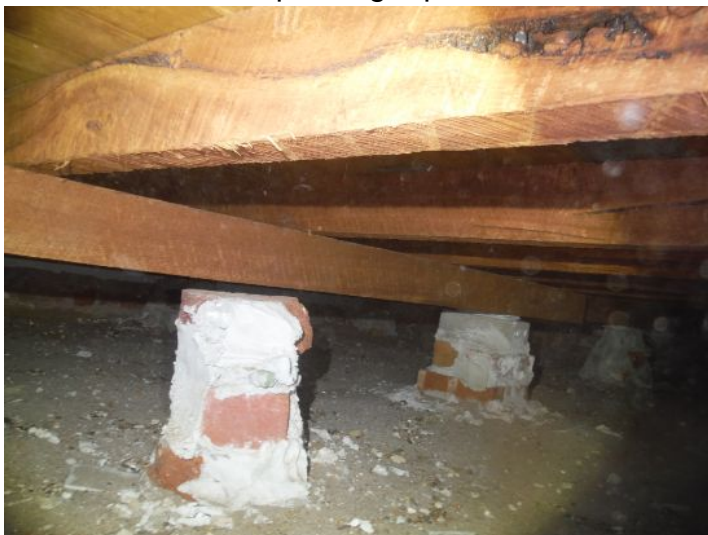
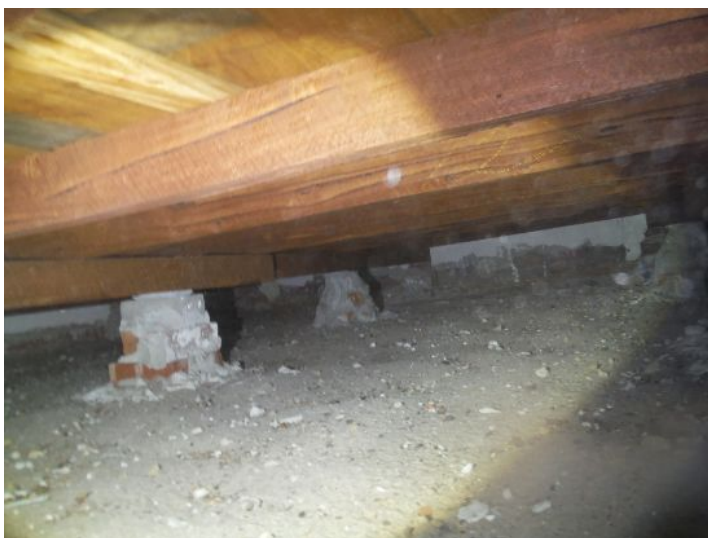
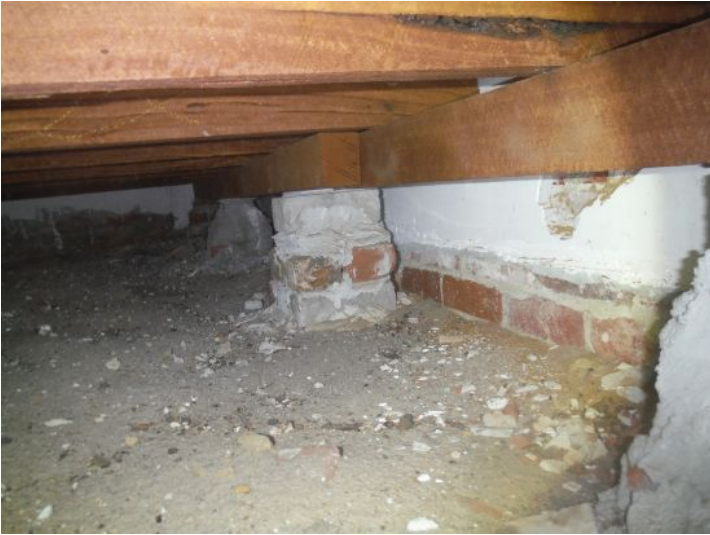
- The foundations appear to be performing satisfactorily.
- Noted one brick pier needs the cement sheet packing replaced.

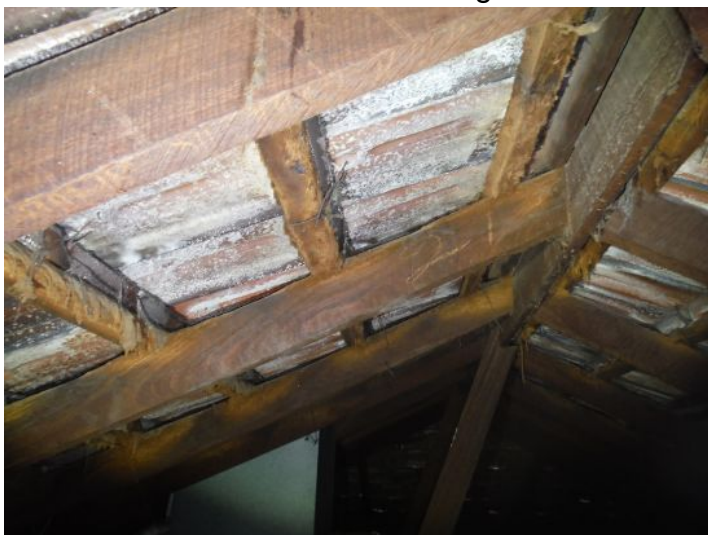
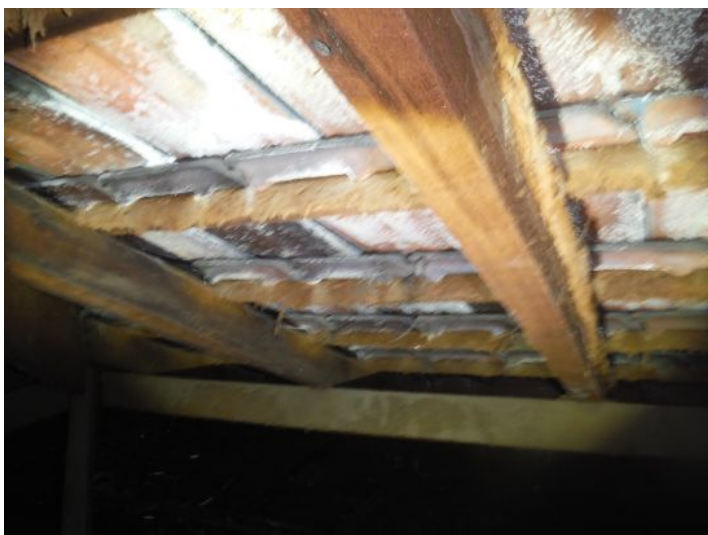
- Evidence of "Chemical Delignification" - (Timber fretting) was noted on some of the timber batten components in the roof space. The roof battens appear to have lost 10% of their width at present. You may wish to obtain a quote for treatment of these battens from Power Drive Roofing.

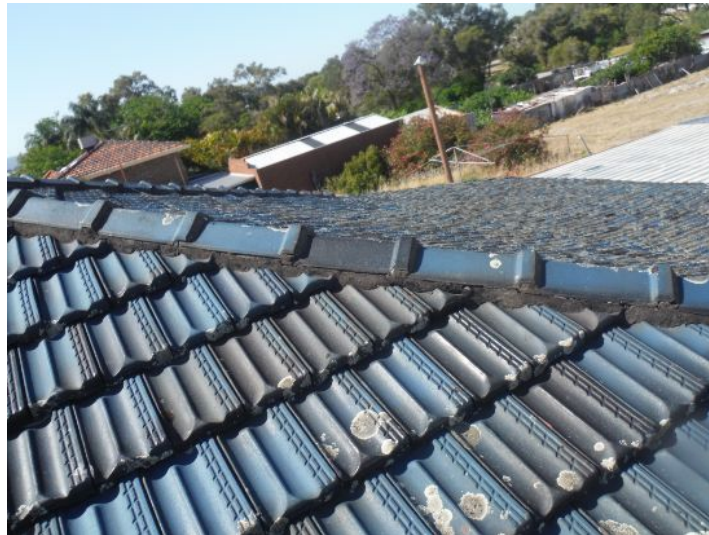
Noted the vent pipe has corroded. Recommend maintenace

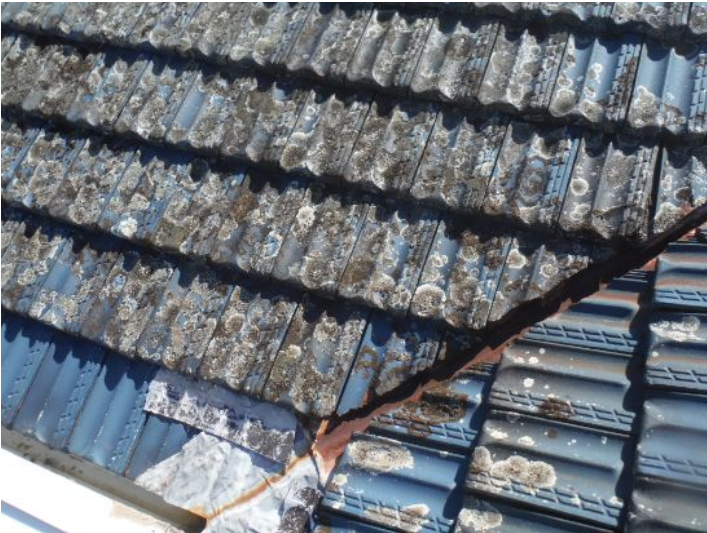
- Flashing is an impervious material (usually galvanized sheet metal) that comes in a variety of shapes and sizes and is used to cover, waterproof, and direct water away from roof penetrations and from valleys and intersections between the roof covering and other materials.
- In the inspector's opinion the flashings are near the end of their useful life due to wear.

Corroded flashing noted

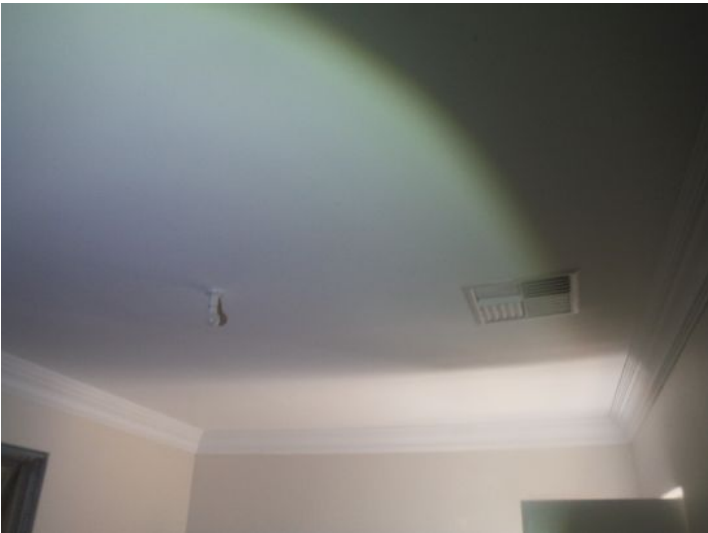
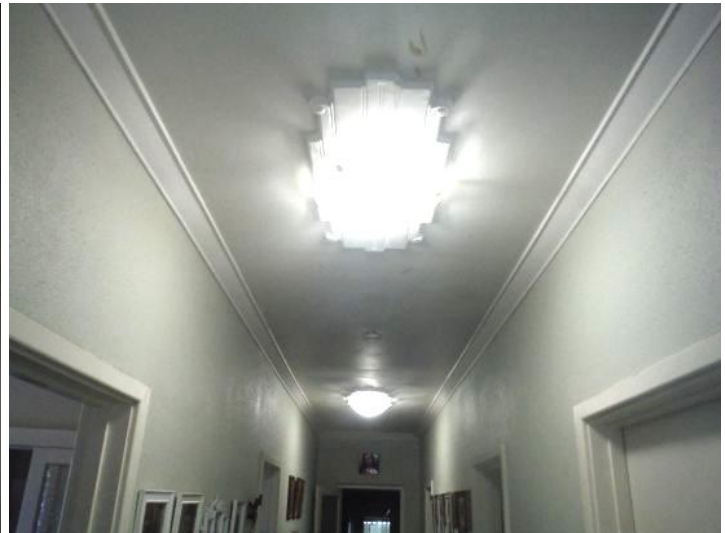
- The ceilings are original plasterglass ceilings. Over time some of the plaster horse hair straps tend to break from the ceiling joists resulting in slight sagging in the ceiling and the formation of small cracks in the under surface of the ceiling. The ceilings have been re-strapped in 2021 the seller stated. Small surface cracks that have been filled in the past, noted in the front bedroom.
- The kitchen and laundry ceilings have been replaced with gyproc.

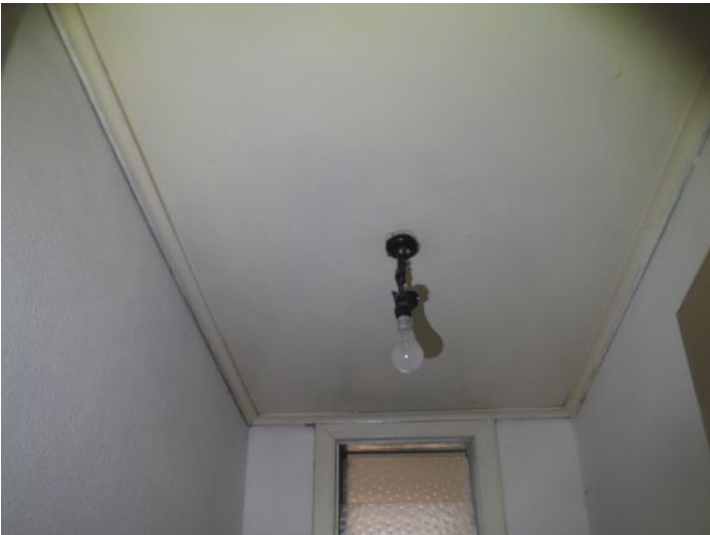
Laundry ceiling has been replaced.

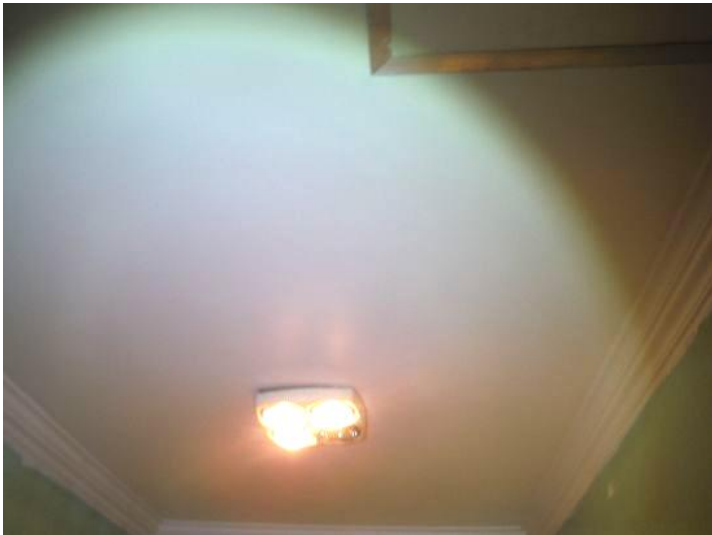
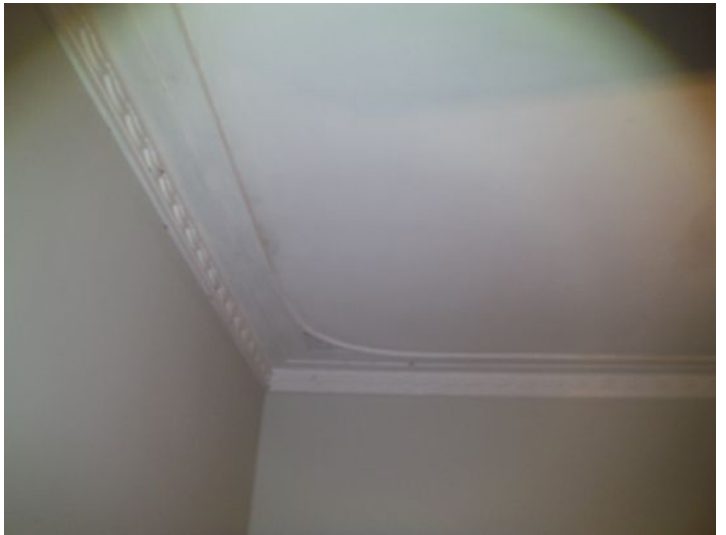
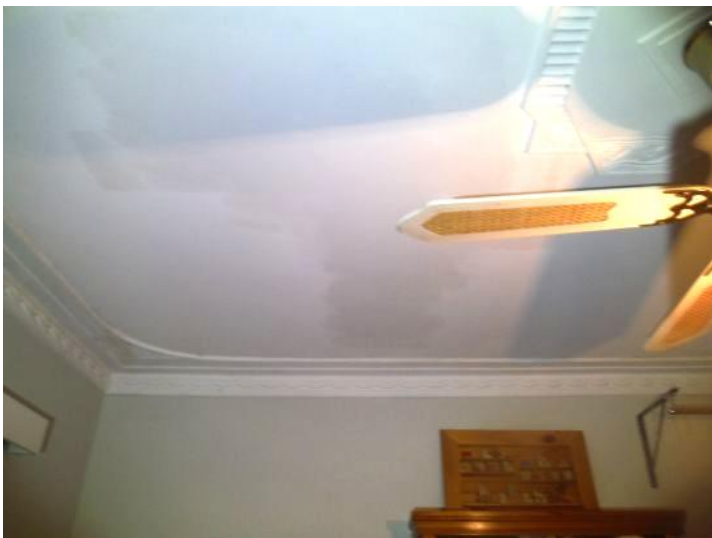
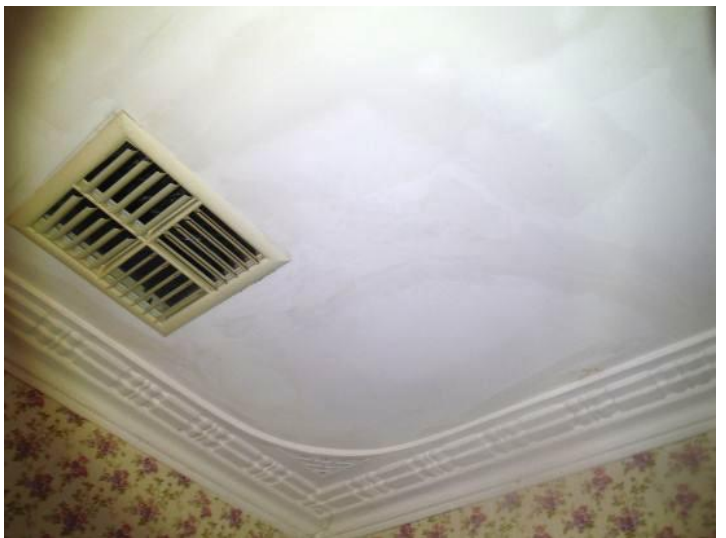
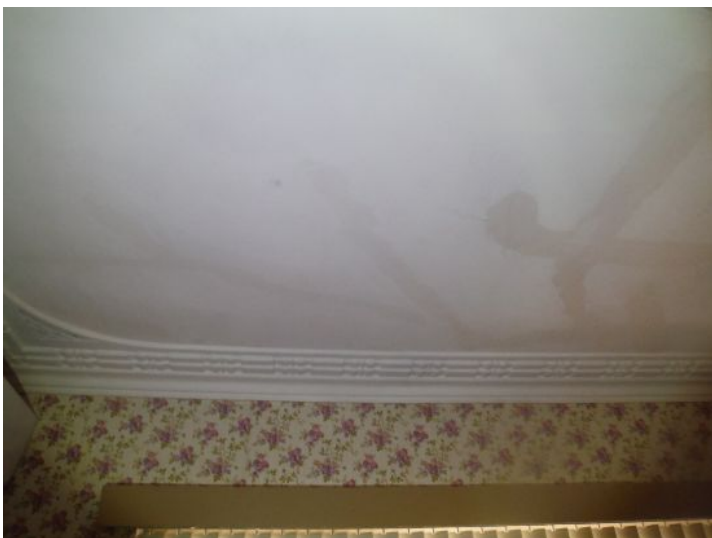
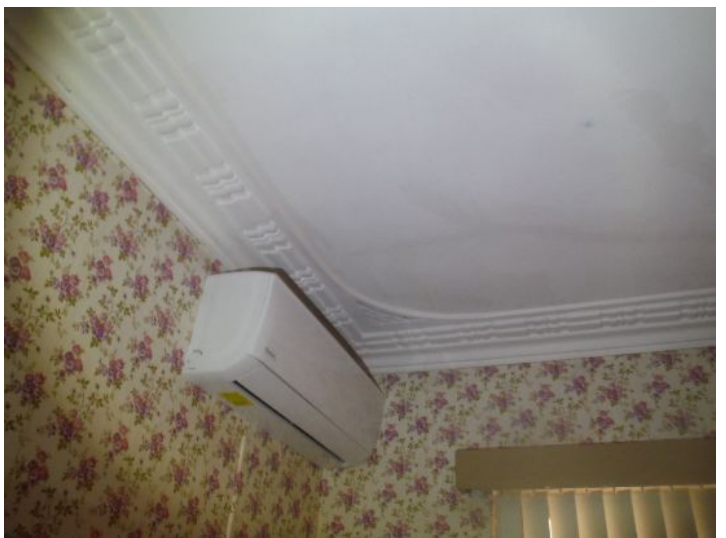
Some surface cracks have been filled in the past at the front bedroom ceiling

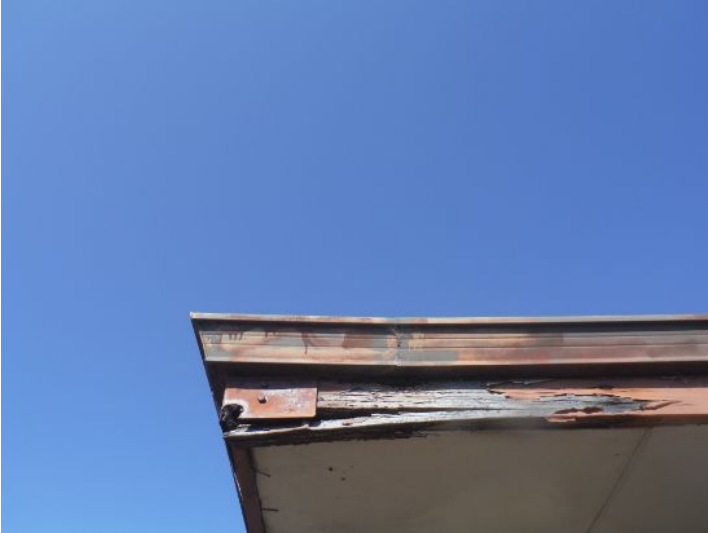
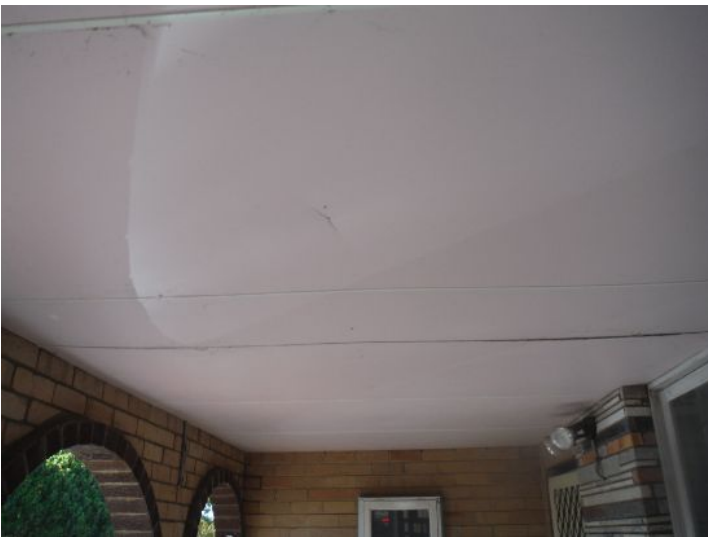
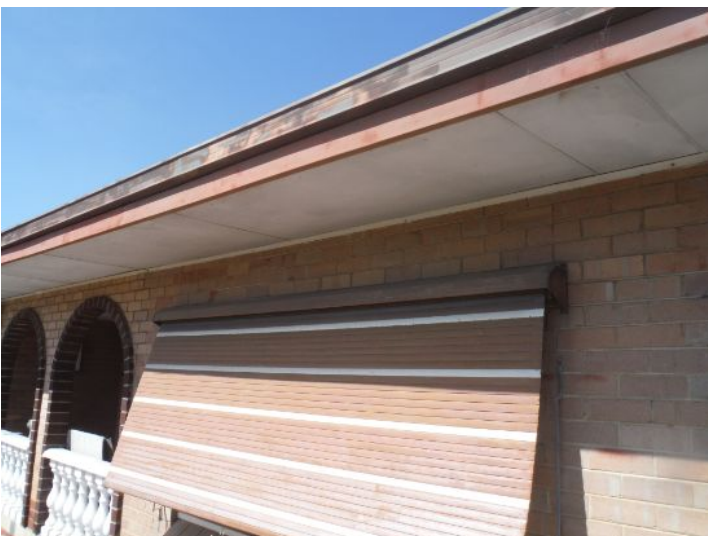
- Some weathered timber noted. Recommend review for maintenance as required.

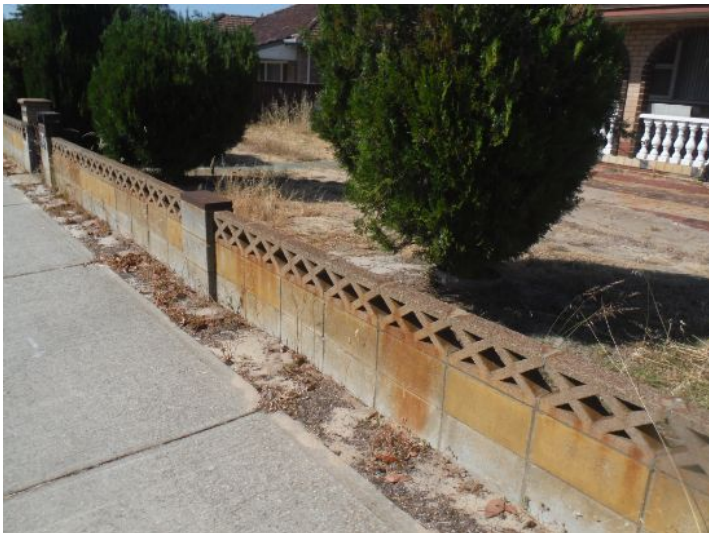
- Some cracks and areas damaged noted in external yard walls. This does not appear to have affected the overall structural integrity of the walls but will require some maintenance at some point.

Small vertical crack noted.

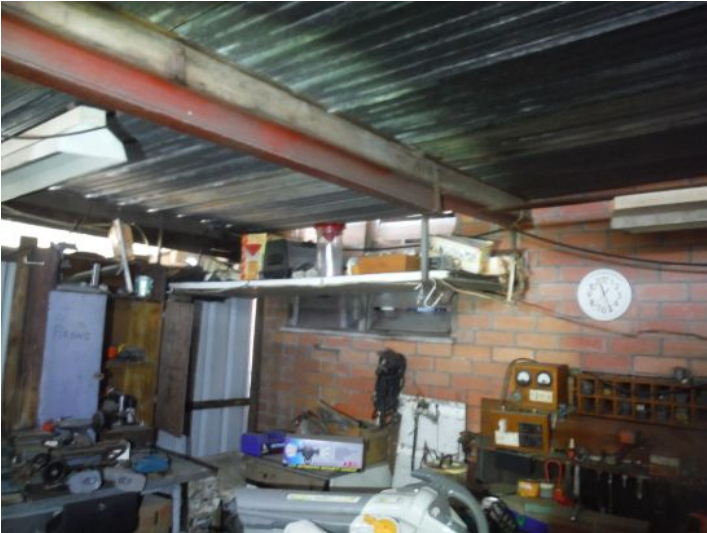
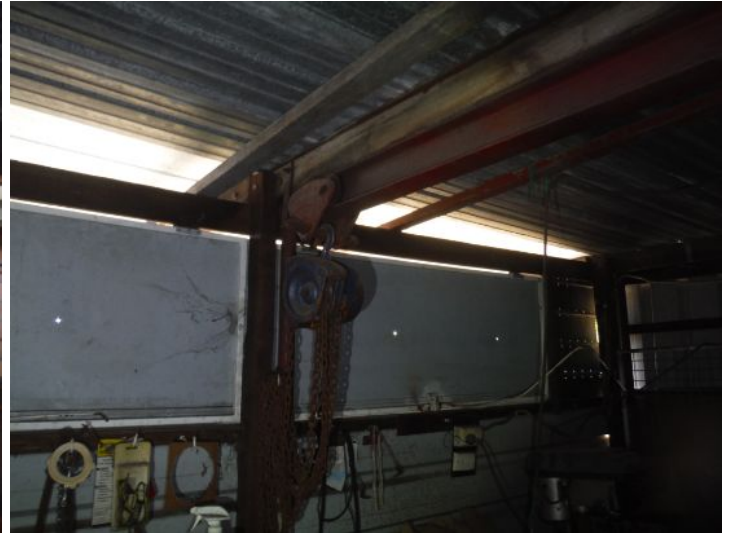
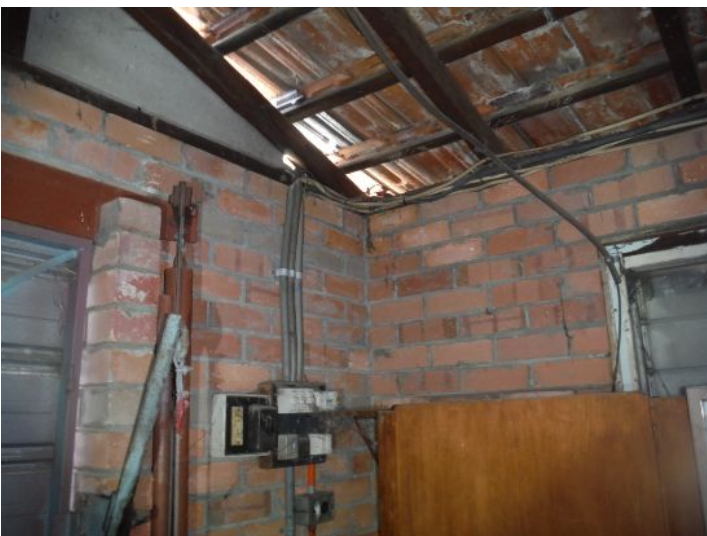
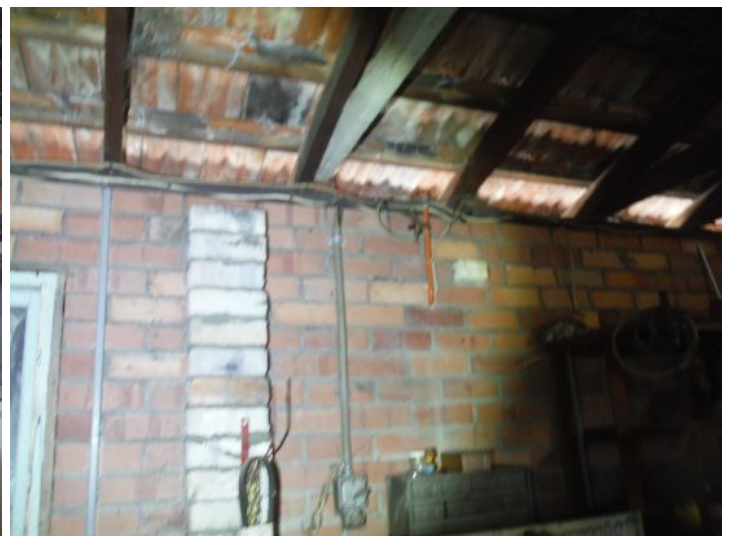
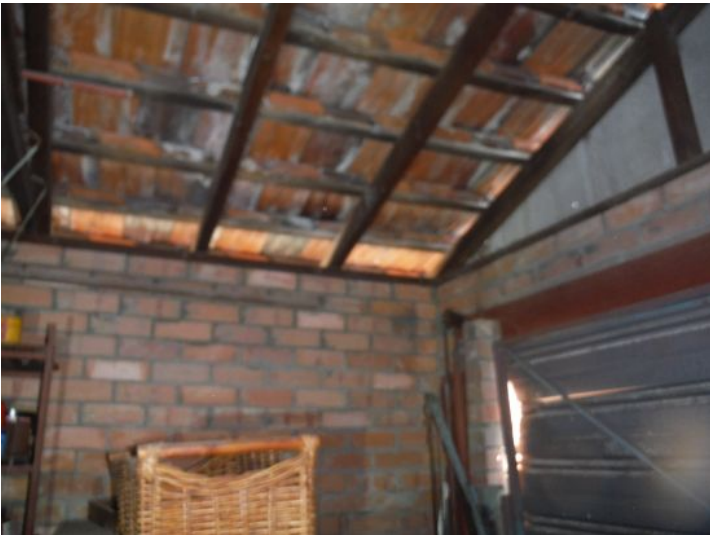
- The attached brick garage appears structurally sound. One repair in the brickwork noted on the North rear wall of the main garage. Appears sound repair.

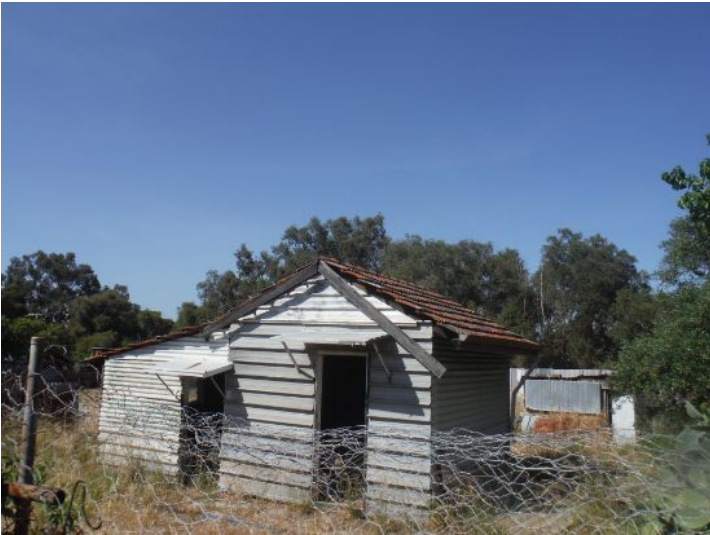
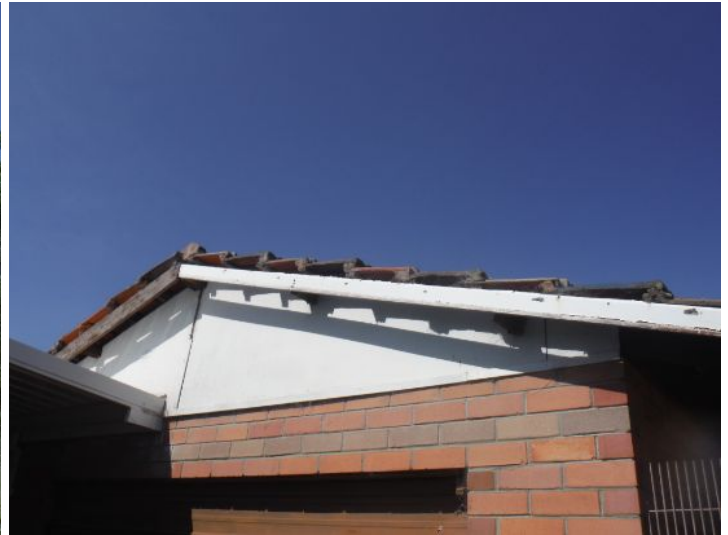
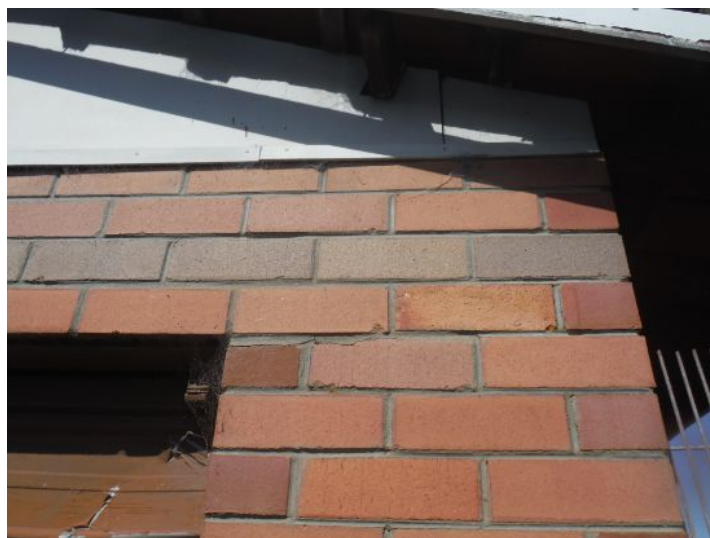
Old repair noted
