# Property Inspection Report

Inspection prepared for: Sample Report  
Date of Inspection: 15/3/2022 Time: 12:00PM  
Weather: Cloudy 26C

Inspector: Resicert Property Inspections  
Sample Report

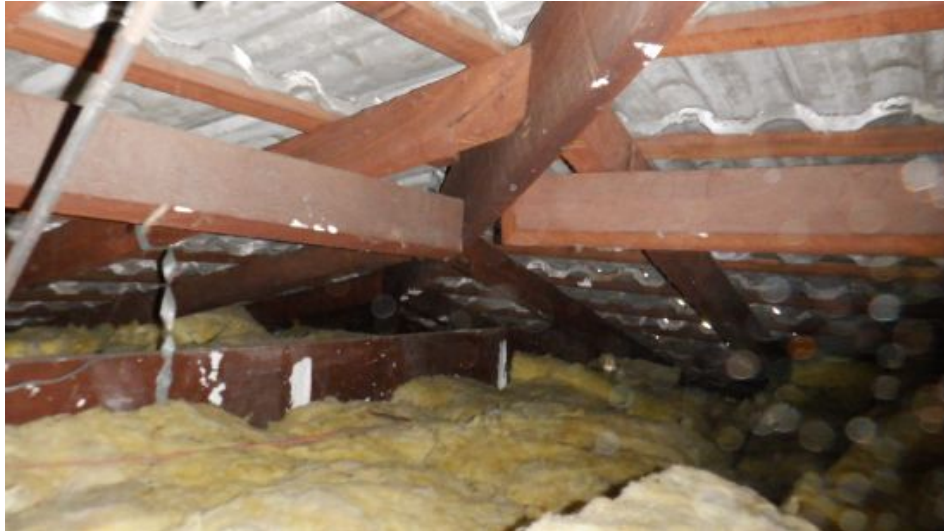
- Bathroom exhaust fan terminates in the roof space. You may wish to flue this to the outside air.

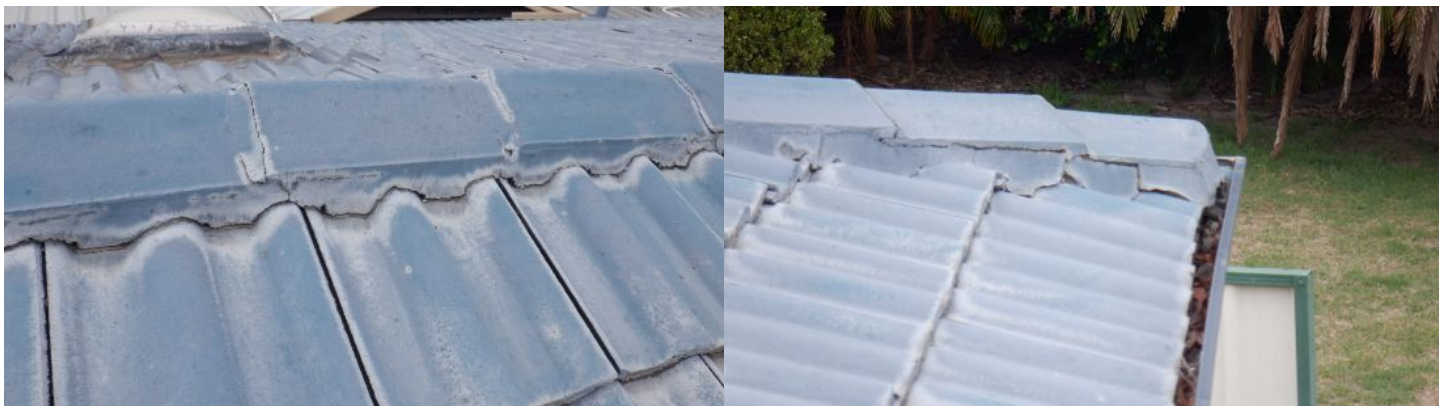
- There are cracks in the bedding cement. This is not unusual for a tiled roof, and is often caused by normal movements in the roof frame. It is recommended that maintenance work is carried out on the roof so that the loose tiles can be re-bedded using mortar and then flexible bedding compound to help prevent re-cracking.

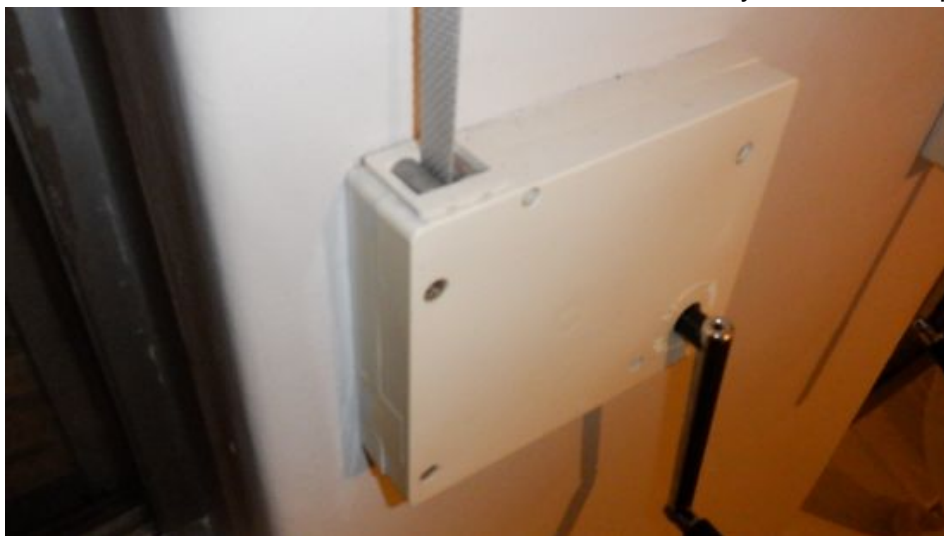
One front bedroom shutter winder requires maintenance to operate

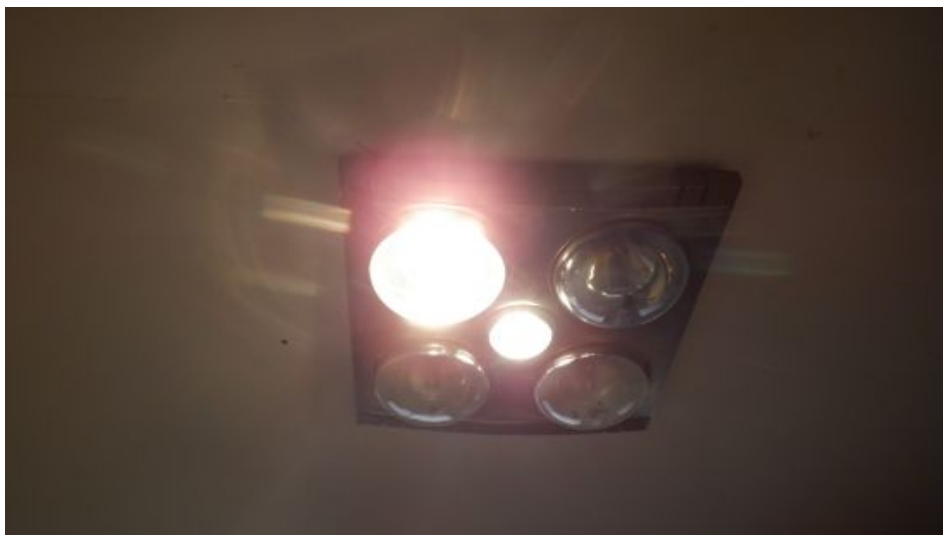
- Heat lamps in main bathroom. At the time of the inspection some of the lamps were not working and require attention. We recommend you replace the bulb and re-test. If still not functional you will need to consult a qualified electrician to rectify.

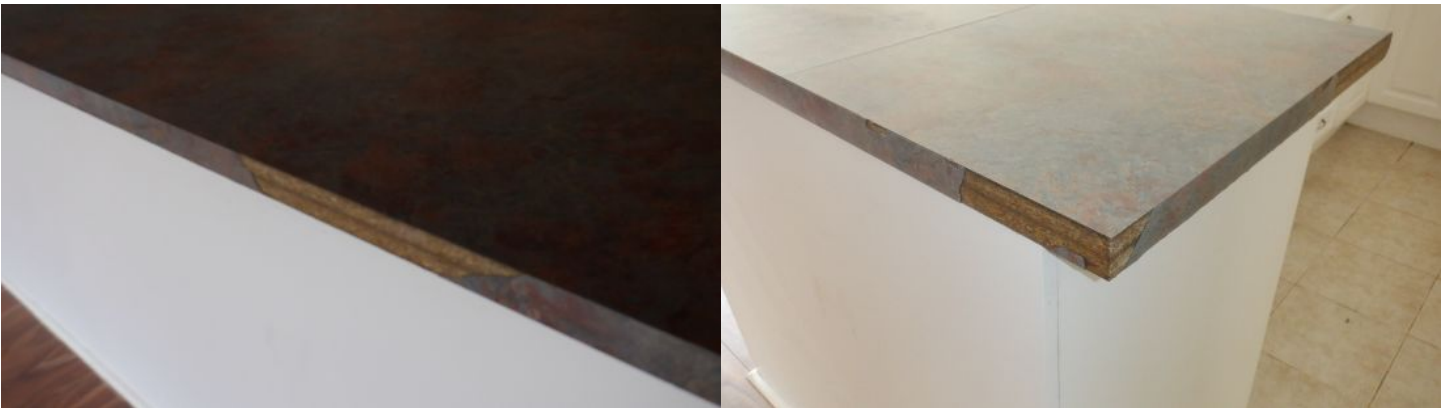
- Appeared functional at the time of inspection.
- Plastic laminate tops noted.
- Some edge strips missing in areas. Maintenance.

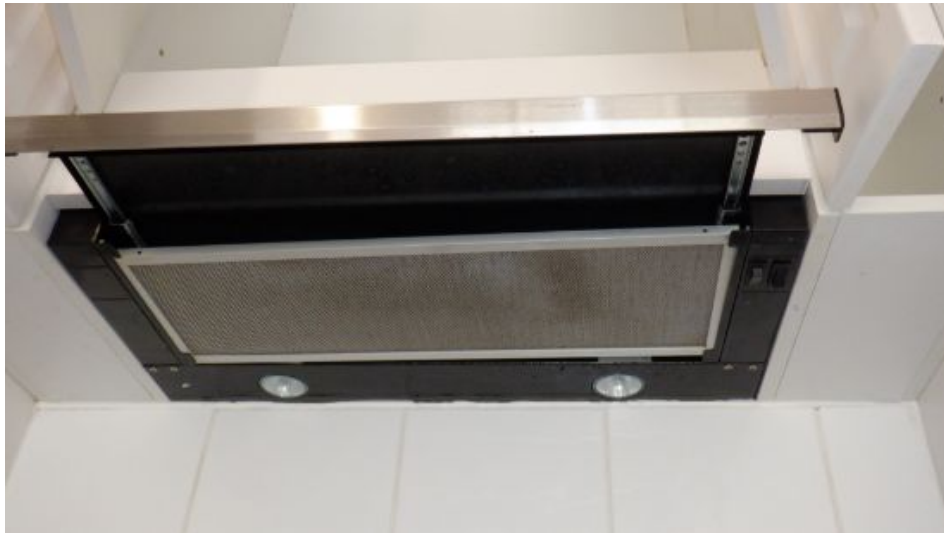
- Vent fan light is inoperable. Recommend replacing bulb and re-testing. If still not working a qualified electrician should be consulted to rectify.
- One mesh filter screen was missing.

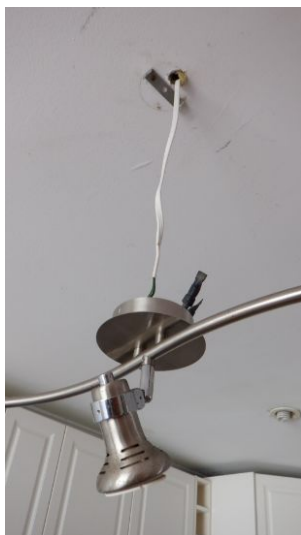
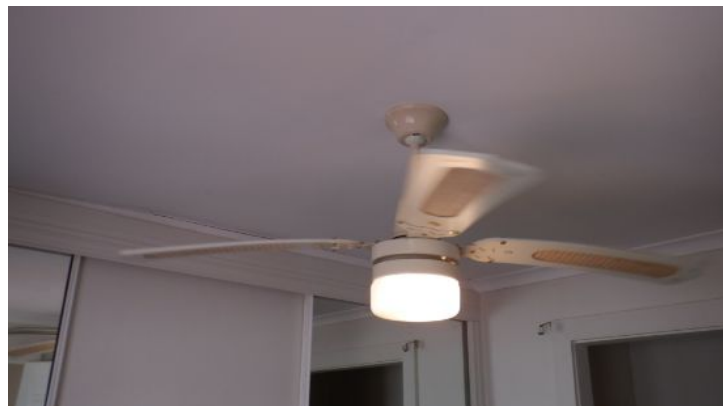
- A light fitting located in the kitchen requires re-fixing to the ceiling.

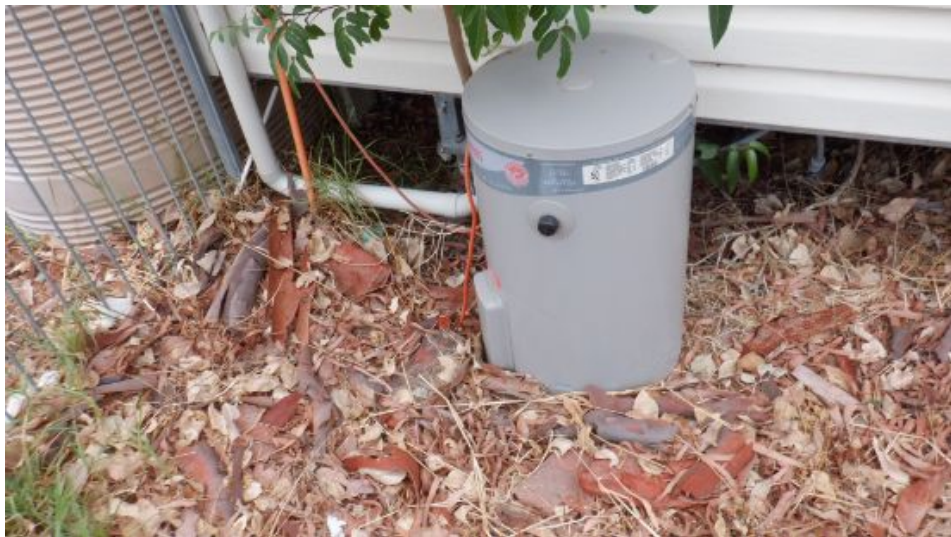
Granny flat , not tested

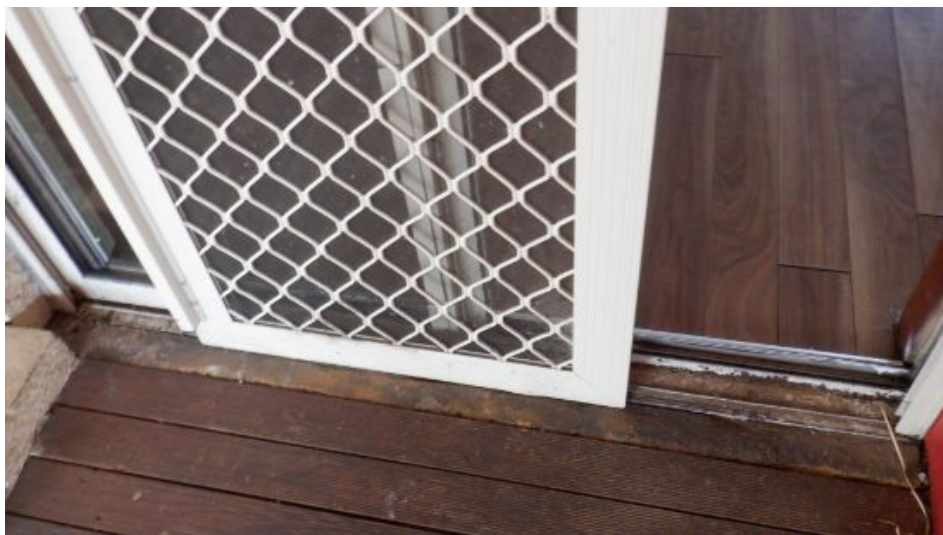
- Fly screen door needs re fitting / maintenance.

The rear fly screen door needs refitting on the track / servicing

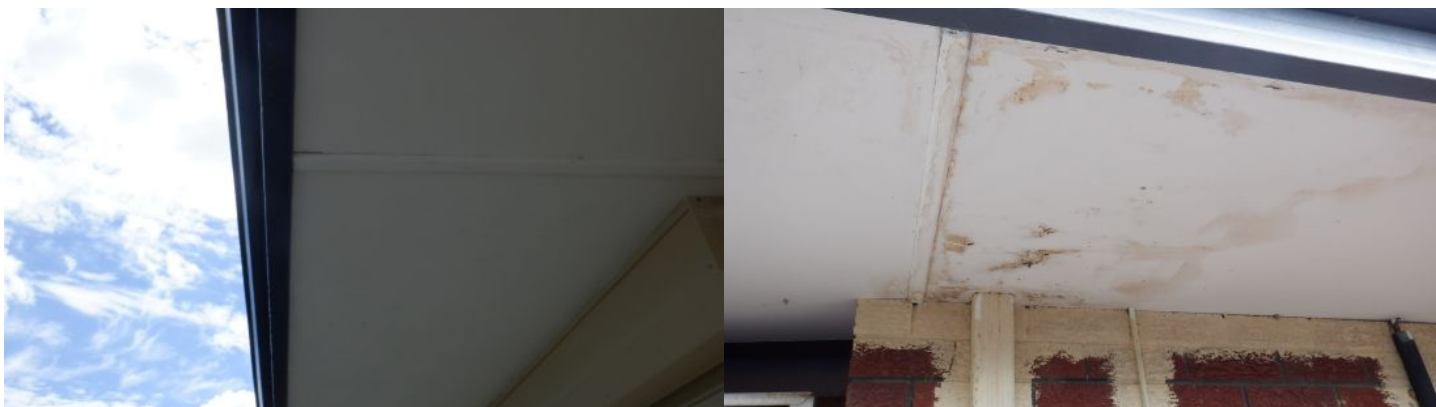
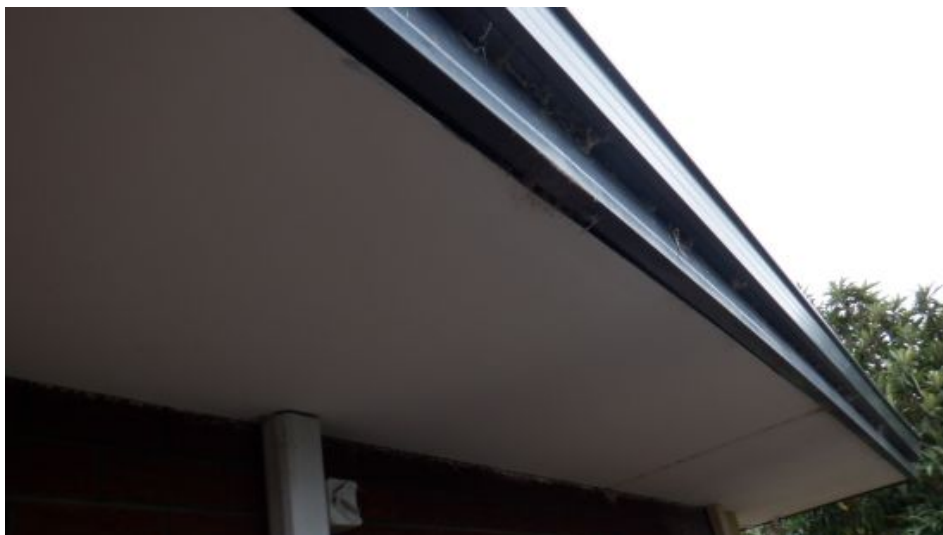
- There appears to be some asbestos eaves material on the property.
- Water stains were noted which is an indication that the gutters have likely overflowed in the past. Ensure that the gutters are kept clear of vegetation and other debris and that the downspouts and drains are functioning correctly.
- Water stains were noted around some of the downpipe to gutter connections around the home. We recommend testing the connections with a hosepipe or checking during heavy rainfall, and sealing where required.

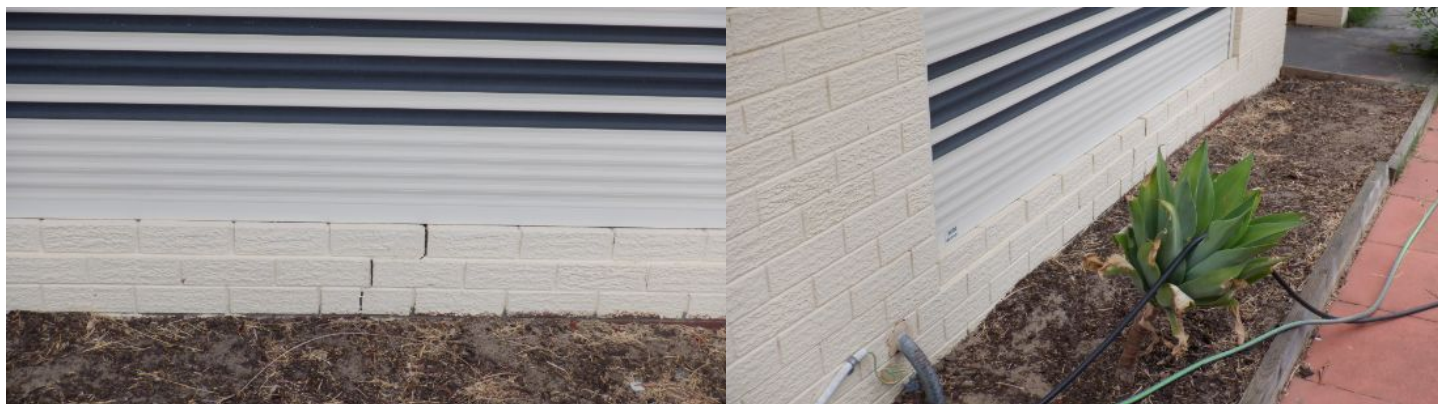
- Due to normal minor differential settlement of the foundations, cracks have appeared on some of the external walls of the house. These cracks do not appear to have affected the overall structural integrity of the house at present and can be repaired. We recommend you obtain a quote to have these areas repaired. The drainage should also be repaired and monitored around these wall areas.
- There are a number of garden beds which are adjacent to the external walls. This can result in water moisture affecting the structure over time. It is recommended that either the beds be removed or a water barrier be placed between the garden bed and the external walls. If these beds are retained it is important that any watering is directed away from the building and kept to an absolute minimum and is controlled.

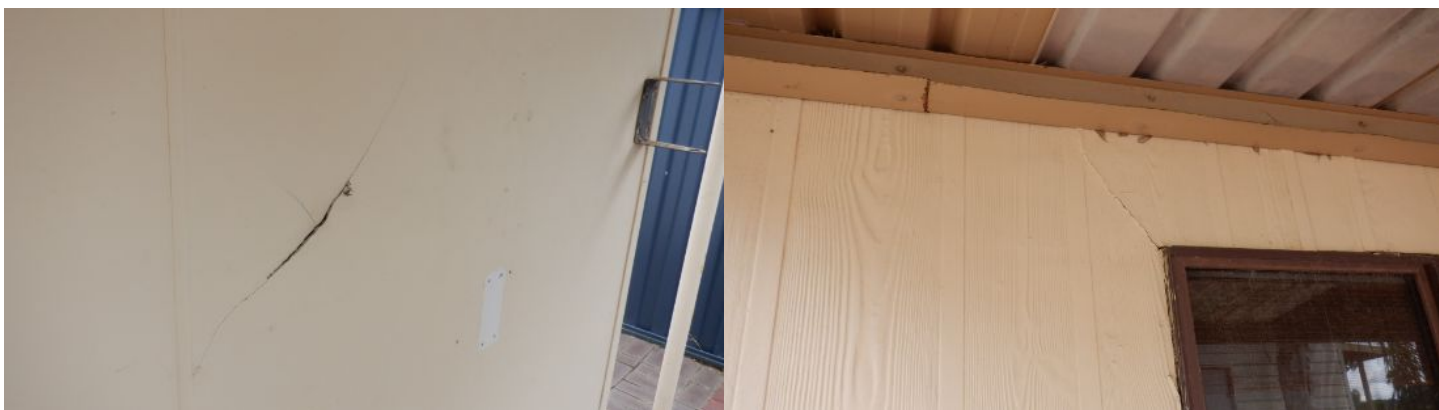
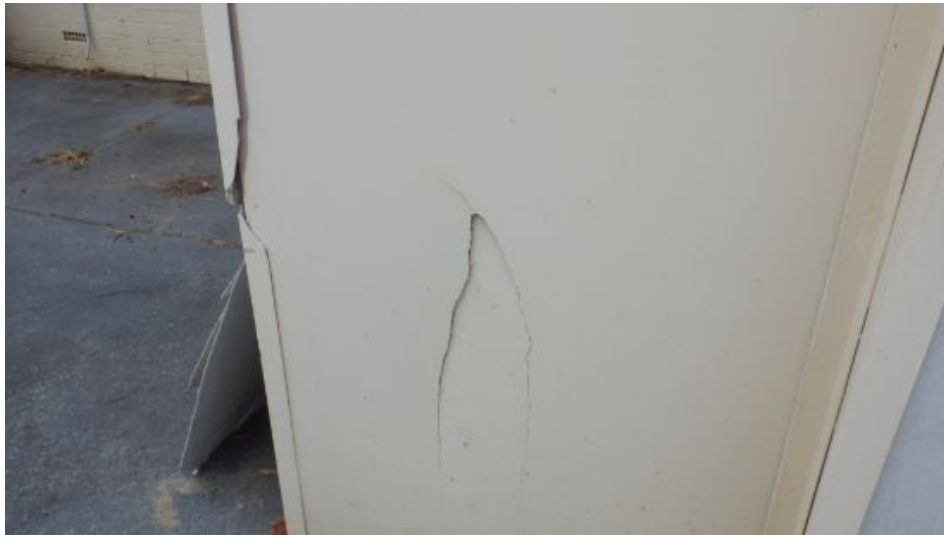
- Some minor cracking has occurred between the cladding sheets for the side addition. This does not appear to have affected the structural integrity and can be repaired normally.
- Cladding-Soil contact or proximity. This may provide entrance of moisture or insects to the siding. Recommend grading soil so there is at least 150mm of space (where practical) between the cladding and the soil below and checking for any damaged trim and siding materials.

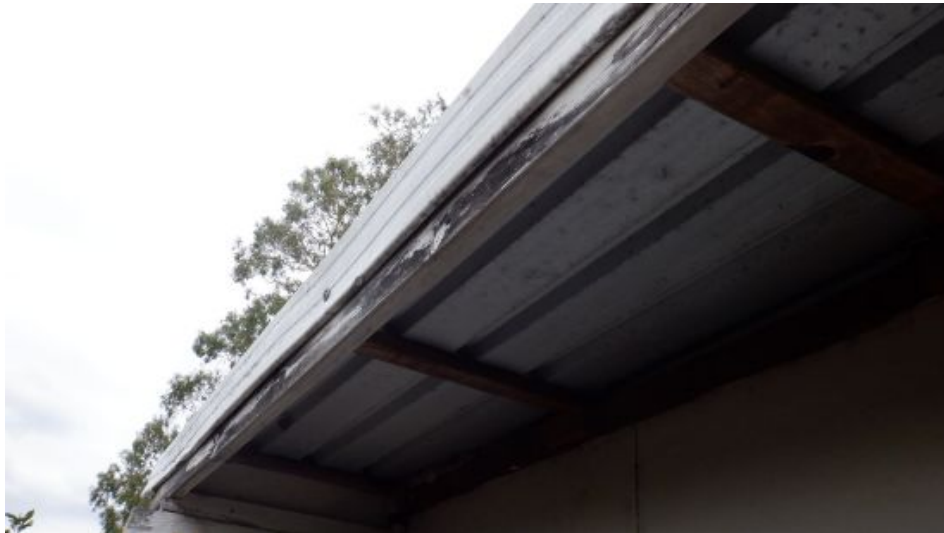
- All exterior painted wood trim surfaces should be annually examined and sealed, re-caulked and re-painted as needed.
- All exterior painted metal surfaces should be annually examined and cleaned, primed with rust inhibitor and re-painted as needed.

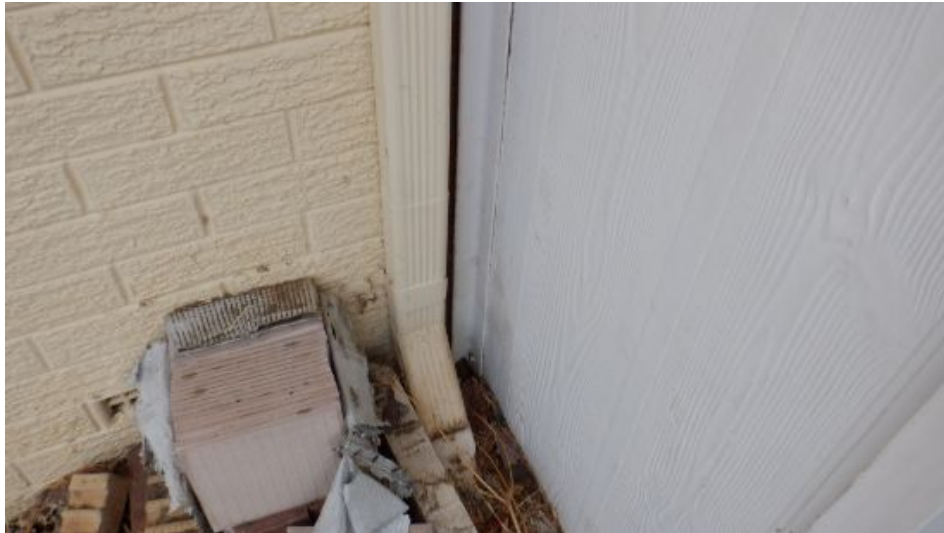
Noted broken connector, maintenance

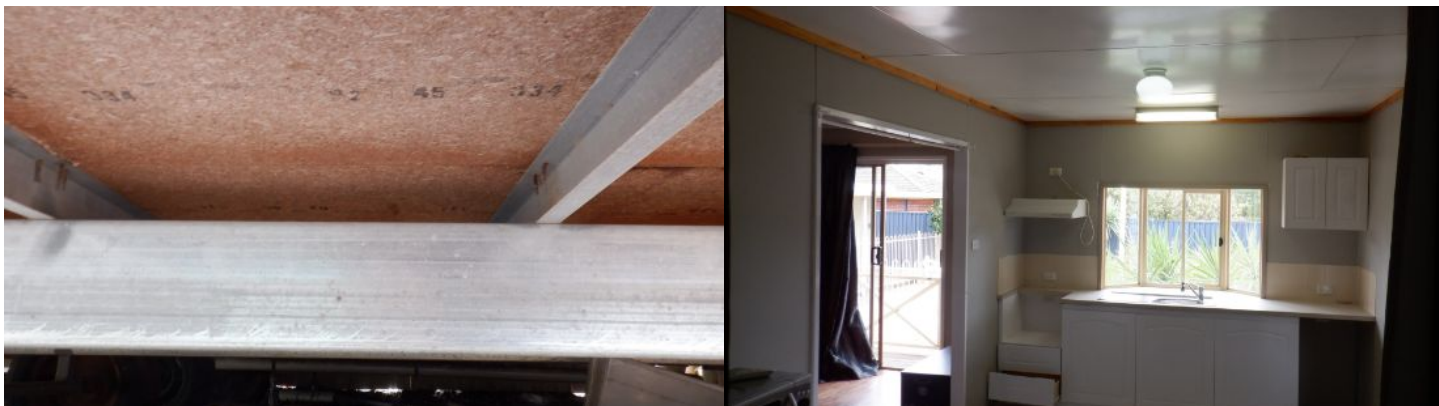
Granny flat floor structure

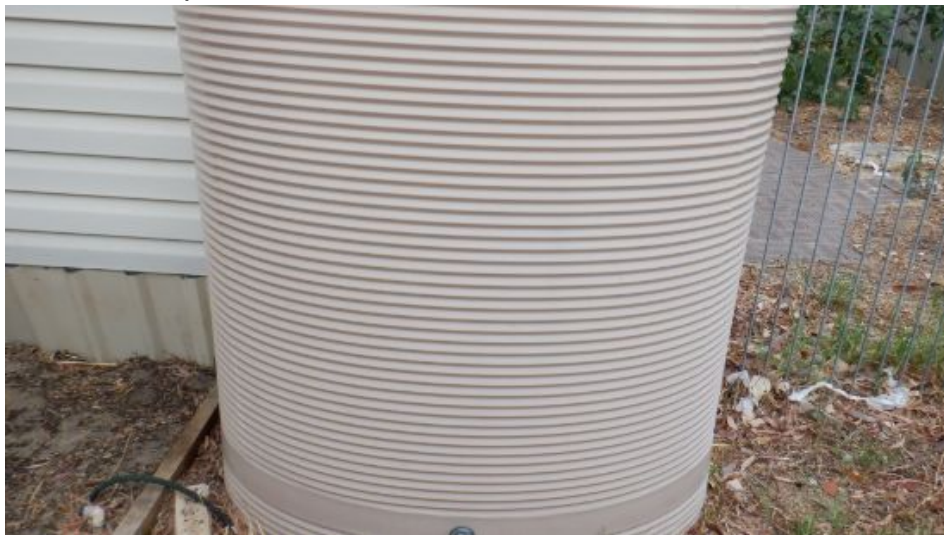
- The water tank appeared serviceable and in good condition at the time of the inspection.

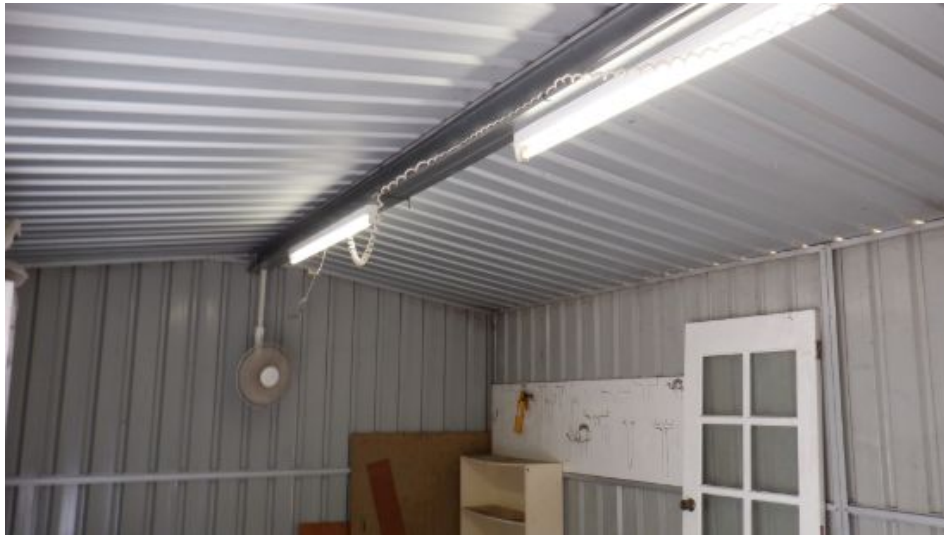
- The rear metal workshop appears to be structurally sound.
